Experimental and numerical analysis of a masonry wall under hydrostatic and debris impact loads

Korswagen, Paul A.; Bricker, Jeremy D.; Jonkman, Sebastiaan N.; Kolen, Bas

Frontiers in Built Environment

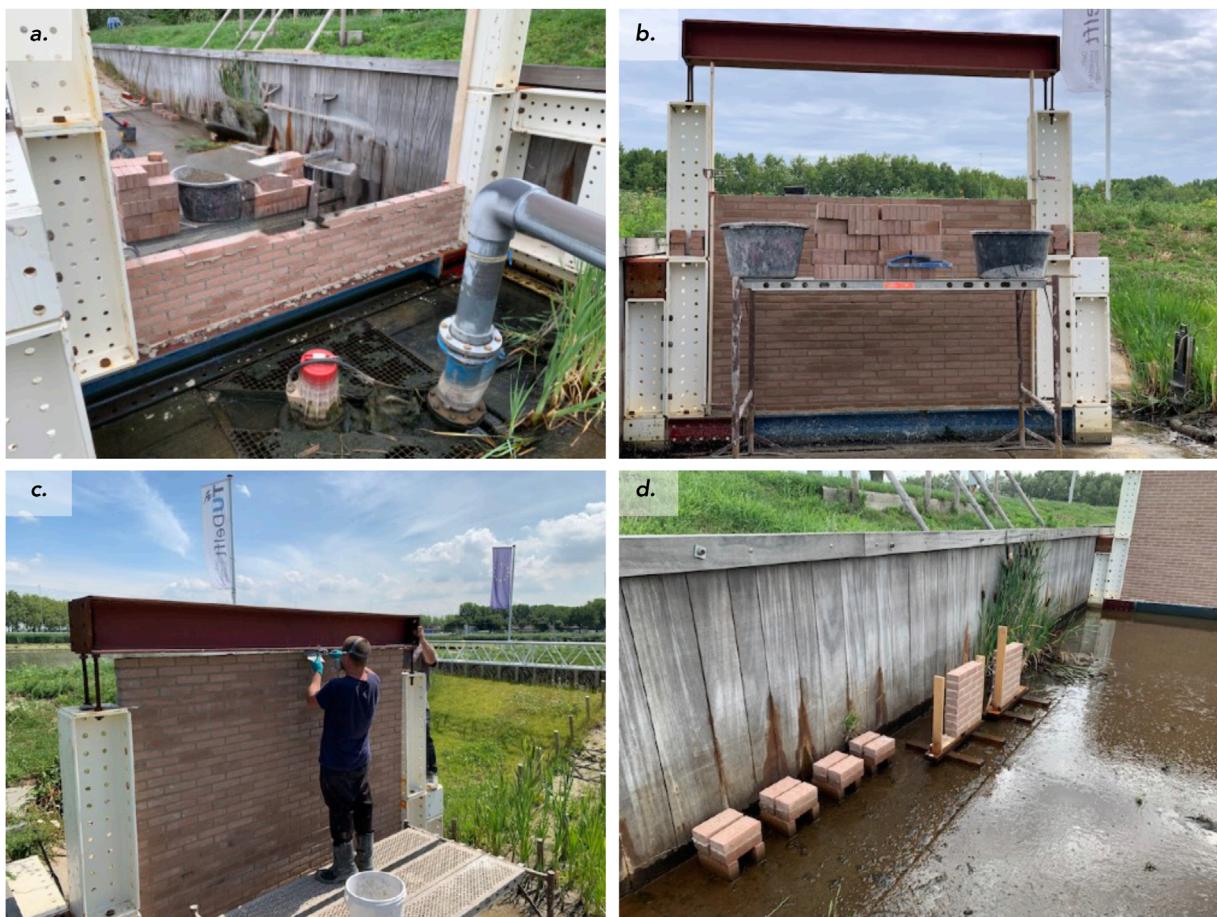
FIGURE 1
Construction process of the masonry wall and companion specimens by professional masons. View from the back (a), and front of the wall (b), including glueing of the last course to the top steel beam (c) and the companion specimens (d).

The wall was laid in a standard stretcher bond pattern, with each course offset by half a brick length. Mortar joints were 10 mm thick, made from a pre-mixed mortar consisting of cement, lime, and sand in a ratio of approximately 1.3:5.5:1 by weight. The water in mortar mix was adjusted slightly on-site to account for weather conditions during construction; see Figure 1.

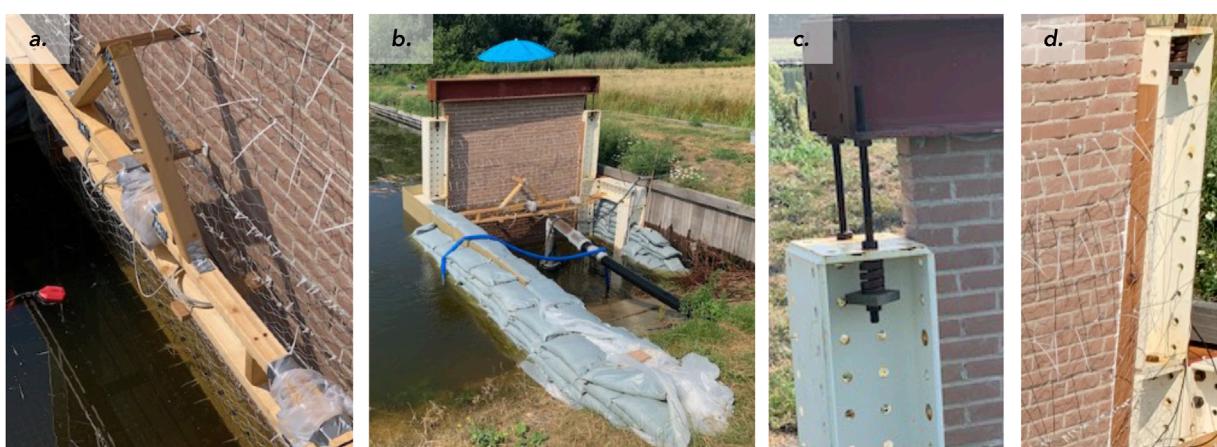
FIGURE 2
Experimental setup with steel rig, instrumentation, and water control system. (a) Timber support for 3 potentiometers, (b) dike made from sand bags and pump, (c) spring for application of vertical force on the masonry wall, and (d) timber support at the sides.

The experimental setup, shown in Figures 1, 2, included a custom-designed steel rig to provide vertical and lateral boundary restraints. Hydrostatic pressure was applied by gradually filling a water basin in front of the wall, while displacement sensors and pressure gauges monitored the deformation response throughout the tests.

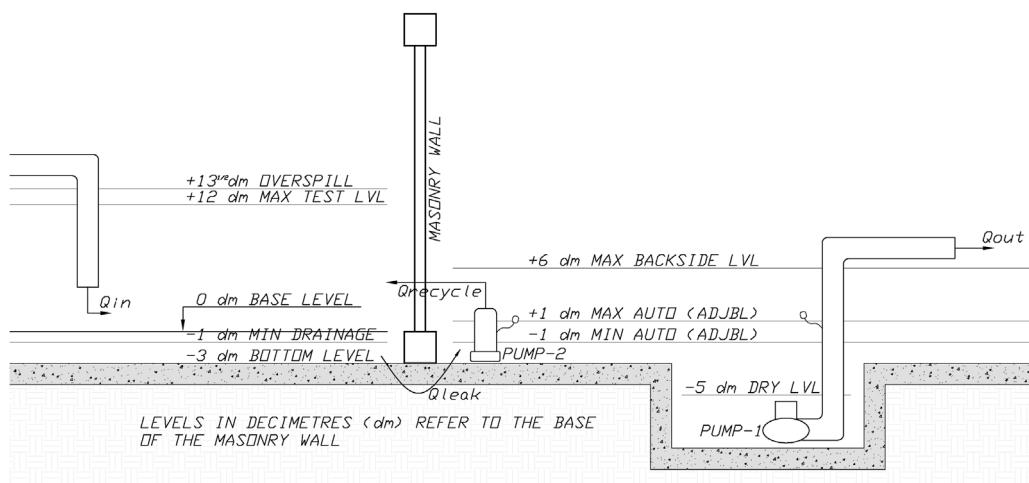
FIGURE 3
Water level control setup and basin arrangement. LVL=Level.

The rig was placed inside a water basin, where hydrostatic pressure was applied by gradually filling the basin with water. The setup allowed creating a head (difference) over the wall. An impermeable sandbag dike, lined with plastic sheeting, was constructed to isolate the back of the test area and allow controlled water level adjustments; see [Figures 2, 3](#). Instrumentation was installed to monitor wall deformation and water levels during the tests, see [Figure 4](#).

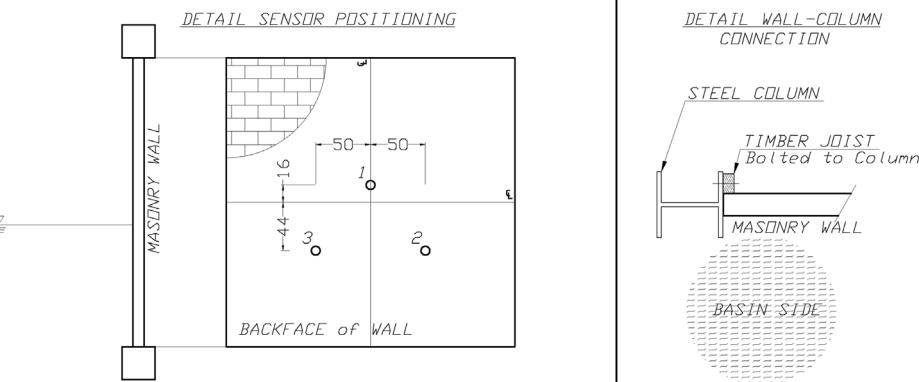
FIGURE 4
Placement of potentiometers on the wall surface. Position of the potentiometers referenced to the centre of the back face of the masonry wall - the lower potentiometers thus at 91 cm from the bottom of the wall. These sensors measure the out-of-plane displacement, i.e. the displacement perpendicular to the face of the wall. Right, detail of the connection between the wall and the lateral steel columns.

- Displacement Sensors: Three potentiometers were positioned on the back of the wall to measure out-of-plane deformations at high precision. These sensors were mounted on a separate timber support structure.
- Pressure Sensors: Two pressure sensors were used to monitor the water levels on both sides of the wall.
- Visual Monitoring: Two cameras, positioned in front of and behind the wall, recorded wall behaviour, overall crack development, and debris impacts at regular time intervals.

small concrete tile, which ultimately settled. The additional leakage meant that Pump #2 (see Figure 4) was insufficient to maintain the prescribed water level difference ($Q_{\text{leak}} > Q_{\text{recycle}}$) and Pump #1 had to be activated.

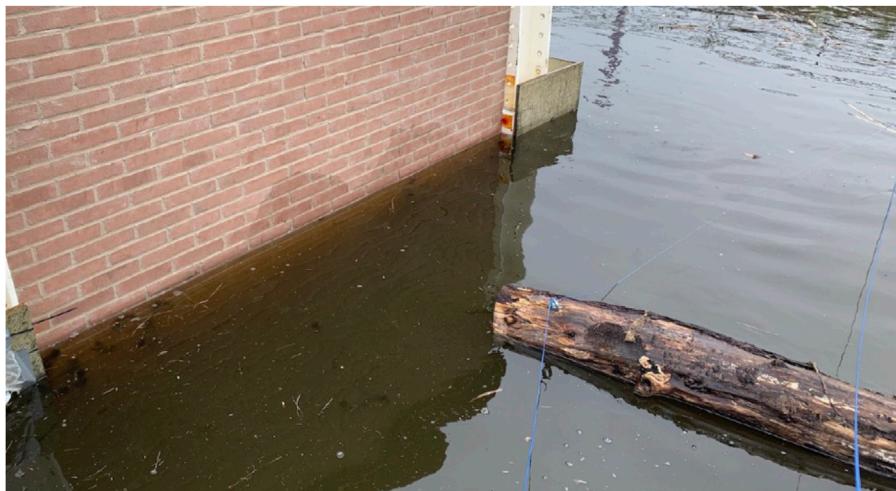
FIGURE 5
Floating tree log setup for soft debris impacts.

Soft debris impacts were performed using a floating tree log weighing approximately 80 kg and accelerated at velocities ranging from 0.5 to 1.8 m/s. Despite repeated impacts at these velocities, the wall exhibited no visible cracking or damage. The

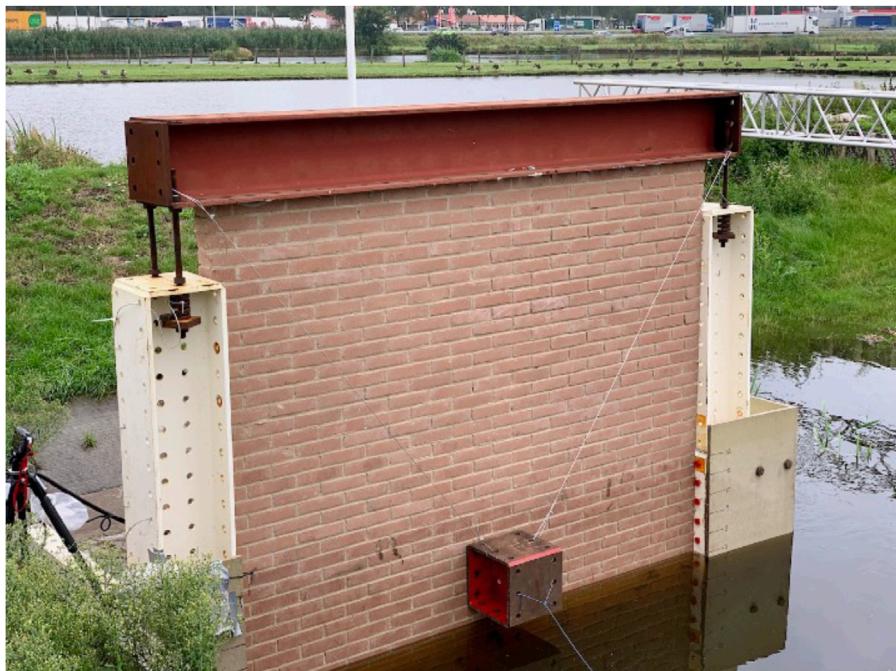
FIGURE 6
Steel cube setup for hard debris impacts.

Steel or “Hard” Debris: A 30 cm steel cube weighing 40 kg (see [Figure 6](#)) was suspended from the top of the rig and swung into the wall as a pendulum. This setup simulated hard, rigid debris such as vehicles or metal objects. The cube's velocity and impact energy were increased progressively, with repeated strikes at the same location to assess cumulative damage. Deformations were measured before and after each impact, and visual inspections were performed to document crack initiation, propagation, and any local failure of the masonry. Hard debris represents typically stiff debris such as vehicles or floating building components; see ([Wüthrich et al., 2024](#)) for an overview of debris carried by the flood in the Ahr Valley in 2021.

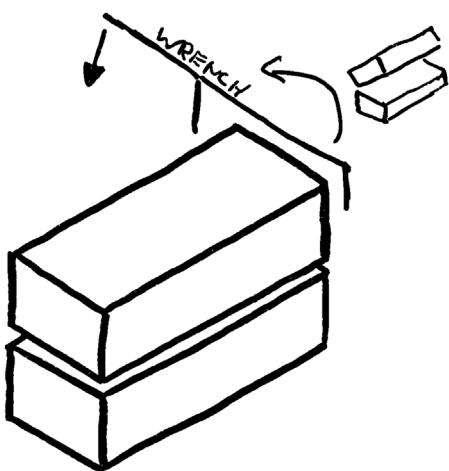
FIGURE 7
Bond-wrench test setup.

To characterise the mechanical properties of the masonry, two types of small-scale tests were performed: 1) Bond-Wrench Tests: These tests measured the tensile bond strength of the mortar joints by applying a bending moment to the brick couplets (see [Figure 7](#)). The results were used to estimate the flexural strength of the wall in the vertical direction. 2) Compression Wallet Tests (see [Figure 8](#)): Two compression wallets were tested vertically to determine the masonry's compressive strength, Young's modulus,

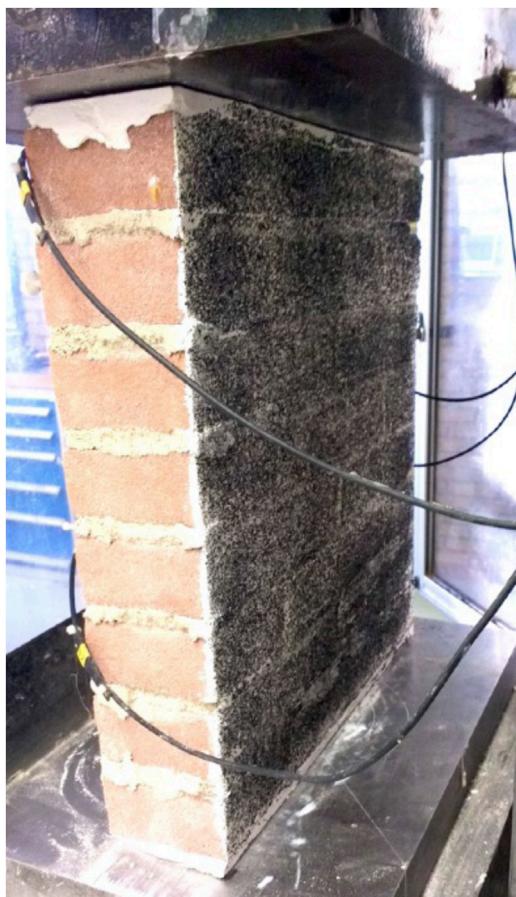
FIGURE 8
Compression wallet test in testing rig with Digital Image Correlation (DIC) black-and-white pattern.

and fracture energy (Jafari et al., 2017). These properties were critical for the calibration of numerical models. The companion material tests were performed in accordance with NEN-EN 1052-1 for compressive strength and stiffness determination, and NEN-EN 1052-5 for the tensile bond strength *via* the bond wrench method.

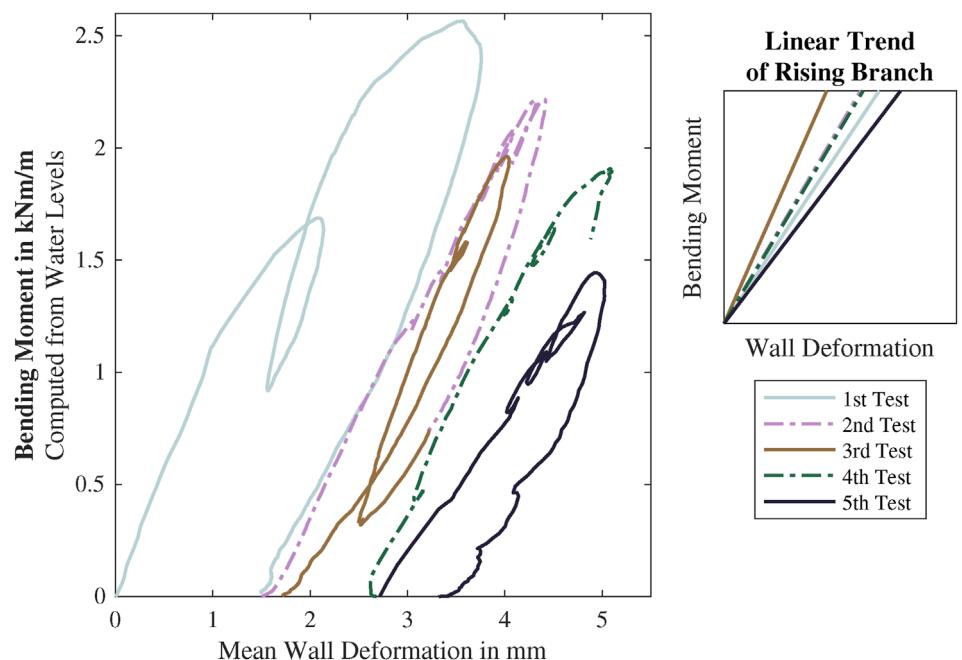
FIGURE 10
Accumulation of residual deformation across successive tests. Bending-moment against wall deformation. The moment is determined based on the difference between outer and inner water levels which, through hydrostatic pressure, cause out-of-plane bending on the wall.

The wall exhibited permanent deformations after each test, indicating damage due to non-linear effects such as cracking. These residual deformations, which remain after loading is withdrawn, were particularly evident following tests with sustained water levels or slow drainage. For instance, the wall did not fully return to its original shape after being subjected to 125 cm of water pressure. Subsequent tests revealed a progressive degradation of stiffness. The stiffness relates the force needed to produce a certain deformation. The degradation meant that deformations increased more rapidly for similar water levels in later stages of testing; see Figure 10. Here, the loading (rising water) and unloading of the wall are represented with the deformation (on the horizontal axis) and the internal bending moment resulting from the applied hydrostatic pressure. The figure shows how earlier tests generally display a higher stiffness (or steeper slope) in this force-displacement diagram. Mainly, the plot emphasises that later tests also start at an accumulated displacement following earlier tests.

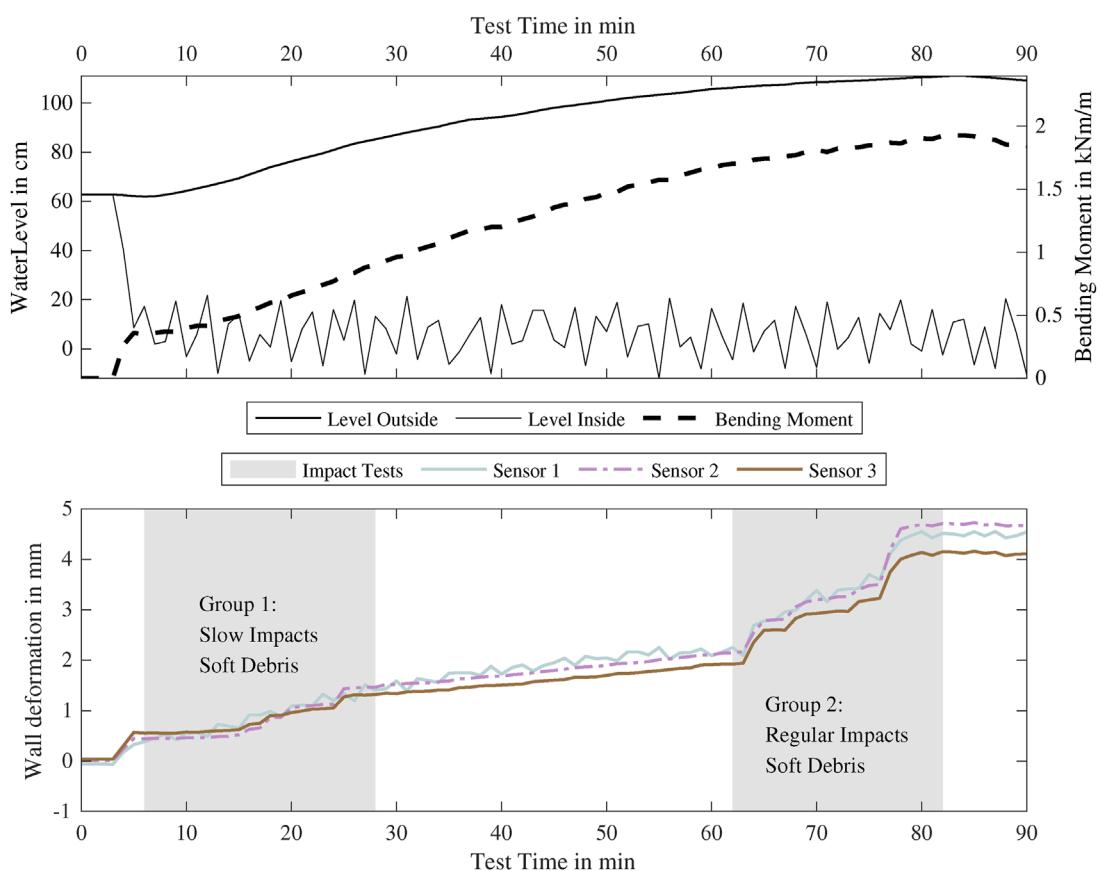
FIGURE 11
Deformation of the wall after impacts.

measured deformations before and after the impacts, see Figure 11 were negligible, with no significant increase in residual displacement. The impacts took place between 70 and 100 cm of water level (head) difference.

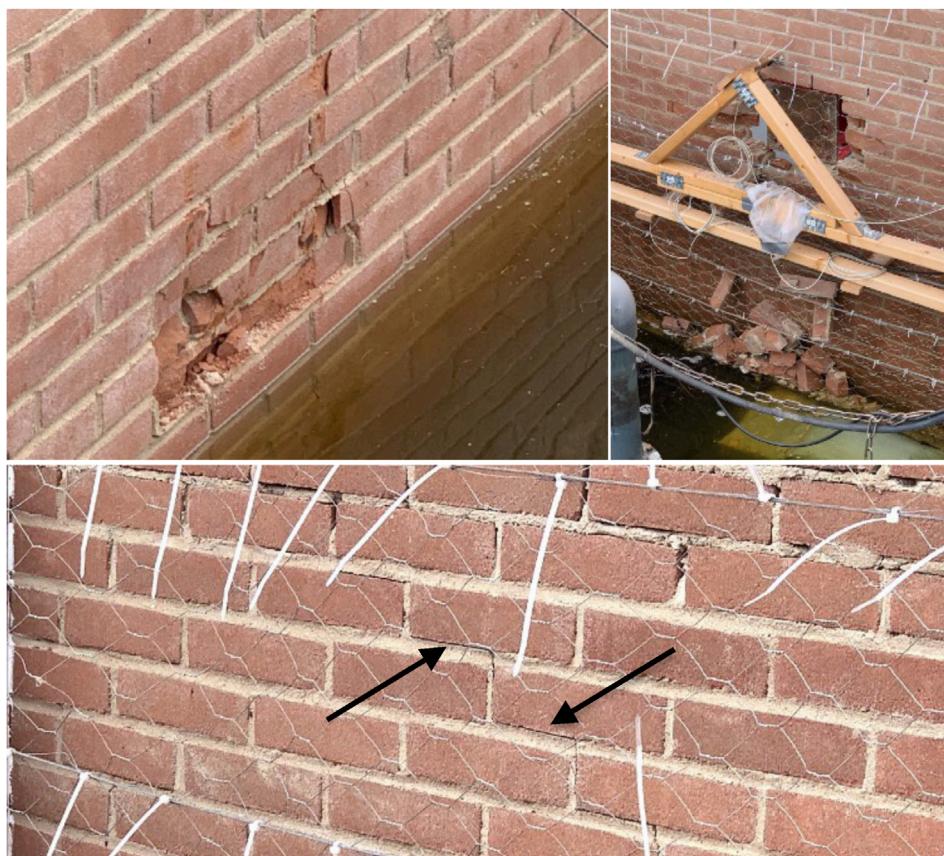
FIGURE 12

Localised failure and crack pattern after steel cube impacts. Left, local damage of the bricks led to a hole in the wall, right. The broken and displaced bricks were trapped by the steel net. Diagonal stair-like crack pattern from the centre going upwards.

In contrast, the impacts from hard debris had a more severe effect on the wall's structural integrity. A 30 cm steel cube weighing 40 kg was suspended as a pendulum and swung into the wall at increasing velocities, reaching up to 3 m/s. The impacts concentrated energy into a small area of the wall, producing localised damage and progressive cracking (see Figure 12).

During the early impacts, strong vibrations were observed, propagating through the testing rig and dissipating over time. As the impacts continued, diagonal cracks developed in a staircase pattern originating from the point of impact and extending toward the edges of the wall. Cracks appeared at the brick-mortar interface and their progression was most prominent in the lower half of the wall, where hydrostatic pressure added to the stress - water seeped-in through

Repeated collisions eventually led to localised failure of the masonry, as the bricks in the impact zone crushed and displaced. A visible hole formed after dozens of impacts, at which point the wall's residual deformation exceeded the range of the displacement sensors.

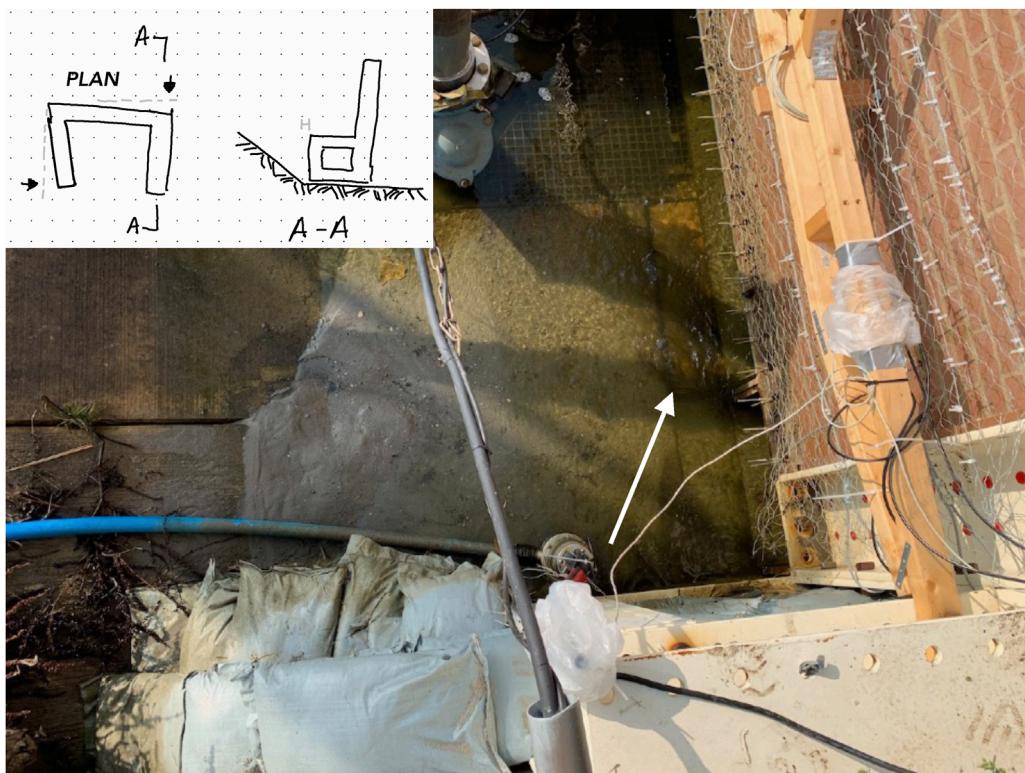
FIGURE 13

Water leakage and rig displacement effects. Small concrete tile (indicated with arrow) and sand scoured from underneath it. Scheme showing displacements of the frame due to the hydrostatic pressure.

During the experiments, minor water leakage was observed around the wall and the testing rig, despite efforts to minimise it with silicone seals and a plastic-lined sandbag dike (see Figure 13). Over time, water seeped through small gaps between the concrete basin plates, creating a piping effect beneath the rig. This phenomenon caused local erosion of the sand beneath a

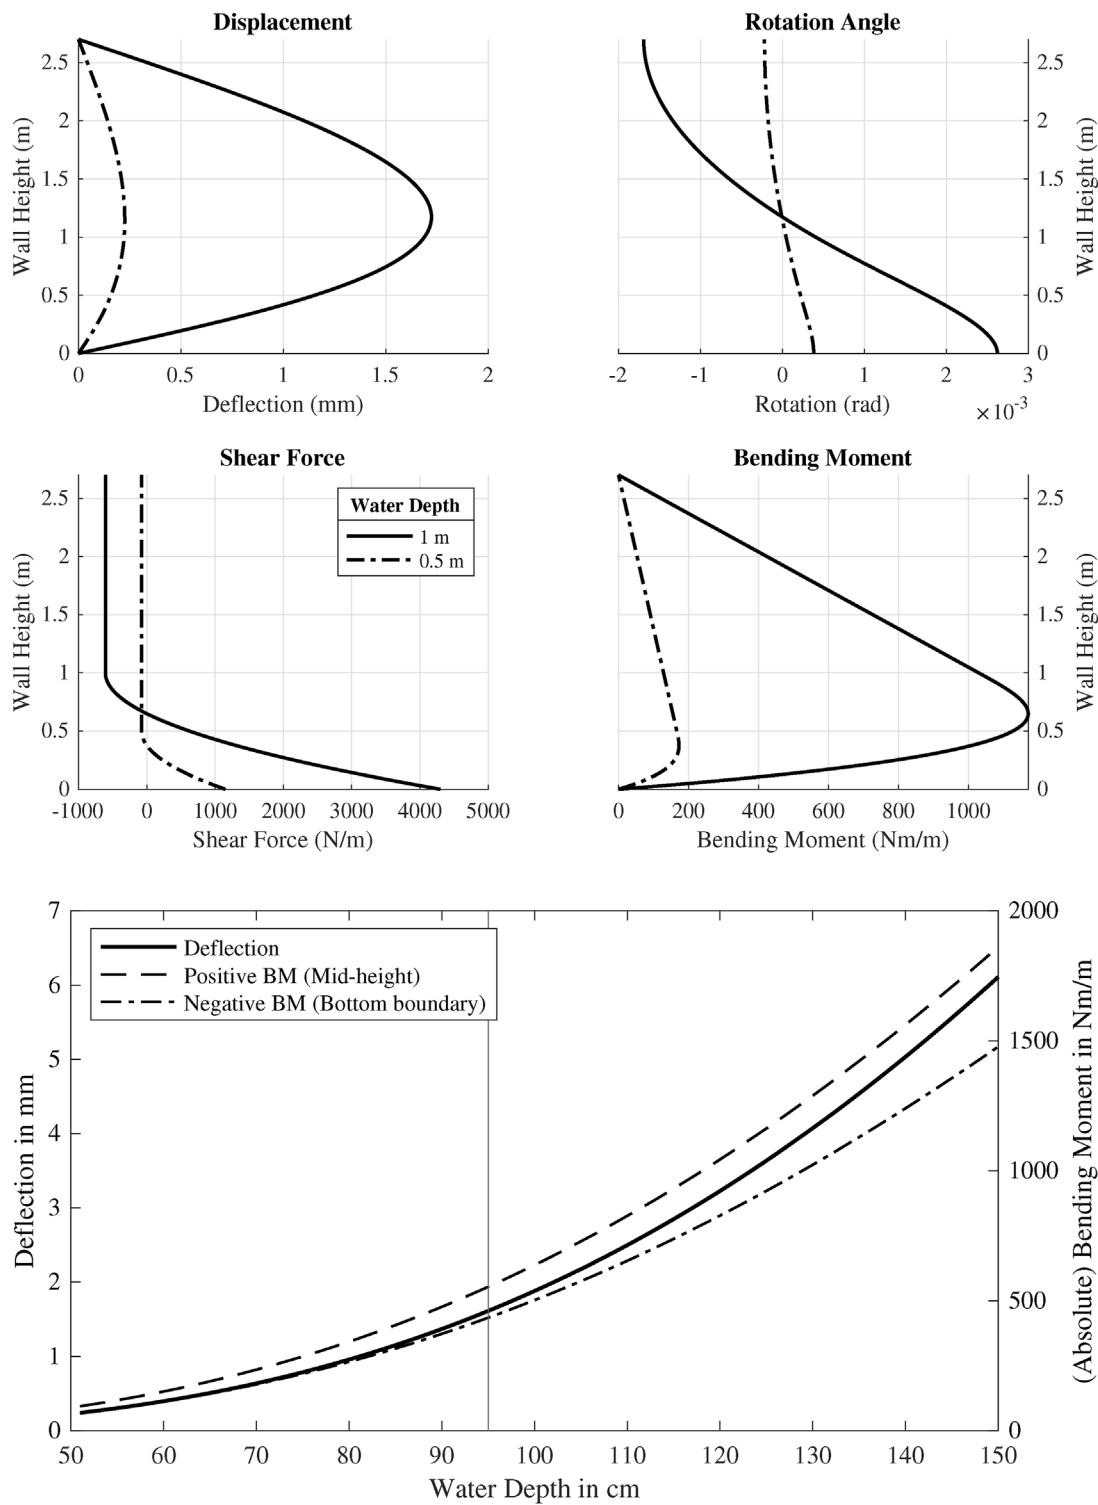
FIGURE 14

Analytical model results – water depth vs. bending moment and deflection. Deflection, line rotation, bending moment and shear force against wall height for a water depth of 0.5 and 1m. Maximum deflection, positive and negative (at supports) bending moments for various water depth values.

Visual inspection revealed no significant cracks during the early stages of testing. However, as water levels exceeded 90 cm, small cracks began to form in the mortar joints. These cracks were primarily concentrated in the bottom third of the wall, where the hydrostatic pressure was highest. Note that the hydrostatic pressure increases with depth and is thus maximum at the bottom of the wall; however, the bending moment is highest at the bottom third of the wall, see later Figure 14.

The analytical results showed that the wall would fail at a water depth between 80 and 95 cm, depending on the assumed flexural strength and boundary stiffness since the acting bending

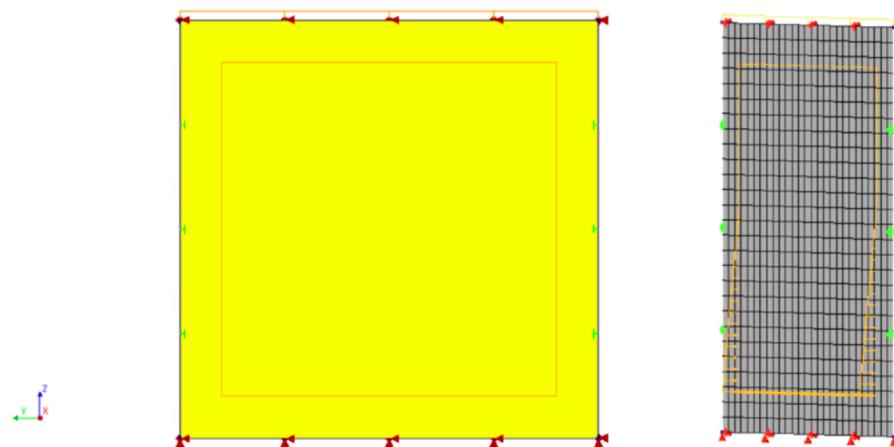
FIGURE 15

Finite element model setup – mesh, boundary conditions, and loading. Right, 3D view in perspective to show perpendicular hydrostatic pressure as a triangular pressure in color orange.

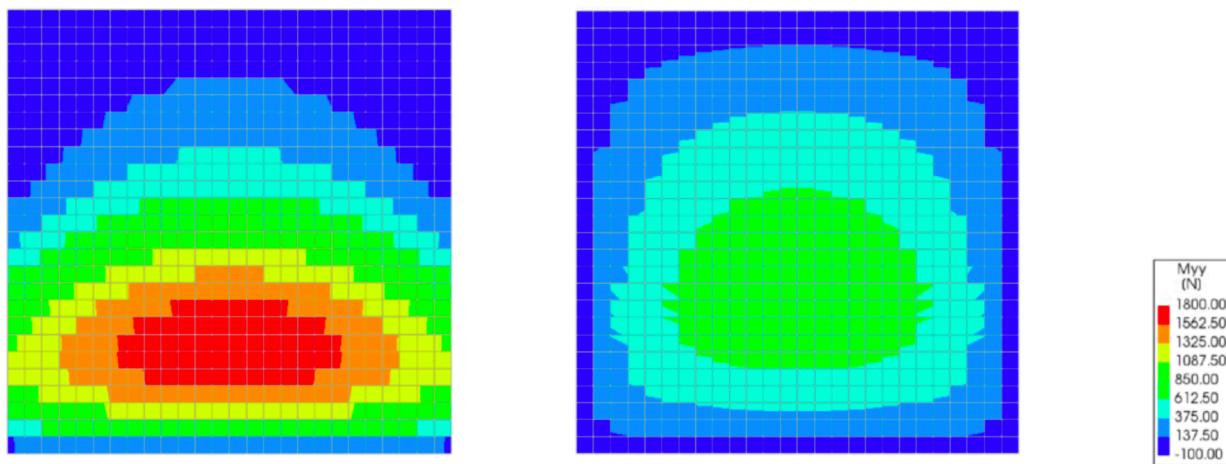
FIGURE 16

Comparison linear FE model deformations. Bending moment distributions for vertical (left) and horizontal (right) bending. Values are expressed in the same scale and in Nm per metre stretch for the case of 140 cm of water.

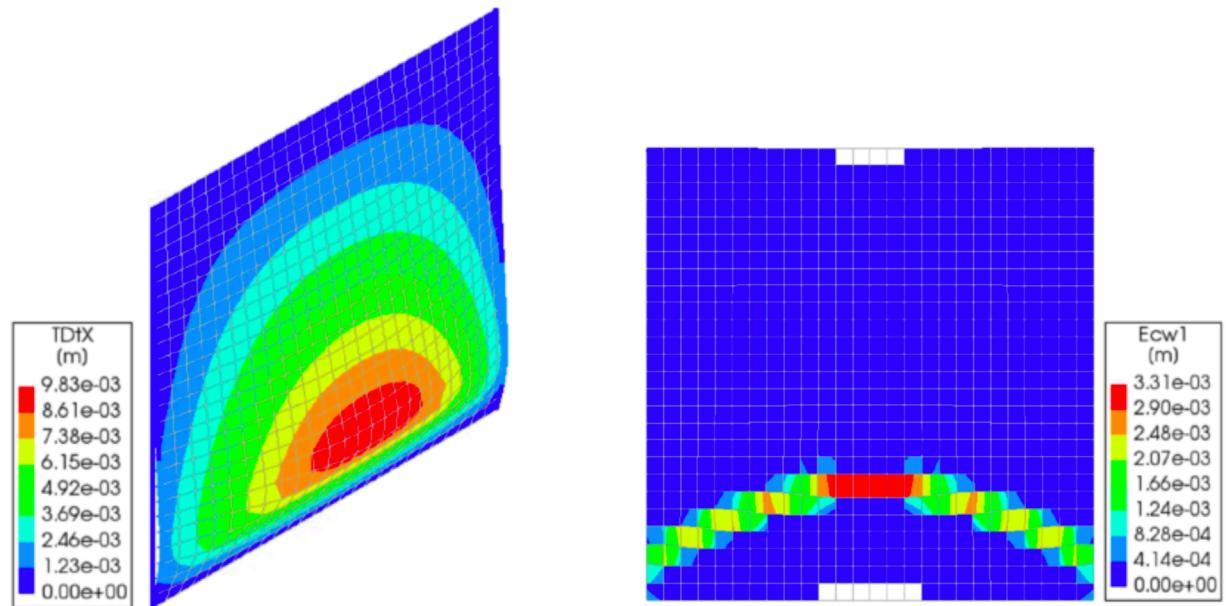
FIGURE 17

Non-linear FE model results – crack patterns and deformation. Two-way bending at a water depth of 130 cm.

Two-Way Bending (Model D): When lateral translational stiffness was included to mimic the timber supports, the wall exhibited a more gradual response under loading. Horizontal cracking developed in the bottom third of the wall, where hydrostatic pressure was greatest, while stress redistribution to the stronger horizontal bending direction increased the wall's load-carrying capacity; see Figure 17. At a water depth of 130 cm, the wall deformed by approximately 10 mm, with crack widths reaching 3 mm. Increasing the

water depth to 140 cm led to further widening of the cracks and a large increase in deformation, signalling imminent failure.

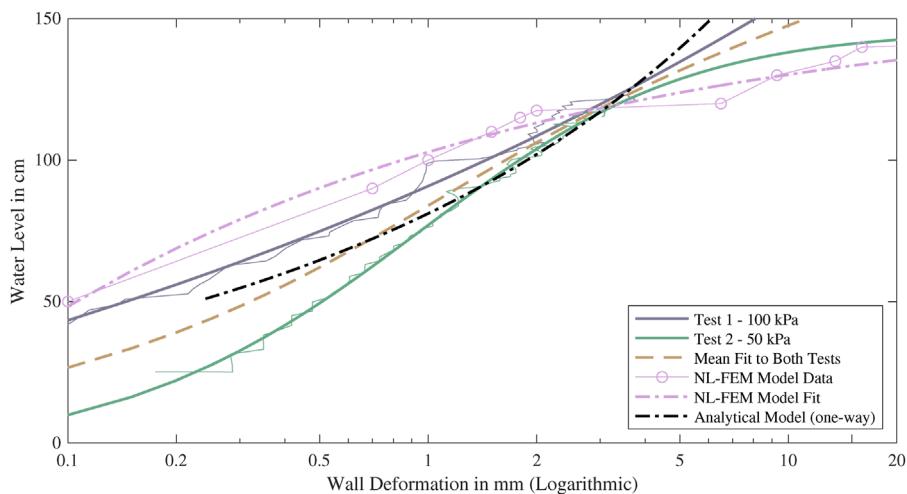
FIGURE 18

Experimental vs. numerical deformation trends. Comparison between Model D and experimental data. Data points from the models are included (Model Data) and fitted with a smooth curve.
