# Prognosis of Structural and Materials Health in Heritage Conservation

Roger M. Groves<sup>1</sup>

<sup>1</sup>*Aerospace Non-Destructive Testing Laboratory, Faculty of Aerospace Engineering,  
Delft University of Technology, Delft 2600 GB, The Netherlands*

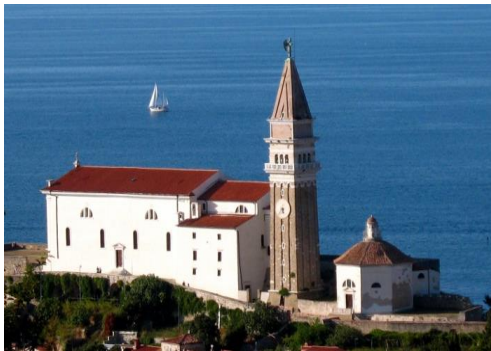
Figure 1. (a) View of the southern side of the church complex. (b) View of the east side of the interior with the high altar present at the end of the nave.

The church is situated close to the sea and is subject to both salt and moisture ingress from the maritime climate. Recent renovations have improved the condition of the buildings, as can be seen from the photos of the exterior and interior of the main church. Viewing the baptistery, the octagonal building on the right of Figure 1(a), reveals that the external plasterwork is subject to attack in the maritime climate, shown more clearly in Figure 2(a). Zooming in on the bronze statue of the Archangel Michael on the top of the bell tower, see Figure 1(a) and Figure 2(b), shows copper-bronze corrosion. Further the stonework below the statue shows additional damage as cracking and structural damage to the stonework and possibly biological attack also. Apart from the green appearance of the statue, the damage to the statue and stonework is not visible from the ground and extensive scaffolding would be needed to carry out an assessment of the conservation needs. Future deterioration to these objects could cause the loss of both structural and cultural details for future generations.

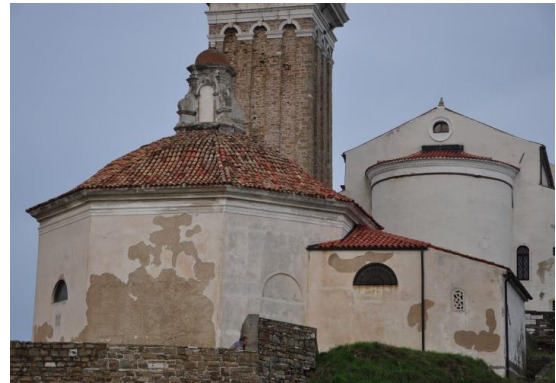
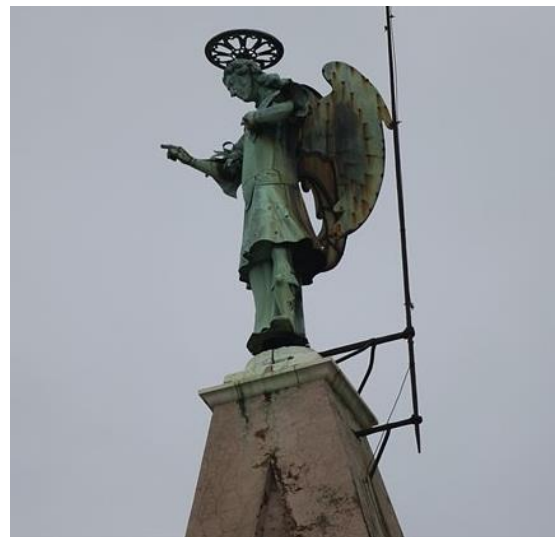
Figure 2. (a) View of the eastern side of the complex, with loss of plasterwork. (b) Close-up view of the bronze statue of Archangel Michael atop of the bell tower.
