Mechanochromic and Conductive Sensing for Crack Detection in FRP-Strengthened Concrete

An experimental study of self-sensing techniques for structural health monitoring

MSc Thesis

Faculty: Faculty of Civil Engineering and Geosciences, TU Delft

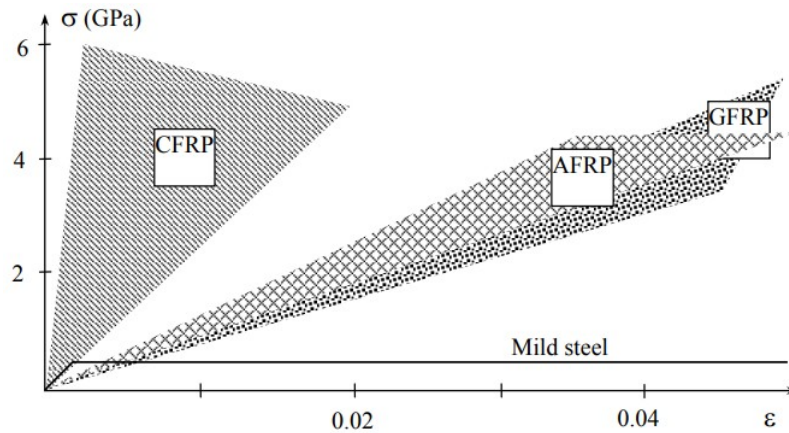
Figure 2.2: Stress-strain diagram for different unidirectional FRPs and steel. (CFRP = carbon FRP, AFRP = aramid FRP and GFRP = glass FRP) [17]

FRP is used as strengthening material for reinforced concrete (RC). The reasons why FRP is used as strengthening are: high corrosion resistance, low weight, no need for scaffolding systems, reduction of labor costs, and tailorable to the design requirements. Disadvantages of using FRP for strengthening are composites are in general linear elastic to failure, which reduces the ductility. Also the thermal expansion coefficients from carbon or aramid are different to those of concrete. Exposure to high temperatures can cause early degradation and collapse. Therefore, steel reinforcement should not immediately be replaced by FRP, but this should depend on factors such as mechanical performance, constructibility, and long-term durability. Retrofitting concrete structures on global level by FRP is usually done as Externally Bonded Reinforcement (EBR) to enhance the shear, flexural or compression capacity of structural element. FRP retrofitting is in recent years often used in seismically active regions, due to its fast and flexibel way to strengthen a damaged structure [17][19]. The stress-strain diagram for unidirectional composites is shown in figure 2.2 to make a comparison with steel. It can be seen that the ultimate stress is higher for FRP than for steel.

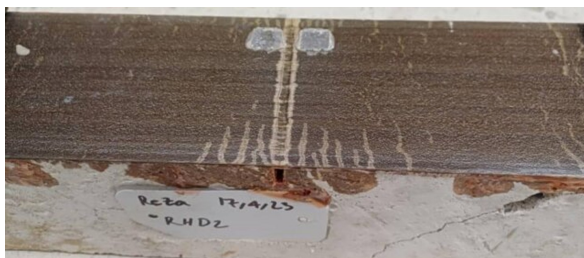
Figure 2.6: Mechanochromic effect on retrofitted concrete beam [7]

In this study five glass layers, one carbon layer, and one top glass layer are used to retrofit the concrete. The first five additional glass layers are used to flexurally strengthen the concrete more. YSH-90 carbon fiber and S-glass prepreps with Epoxy Hexply@913 were used. It was shown that the mechanochromic effect can be used both to detect cracks in the concrete and to strengthen it [7]. In Figure 2.6 the mechanochromic effect on the retrofitted concrete beam can be seen after testing. Figure 2.7 shows the results that are obtained with four-point bending tests for different test groups.

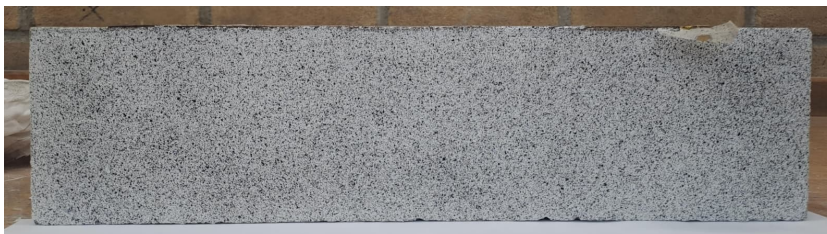
Figure 3.9: Stochastic pattern applied over the full length of the beam

Each specimen is first coated with two layers of white paint to form a uniform base layer. Subsequently, a stochastic black speckle pattern was applied using a spray gun on one side of the specimens, covering the entire length and height of the beam, shown in Figure 3.9. During testing, images were captured using a 50 MP Canon 5D camera with a 50 mm lens and ISO 100 setting. The accuracy of the measurements depends strongly on lighting conditions. Therefore, a flash was used for each image to ensure consistent illumination. However, due to reflections from surrounding steel components, images could only be recorded at intervals of five seconds.

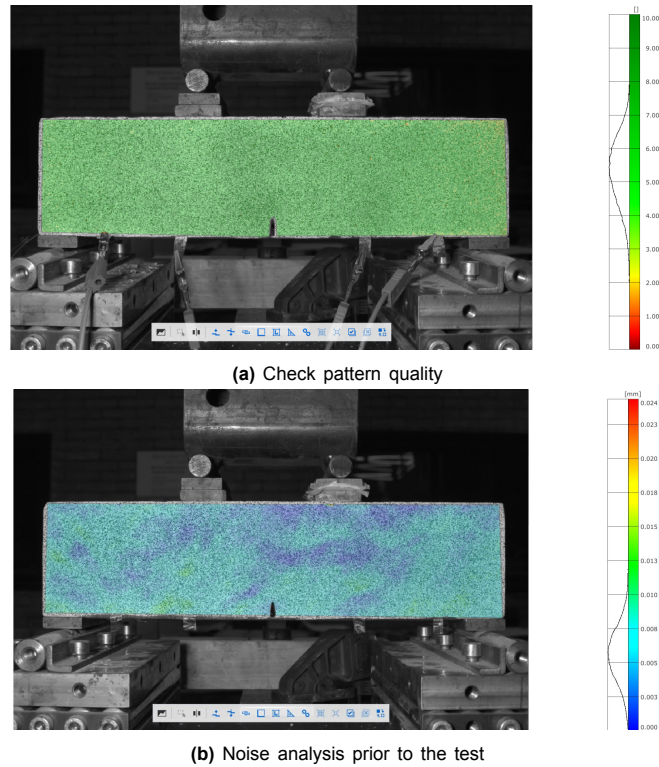
Figure 3.10: Overview of DIC preparation: (a) check pattern quality and (b) noise analysis prior to testing.

The DIC software *Zeiss Correlate* is used to compare the speckle patterns at different loading stages and to compute the displacement, strain, and deformation fields. A facet size of 19 pixels and point distance of 12 are used. Prior to each test, the quality of the applied speckle pattern is verified in *Zeiss Correlate*, as shown in Figure 3.10a, and adjustments were made when necessary. A mean value above 5 is accepted for these experiments. In addition, two images were captured before the start of each test to perform a noise analysis, with the maximum measured displacement used to assess the background noise level, shown in Figure 3.10b. It can be seen that the difference in displacement is below 0.013 mm, which is considered to be acceptable for all beams.

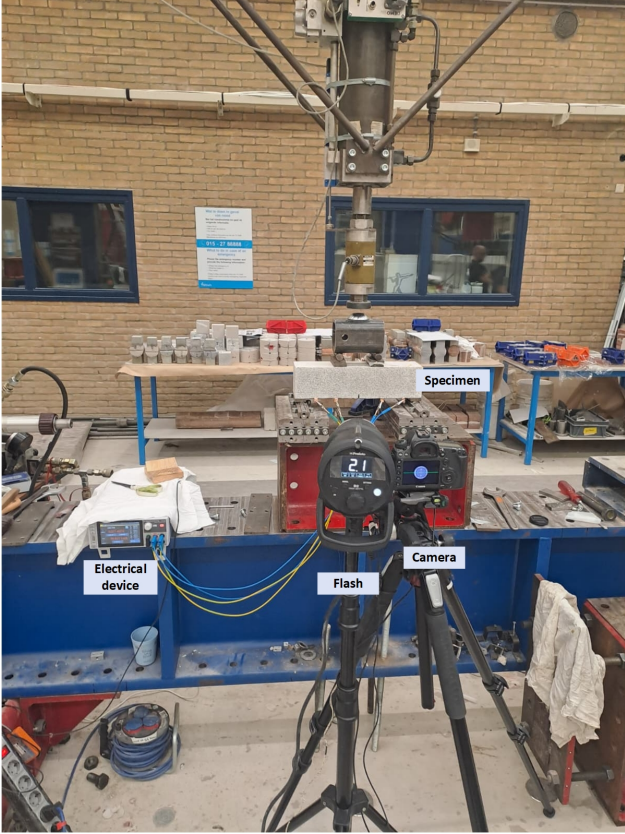
Figure 3.16: Test set-up Iteration 1

The electrical device used is the Rohde Schwarz NGU401, with similar settings when testing the samples. Four cables with alligator clips are used to connect the device with the copper strips. The complete set-up of the testing is shown in Figure 3.16.

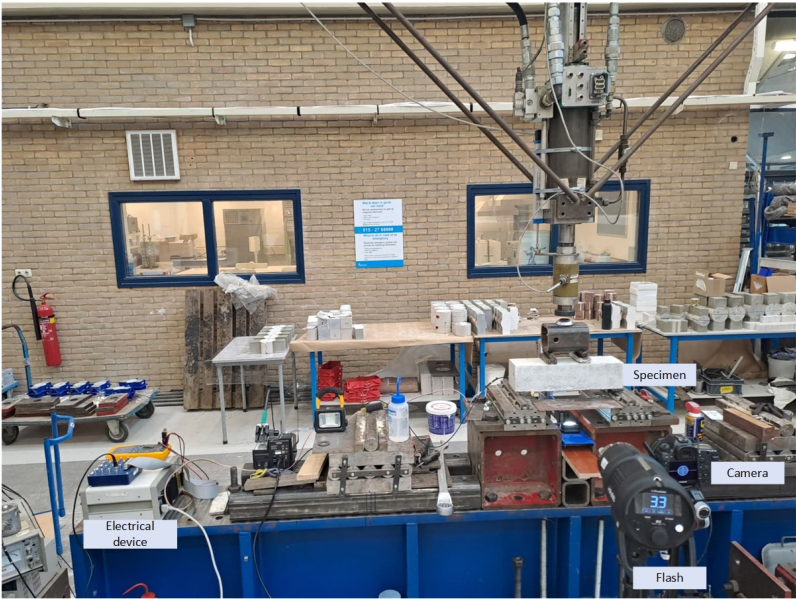
Figure 3.21: Test set-up Iteration 2

Some modifications were made in Iteration 2 of the experiments. As mentioned in Section 3.7.2, the electrical setup was different. Instead of using alligator clips, a soldered connection was made. In addition, a laser setup was used to more accurately measure the specimen’s deflection during loading. A 3D-printed plate was also fabricated to allow the specimen to be recorded from below, enabling observation of any color changes during the experiment. To ensure a sharp video, an additional light source was placed beneath the specimen to improve camera focus. The set-up can be seen in Figures 3.21, 3.22a and 3.22b.

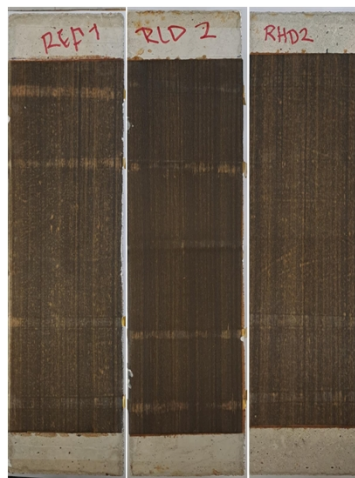
Figure 4.1: Three specimens after curing with different visibility in color stripes

After manufacturing the retrofitted specimens, as described in Section 3.6.1, each specimen is carefully inspected. During inspection, hollow sounds were detected when tapping on the composite surfaces, with the intensity of sound varying among specimens. These sounds were accompanied by uneven surface profiles, particularly in the areas between the inner and outer strips. The occurrence of hollow sounds and surface irregularities may indicate bonding issues between the concrete substrate and the composite layer. In addition, visible stripes corresponding to the copper strips were observed after curing. The degree of visibility differed between specimens. More orange-colored speckles were also noted, likely originating from the glass prepregs. Although the copper strips were placed beneath the black carbon prepregs, their visibility, along with the orange speckles, suggests that the carbon fibers may have opened locally, exposing the underlying materials. Figure 4.1 presents three specimens to illustrate the differences in copper strip visibility.

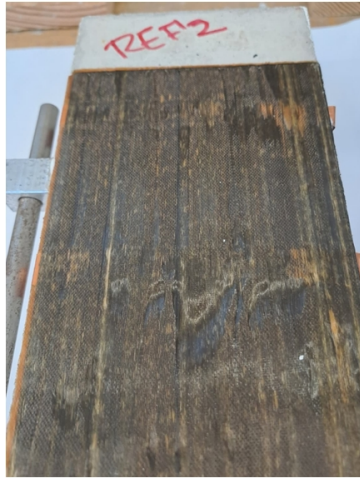
Figure 4.2: Indentations in REF 2 sample after curing

The elevated initial resistance of REF 2 is likely related to variations in the prepreg material, which may contain minor initial defects. Directly after curing, REF 2 exhibited visible indentations, as shown in Figure 4.2. These indentations can contribute to the higher measured resistance. In no other sample, these kind of indentations were observed.

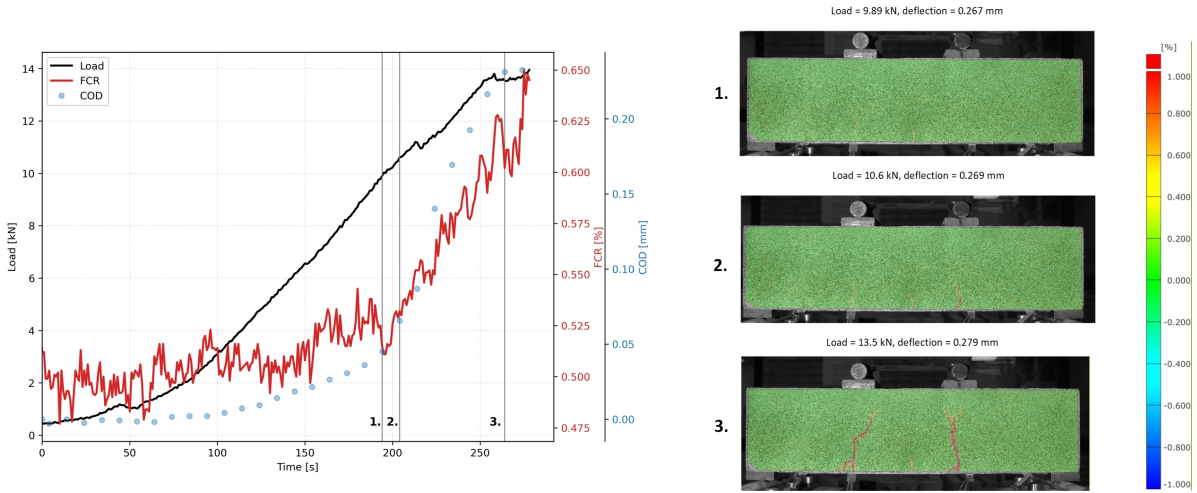
Figure 4.10: REF1: Load, FCR, COD vs Time with DIC images

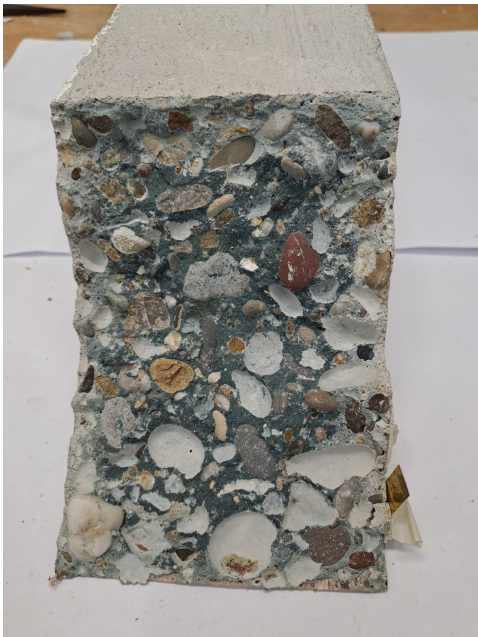
Figure 4.22: Cross section specimen 2-REF1 with glued support plates after testing

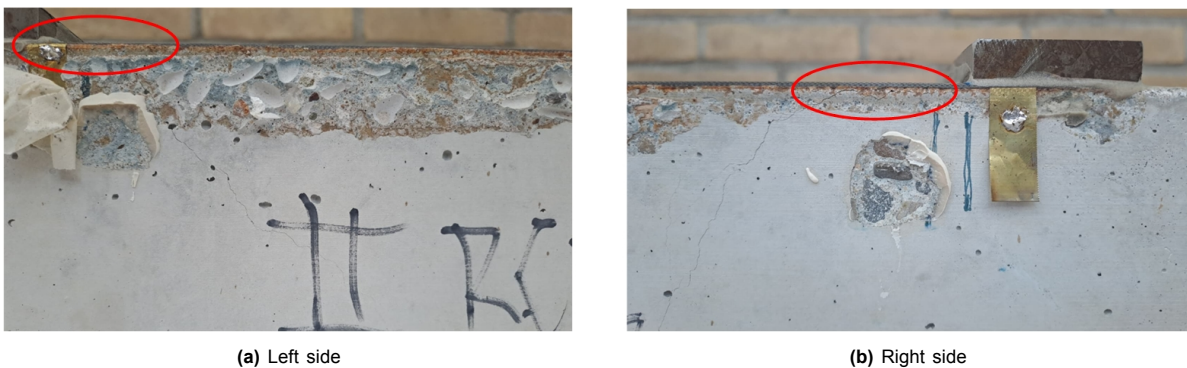
Figure 5.2: Post-test images of Specimen 2-REF3 showing delamination in the regions highlighted with red circles.

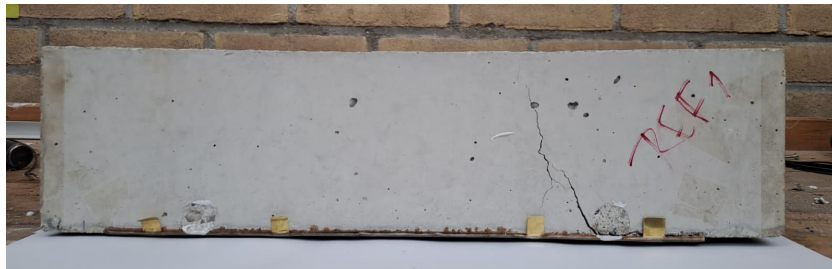
Figure D.1: Specimen REF1 after testing

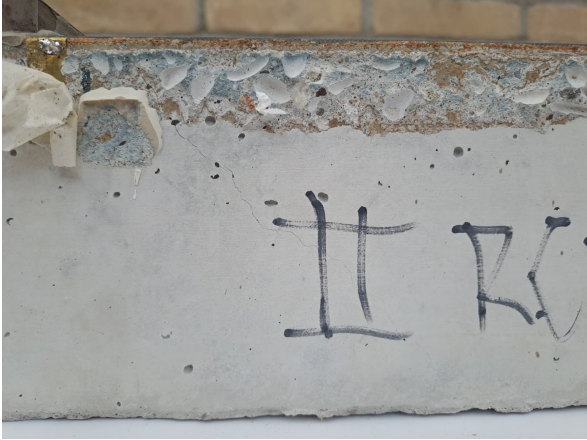
Figure D.13: Close up crack

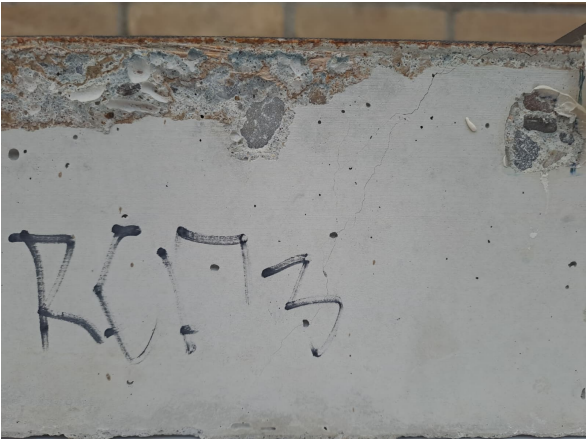
Figure D.14: Close up crack, including crackline along composite
