# Numerical investigation into the effects of corrosion on the shear performance of pretensioned bridge girders with cast-in-place slabs

Corrosion and shear cracking are frequently observed near supports of pretensioned bridge girders in coastal climates, so non-linear finite element analysis was used to study the effect of corrosion on shear performance in a real case study. Varying degrees of corrosion and various locations (top strands, bottom strands, vertical stirrups and girder-slab interface) were considered. The analyses included construction phases, concrete creep and shrinkage, and the effects of corrosion on the properties of prestressing and reinforcing steel, concrete, and the bond between concrete and reinforcement. The study shows that high (20%) corrosion in the bottom layer of strands can modify the failure mode from concrete crushing in the web to strand slippage or crushing of concrete in the support zone with limited cracking. Although severe strand corrosion significantly compromises girder capacity and ductility, failure occurs only when there is overloading. The predicted failure mode was also sensitive to material parameters, in particular the corrosion-ind

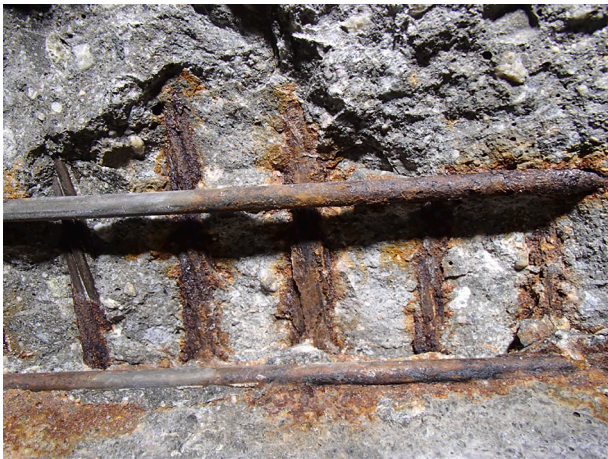
Fig. 7. Corrosion in the bottom layer of strands found near the middle support in an NIB girder in Hafstrfjord Bridge near Stavanger.

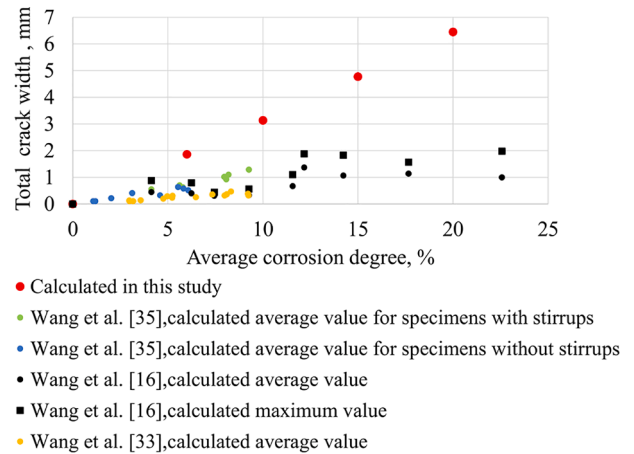
**Fig. 14.** Total corrosion-induced crack widths in pretensioned elements recorded from experiments.

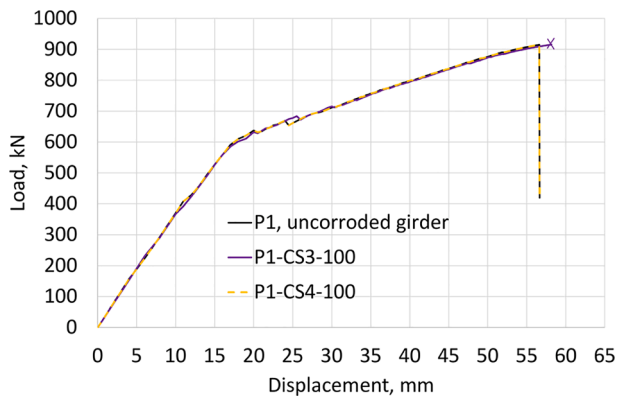
**Fig. 24.** Load-displacement curves obtained for the uncorroded girder (P1), the girders with corroded top strands (P1-CS3-100), and the girders with corrosion in the extended stirrups (P1-CS4-100).

Considerable corrosion in the top strands (P1-CS3-100) or in the extended stirrups near the support (P1-CS4-100) affects neither the capacity of the NIB girder nor its failure mode, see Fig. 24. The partial loss

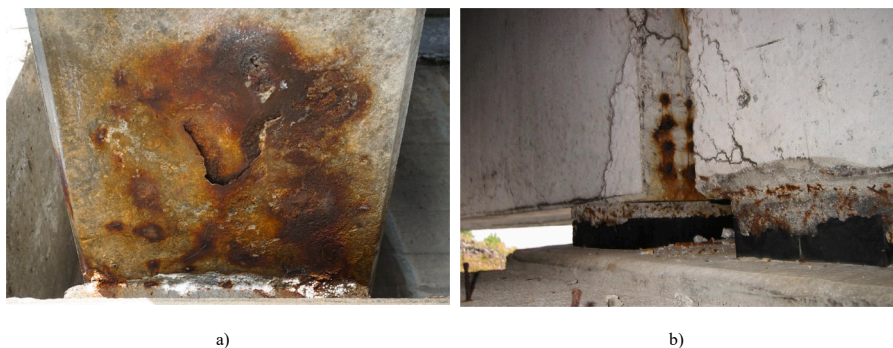
Fig. 30. Corrosion cracking in bottom of pretensioned girders: a) significant corrosion cracking in the NIB girder bottom flange near support, bridge close to Kristiansund; and b) corrosion cracking and spalling in the NIB girder-ends, photo by NPRA [7].
