Evaluation of Potential Use of Vegetation for Erosion Abatement Along the Great Lakes Shoreline

by
V.L. Hall and J.D. Ludwig

MISCELLANEOUS PAPER NO. 7-75
JUNE 1975

Prepared for *1909. 1295*
U.S. ARMY, CORPS OF ENGINEERS
COASTAL ENGINEERING
RESEARCH CENTER

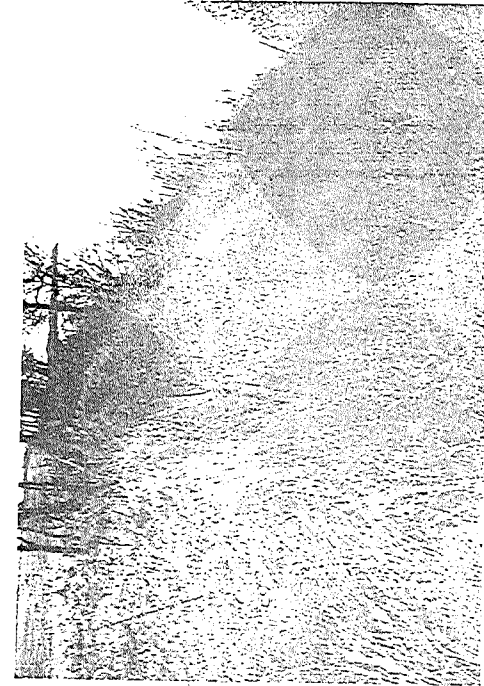
Figure 6. Lake Michigan bank erosion caused by seepage through sand and gravel layers in the glacial till (left). Dewatering, bank reshaping, and seeding to prevent erosion by runoff has stabilized bank recession (above). (Courtesy of Soil Conservation Service.)

The Soil Conservation Service at Kewaunee, Wisconsin, has successfully stabilized shores by dewatering the glacial till, sloping the face of the bluffs, and seeding the reshaped slopes (Fig. 6). In this case, dewatering is the key factor and is essential to control erosion caused by seepage.

Land alteration has proved essential for controlling shore and bank erosion in many areas of the Great Lakes. Near Kewaunee, Wisconsin, for example, seepage contributes to bank failure along Lake Michigan. The Soil Conservation Service has successfully installed a deep tile line to intercept seepage and conduct the underground water to Lake Michigan. The banks were reshaped to an approximate slope of 2:1 and the soil was seeded with a mixture of crown vetch and fescue to control surface runoff. Similar dewatering has been effective in urban and rural areas. The work is costly, especially on high banks. In time, if seeding has successfully stabilized soil on the banks, native plant species invade and become established along with planted species.

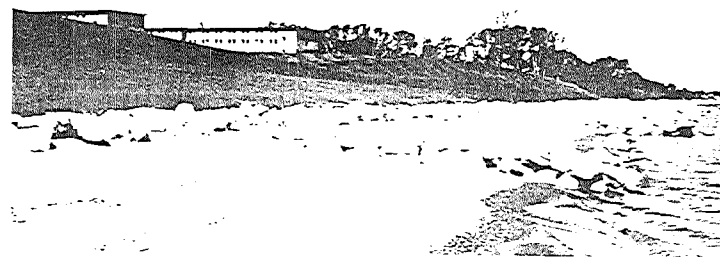
Figure 11. Reformation of rough bank (above) and landscaping of shoreline (below).
(Courtesy of Soil Conservation Service.)

An example of a Lake Michigan shore modification is shown in Figure 11. The site was in Racine County about 3 miles north of Racine, Wisconsin. Rock was used for shoreline protection to minimize erosion of the embankment. The rough steep bank was graded to a more gentle slope and was seeded to control surface erosion. This shore front modification requires a soil that is not subject to seepage so severe that it causes bank failure. Loam soil is best for this type of reclamation. The best vegetative growth is obtained by topdressing with fertilizer and irrigating. Where a specific type of vegetation is desired, weed control may also be required. This shore front renovation requires constant management to maintain a turf appearance.
