# Flash floods in Cebu: monitoring, modelling and preventing

Additional thesis

November 2022

An additional thesis submitted to the Delft University of  
Technology in partial fulfillment for the degree of  
**Master of Science**  
in Civil Engineering specialised in Water Management.

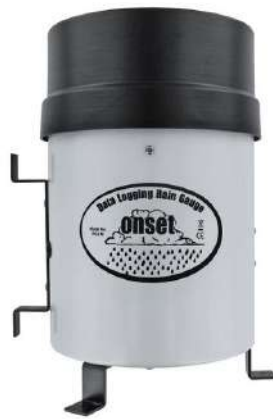
Figure 3.1.: Onset HOBO Rain Gauge Data Logger RG3-M

Very few information about the precipitation amounts and intensities for Cebu City is publicly available. This is why three tipping buckets were brought from the Netherlands. They were lent by the Water Management department in the Civil engineering faculty of Delft University of Technology. The tipping buckets are the Onset HOBO Rain Gauge Data Logger RG3-M with a bucket size of 2mm, an example is shown in figure 3.1.

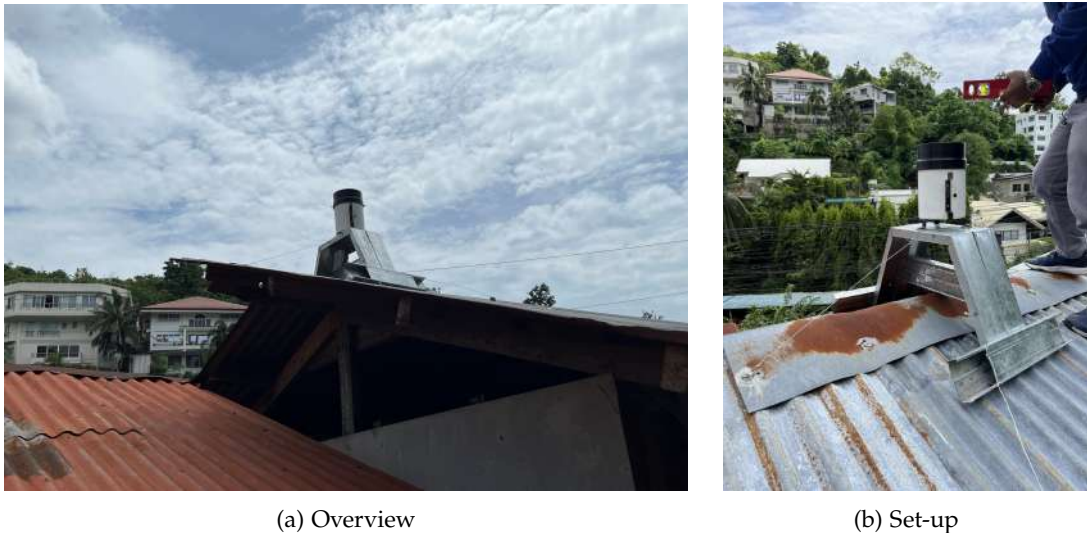
Figure 3.2.: Rain gauge 1

The first tipping bucket is installed close to the location where later the cameras are installed. Knowing at which exact moment precipitation fell above the cameras is useful because it gives a good indication which camera recordings are interesting for calculating the discharges. The first tipping bucket is installed on the roof of the house of the leader of the barangay, so the tipping bucket is very safe. A sturdy, very nice, custom-made support for the tipping bucket has been made by the WRC and can be observed in figure 3.2. The tipping buckets is at an altitude of 70 meters.

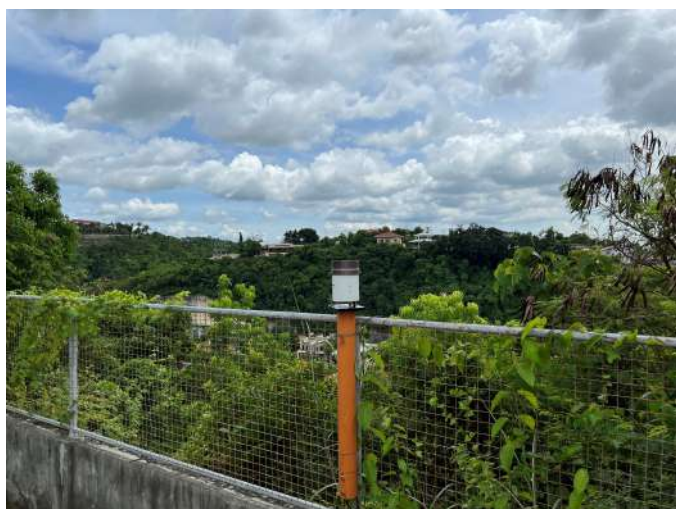
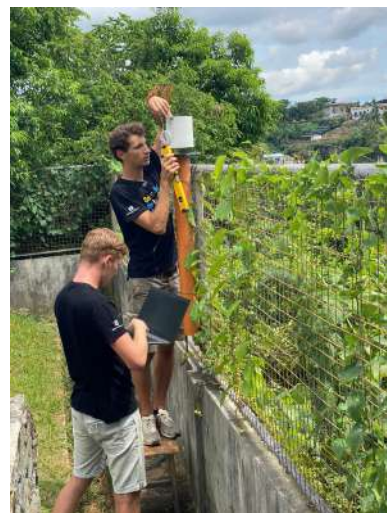
Figure 3.3.: Rain gauge 2

The second tipping bucket is installed in the gated-community of the elite population of Cebu called Maria Luisa. A special authorisation had to be requested to install the tipping bucket because it is not allowed to enter the neighborhood without permission. The tipping bucket is installed on a fence in the upstream part of the neighborhood. Some branches had to be cut down to clear any obstructions. The tipping buckets is at an altitude of 170 meters.

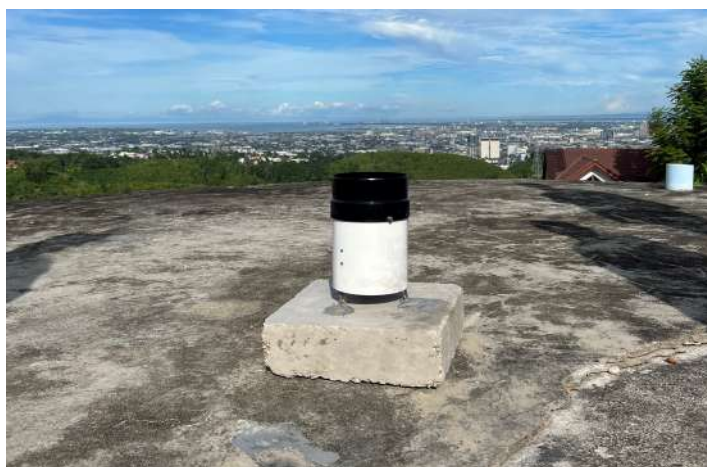
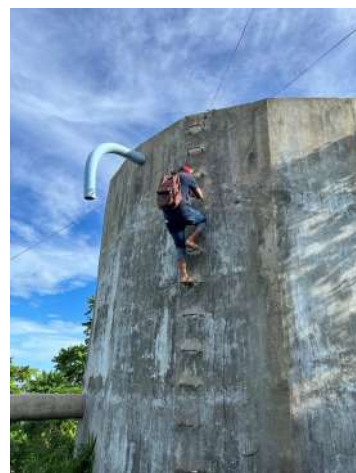
Figure 3.4.: Rain gauge 3

The third tipping bucket is installed on the most upstream part of the catchment. It is installed on the top of a big water storage tank. The tipping bucket is mounted on a concrete mold which is cemented to the tank to avoid someone of stealing it. The tipping buckets is at an altitude of 233 meters.

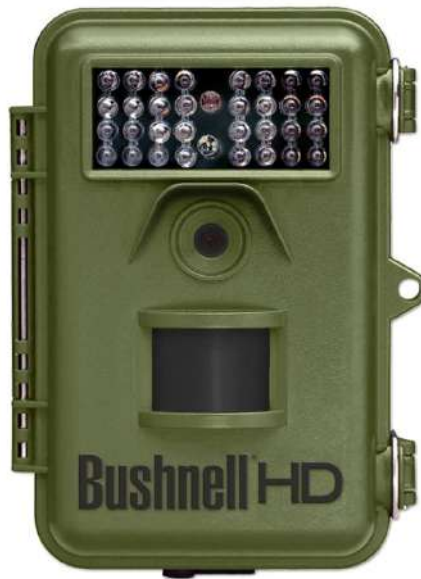
Figure 3.6.: Bushnell Nature view HD #119739

After a discussion with Rainbow Sensing it was decided to purchase two cameras from the brand Bushnell with the model number 119739. These cameras were bought beforehand in the Netherlands, the price of one Bushnell HD camera is 213 euro + 1 SD card of 32 GB of 29 euros. On paper the Bushnell HD camera responds to all the practical requirements (battery life, night vision, automated scheduled video making) except one; the video quality. Unfortunately during testing of the camera in the Philippines it was observed that the camera quality was only 720p instead of 1080p. This exact model should not have been bought. This was a mistake due to a misunderstanding and confusion. The camera is sold as making HD videos, which was true when the cameras were first sold in 2015. Except that today 720p is not classified as HD anymore, the reseller of the camera omitted to mention that it was 720p and a camera dating from 2015. We would have like to sent them back except that we were already in the Philippines, so it was unfortunately not possible. Luckily, the OpenRiverCam program can still function properly with 720p for small rivers which is the case of the Mahiga creek.

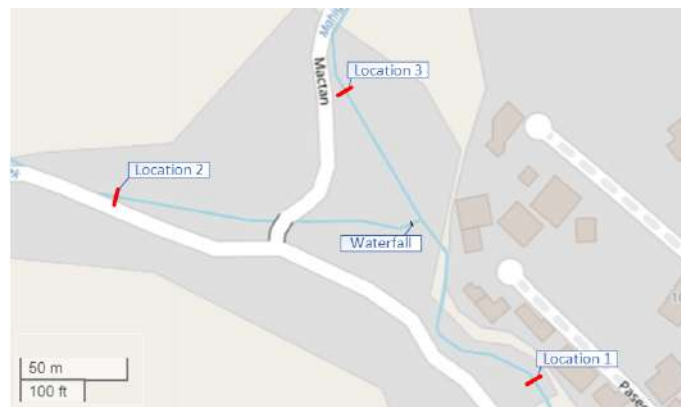
Figure 3.8.: Mahiga creek camera locations

For every camera location a bathymetry of the river cross-section has to be made using a total station. It is recommended by OpenRiverCam that a coordinate is measured every 0.30m, also four control points have to be registered. A staff gauge has to be installed (ideally cemented this way it can resist the high discharges of the river) in the camera view.

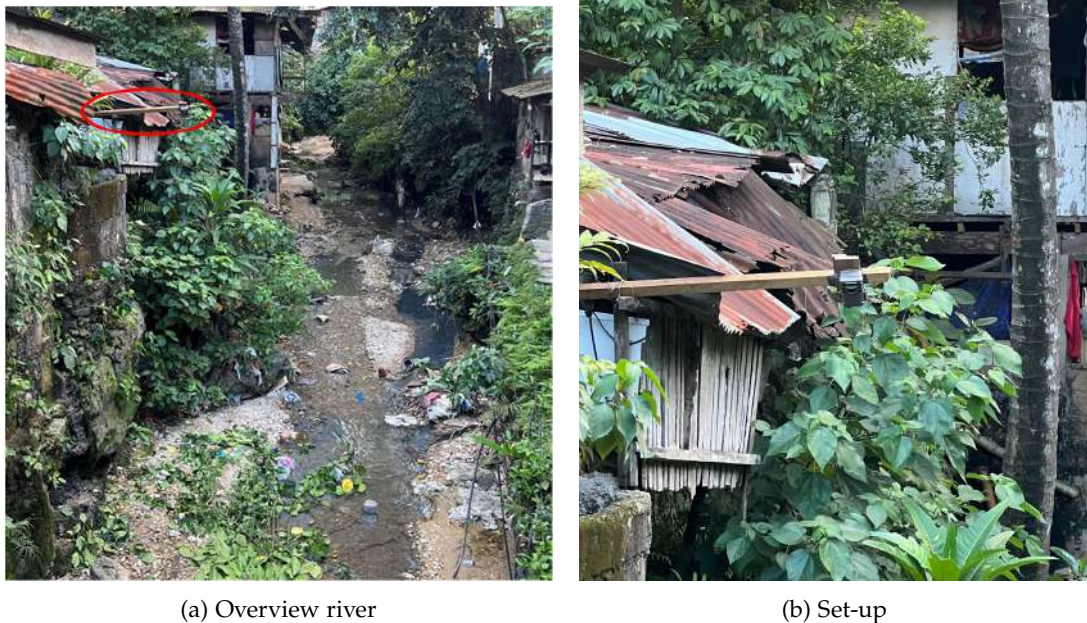
Figure 3.9.: Camera location 1

Finding the approximate area (depending of the river characteristics aspects) where the first camera was going to be installed went quite easily. A nice constant cross-section was found with vertical banks sides. The cross-section has a constant width of approximately 4 meters and a bank height of 1.8 meters. The water does not overflow even during typhoons. The exact location and installation of the camera (the practical aspect) was much more complicated and resulted from a lot of different trials and errors. The first challenge was with the first camera from section 3.1.2, this camera had a very limited recording angle. However the highest practical height the camera could be installed was approximately 5 meters. With this height not the whole width could be captured (about 80% of the width). The program OpenRiverCam program was still able to function but it did impact the accuracy of the measurements. However, after a week of recording the first camera from section 3.1.2 broke down. After studying the results of the first set-up it was concluded that the quantile uncertainty was too large. This is why it was decided to build a new set-up for the new camera of subsection 3.1.2 which guarantees the possibility of recording the whole cross-section. The new camera set-up is installed using a pole which is hanging above the river (see figure 4.4). The length of the post is determined so that the entire cross-section is captured and it still remains possible to replace the SD card from the camera without moving the camera.

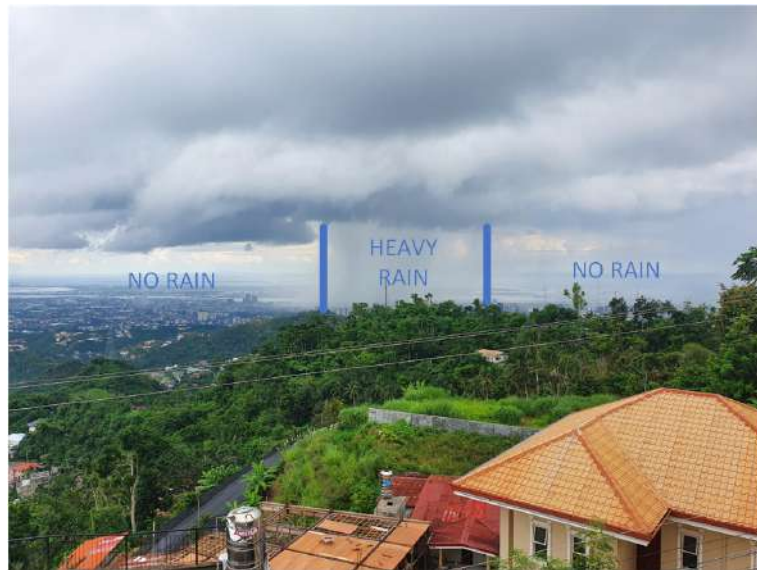
Figure A.1.: Local rain

Specific factors about the precipitation should be stated. The precipitation can be extreme locally, suddenly and intensely. This realisation happened when a very local and heavy rain was observed for the first time as seen in the figure in appendix A.1. This heavy rainfall was happening over a diameter of around 0.5km. These kind of super local rains are common here in the Philippines. Tipping buckets are only point measurements and the locality of the rainfall makes it hard to assume that the best estimation of the precipitation in the surrounding area is represented by the point measurement of the tipping bucket. Realising that the type of rains are very different here compared to Europe had a big importance on the strategic location of the tipping buckets in the catchment. Secondly, an important factor of influence for the location of the tipping buckets are the obstructions. It is common in the Philippines that the rain can be carried by the wind and falls almost horizontally (it is
