# ANALYSIS CAMPUS SOUTH hembrug peninsula

MSc3 P1 Heritage and Architecture  
Sophie Luyckx 4395948  
Soumaya Boujamaa 4287258  
Maaike Lengton 4272110  
15-04-2019

Title: Analysis Campus South  
Hembrug Peninsula

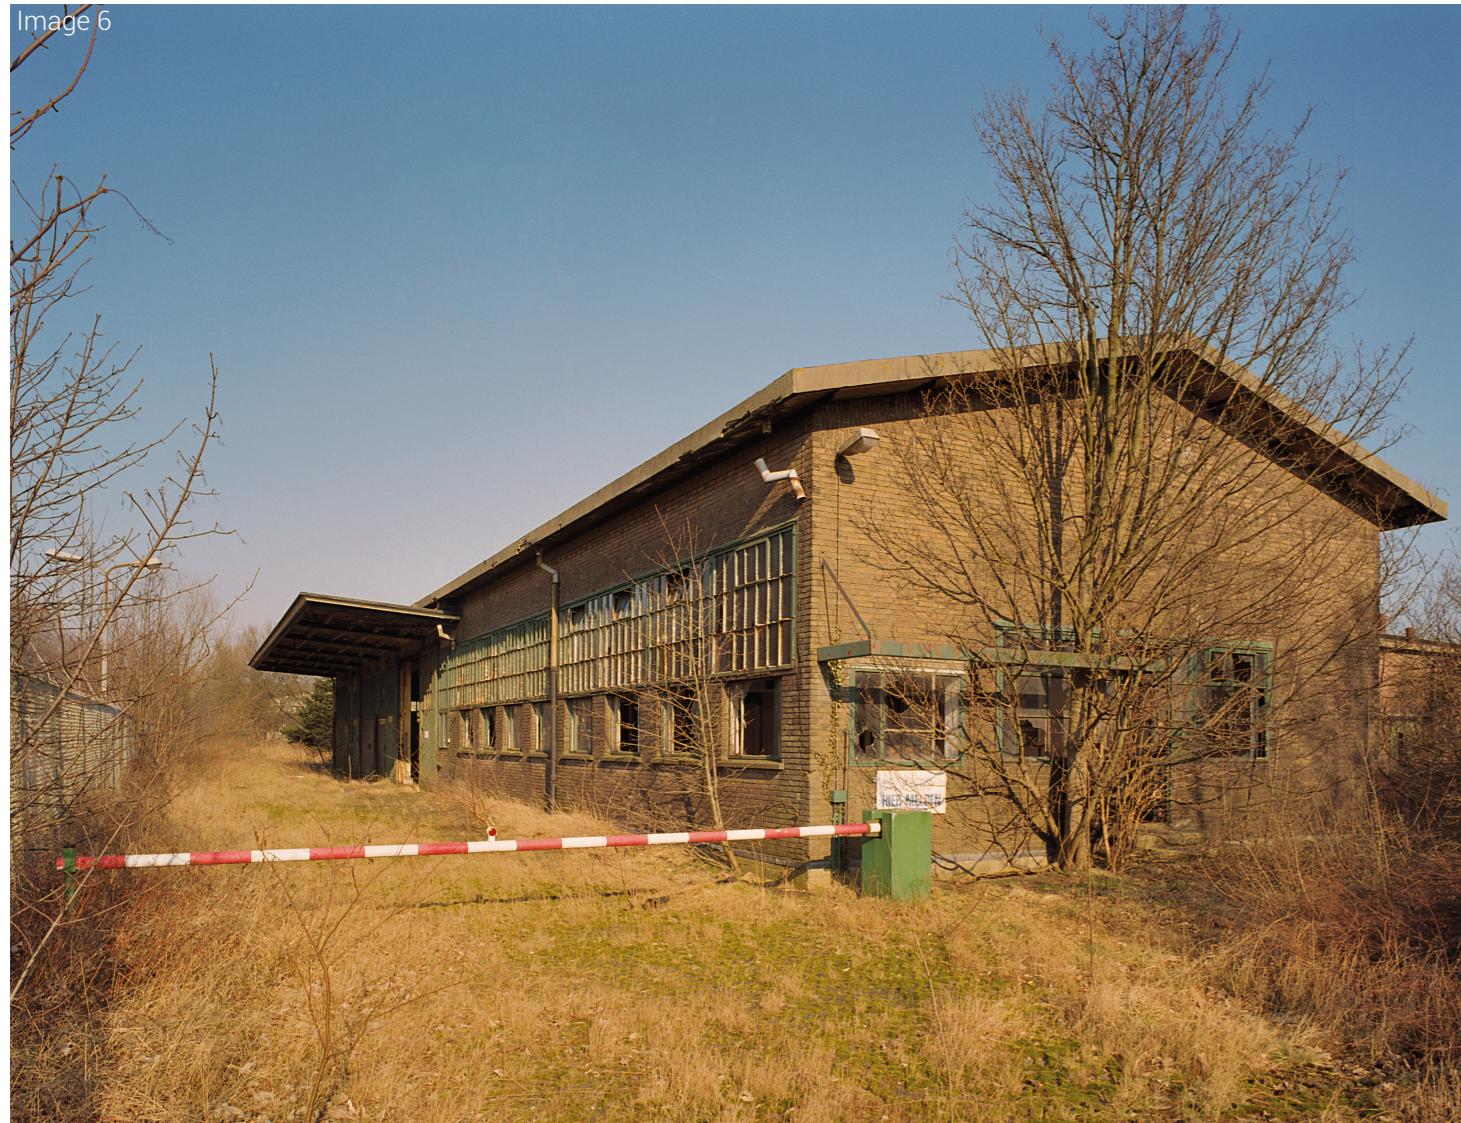
Image 6

Image 6: The state of the expedition building in 2003. Source: Rijksdienst voor Cultureel Erfgoed, 2003.

In 2003, people encountered the expedition building in a state in which nature took over the whole site. We assume the original entrance to the site was still present. The sign on the facade says 'report here'. There was a fence between the former rail road and the expedition building. In 2010 renovation of the site started. On the road where the track once ran, an entrance was made for cars. And an old building has been demolished to create an open view (see Images 7,8,9,10).

Image 6: Rijksdienst voor Cultureel Erfgoed. (2003). Overzicht van gebouw 341, de voormalige overslagloods cq expeditegebouw met kantoor. Fotocollectie. 516.978. Retrieved March 19, 2019 from <https://beeldbank.cultureelerfgoed.nl/alle-afbeeldingen/detail/c6b4044ef9b9-522e-3be5-963cd75e9bcc/mdia/85464f93-284a-292f-79f7-0c30d96b45e3?mode=detail&view=horizontal&q=Hembrug%20&rows=1&page=15>

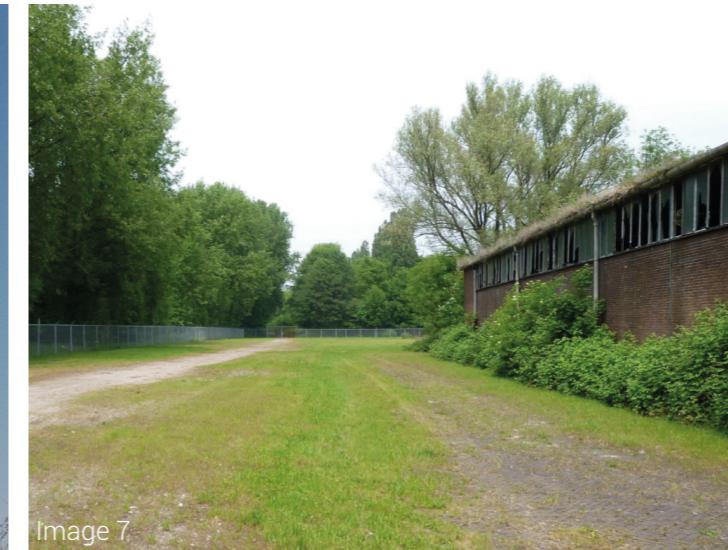
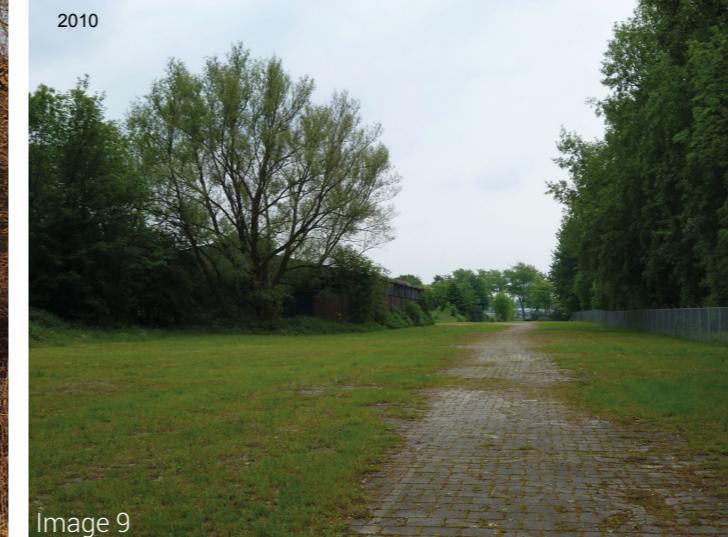
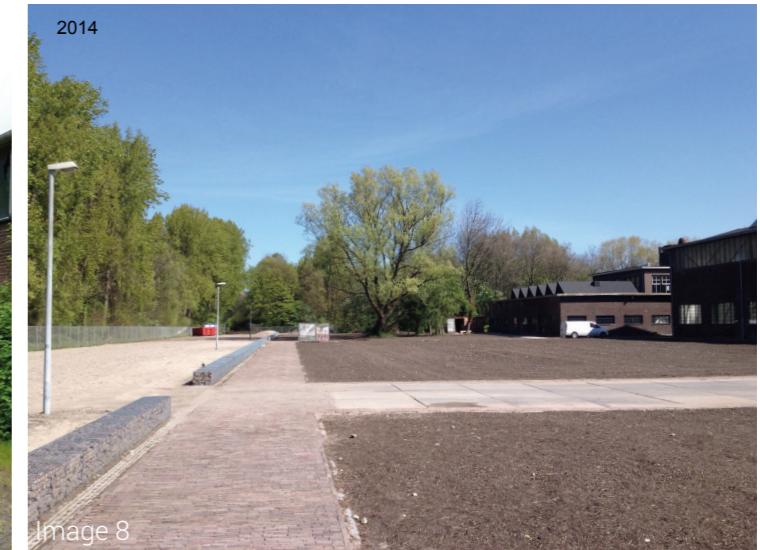
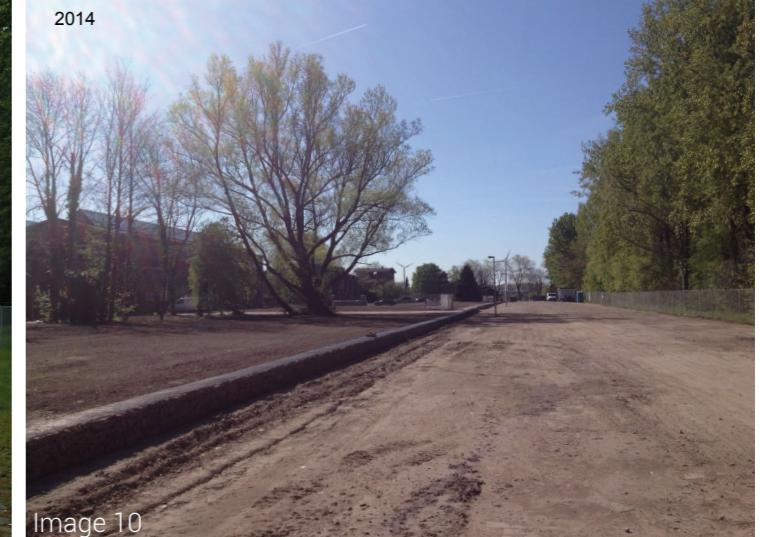
Image 7

Images 7,8,9,10: Before and after the renovation that started in 2010. Source: Palmboom, F., 2019.

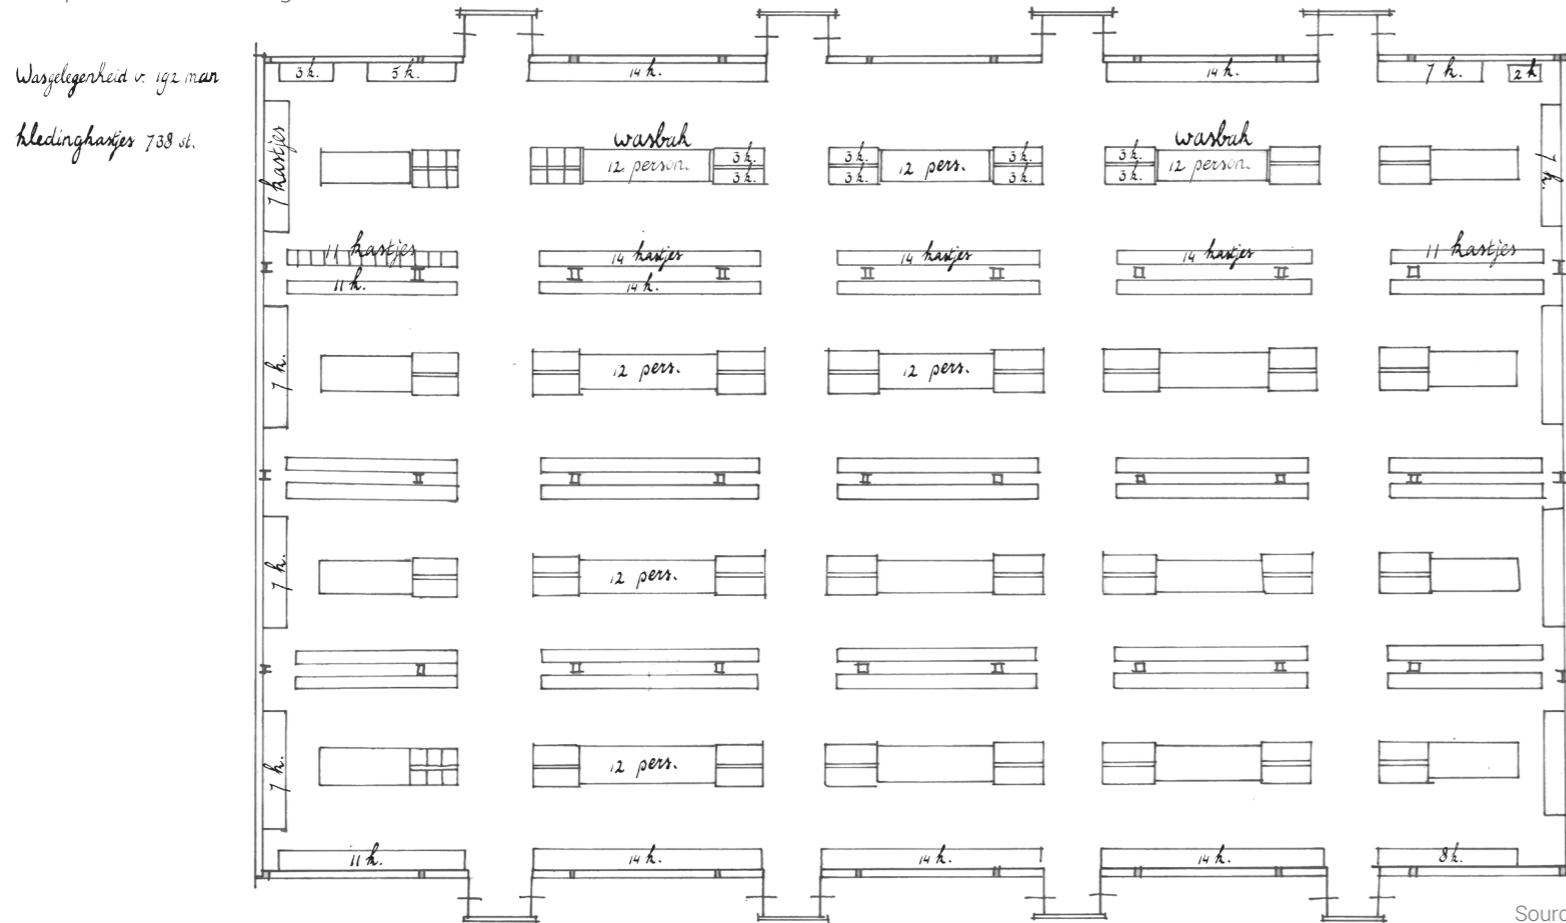
The original floorplan of the washing hall

The washing hall was used by 192 men at the same time and had 738 locker cabinets. The employees entered the building through eight entrances, which had two doors per entrance. The building consists of a grid of washing basins and cabinets. The lockers enclosed the wooden structure and were positioned alongside the walls, to serve as many people. The employees were not allowed to take their working clothes home, so they started and ended the day at the washing hall.

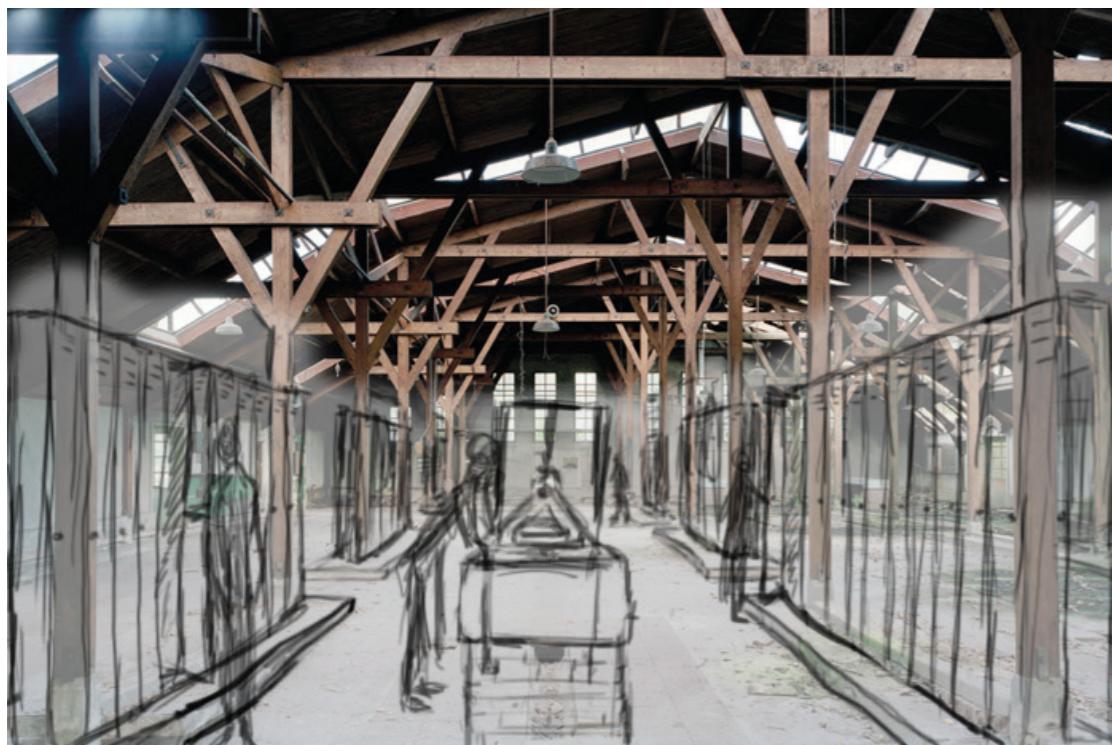
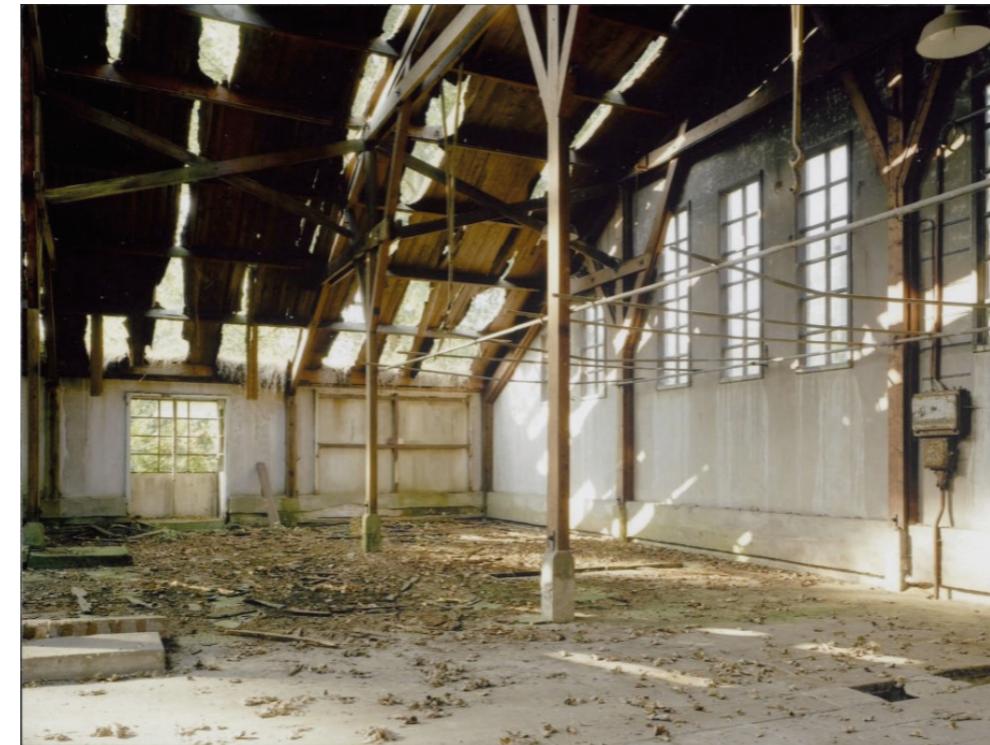
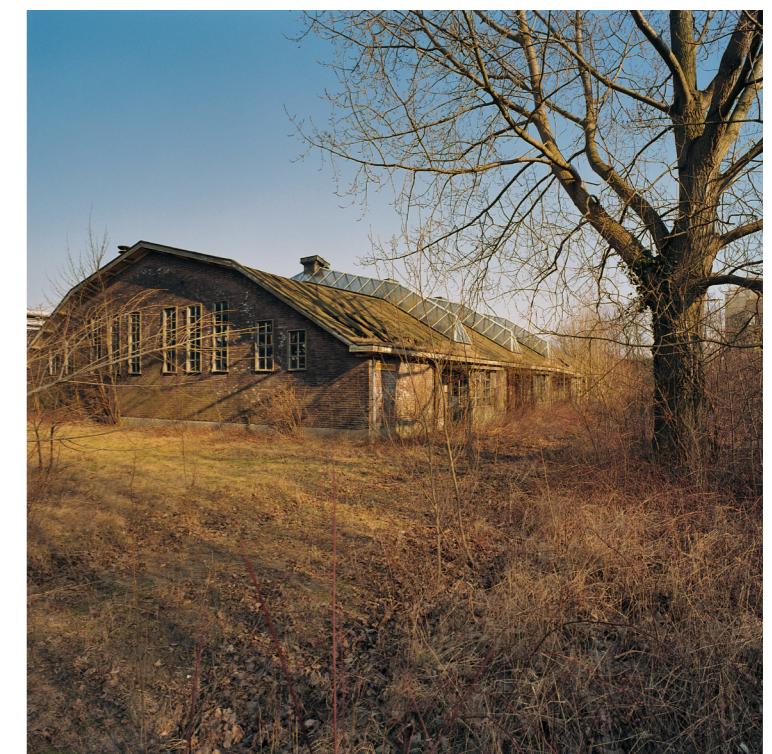
In 2009, the building was found with a broken and collapsed roof, taken over by nature. The roof is renovated as well as some elements of the structure.

Image 11(l.): The use of the washing hall.  
Source: Boujamaa, S., 2019. Image 12 (m.):  
The state of the washing hall in 2003.  
Source: Archief Zaanstad, 2003. Image 13 (r.):  
The state of the washing hall in 2003.  
Source: Rijksdienst van Cultureel Erfgoed, 2003.

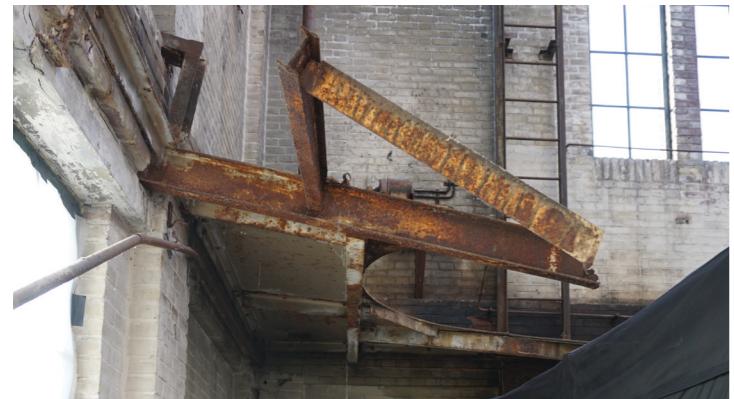
Image 14: Traces of the ovens; a curved hole in the steel construction of the entresol. Source: Luyckx, S.L., 2019.

Image 14: Luyckx, S.L. (2019). Traces of the ovens; a curved hole in the steel construction of the entresol.

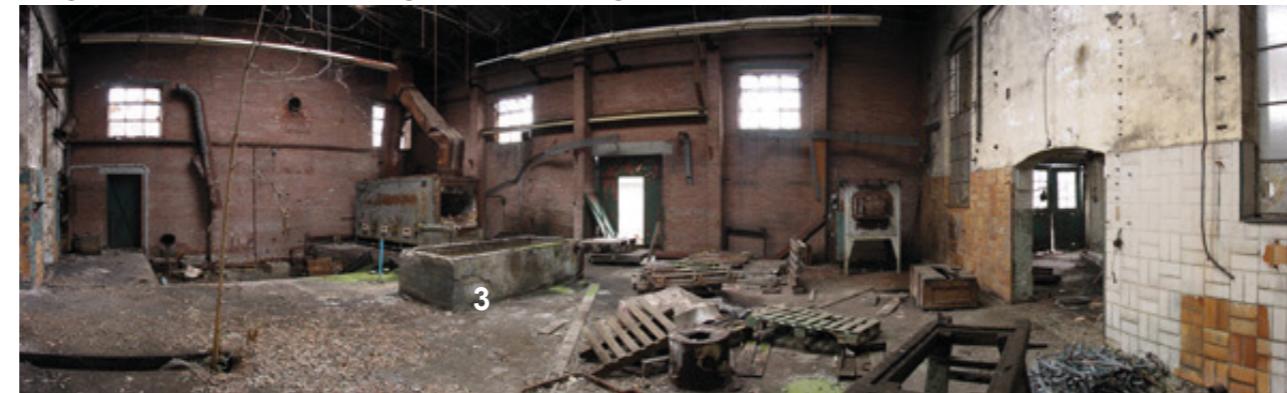
Image 15: Heat treatment building of 197, remaining interior. Source: Zaans industrieel erfgoed, n.d.

Image 15: Zaans industrieel erfgoed. (n.d.). Het interieur van gebouw 155 uit 1917, de harderij. Deze gebouwen zijn onderdeel van de Machinefabriek Hembrug. Retrieved March, 18, 2019 from [https://www.zaans-industrieel-erfgoed.nl/images\\_8/eurometaal-harderijpan.jpg](https://www.zaans-industrieel-erfgoed.nl/images_8/eurometaal-harderijpan.jpg)

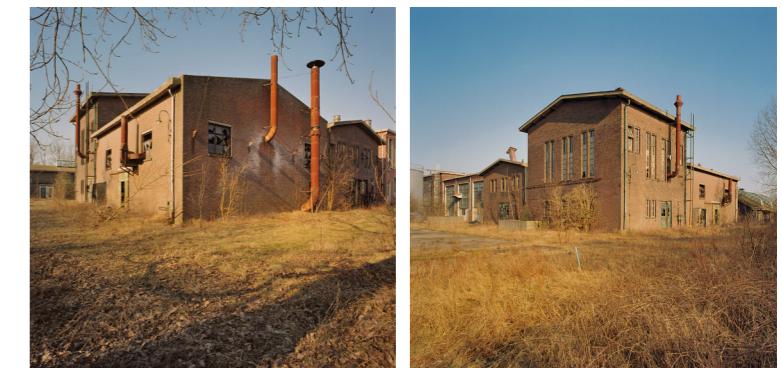
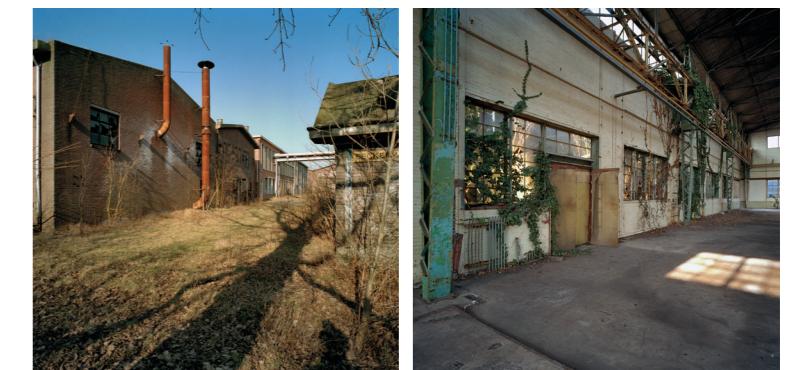
Image 16, 17, 18, 19: Heat treatment building, 2003.  
Source: Rijksdienst voor Cultureel Erfgoed, 2003.

Image 16: Rijksdienst van Cultureel Erfgoed. (2003). Overzicht van gebouw 155. Fotocollectie. 516.979. Retrieved March 19, 2019 from <https://beeldbank.cultureelerfgoed.nl/alle-afbeeldingen/detail/6e2c814b-8abc-61c8-9c2a-c57f854984f2/media/b5c68e62-af11-ae2d-4859-75a1645df484?mode=detail&view=horizontal&q=Hembrug%20&rows=1&page=1>

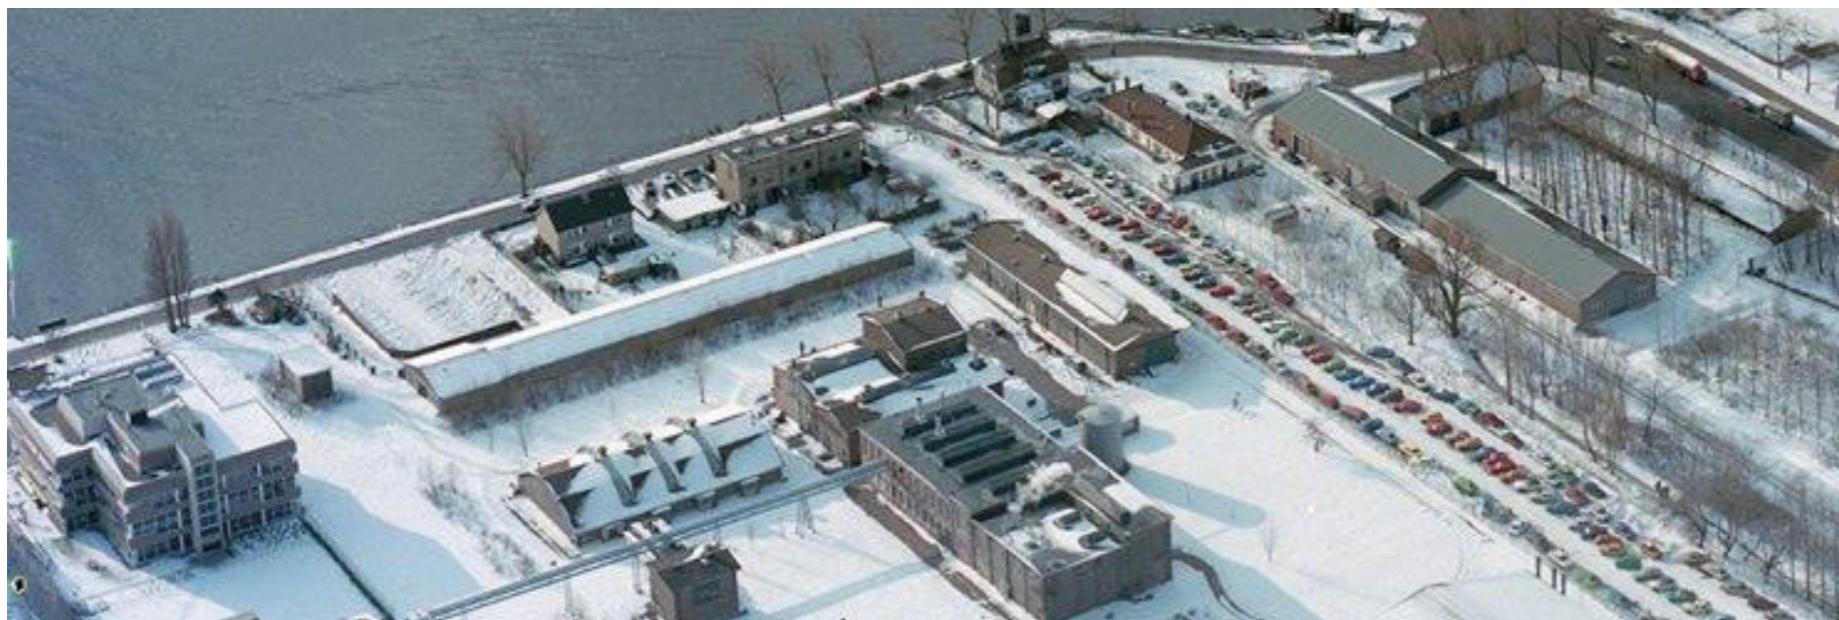
Image 22: Aerial view on the bicycle shed, estimated around 1984. Source: Artillerie Inrichtingen Hembrug, n.d.

What is left of the bicycle shed is a foundation and one wall which is supported by the rusted steel columns. It is empty, yet it catches the eye because one gets curious as to what happened here. This curiosity increases when looking at a closed gate and walls which lead to this wall with openings in it which now seem like entrances. Knowing it was a bicycle shed, one tries to imagine where the employees would enter Campus South when they came by bike. The fact that this building only has a foundation and one wall left, makes the visitor only wonder and imagine how it looked like as a whole building and how it was used.

We assume that the bicycle shed had a similar steel construction as the expedition building, based on the remaining corroded steel columns in the wall. The heat treatment building has a load bearing brick structure and the washing hall has a wooden structure.

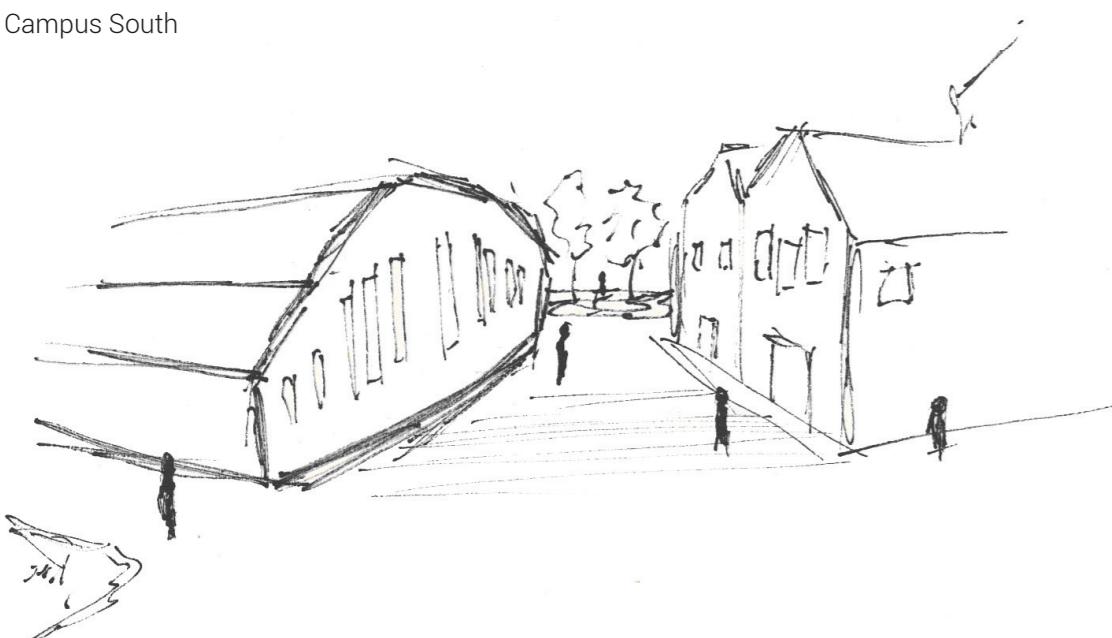
Image 23: Future strategy for Hembrug, with its ensembles. Source: Palmbout Urban Landscapes, 2011.

Palmbout landscape architects made a strategy for the Hembrug site. They divided the terrain in ensembles. Campus South is part of the "Campus" ensemble and they describe the choice for this name as followed: "On the West side, the former large halls of arms production are loosely spread over the predominantly green terrain. They form a collection with the spatial character of a 'campus'"(Palmbout Urban Landscapes, 2011). We assume campus is referred to the literal translation of the Latin word 'campus' which means field or area (Campus, n.d.).

However, our area is called Campus South, so it is divided into two parts. The Northern part has large buildings surrounded by green and the Southern part has smaller buildings surrounded by green and water. The Southern part also shows the former buildings which are now replaced by green lawns. The whole campus has a strong North-South orientation which makes it logical to call the Southern part Campus South.

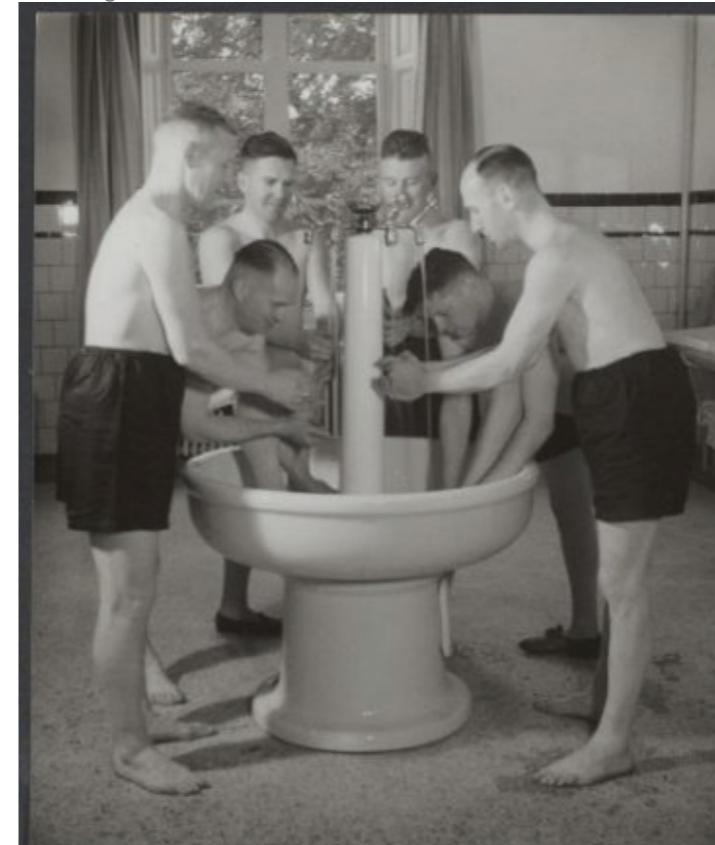
Image 25: Men of the Grenadiers and Hunters in the washing hall in the Orange barracks, 1900-1915. Source: NIMH, n.d.

The washing hall of Campus South (building nr. 316) is not the only washing hall on the Hembrug terrain. Building 148 was another washing hall of the ammunition factory, located on the corner of the coal shed of the navy. This washing hall has a different typology then the washing hall of Campus South. There are no columns used and the entrances are on the front walls of the building in comparison to the side walls of washing hall 316. Furthermore, the washing basins do differ as well; in building 148 they are round and positioned over the entire length of the building. We assume these looked like the washing basins in image 24. The other images show different types of washing basins used in washing halls.

Image 25: NIMH. (n.d.). Manschappen van de Grenadiers en Jagers in het waslokaal in de Oranjekazerne, 1900-1915. Fotoafdrukken Koninklijke Landmacht. 2155\_008269. Den Haag. Retrieved March 20, 2019 from <https://nimh-beeldbank.defensie.nl/memorix/4d7c3b66-eb18-11df-a391-13966e870614>

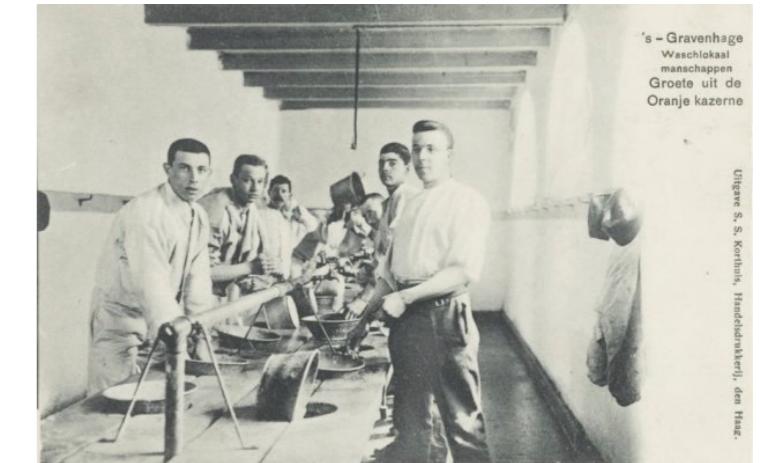
Image 26: Washing hall of the Mariniekazerne Amsterdam (MKAD) at the Kattenburg in 1927/28. Source: NIMH, n.d.

Image 26: NIMH. (n.d.). Waslokaal van de Marinekazerne Amsterdam (MKAD) aan het Kattenburg in 1927/28. Losse Fotografische Objecten. 2000-376-004. Den Haag. Retrieved March 20, 2019 from [https://nimh-beeldbank.defensie.nl/beeldbank/indeling/detail/start/12?q\\_searchfield=waslokaal](https://nimh-beeldbank.defensie.nl/beeldbank/indeling/detail/start/12?q_searchfield=waslokaal)

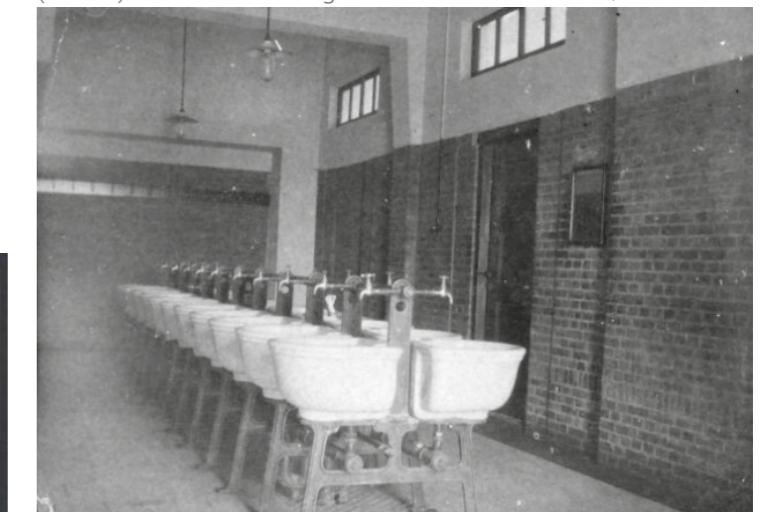
Image 27: 9x12 bath-rooms and lavatory american brake-shoe and foundry co. Source: Nationaal Archief, n.d.

Image 27: Nationaal Archief. (n.d.). 9x12 bath-rooms and lavatory american brake-shoe and foundry co. Image bank. Fotocollectie Arbeidsinspectie. 2267. 256-1189. Den Haag.

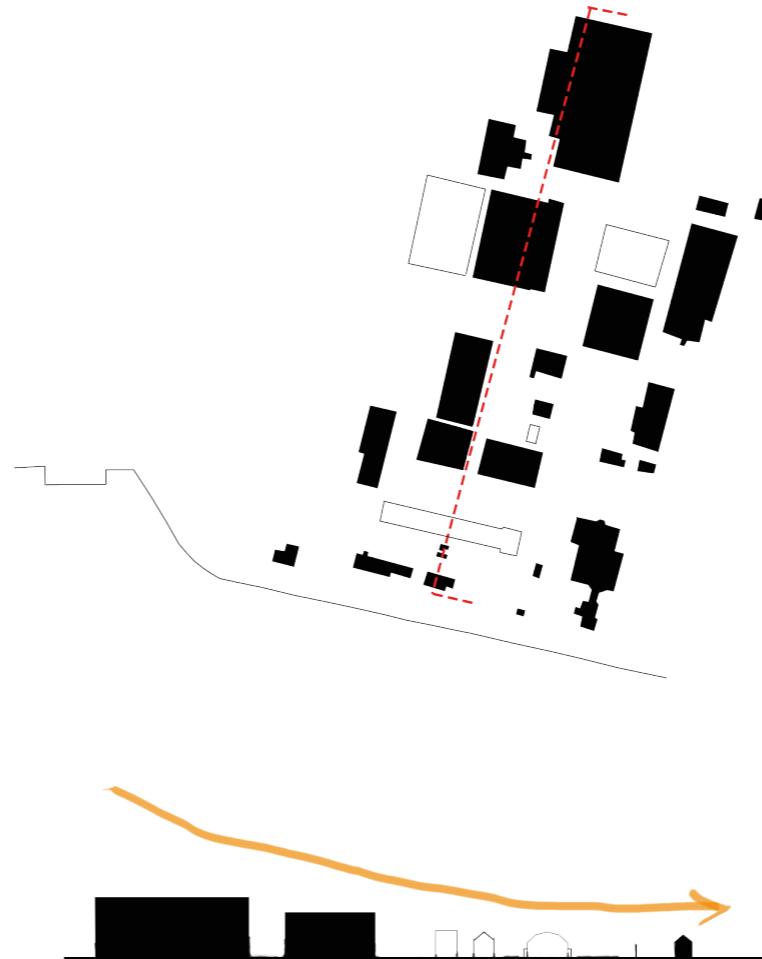
### human scale

The Campus (weapon factory area) of Hembrug is divided into Campus North and Campus South. When comparing these two parts of the Campus; Campus North has larger buildings than Campus South. Campus South is, when looking at the human scale, more in proportion. The large buildings at Campus North are placed on large plots and some of the grass / open fields are as large as these plots. The open areas at Campus South are smaller but are in proportion with the buildings as well.

The exception, in terms of proportion with human scale, is the heat treatment building which is quite high. This was needed for the large ovens and machines which stood in this building.

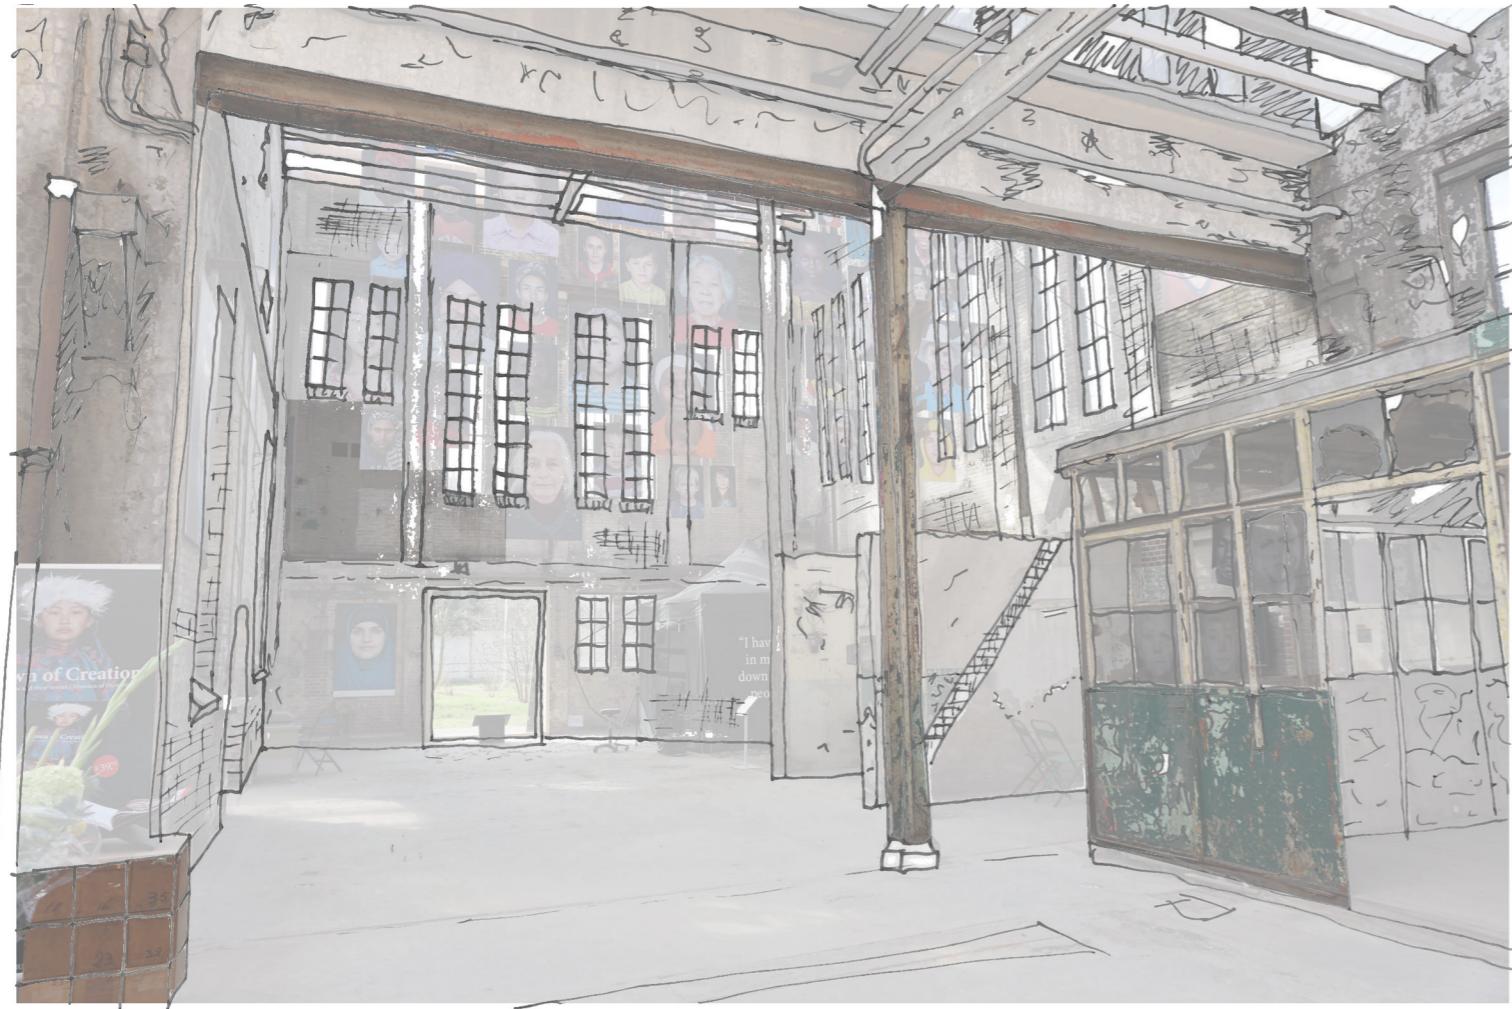
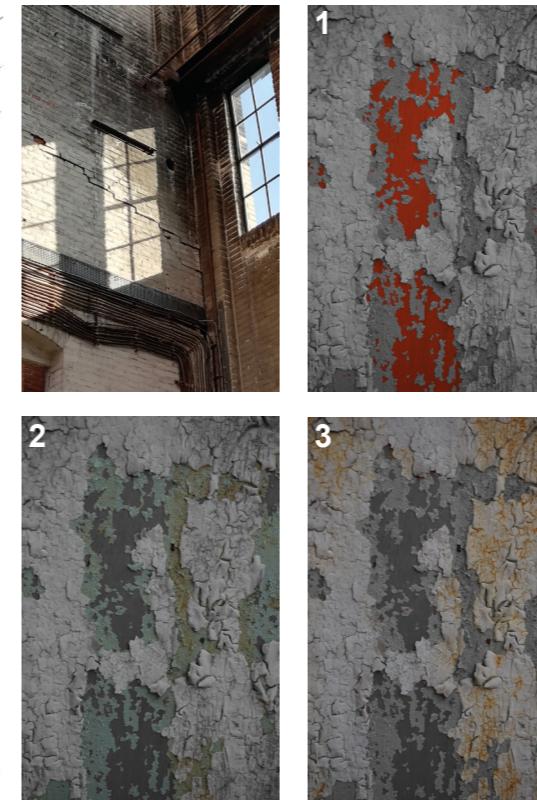
## architectural language

Which elements contribute to the spatial idea/atmosphere of the heat treatment building?

Source light, shadow, triplation and colour: Boujamaa, S.  
Source character and materiality: Luyckx, S.L.

Compared to the other buildings on the ensemble, the heat treatment building takes a lot of space, ground wise but also in height which makes it a quite dominant building in the area which catches the eye quickly. On the inside, many traces of what used to happen there is still visible. Marks on the ground which show where machines stood. Steel beams which were cut off show another floor which is not there anymore. Steel beams which had a circular shape which represents the former large barrels which stood in it. The rusted wires and cables which still know their way in the building just like snakes and some hanging from the walls. The big crack in the brickwork where a new (second building) layer was added show the experience through time of the materials themselves. In many walls, big holes were made for pipes which are now gone. The holes are only filled up with bricks on the outside of the cavity wall. On the inside, the holes are still visible. The holes, together with cracks, the rough bricks and all the other elements show how this building, as only production building in the ensemble, was used and how hard the man must have worked. They hardened steel for helmets, tools, etc. and this was done in salt baths which had a very high temperature. The many windows at about 4 meters height could be opened in order to make it less hot in the building. It must not have been an easy task for the employees to work a whole day in such circumstances and this represents the building today.

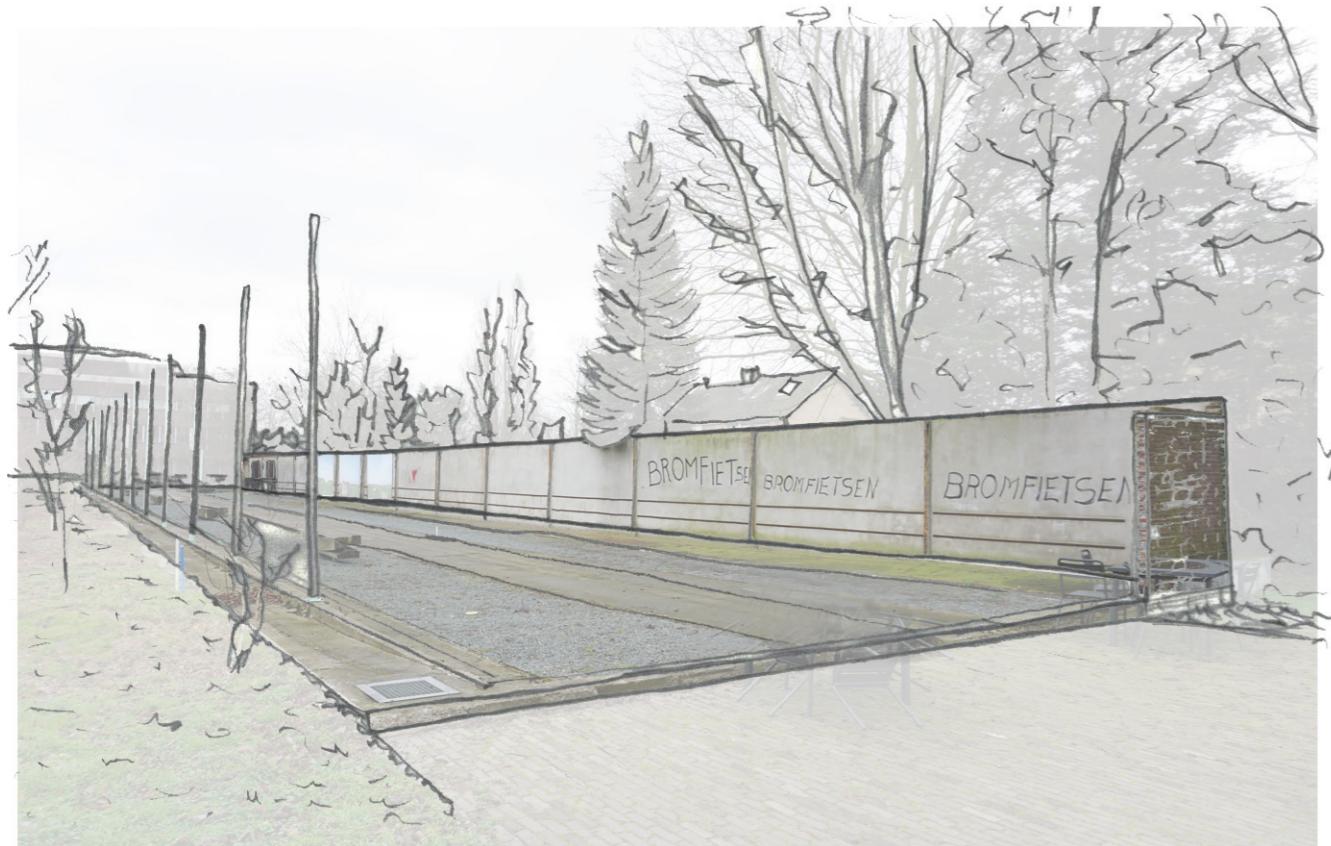
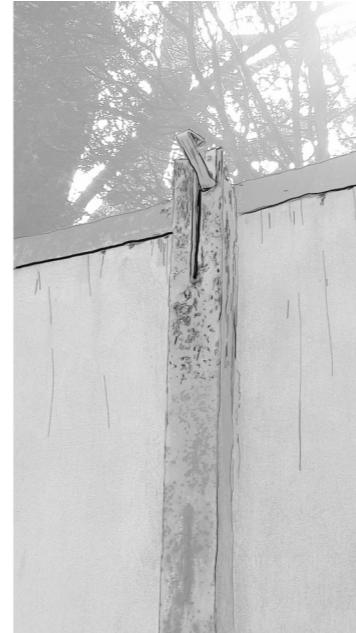
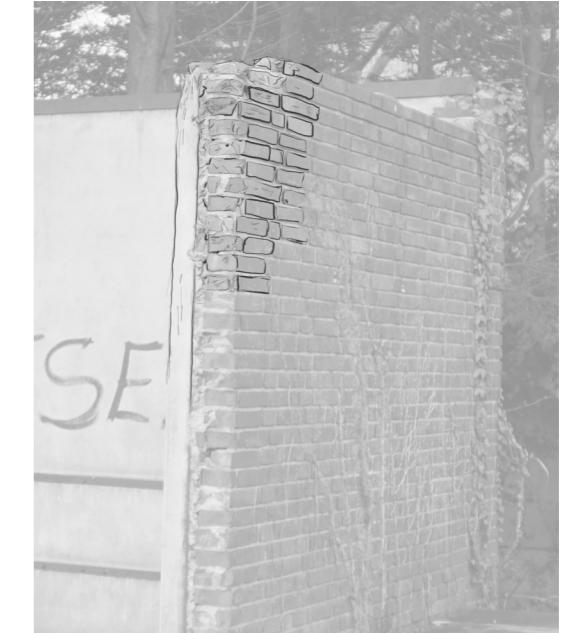
### architectural language

Which elements contribute to the spatial idea/ atmosphere of the bicycle shed?

Source materiality, colour and rhythm: Boujamaa, S.  
Source character: Luyckx, S.L.

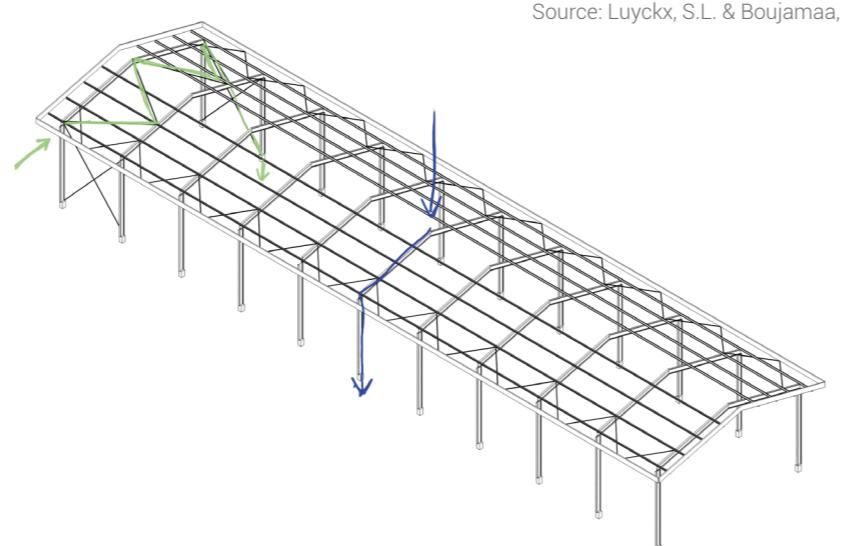
There are different types of structures on the ensemble. The expedition building, washing hall and bicycle shed exist out of a column and beam system. The heat treatment building exists out of a box system in which the walls are load bearing.

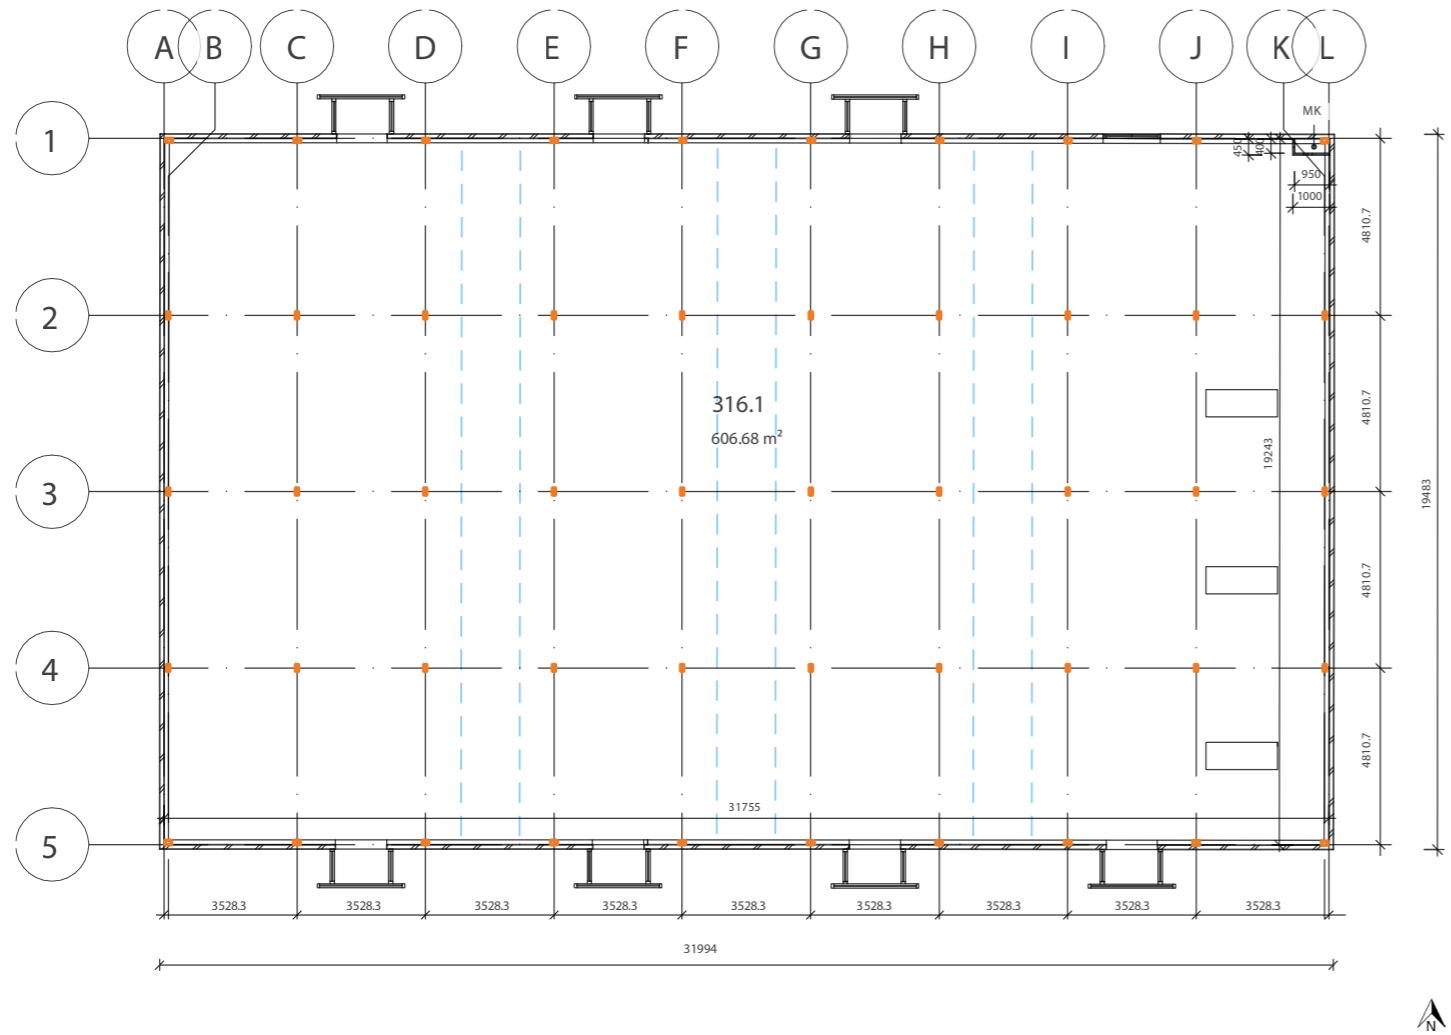
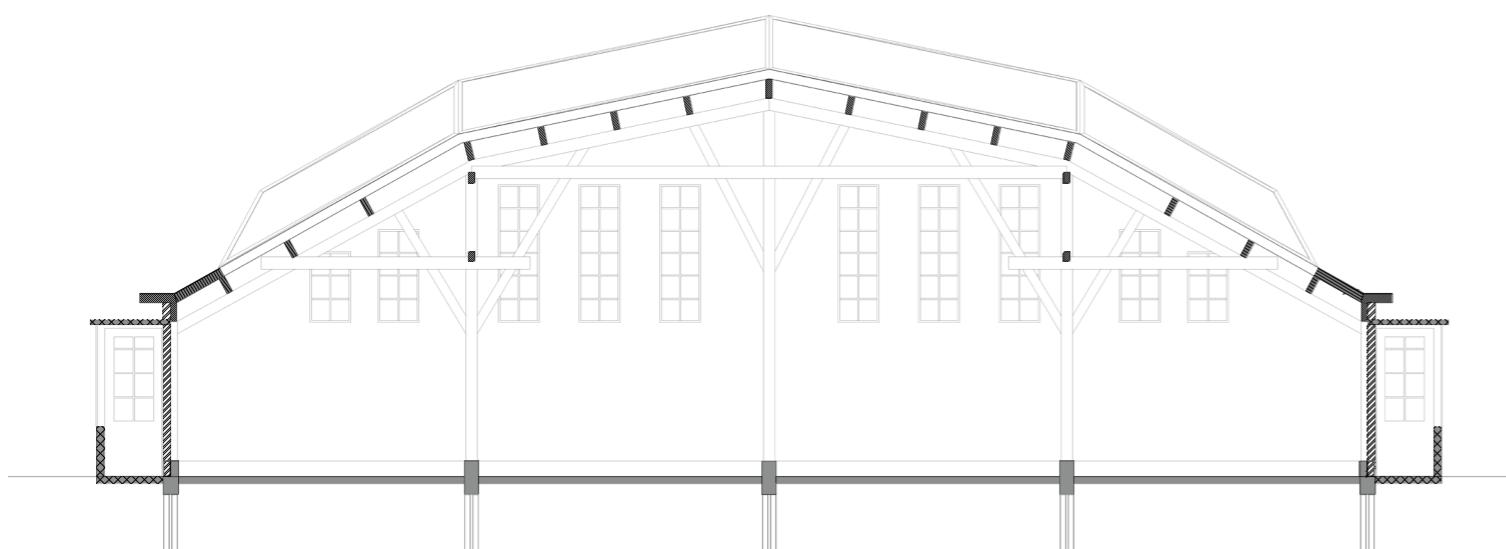
## washing hall 316

It has a four-aisled wooden structure over 9 bays, consisting of a roof with intermediate pillars on foundation blocks. The wooden columns are provided with braces and double lintels which connect the braces. The columns and braces support the roof beams. Between the shingles at the side aisles a wind bracing is applied.

The four entrances on both sides of the building are situated along the 2nd, 4th, 6th and 8th bay. In the 3rd, 5th and 7th bay, three iron caterpillar lanterns are applied which have a ventilation outlet on the ridge.

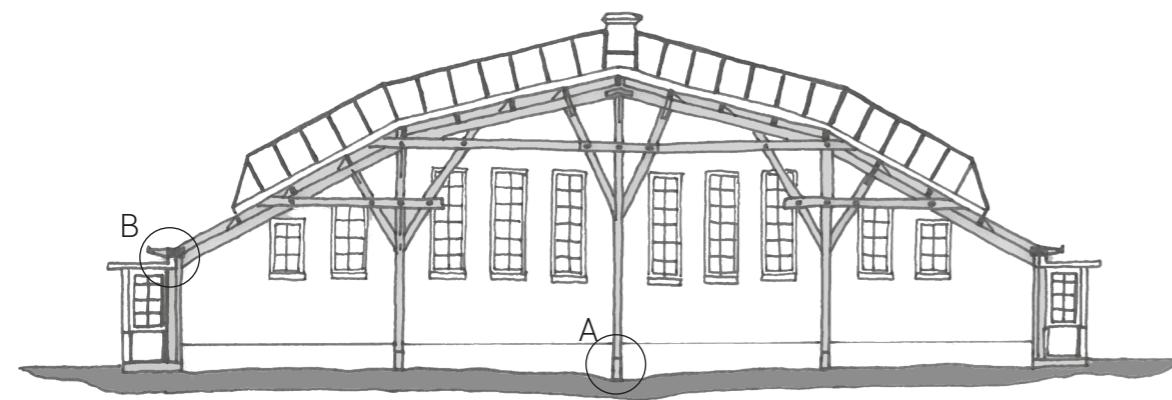
The wetland on which Hembrug was built has a peat soil. To build Hembrug, sand was poured on this layer. The buildings were built right on it, although the soil didn't set yet. Over time the peat settled, causing a lower ground level. As the foundation piles rested on a dense sand layer they remained on their place, while the floor, resting on a looser sand layer, subsided along with the settling of the soil. This is visible around the columns and we came up with two options for the unknown foundation.

Option 1: The wooden columns have a reinforced concrete base which runs through the ground floor and ends below the groundwater level. This base rests on wooden foundation piles following the Amsterdam pile foundation principle. In this situation, the floor slides down along the column.

Option 2: The wooden columns have a reinforced concrete base which rests on a concrete slab. This slab carries the ends of the floor which causes it to break near the column. The concrete slab rests on the wooden foundation piles following the Amsterdam pile foundation principle.

We found that option 2 would work differently than we had imagined. The concrete slab would not deform as it is stiff enough, causing the floor to break in the middle. Therefore option 1 is more likely
