# ANALYSIS CAMPUS SOUTH hembrug peninsula

MSc3 P1 Heritage and Architecture  
Sophie Luyckx 4395948  
Soumaya Boujamaa 4287258  
Maaike Lengton 4272110  
15-04-2019

Title: Analysis Campus South  
Hembrug Peninsula

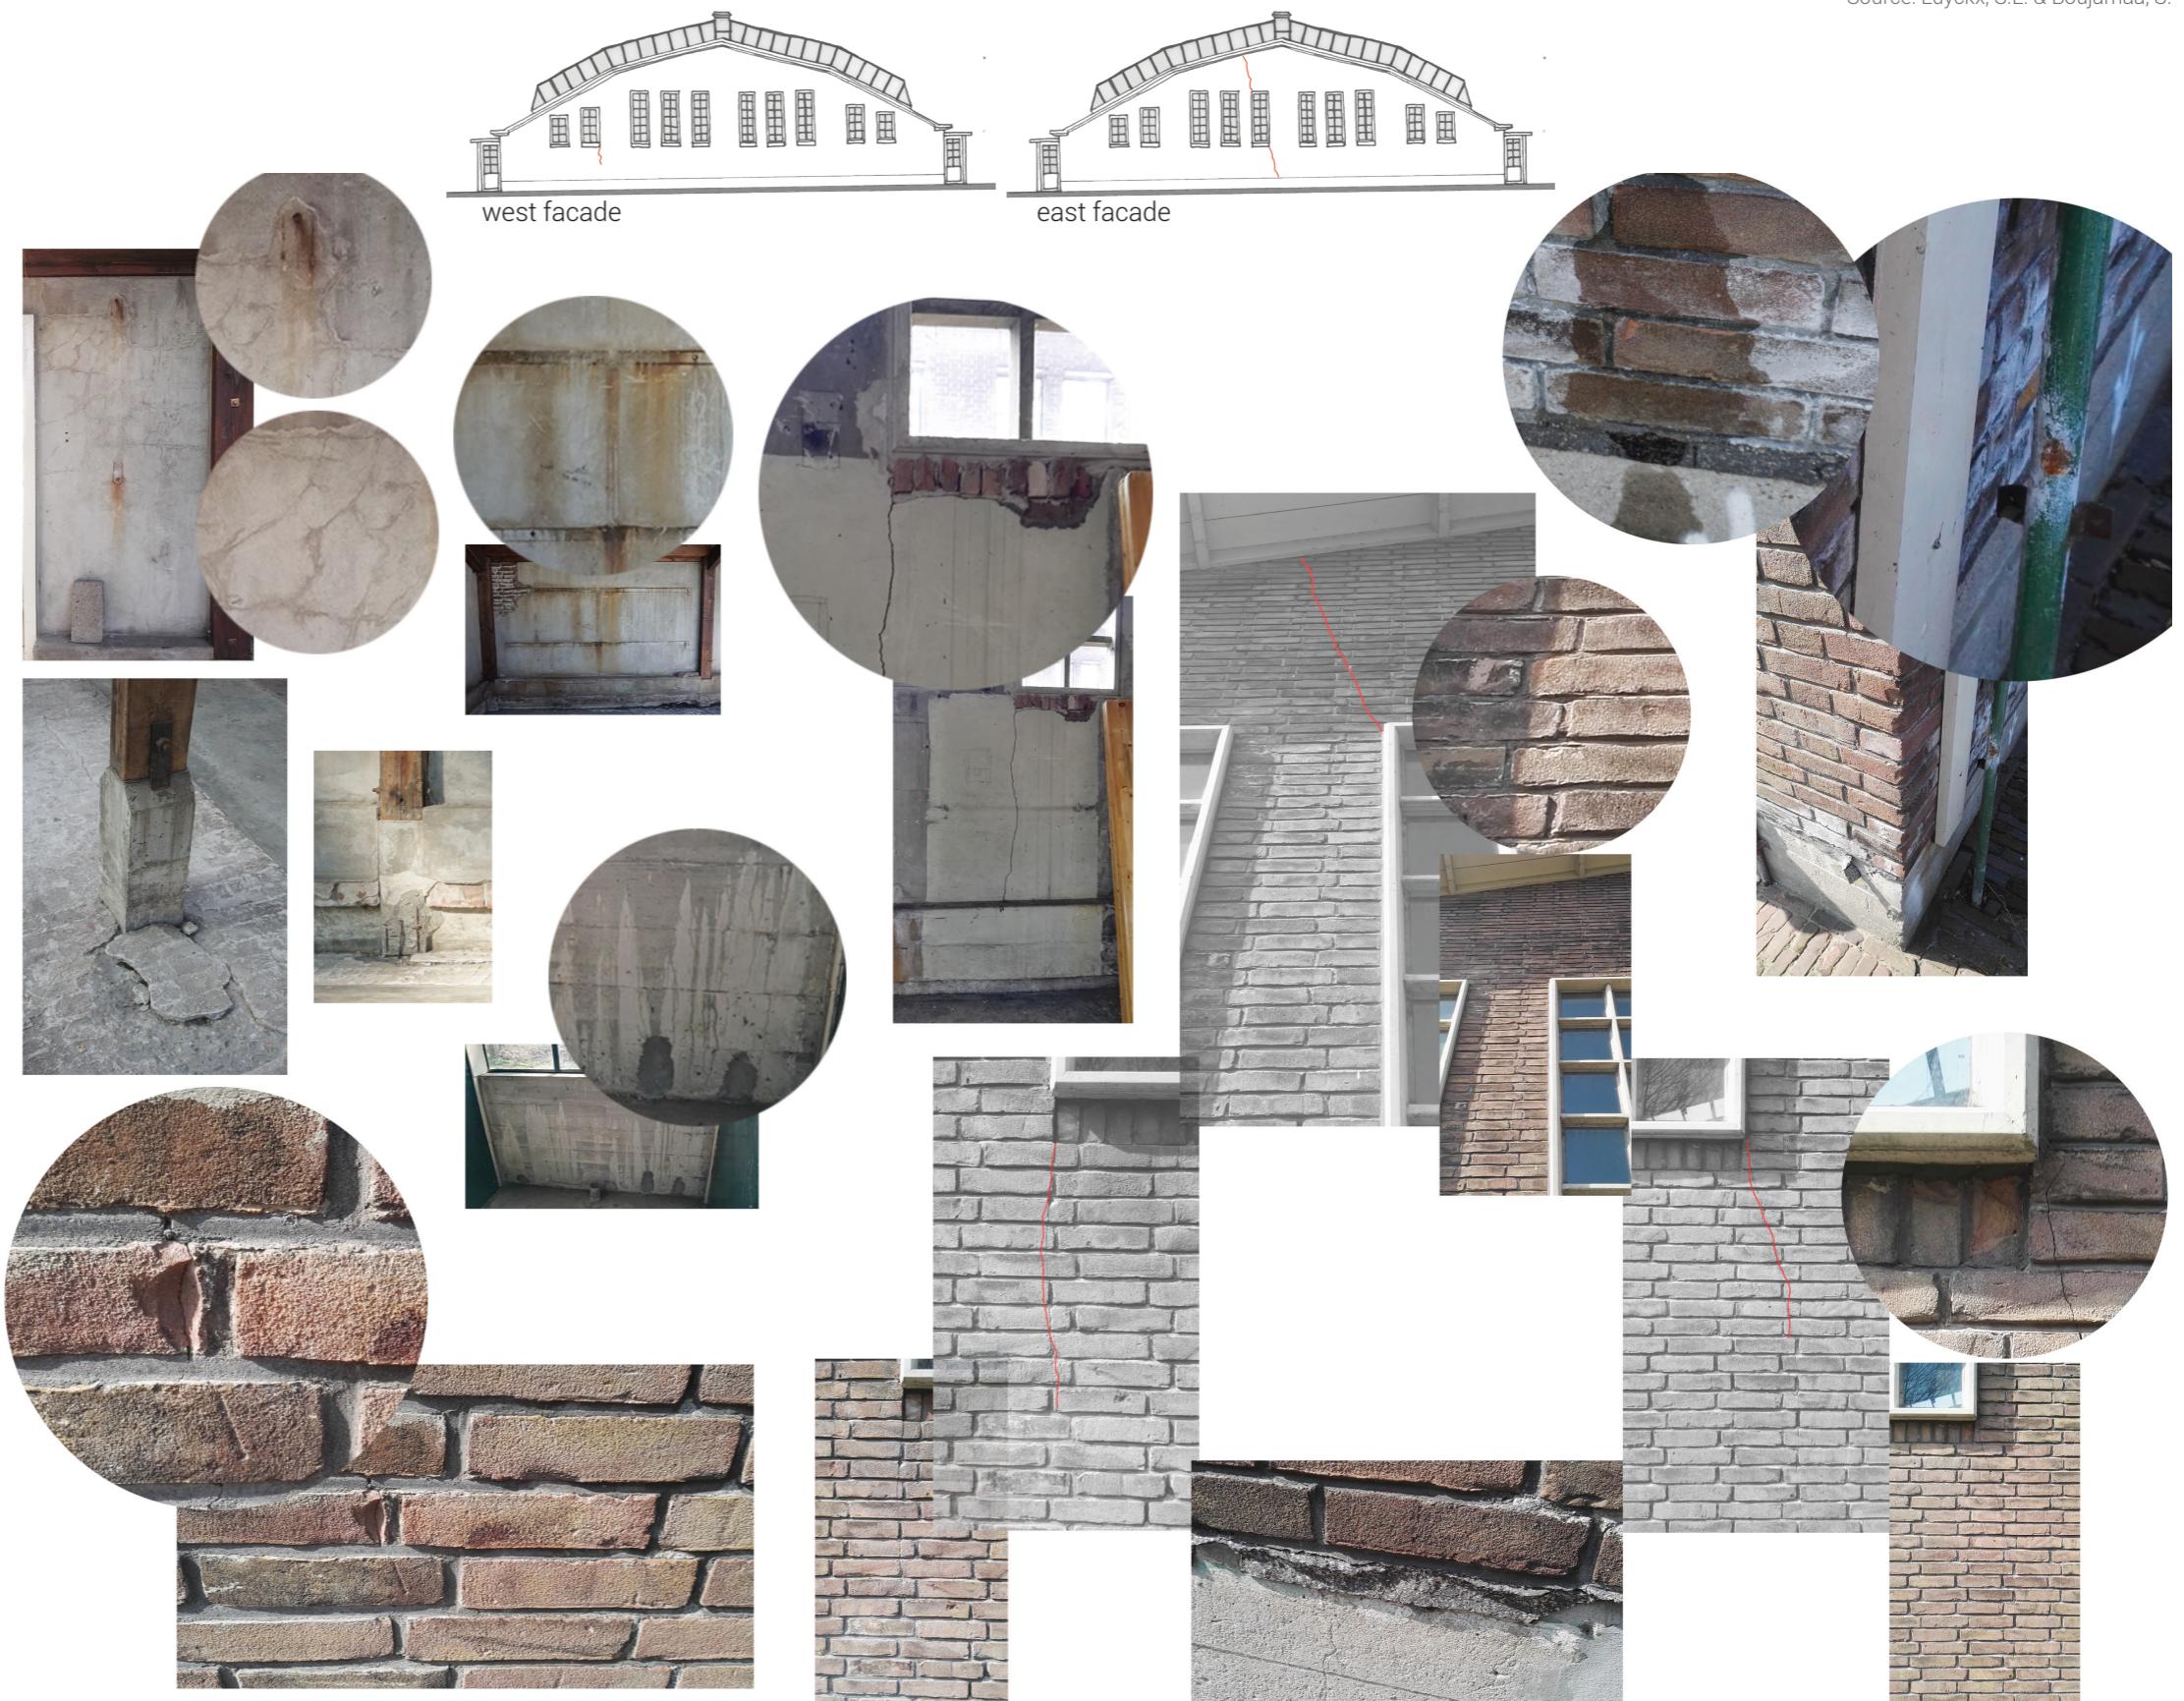
## 03 - DAMAGES

The washing hall has a significant amount of damages. On the outside (next to the windows) a lot of cracks can be seen. One particular crack in the wall is also visible on the inside. On the inside it looks like the crack is only in the concrete but the two parts of the wall next to the crack differ from depth. When the crack goes further down, the difference in depth becomes bigger. This probably is not only in the concrete which is cladded on the brickwork on the inside. It is also logical that there is a crack through the brickwork which makes the concrete crack as well. This crack could be caused by a bad condition of the foundation. However, on the inside it looks like the pillars are still intact and are on the same height. The cracking might be because of frost damage and different kinds of loads (wind).

In the brickwork on the outside a few broken bricks were visible. Most of them situate under the windows. Parts of the brick did not stay in place. This could be caused by rain which stays right under the windows. Parts of brick could fall off due to frost damage in this case since the most broken bricks are right under the windows. Furthermore, on the inside the corroding of steel is visible. It leaves an orange-brown colour on the concrete cladded brick-work. This steel belongs probably to the structure of the former lockers. Some of the corroding steel maybe belonged to pipes which went through the wall.

Another damage which is visible on the inside is the map cracking of concrete. Random cracks in the concrete appear which is caused by the shrinkage of the surface of concrete. On the brickwork on the outside efflorescence started. A layer of white is on the bricks. One might think it could only be paint which was put on the wall (by accident) but when water is poured on it, the colour of the brick appears. There is a layer of salt on the bricks, caused by the salt in mortar but also in the bricks. This salt could also be from the soap which was used inside and somehow salts came in the ground. There was a 'soap cart' in the washing wall which was located closely to the efflorescence spots. These spots were also higher on the walls. At these places the gutters might not have been intact.

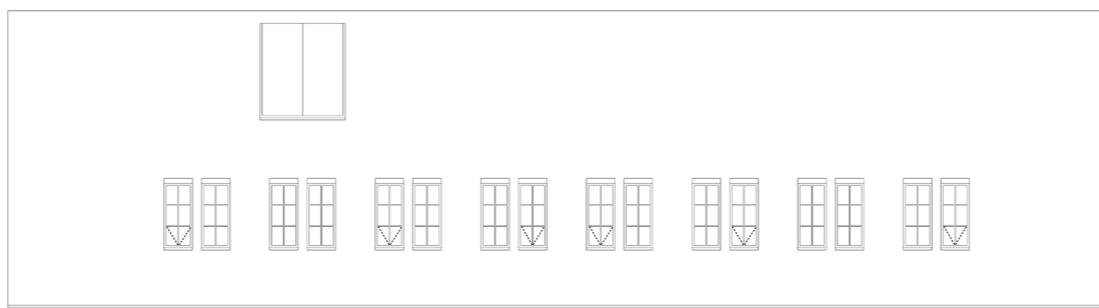
Detail A: The heat treatment building consists of a brickwork structure for the walls combined with a steel roof structure which is placed in the cavity wall. The load bearing part of the wall which is a 2 layer masonry wall, holds the steel roof structure. The lower connection is a pulling connection and is placed over two bricks with an angle profile. The upper connection is a steel plate which transfers the vertical load onto the wall.

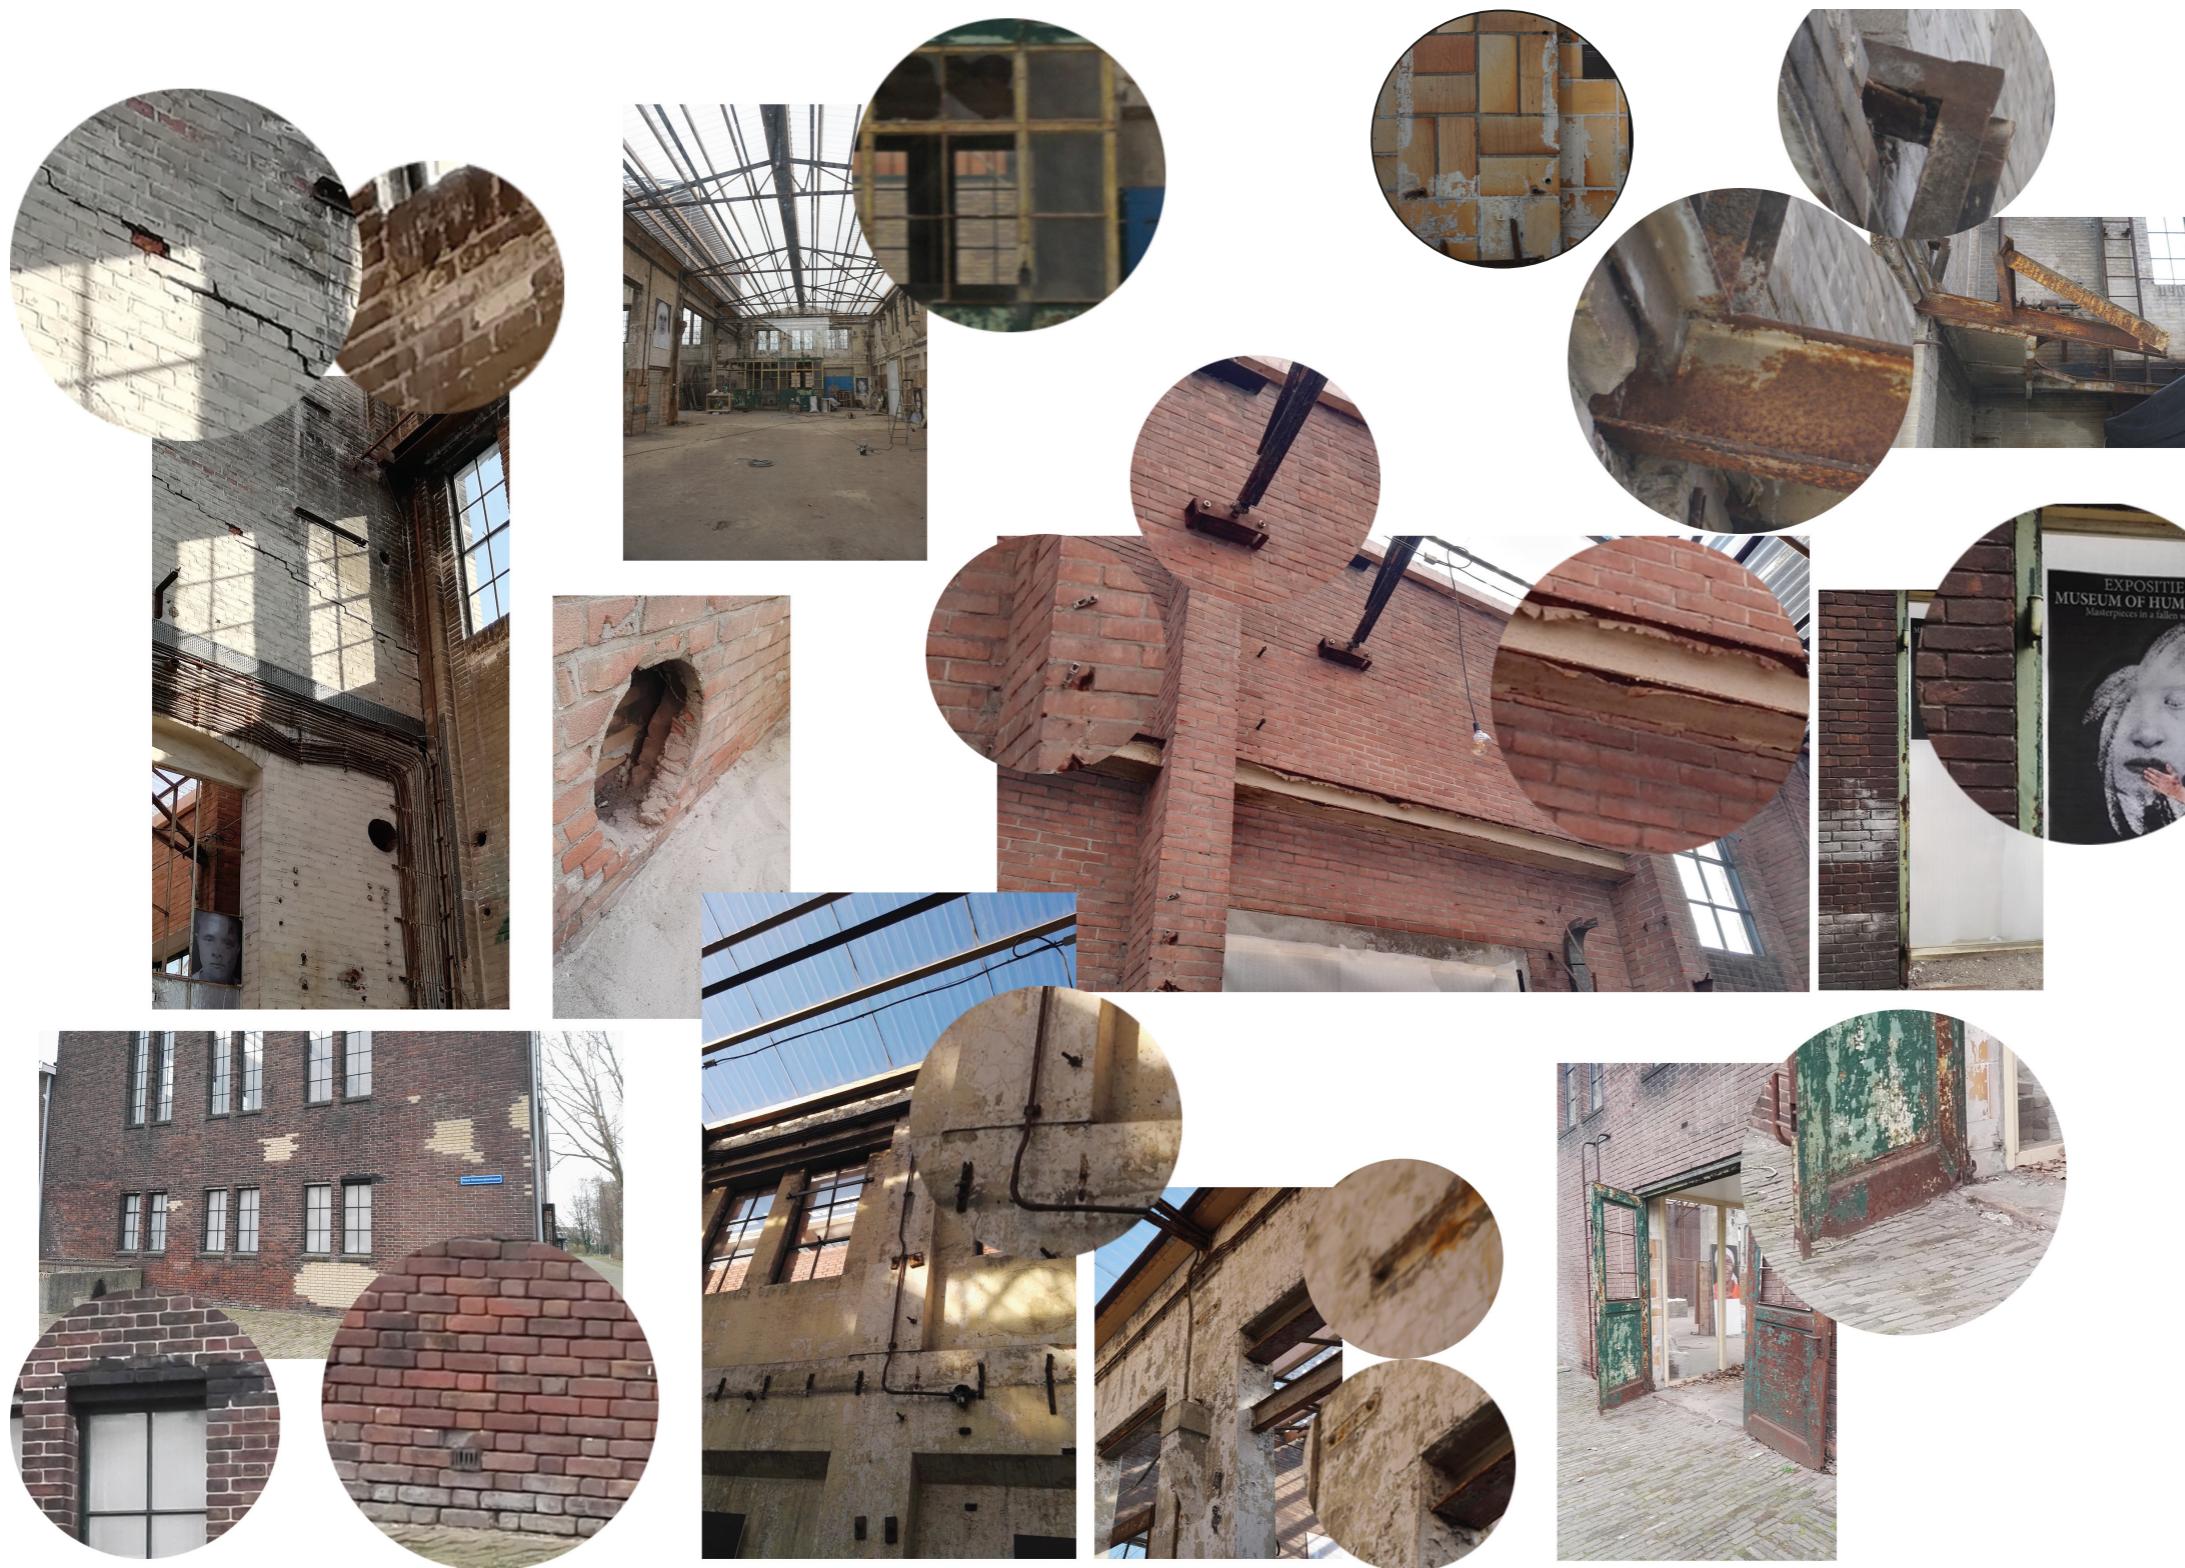
## 03 - DAMAGES

The heat treatment building knows a lot of damages. Most of them are corroded doors and steel beams which are cut through. A big crack in the brickwork tells us how one part of the building became the second part of a whole. Damages in brickwork on the inside is caused by a combination of corroding steel and rain which can enter through a small opening between wall and temporary roof. Holes in brick-work are mostly caused by mechanical damage.

There is a significant amount of big holes with a diameter of about at least 30 cm. These holes are only on the inner side of the cavity wall. The outer side is filled with yellow bricks. In the past, big pipes/chimneys stuck out of the walls. Afterwards, when the site was left neglected, the chimneys/pipes got rid of and only the outer walls were filled.

The layers of paint are clearly visible. This paint is coming off the walls and tiles due to moisture.

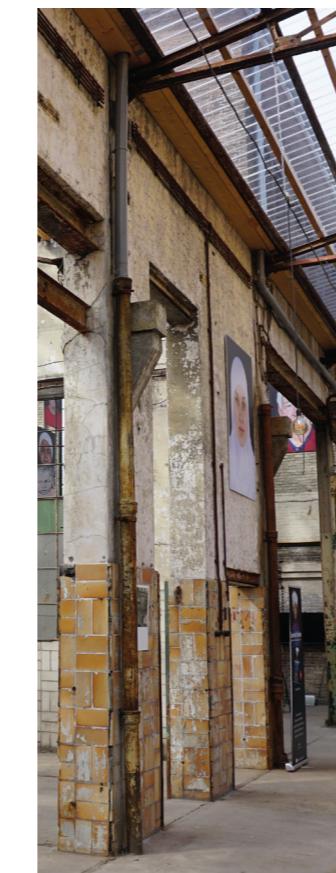
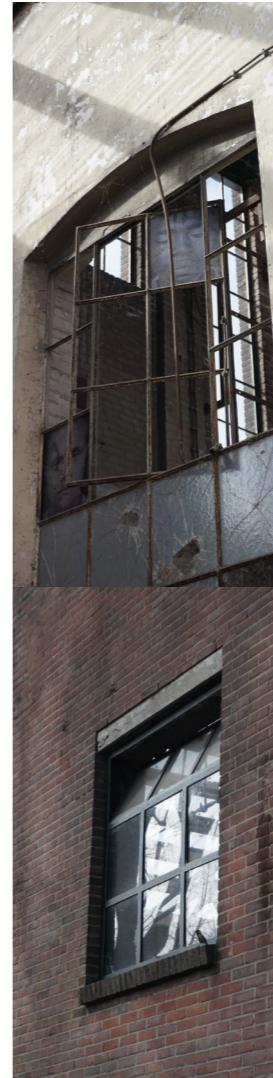
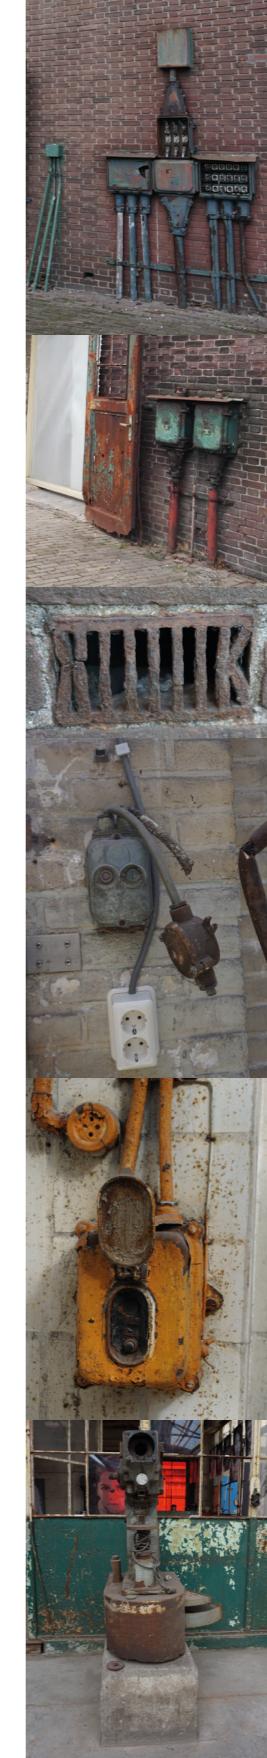
The heat treatment building has no longer its original roof and on the new wooden beams lie transparent corrugated sheets.

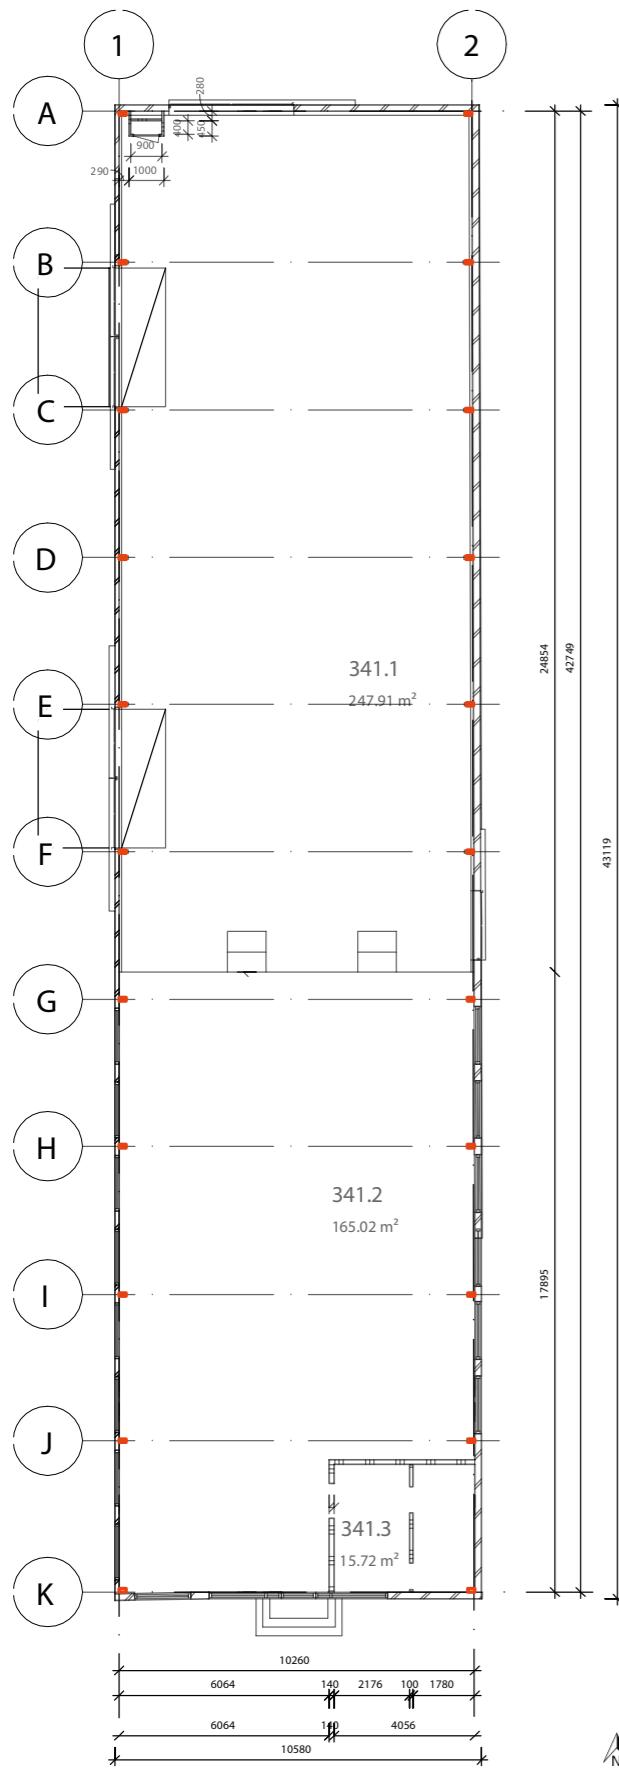
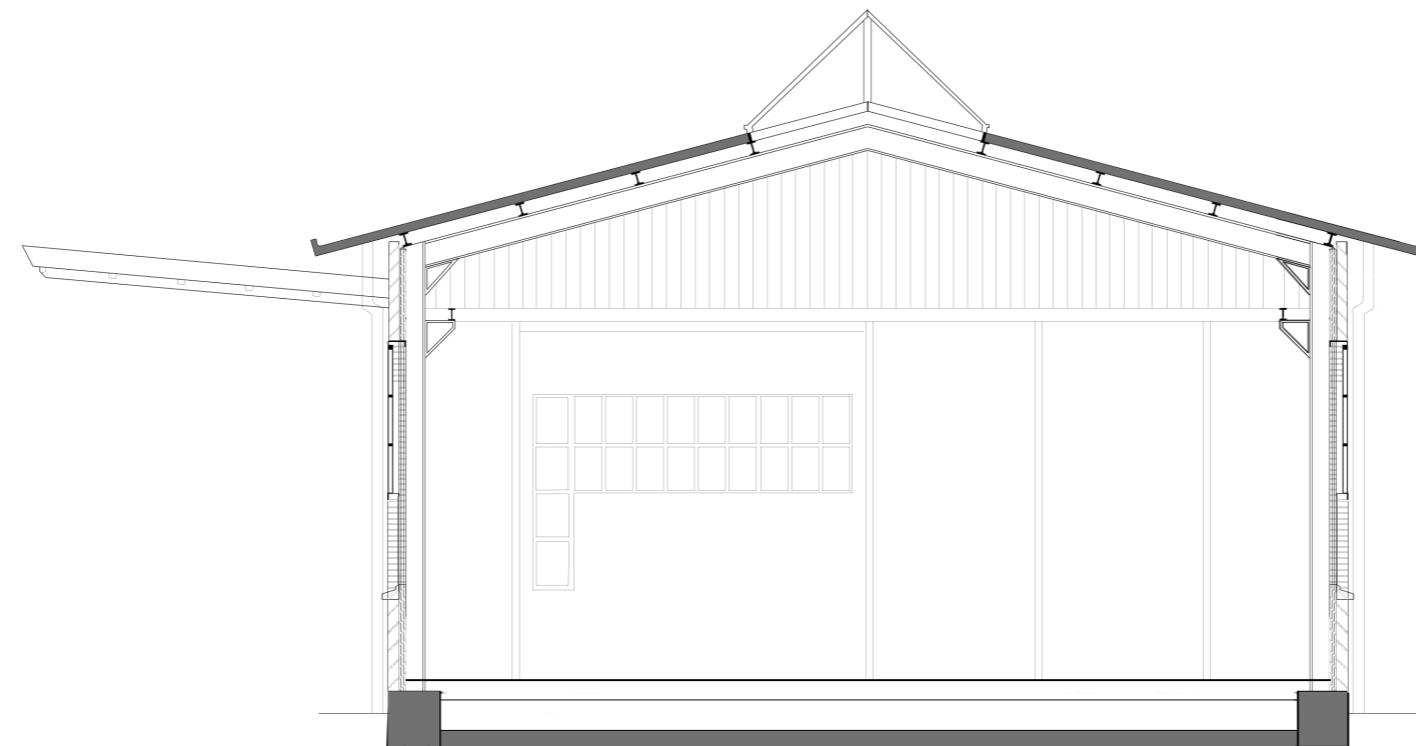
## expedition building /office 341

The expedition building is supported by steel beams and columns which are at their turn supported by a reinforced concrete foundation. This foundation doesn't use the traditional foundation piles, which are very common in the Netherlands, as the building stands on the part which was the peninsula, called: 'de Hem'. This thick layer of sand provides enough support for the building's structure.

The wind bracings are applied in the roof structure which consists out of steel beams with on top a cassette roof.

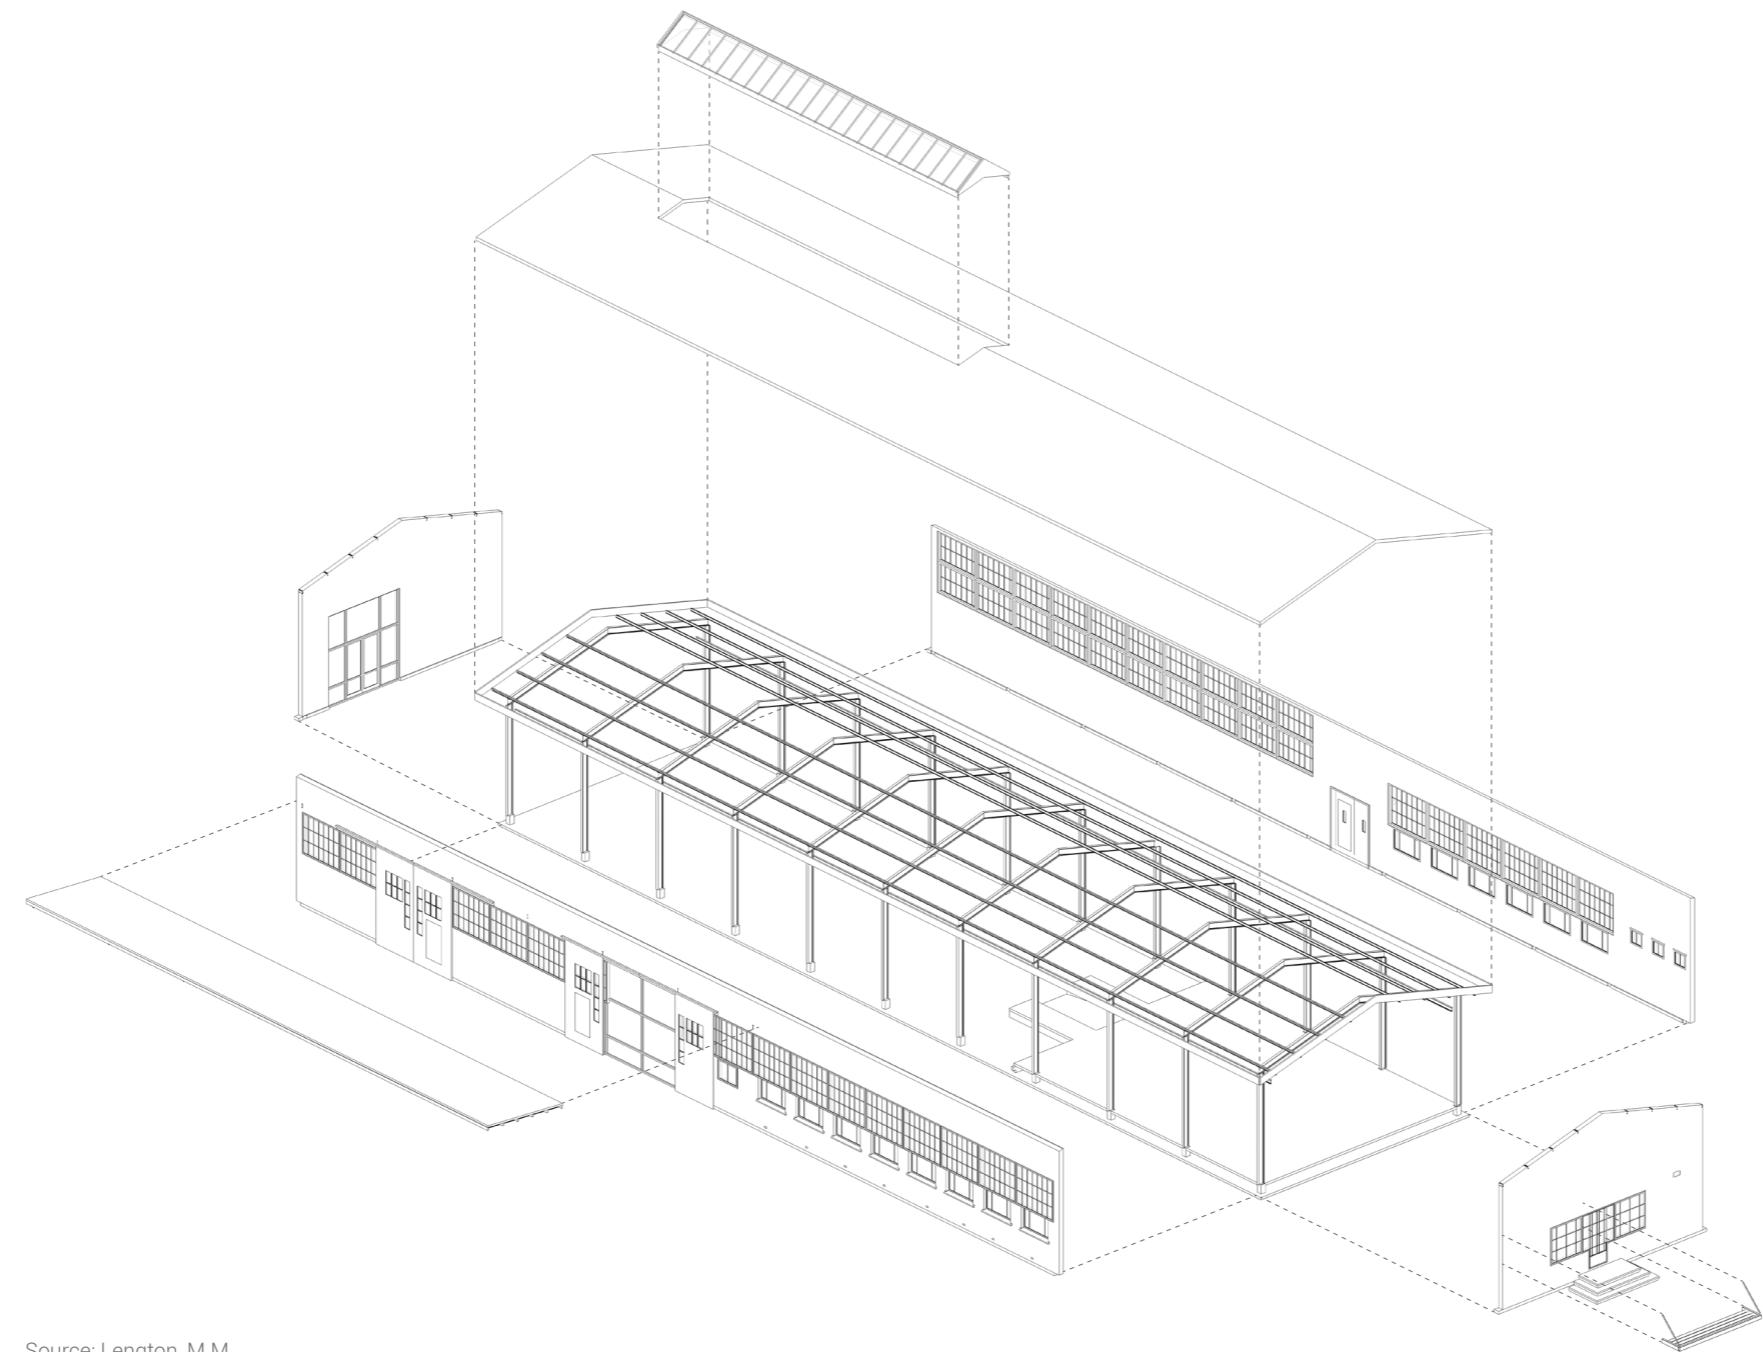
The canopy which is connected to the steel columns has been renovated after it was encountered in such a bad condition.

Due to the steel structure and the grid which follows the walls, the space in the expedition building remains open without any obstructions of columns.

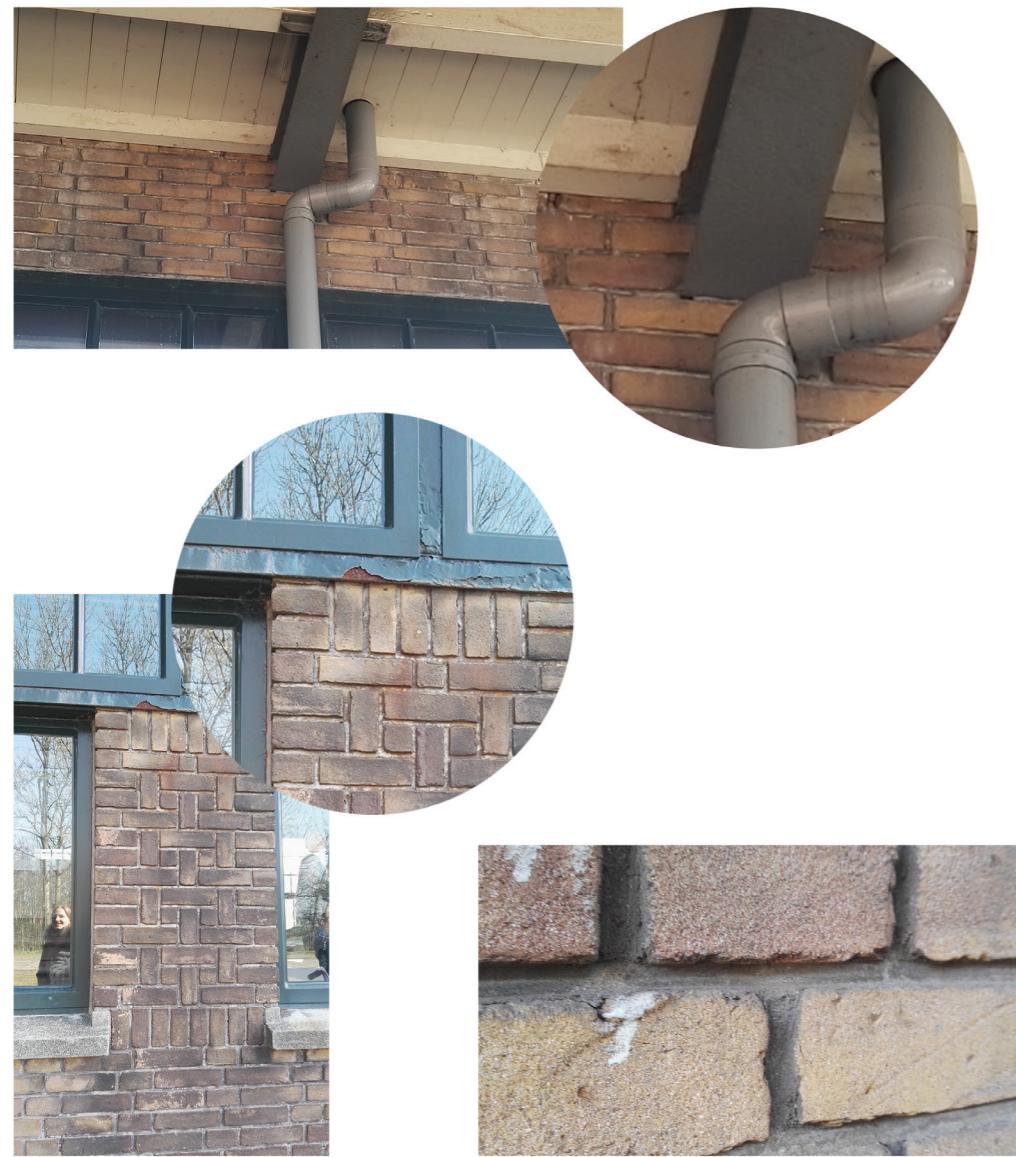
## 03 - DAMAGES

The expedition building was already renovated. They repaired or replaced many parts of the building. Therefore, very visible or crucial damages cannot be seen. The steel/iron window frames are partially corroded. When closely looking at the brickwork, the pointers most likely have fallen off.

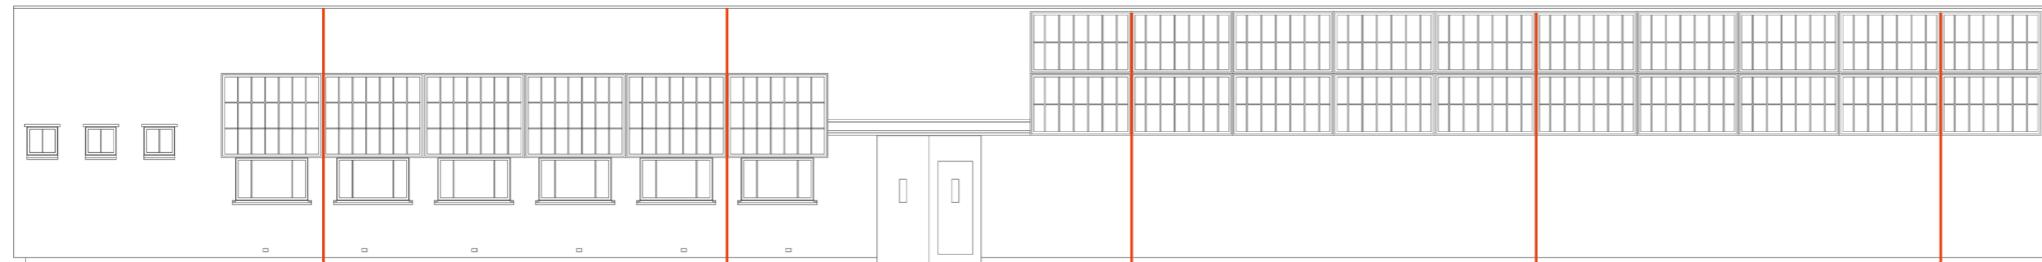
east facade

rainwater drainage

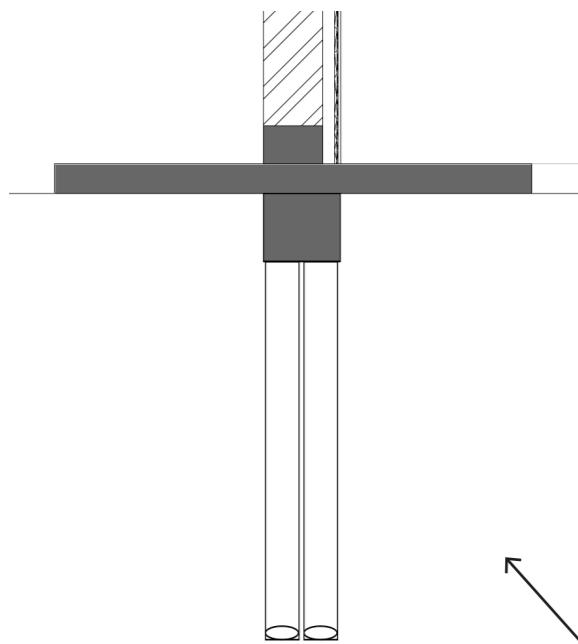
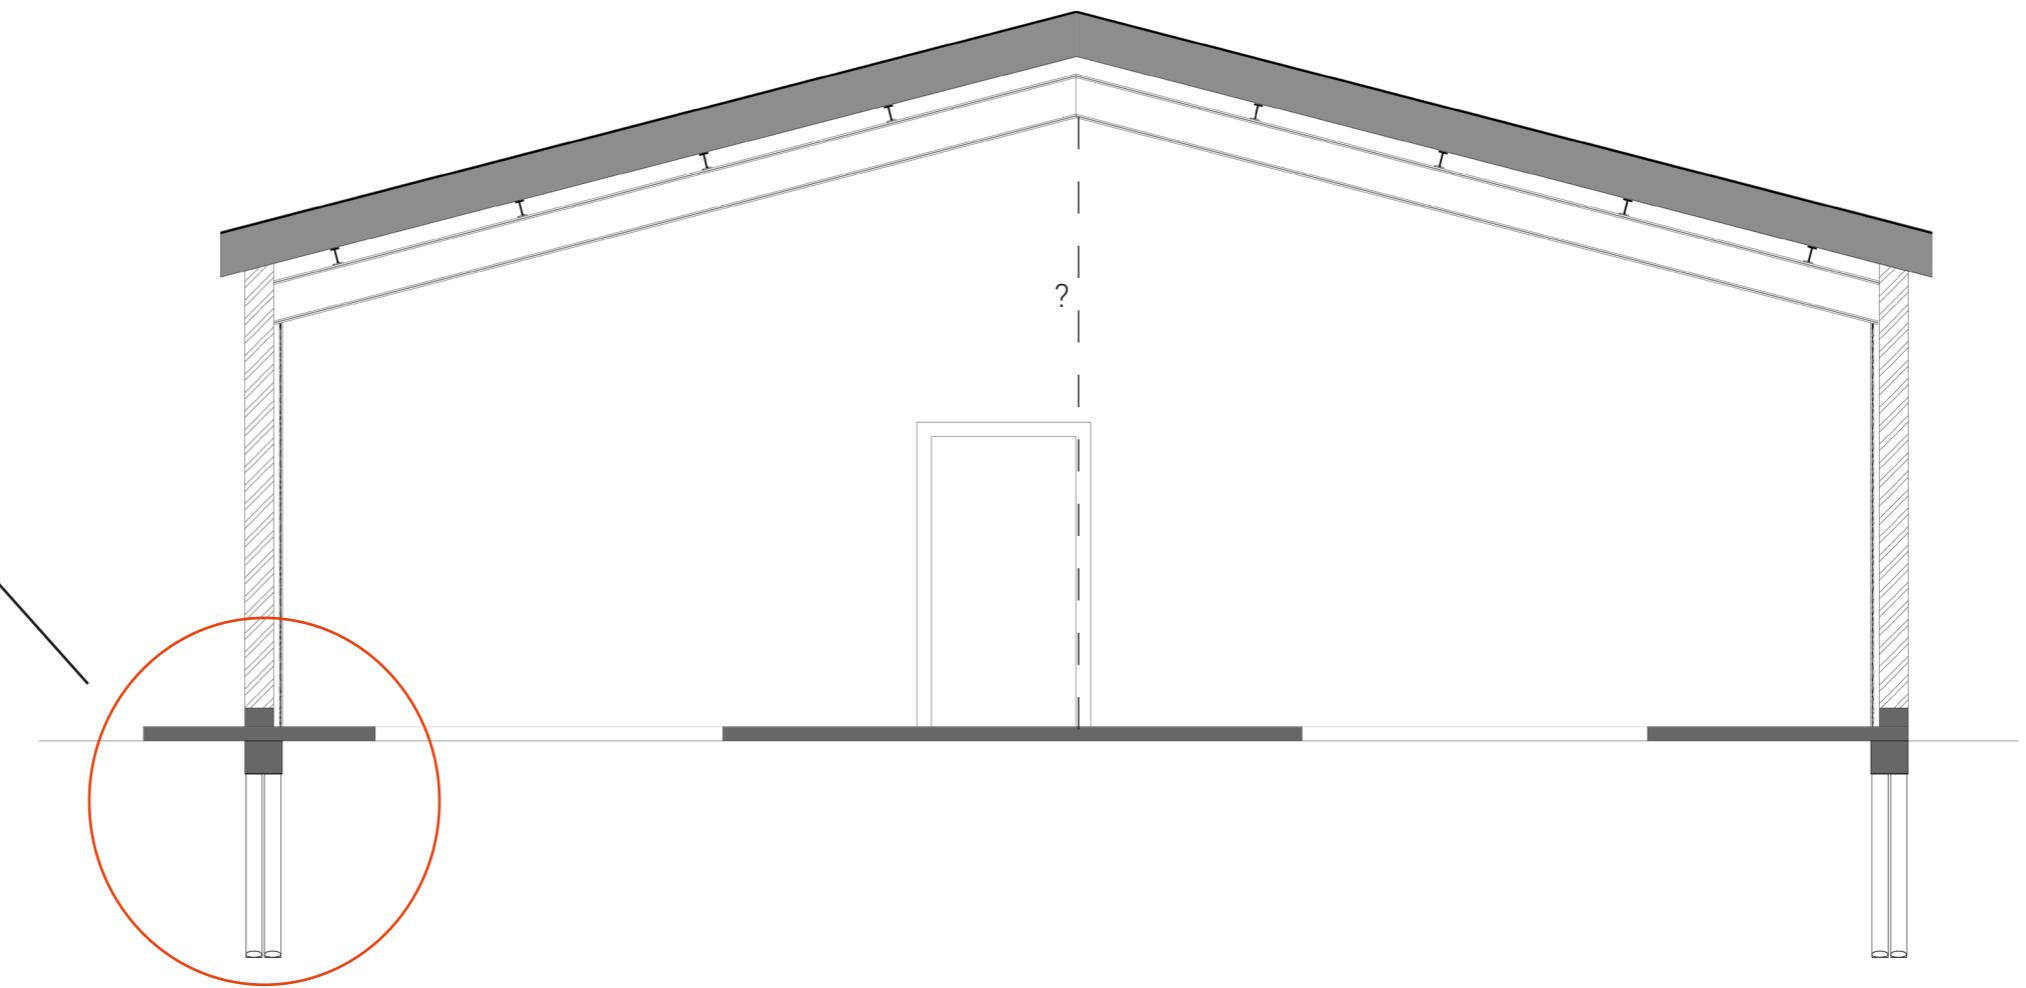
### bicycle shed 422

The former bicycle shed used to have a concrete foundation with a steel structure on top of it. It is still unclear how the roof structure once was; it could be two beams supported in the middle by a column or it was a roof structure which was already rigid on its own, just like the roof structure in the expedition building.

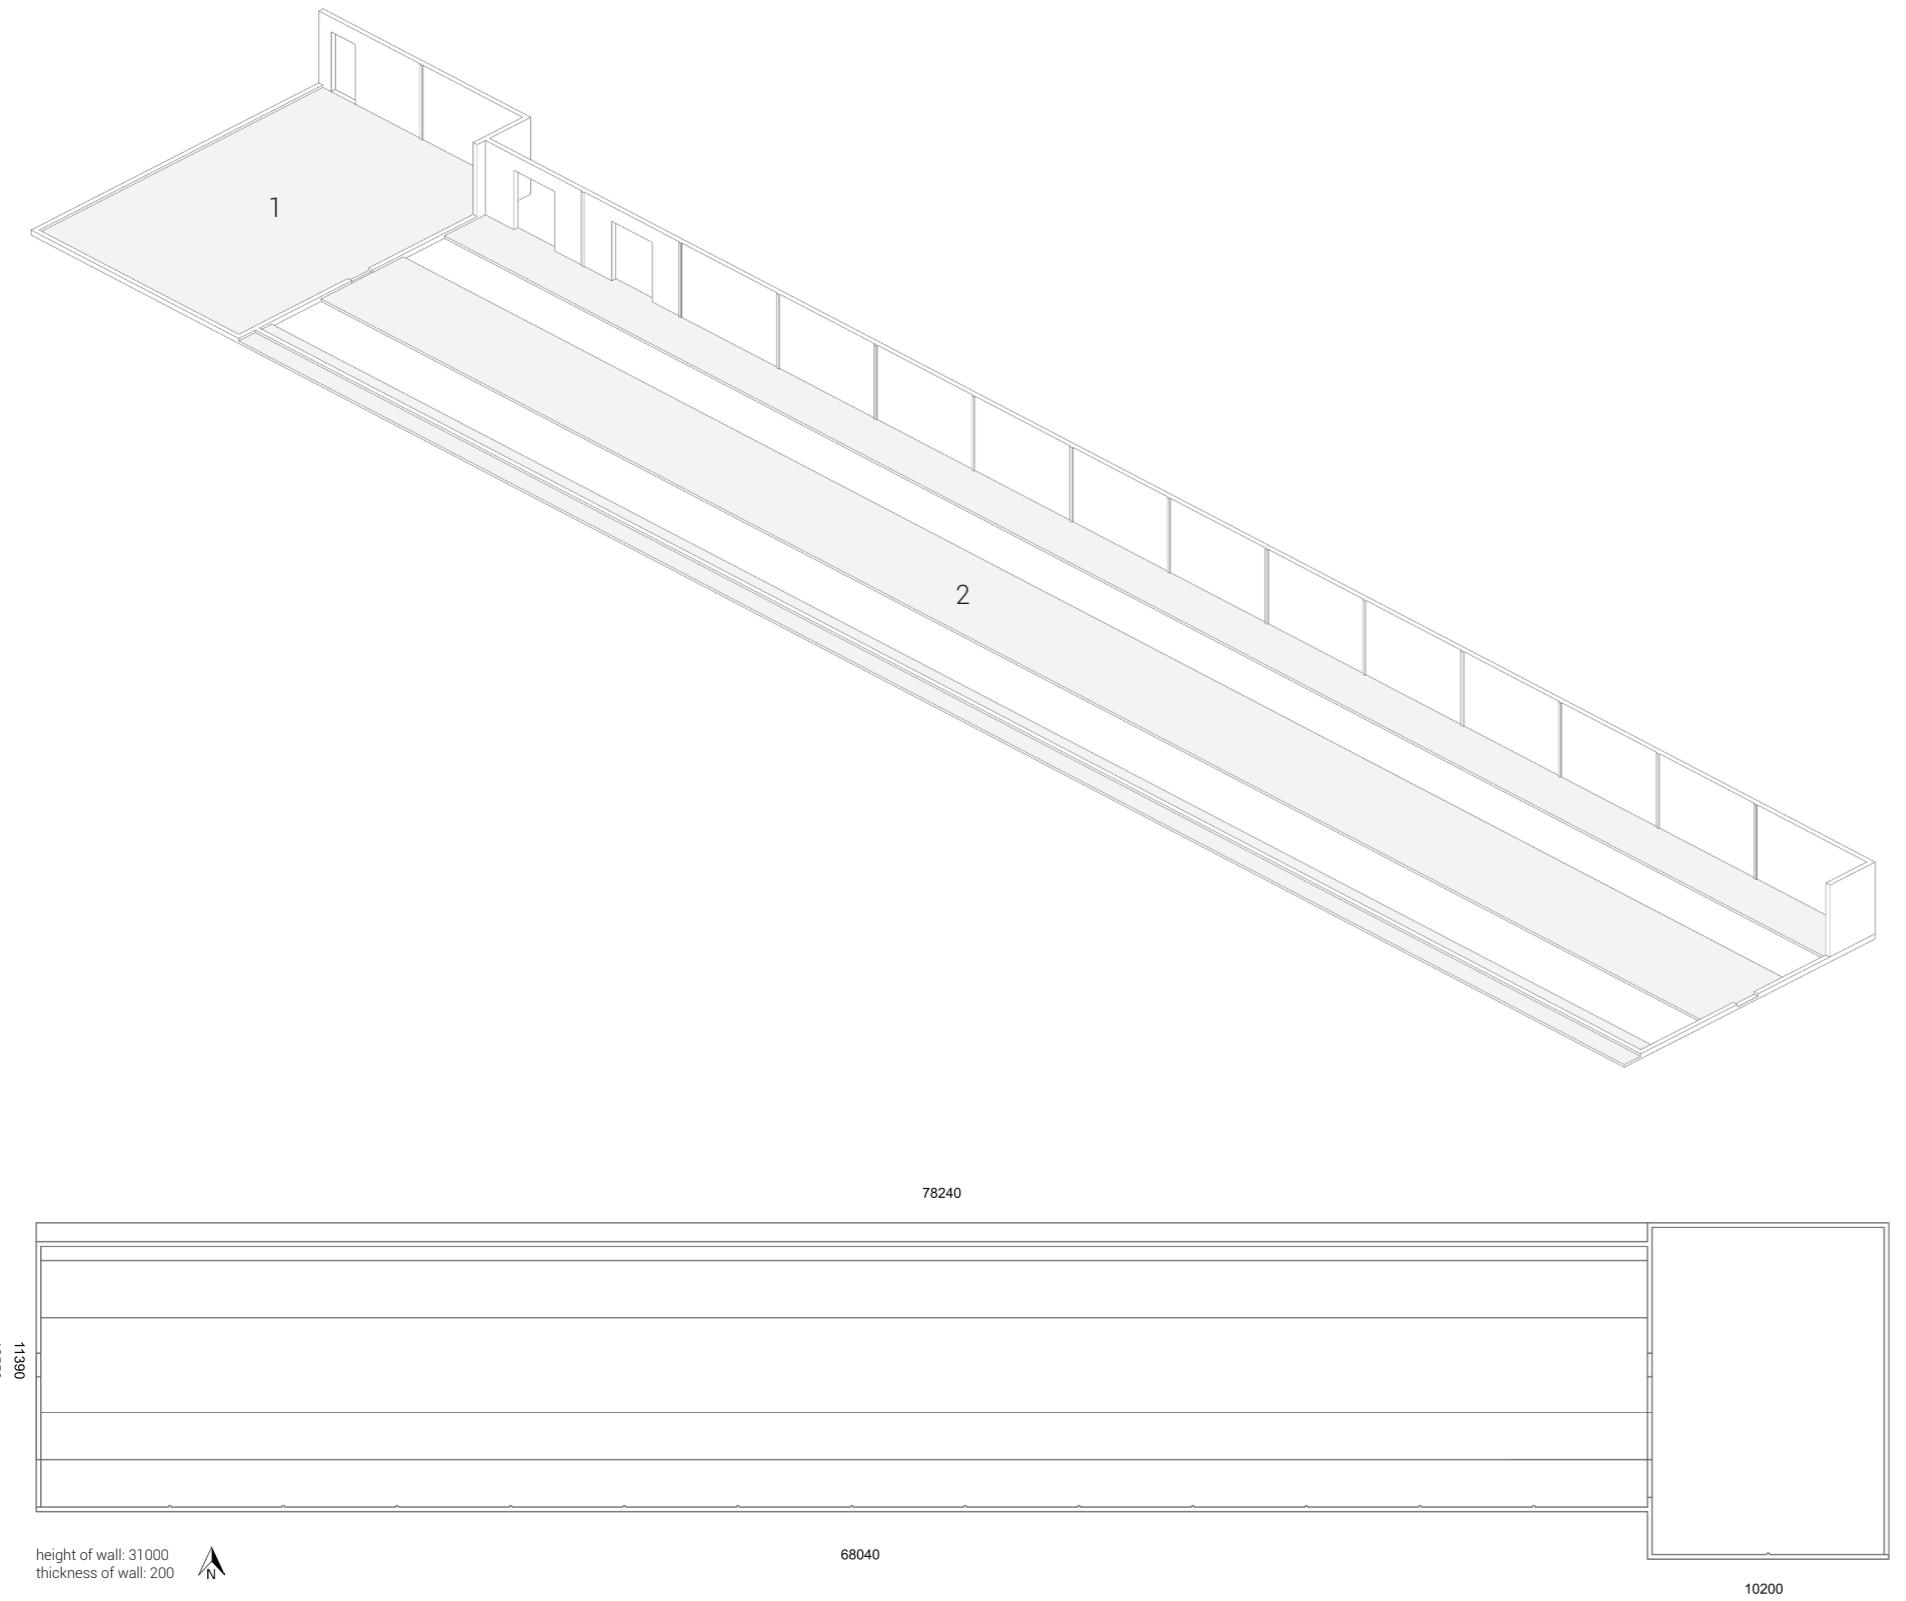
The remaining brick wall and concrete foundation of the bicycle shed, existing out of two parts.

The remaining concrete foundation and brick wall of the bicycle shed are deteriorated by nature. Openings in the wall are located at the entrance at the waterfront, where employees would enter with their bike. The foundation exists out of two parts and because of this and together with an old photograph where you can see that this part has a higher roof, we assume the building was divided into two functions. Probably an indoor entrance and the bicycle shed itself.
