# ANALYSIS CAMPUS SOUTH hembrug peninsula

MSc3 P1 Heritage and Architecture  
Sophie Luyckx 4395948  
Soumaya Boujamaa 4287258  
Maaike Lengton 4272110  
15-04-2019

Title: Analysis Campus South  
Hembrug Peninsula

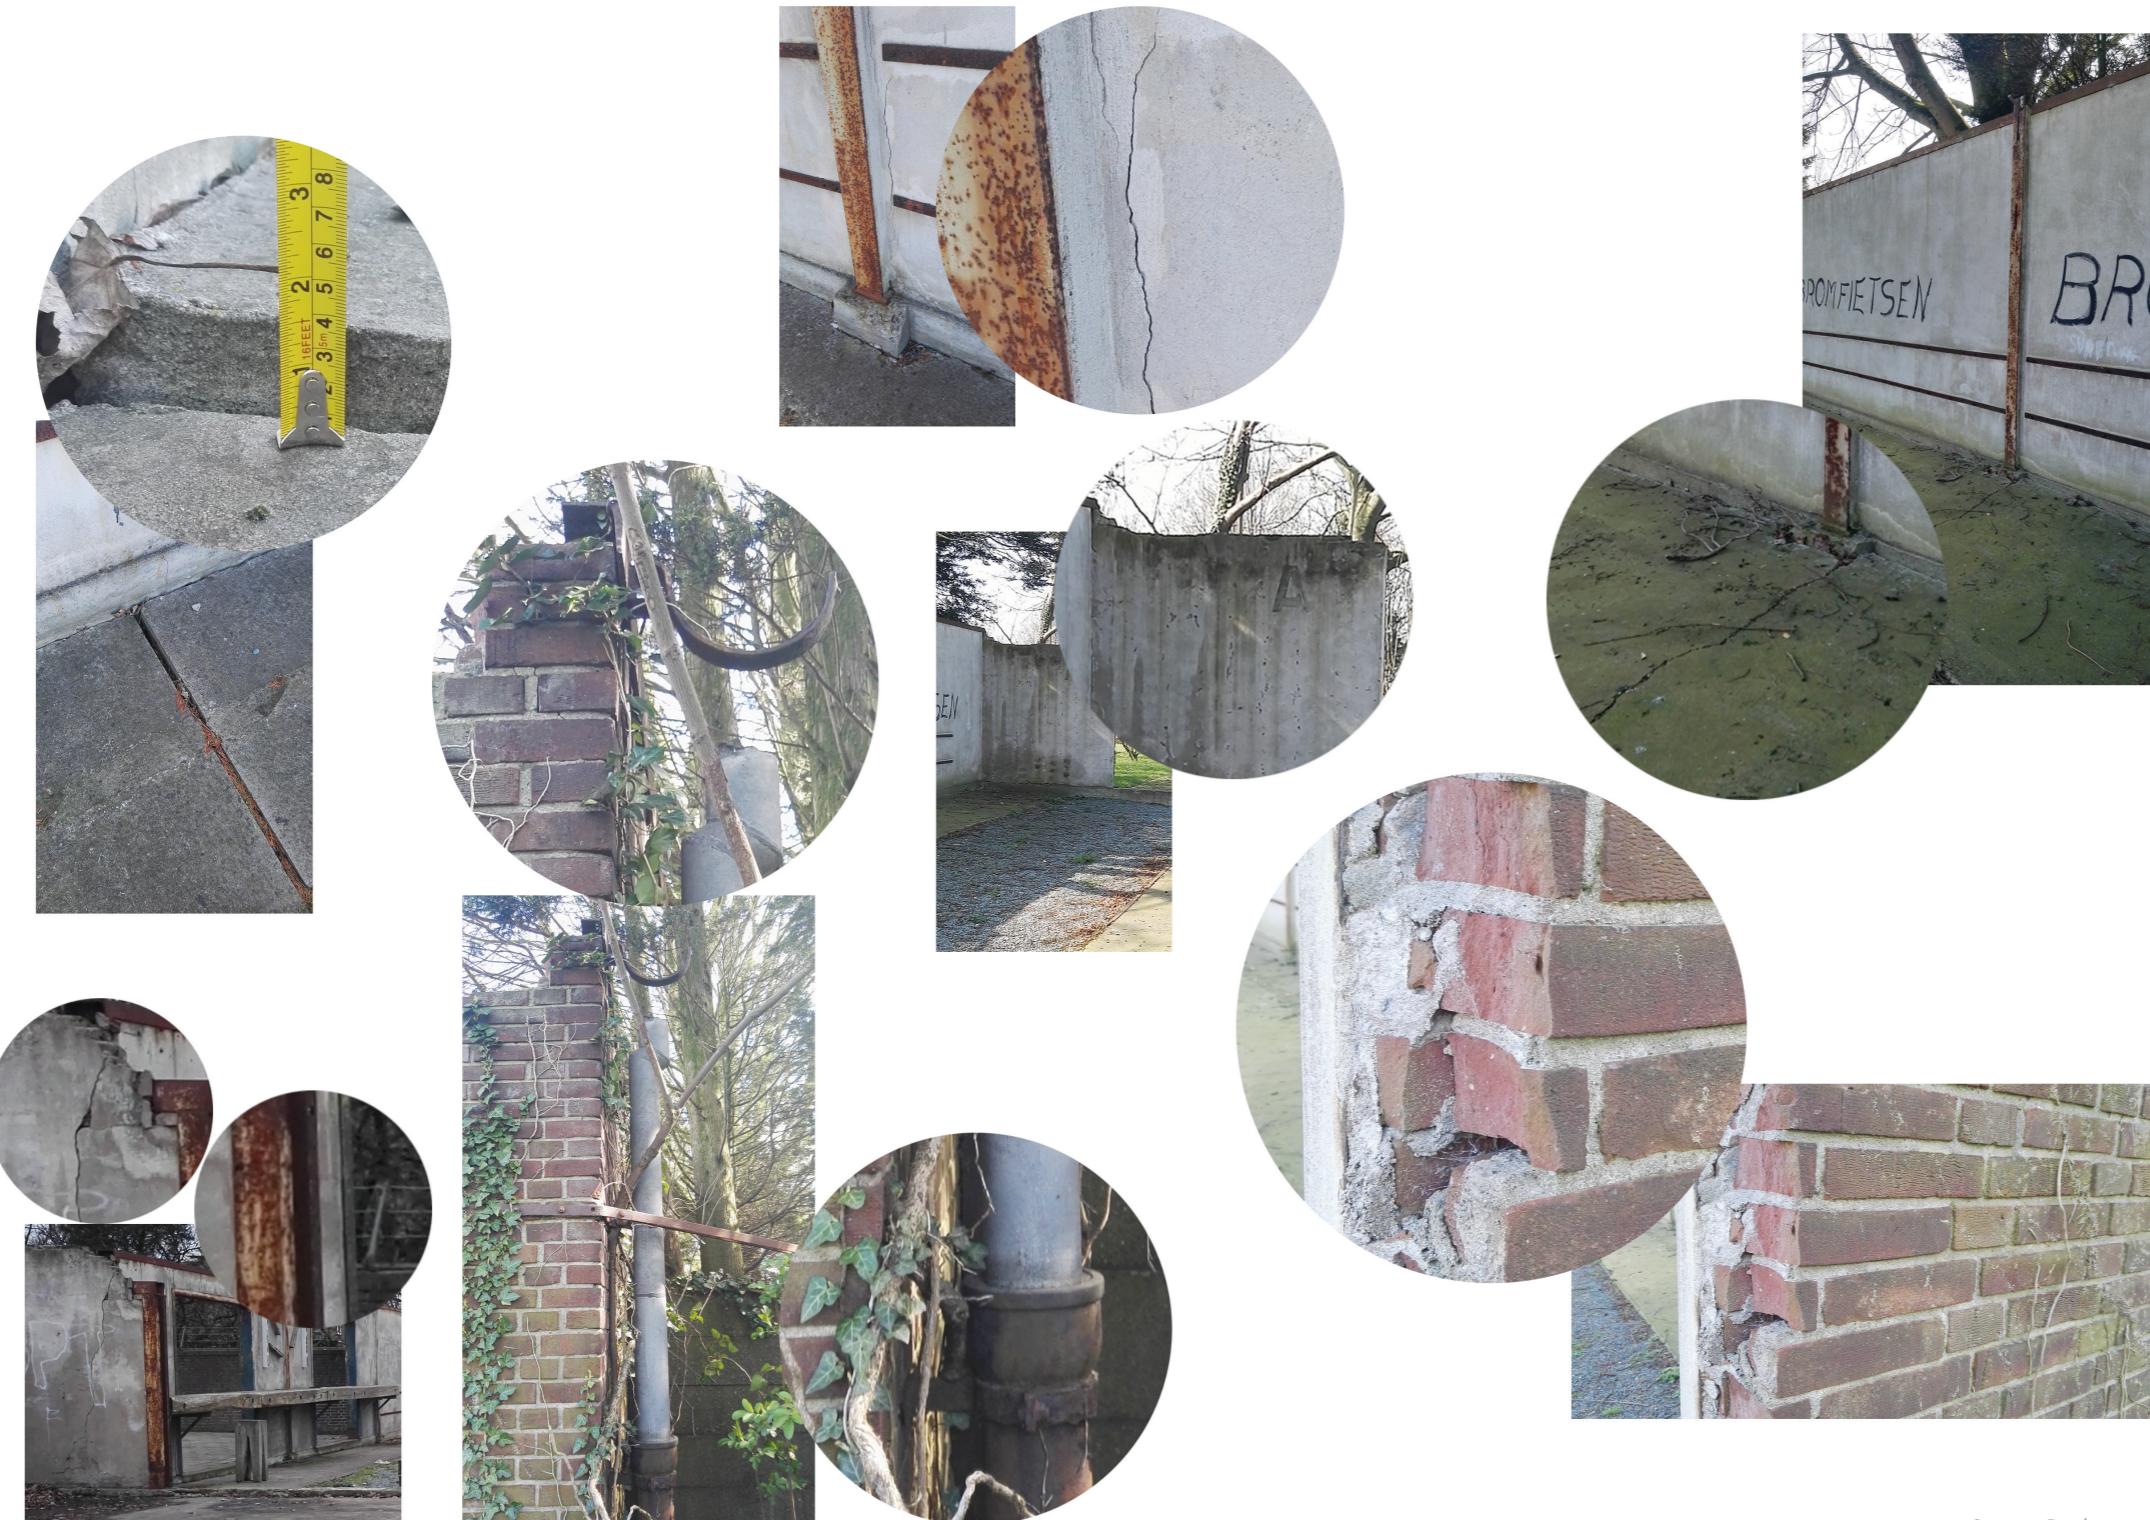
## 03 - DAMAGES

There is only a foundation and one wall left from the bicycle shed. The steel structure which is partly visible, is corroded which is very normal since it is now in the open air.

The brickwork is damaged but this could have been done by hand as well, when the rest of the building was being demolished. The wall suffers from graffiti.

A lot of cracks are visible in walls, next to the steel columns or on the 'floor'. Parts of the foundation might not be in a good condition anymore. Some parts of the concrete floor are being pushed upwards. One part was 4 cm higher than it should be. Also, the foundation became disconnected from the floor. There was a 2 cm void between the part of the wall's foundation and the floor. The part where the steel column stood had a crack around it on the floor. This all could be an indication of a foundation which is in a bad condition.

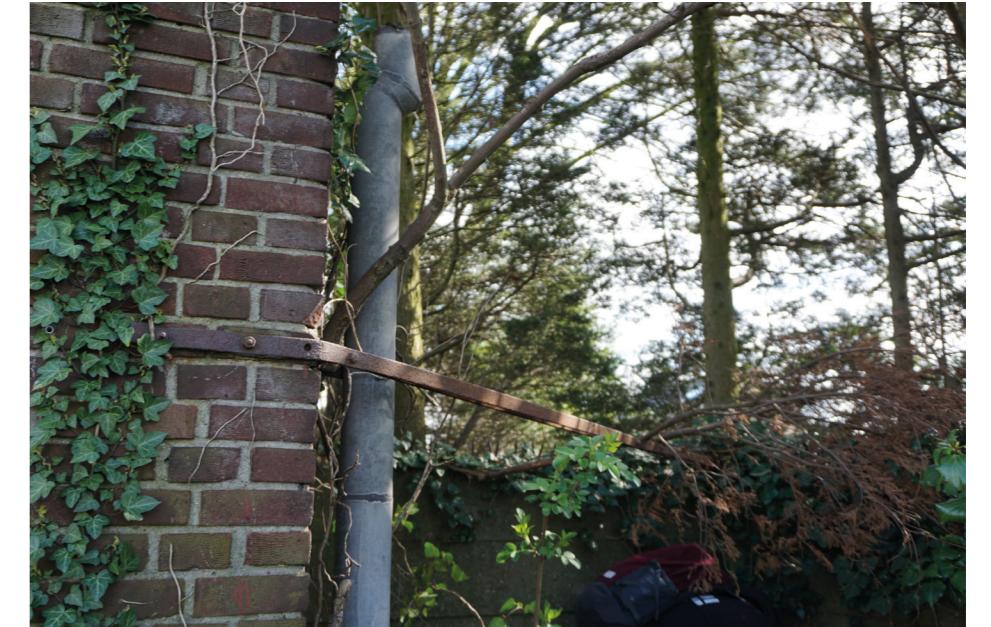
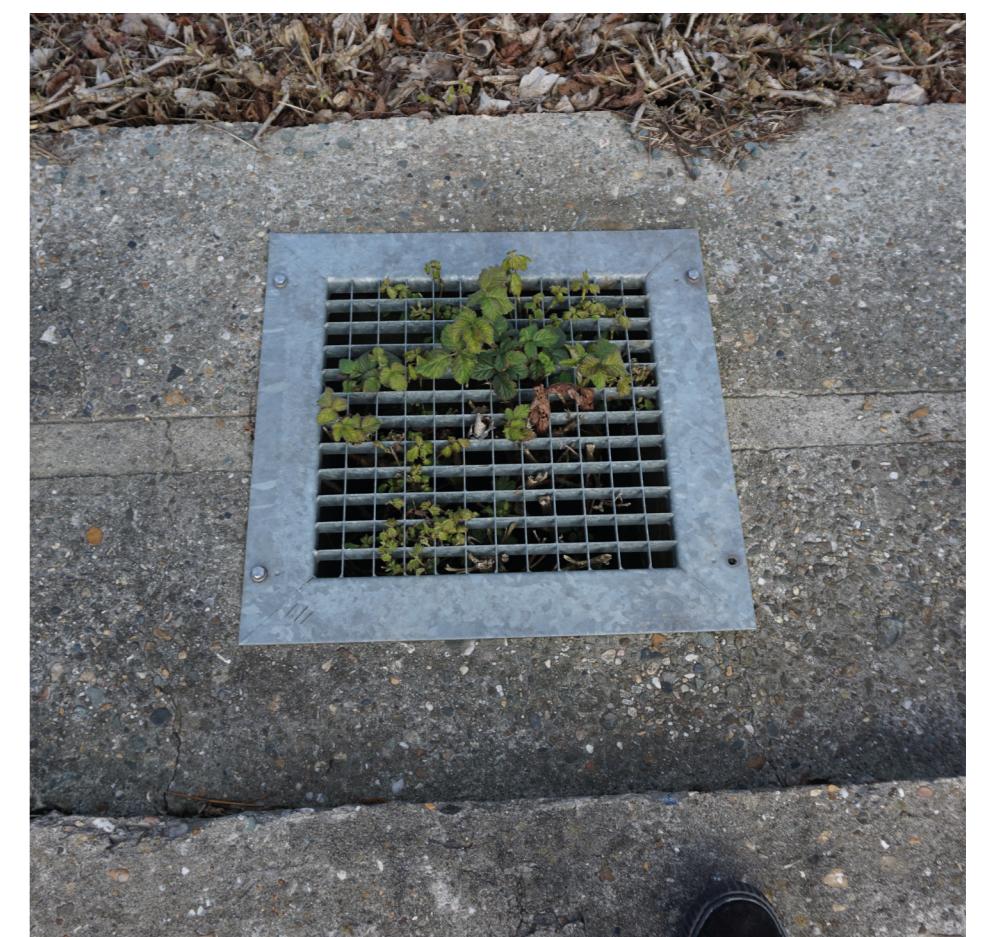
The sewer system runs from the washing hall to the bicycle shed and ends just before the expedition building where it is connected to the main sewer system.

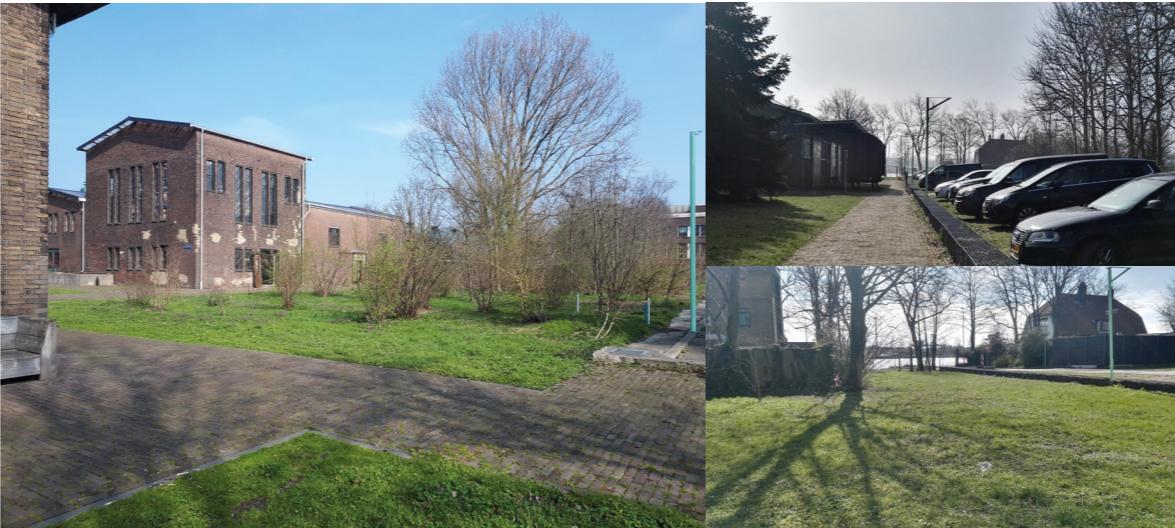
### Site

Red = the intimate yet at the same time open character of the campus and the former railroad which has a sightline towards the water which helps orientate one self.

Orange = Area of the bicycle itself and the area around the expedition building on the side of the former railroad.

Green = The greenery and forest like area on the other side of the railroad.

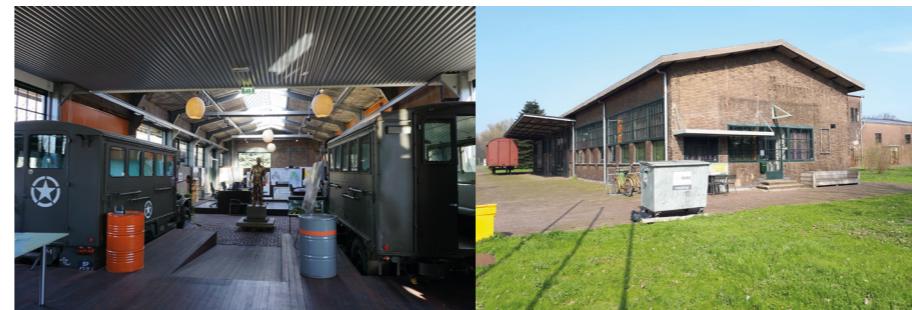
### Expedition building

Red = The effect of the sky light, the former railroad car with the canopy above it and the big windows/openings in the wall which faces the former railroad.

Orange = The steel structure and the brickwork facade with multiple kinds of brickwork bonding

Green = The floor which is there now, however this floor is seen apart from the foundation. The foundation is special because it does not have the usual piles in the ground. Therefore it should be coloured red but since this is not visible, the colour is not shown.

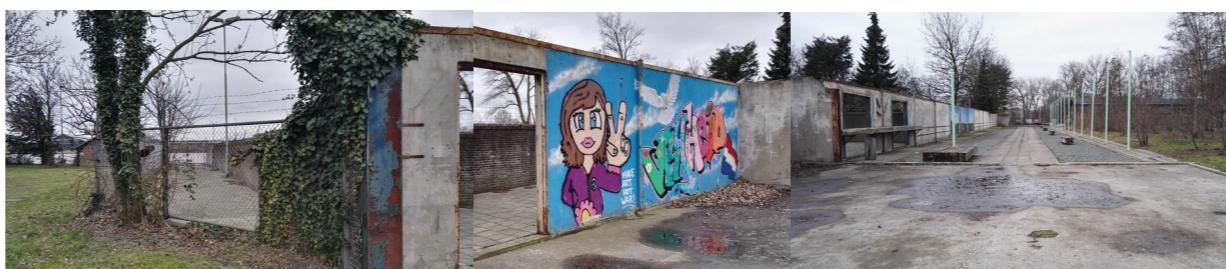
### Bicycle shed

Red = A former entrance and the thought of a building being there back in the day.

Orange = The physical traces of the bicycle which consists of the wall and foundation. Only the wall could not have shown the dimensions of the building or even if a building ever stood there. It could've also been only a wall as a border.

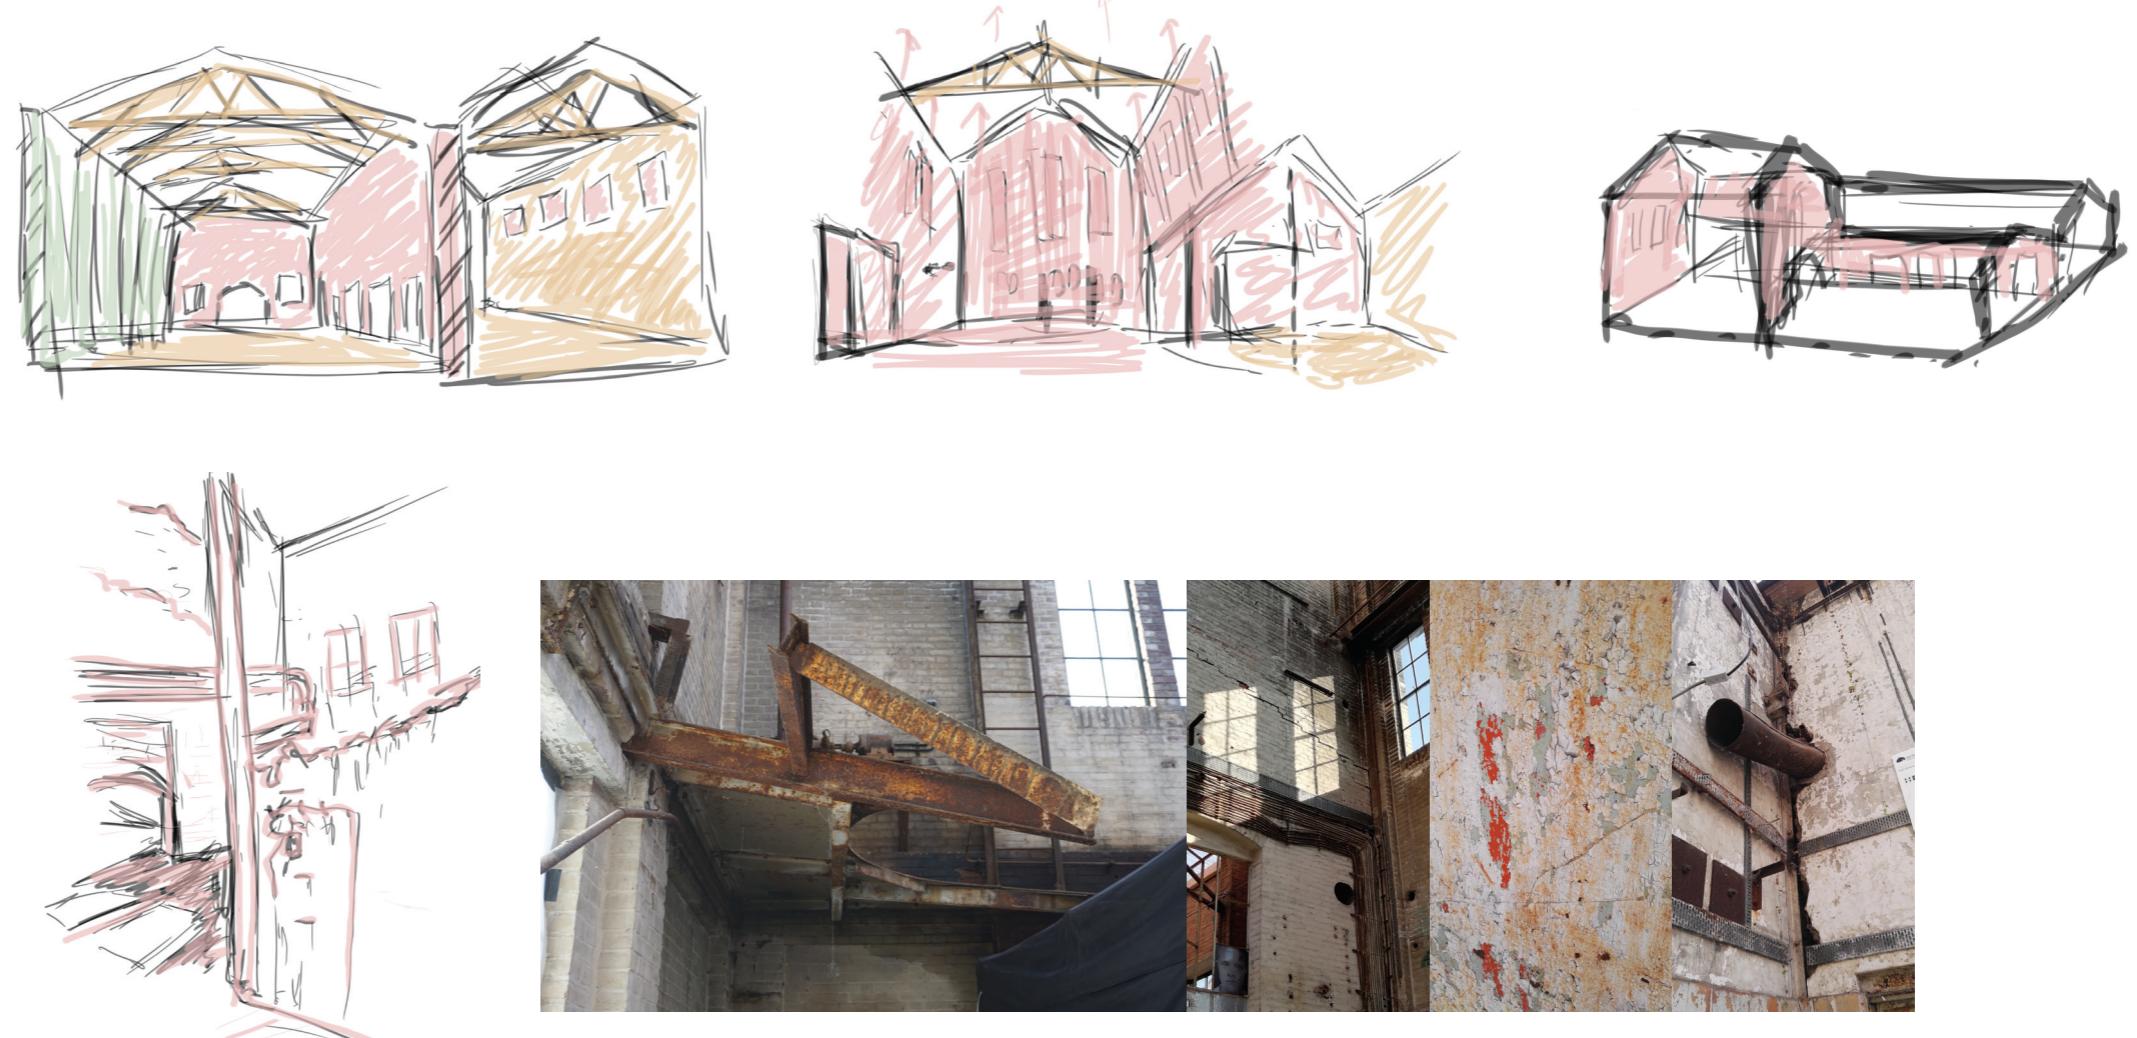
### Washing hall

Red = Wooden structure, space plan and washing basins.
