Experimental damage tolerance evaluation of thick fabric carbon/epoxy laminates under low-velocity and high-velocity impact and compression-after-impact

van Hoorn, Niels; Kassapoglou, Christos; Turteltaub, Sergio; van den Brink, Wouter

Journal of Composite Materials

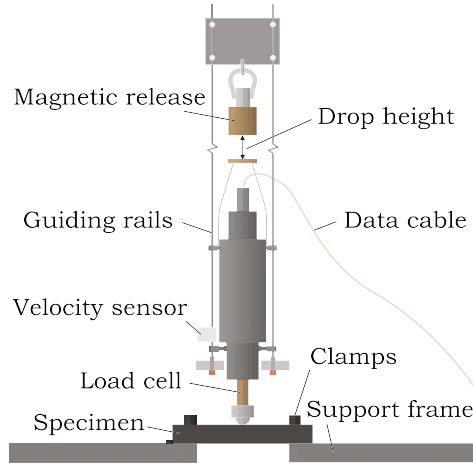
Figure 2. Illustration of the drop-weight setup used for large-mass impacts.

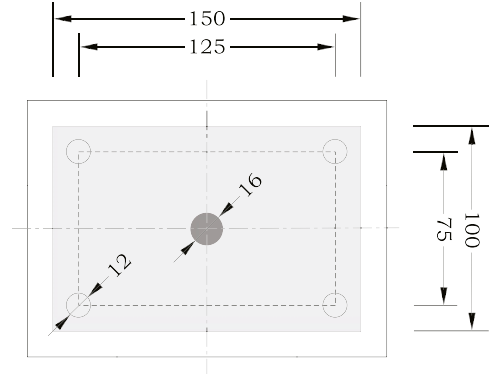
Figure 3. Top-view of the support fixture used for the drop-weight and gas-cannon tests.

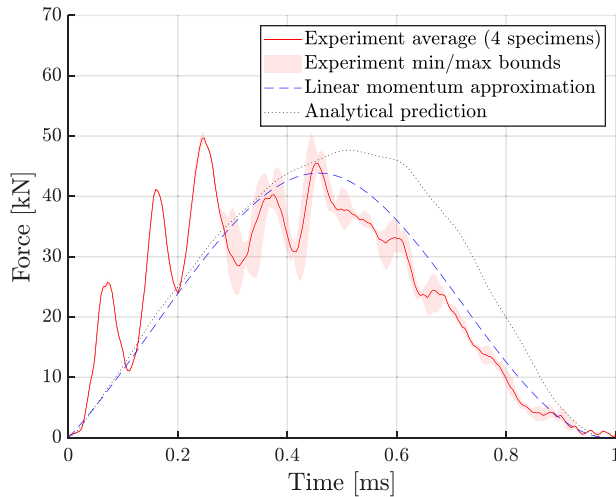
Figure 4. Averaged force history for 55 J drop-weight impact tests on 20 mm thick specimens.

In addition to the outputs that can be calculated directly from the experimental measurements, estimations can be made based on alternative models. For instance, the impactor indentation history, $\delta(t)$, and plate deflection history, $w_p(t)$, can be estimated by assuming a contact law. Talagani¹¹ proposed a contact law for thick composites that has been implemented in an analytical impact response model in an earlier work.¹² An example of a drop-weight force history, including an approximation of the analytical impact response model, is given in Figure 4.

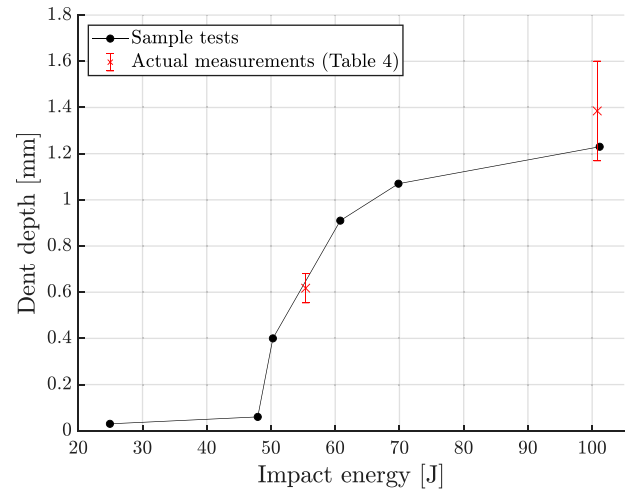
Figure 5. Energy level determination including the dent depths of 55 and 100 J drop-weight impact tests on 20 mm thick QI specimens.

were performed to determine the relation between impact energy and dent depth (e.g. permanent indentation δ_0). From the results in Figure 5, a maximum impact energy of 100 J was chosen (i.e. the limit of the gas-cannon) and, in addition, an impact energy at the point where BVID is expected to occur (i.e. 55 J). For the drop-weight impacts, these impact energies correspond to approximately 6.96 and 9.38 m/s for a 2274 g impact mass.

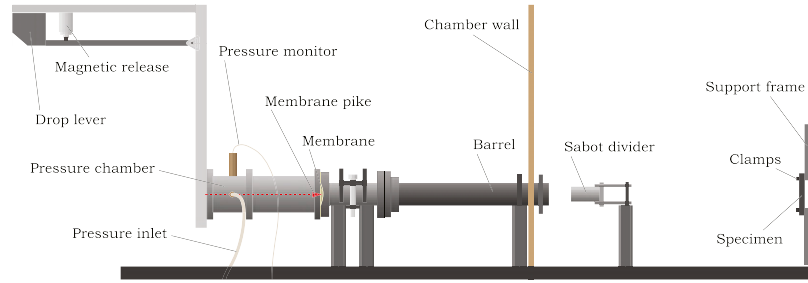
Figure 6. Illustration of the gas-cannon test setup used for small-mass impacts.

For the high-velocity impact tests, a gas-cannon designed at Royal NLR is used, as shown in Figure 6. This gas-cannon was originally designed for hail impact and modified for a 16 mm steel ball with a mass of 16.72 g, which resulted in a maximum impact energy of 100 J previously indicated. The 55 and 100 J impact energies translate to an impact velocity of 81.11 and 109.37 m/s. To match the diameter of the gas-cannon barrel, the steel ball is positioned in a 3D printed sabot that consists of two halves. By puncture of a plastic membrane, the pressurised gas is released and the sabot, including steel ball, travels through a 1 m long barrel. At the end of this barrel, it enters an approximately $2 \times 2 \times 2$ m chamber, illustrated in the high-speed images in Figure 7, on the left side. Immediately the sabot is split in half and blocked by a divider, and the steel ball crosses the chamber alone before impacting the specimen. The support fixture used for the drop-weight impact experiments is mounted vertically to feature identical boundary conditions. Two high-speed cameras and required lighting equipment are situated in the chamber and one wall is made of protective glass to observe the experiment.

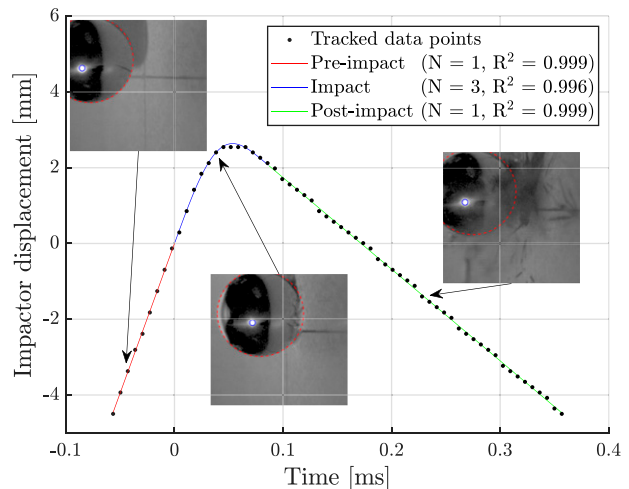
Figure 8. Tracking the impactor during a gas-cannon impact on specimen 20-QI-SM-55-1.

From Figure 8, it can be concluded that the impactor displacement can be tracked very accurately. The values of the tracked data points in terms of pixels are translated to length measured in mm by using the fact that the slope of the pre-impact region should be equal to the initial velocity measured from Figure 7. In addition, three regions are defined: pre-impact (red), impact (blue) and post-impact (green). During impact the tracked data points can be fitted using a cubic polynomial. Similar to the pre-impact region, the post-impact region can be fitted using a linear expression of which the slope represents the exit velocity.

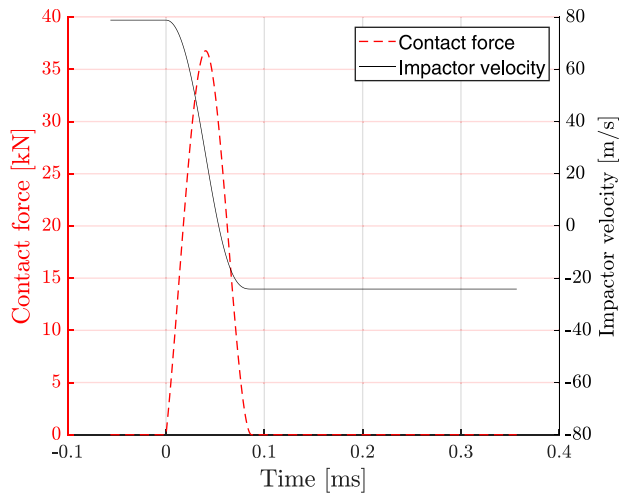
Figure 9. Estimated contact force and impactor velocity history of specimen 20-QI-SM-55-1.

The impactor velocity history is determined by integrating the impactor acceleration, as shown in Figure 9.

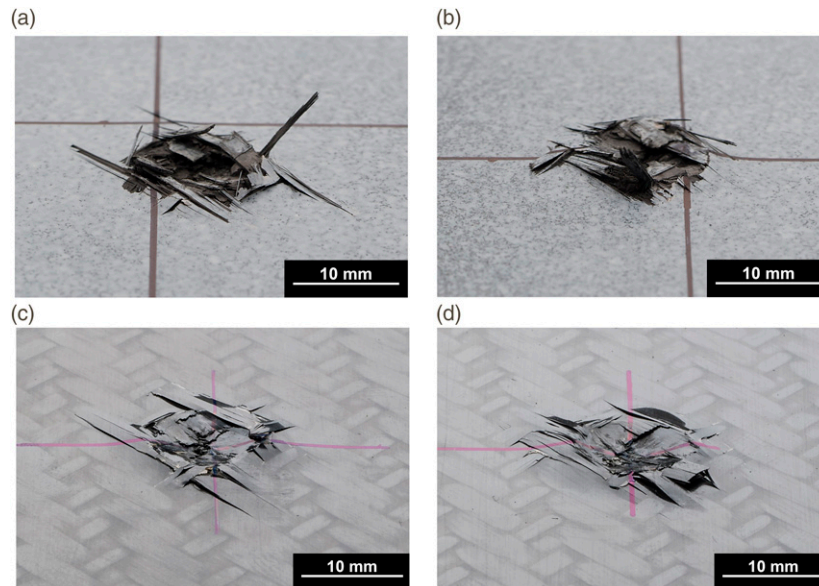
Figure 10. Typical dents for 55 J drop-weight impacts and gas-cannon impacts on 20 mm thick specimens with a QI and OT layup.

energy is dissipated by creating a dent at the impact location, see Figure 10. This dent is formed due to crushing of several plies at the impact location of which some parts are propelled in the air. At the same time, material is pushed outward in the top few layers that experience compression in the longitudinal direction. In this area, kinking and buckling occurs, which is identified by protruding layers around the dent. This phenomenon may be observed in Figure 13, which shows the cross-section of a specimen subjected to 55.3 J impact. Kinking and buckling, which may be seen at the bottom left of Figure 13, is mainly observed for large-mass low-velocity impacts on 20 mm specimens, with a lower impact energy, that result in smaller dents.

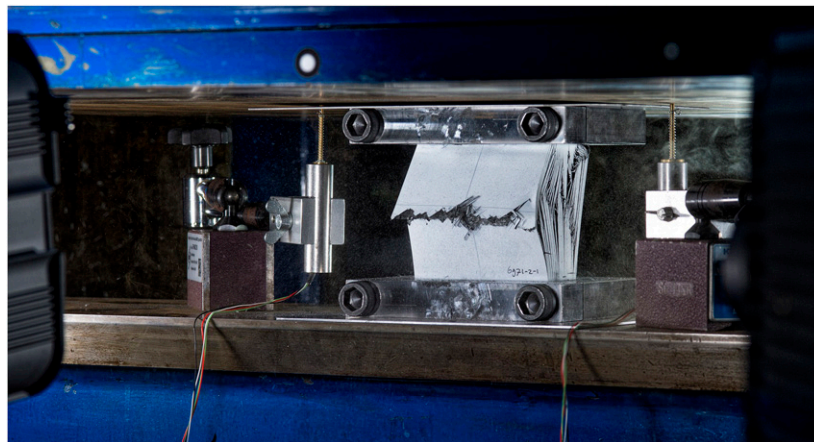
Figure 11. The CAI test setup with a 40 mm thick specimen subjected to a 100 J gas-cannon impact (40-QI-SM-100-1) showing a Middle Top Progress failure mechanism. Note: CAI: compression-after-impact.

The CAI experiments were performed using a static test bench at Royal NLR, see Figure 11. It was chosen to deviate from the ASTM standard for determining the compressive residual strength as it is focused on testing of thin specimens. The expected failure mode, and lack of a global buckling mode, require a different support fixture, contrary to the recommendations of ASTM standard for thin laminates. Instead of the ASTM standard, the following method was applied: The support fixture is derived from previous CAI experiments performed at NLR,²⁰ and consists of two anti-brooming devices clamped on the short edges of the specimen. If not used, brooming or splitting of plies might occur at the contact surface with the test bench due to high contact forces. The applied load is measured by the test bench as well as the applied displacement. However, due to the deformation of the test bench itself, the actual displacement is measured using two calibrated Linear Variable Differential Transformers (LVDTs). These are positioned on both sides of the specimen such that an average

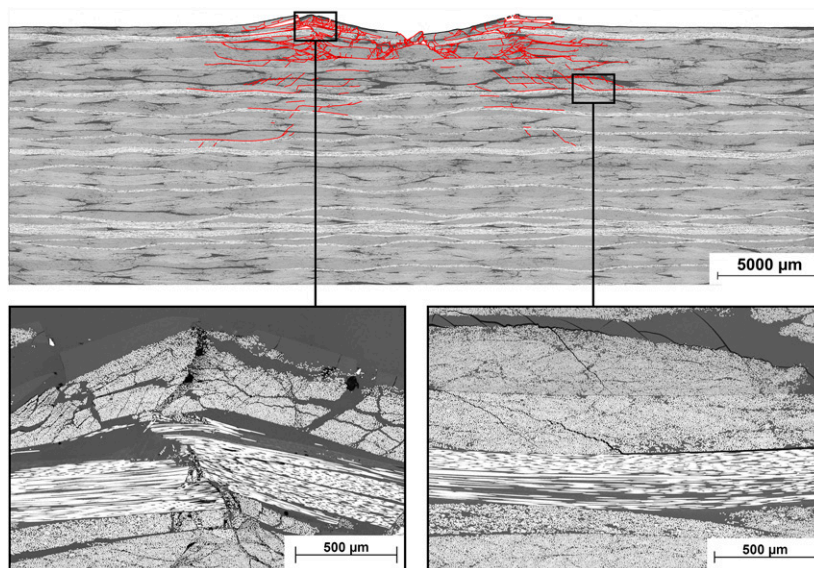
Figure 13. Cross-section of specimen 20-OT-LM-55-4 with highlighted crack boundaries and a detailed view of two damage mechanisms characteristic of thick composite specimens. On the left, longitudinal compressive loads resulting in fibre kinking and buckling in the top plies and, on the right, interaction between transverse cracks and delaminations.

Beside a dent, no damage is typically observed directly underneath the impact location. Due to increasing transverse shear stresses away from the centre of impact, delaminations and transverse cracks appear, resulting in a typical *hat-shaped* damage pattern as highlighted in red in Figure 13. In the same figure, the detailed interaction between delaminations and transverse cracks is illustrated in the magnified view, which shows the transition from transverse cracking to delamination. In all cross-sections the dominant delaminations extend along the interface between warp yarns. For instance, the delamination in Figure 13 initiates from a transverse crack and propagates along the warp yarn in white. Interestingly, these delaminations only occur above the warp yarns. The bending, although limited, leads to compressive forces in the top half of the specimen. The compression causes slight buckling of the warp yarn, which makes it easier for these interfaces to delaminate. The depth of delaminations is approximately 4–7 mm. In

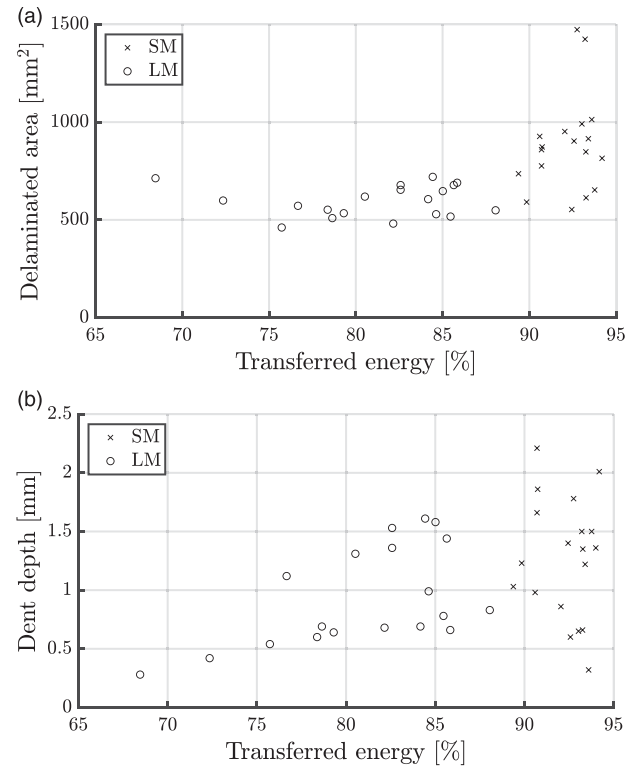
**Figure 14.** Relation between transferred energy and (a) delaminated area and (b) dent depth for LM drop-weight impacts and SM gas-cannon impacts. Note: LM: large-mass; SM: small-mass.

To get further insight on the damage induced in each type of test, the delaminated area and the dent depth are shown in Figure 14 as functions of the energy transferred from the impactor to the specimen. The results in Figure 14 show a 68–88% transferred energy range for large-mass low-velocity test, while for small-mass high-velocity tests 89–94% of energy is transferred to the specimen. For the drop-weight impacts an overall trend is that for a higher transferred energy the dent depth increases (see Figure 14(b)), while no significant change in delaminated area is observed (see Figure 14(a)). Since drop-weight impacts generally tend to a quasi-static response, the force

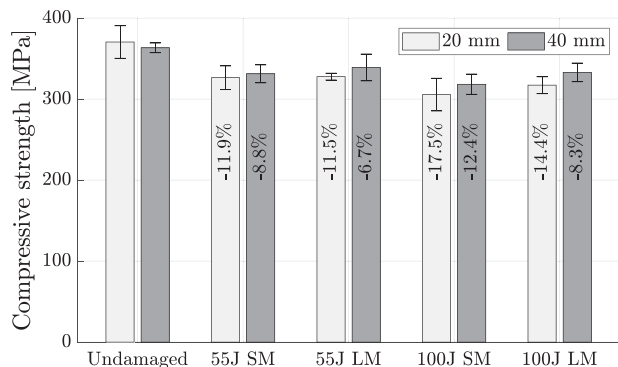
Figure 17. Compressive strength for 20 and 40 mm specimens subjected to LM drop-weight impacts and SM gas-cannon impacts. Note: LM: large-mass; SM: small-mass.

The resulting compressive strengths are visualised in Figure 17. Exact values of the residual CAI strengths can be found in Table A4, while the compressive strengths of undamaged specimens are given in Table 3. As expected, the residual CAI strength is closely related to the delaminated area and damage depth. For instance, specimens subjected to a 100 J gas-cannon impact have the highest delaminated area and therefore the largest reduction in residual CAI strength (i.e. 12% and 18%). In addition, the effect of both gas-cannon and drop-weight impacts is larger on the residual CAI strength of 20 mm specimens compared to the 40 mm impacted specimens. For the 20 mm specimens with gas-cannon impacts, this is explained by larger delaminations that appear deeper in the specimen. For the 20 mm specimens, with drop-weight impacts, the gap with 40 mm specimens is larger, with no significant change in delaminated area. A possible explanation is that the delaminations are approximately 25% deeper for 20 mm specimens. Deeper delaminations mainly affect the sub-laminate bending stiffness, which results in failure at a lower load.

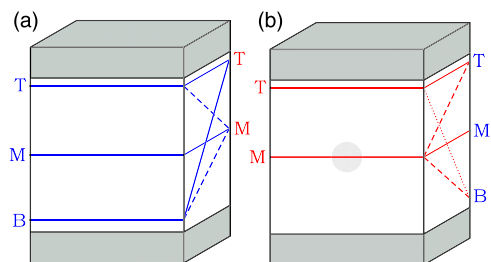
Figure 18. Failure mechanisms observed during the CAI tests with buckling of sub-laminates at the middle (M), top (T) or bottom (B) of the specimen. Distinction is made between symmetric failure (MM and TT) and asymmetric failure (MT, MB and TB). Note: CAI: compression-after-impact.

categorised based on the location of sub-laminate buckling. Depending on the location where buckling initiates, the failure is identified with a letter as follows: T for top, M for middle and B for bottom. This is recorded for each side of the specimen separately, so TT indicates that buckling initiated at the top of the specimen on both sides. Similarly, MT indicates that buckling initiated in the middle on one side and at the top on the other side. By convention, the first letter refers to the side of the specimen that was previously damaged by impact. Due to the absence of global buckling, these damage mechanisms are usually not observed in CAI tests on thin composite specimens. For instance, in addition to the in-plane behaviour, the through-thickness behaviour is equally important for thick composite specimens.

Symmetric failure (MM and TT) occurs when delaminated plies start to buckle at approximately the same location on the impact and non-impact side of the specimen. As a result, the through-thickness damage pattern is also symmetric and usually horizontal, with variations that have a v or w shape. Within the symmetric failure mechanism two distinctions are made. MM failure occurs at the middle of the specimen, usually through the impact location, and represents 11% of the cases. TT failure occurs near the anti-brooming device at the top of the specimen and is the second frequent observed mechanism in 34% of the cases. No symmetric failure near the bottom of the specimen (BB) is observed.

Asymmetric failure (MT, MB and TB) occurs when sub-laminate buckling of delaminated plies occurs at a different location on the impact side and non-impact side. For instance, the most common case is an MT failure mechanism observed in 45% of specimens. In this mechanism, the impact side sub-laminate buckling occurs in the middle (M) and on the non-impact side at the top of the specimen (T). Sub-laminate buckling generally starts at the impact side. During progressive failure, the cracks in the thickness direction propagate to the location of sub-laminate buckling on the other side. Asymmetric MB and TB failure is observed in two specimens for each mechanism.

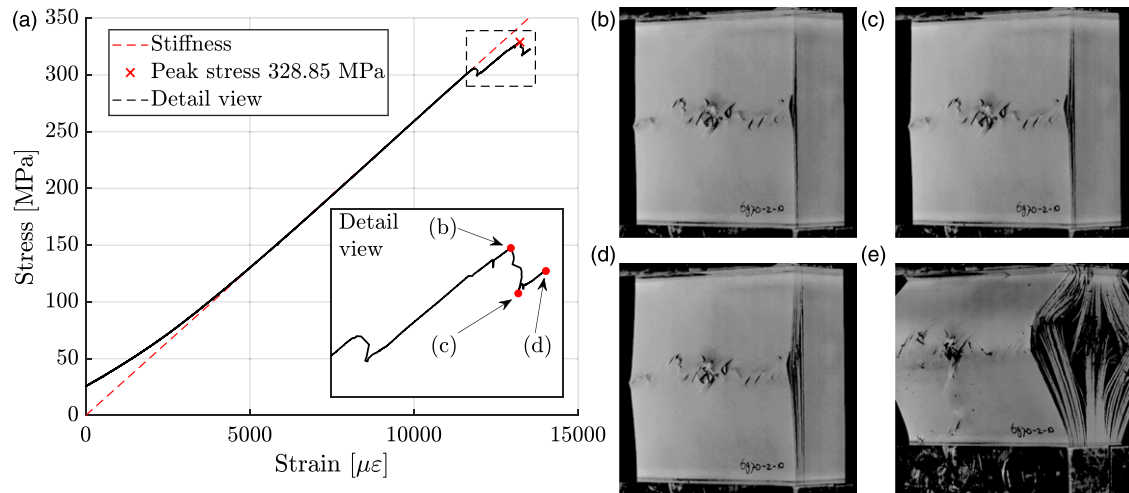
Figure 19. CAI test of a 40 mm thick specimen subjected to a 55 J drop-weight impact (40-QI-LM-55-4) with in (a) the stress-strain curve and detail view of progressive sub-laminate buckling (b)–(d) leading to (e) final failure with a MMP failure mechanism. Note: CAI: compression-after-impact; LM: large-mass; SM: small-mass.

An example of a CAI test is illustrated in Figure 19. A 40 mm thick specimen subjected to a 55 J drop-weight impact shows progressive damage of category MMP. It is observed that it takes a while for the stress–strain curve to align with the stiffness slope, which indicates that the test bench and specimen are settling. The slope of the stress–strain (i.e. compressive stiffness) originates from the centre and is used to align the stress–strain curve. A compressive stiffness of 25.9 GPa is approximately 50% lower than the undamaged compressive stiffness and comparable discrepancies are observed for the other specimens. Only a part of this difference is explained by the impact damage. For instance, specimen 40-QI-LM-55-4 in Figure 19 has a damage depth of 4 mm, which is approximately 10% of the specimen thickness. The apparent stress, and thus compressive stiffness, should only be 10% higher if it is assumed that this 4 mm of the specimen does not bear any load. The main reason is that due to high compressive forces the steel support of the test bench started to indent, resulting in additional displacement measured by the LVDTs. Since a measured compressive stiffness has no effect on the residual strengths the values obtained are still valid.

From the detailed view in Figure 19(a), it is observed that multiple events occur prior to final failure. The first load drop at 1205 kN indicates propagation of one or multiple

delamination(s) and subsequent sub-laminate buckling. This propagated delamination is present when the specimen reaches its peak strength, visualised in Figure 19(b). A second load drop of 47 kN occurs due to a second delamination that propagates, see Figure 19(c). Between this point and the point illustrated in Figure 19(d), a third delamination propagates, after which final failure occurs. Despite multiple delaminations, the specimen is able to carry an increasing load.
