## SHEAR TESTS ON LARGE PRESTRESSED CONCRETE T-BEAMS

Sebastiaan Ensink<sup>1</sup>, Cor van der Veen<sup>1</sup>, Ane de Boer<sup>2</sup>

### ABSTRACT

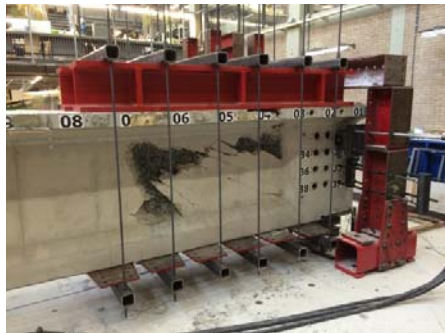
**Fig. 6.** Support frame with vertical prestressing

Each beam is tested at both ends. After the first test of a beam, although now heavily damaged, the prestressing still prevents a complete fracture of the beam. To resist the forces of the second test the damaged area is outfitted with a support frame consisting of steel beams and vertical prestressing, see Fig. 6.

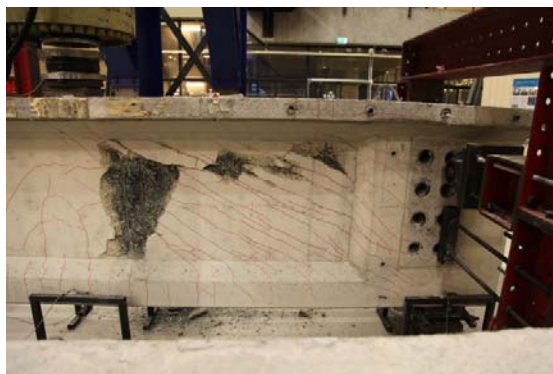
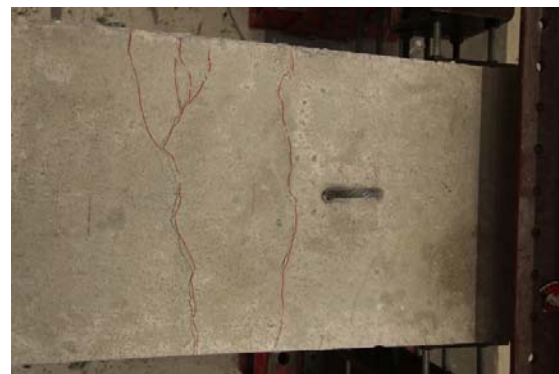
**Fig. 10.** Failure of beam 301 (first test)

The fracture of the beam is shown in Fig. 10. During failure several transverse cracks occurred in the top flange near the end block, see Fig. 10b. Because of the filling of the empty ducts almost no crushing of the top flange underneath the loading jack is observed. The fracture of the second test is consistent with the first test. The minimal shear crack angle in both tests is about  $25^\circ$ .

(a) side view

(b) top view
