# **DEGRADATION OF CIGS SOLAR CELLS**

## Proefschrift

ter verkrijging van de graad van doctor  
aan de Technische Universiteit Delft  
op gezag van de Rector Magnificus prof. ir. K. C. A. M. Luyben,  
voorzitter van het College voor Promoties  
in het openbaar te verdedigen op  
vrijdag 2 oktober 2015 om 15:00 uur

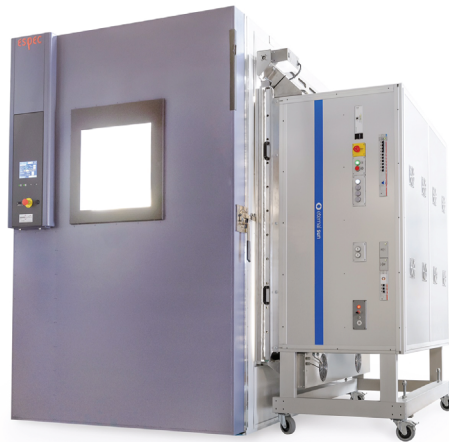
Figure 3.9

*Photograph of the commercial hybrid degradation setup.*

A spin-off of this thesis is the commercialisation of this setup, due to extensive market interest. A Dutch consortium, consisting of Eternal Sun, Hielkema Testequipment, ReRa Solutions and Solliance partners ECN and TNO has begun to develop a commercial variant of setup. The first commercial version will be in operation in 2015 and will have a 1x1 m<sup>2</sup> AAA calibrated illumination area (Figure 3.9). In comparison to the setup as designed, built and used in this thesis, the following five general improvements are implemented:

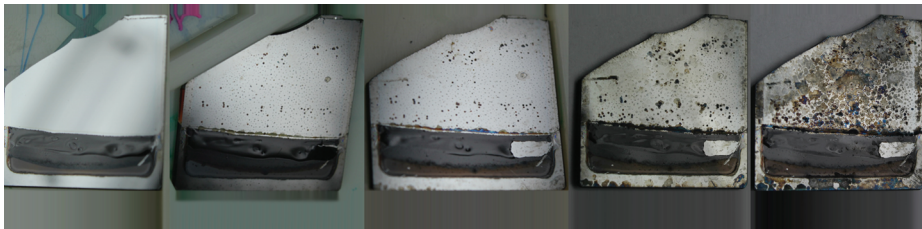
Figure 5.17

*Photographs of Mo<sub>25/15</sub> before and after 8, 32, 88 and 150 hours exposure to 85°C/85% RH. The width of the sample is 25 mm.*

Damp heat exposure of the samples lead to the appearance of black and blue spots as is shown in Figure 5.16 and Figure 5.17. This effect is stronger for Mo<sub>25/15</sub>, which is likely caused by the high porosity of this sample, obtained due to the higher deposition pressure. The changes are similar to the ones for the Mo/MoSe<sub>2</sub> samples in the 'selenisation and pressure' experiment, but it should be noted that the degradation characteristics of the previous samples occurred faster than observed in the 'lift-off experiment'.

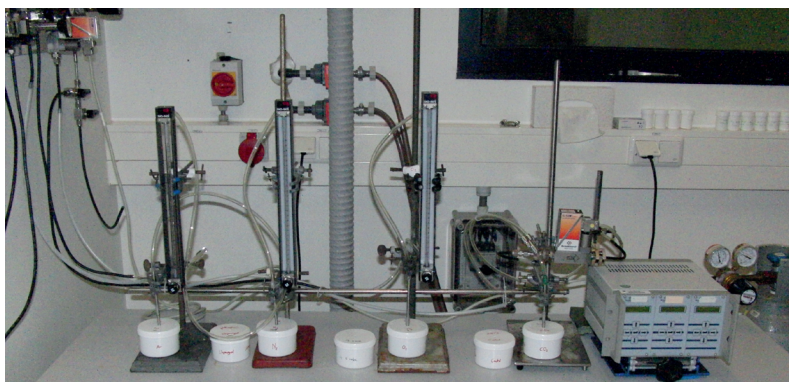
Figure 8.2

*Photograph of the complete degradation setup, including the white degradation vessels, and three flow meters to define the O<sub>2</sub>, N<sub>2</sub> and air flows. The mass flow controller (right) is used to determine the CO<sub>2</sub>/N<sub>2</sub> flows.*

Samples were placed in ultrapure water (deionised water further treated with a Synergy Millipore purifier) in high density polyethylene (HDPE) containers, as is shown in Figure 8.2. A schematical representation of this setup is shown in Figure 6.1. The vessels are non transparent, so the samples are kept in dark. The setup is further similar to the one earlier described in reference [3] and chapter 6, which was used to test ZnO:Al layers. Gas purges were fed into the containers, namely air, nitrogen (Air Liquide, 99.99995% purity), oxygen (Air Liquide, 99.995% purity) and a carbon dioxide (Air Liquide, 99.7% purity)/nitrogen mix. Flow rates for the air, nitrogen and oxygen samples were each maintained at about 0.3 L/min with calibrated flow meters (Brooks Instrument).

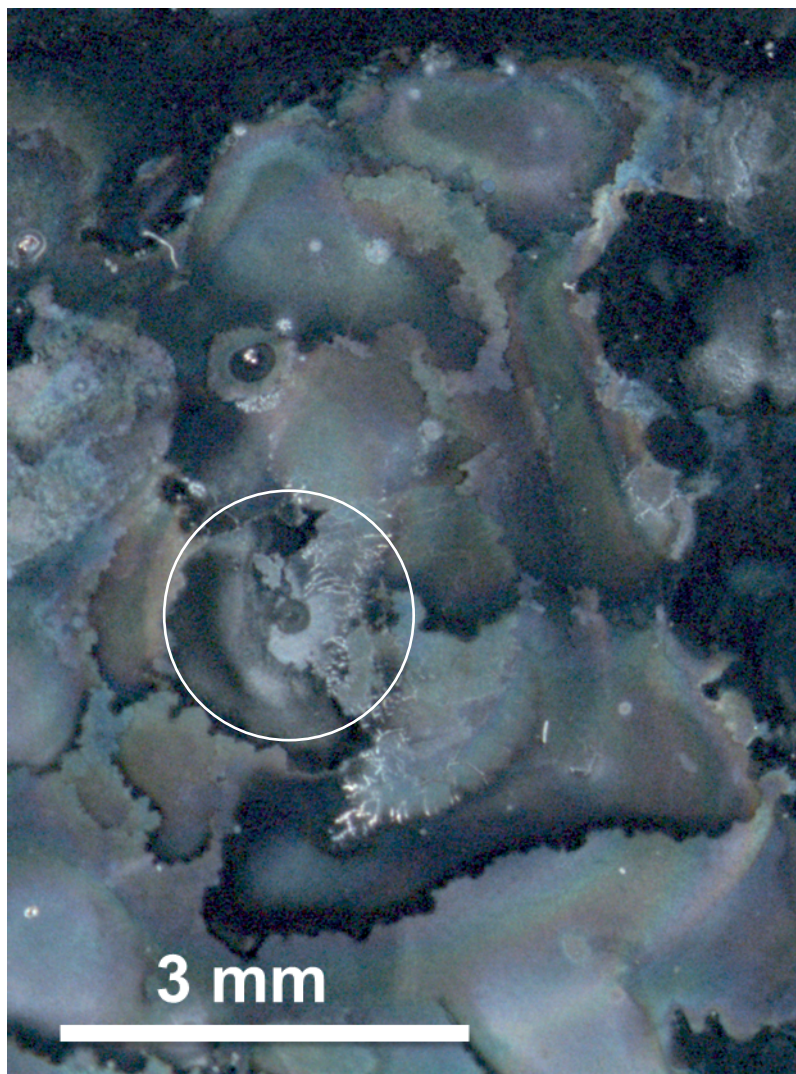
PS: Voor alle mensen die niet geloven dat het plaatje op de cover een echte, onbewerkte microscoopfoto van gedegradiseerd molybdeen is, op de volgende pagina staat dezelfde plek op het sample op een andere vergroting:
