**Building water quality deterioration during water supply restoration after interruption
Influences of premise plumbing configuration**

Building water quality deterioration during water supply restoration after interruption: Influences of premise plumbing configuration

Premise plumbing
Water supply restoration
Water quality deterioration
Discoloration
System configuration

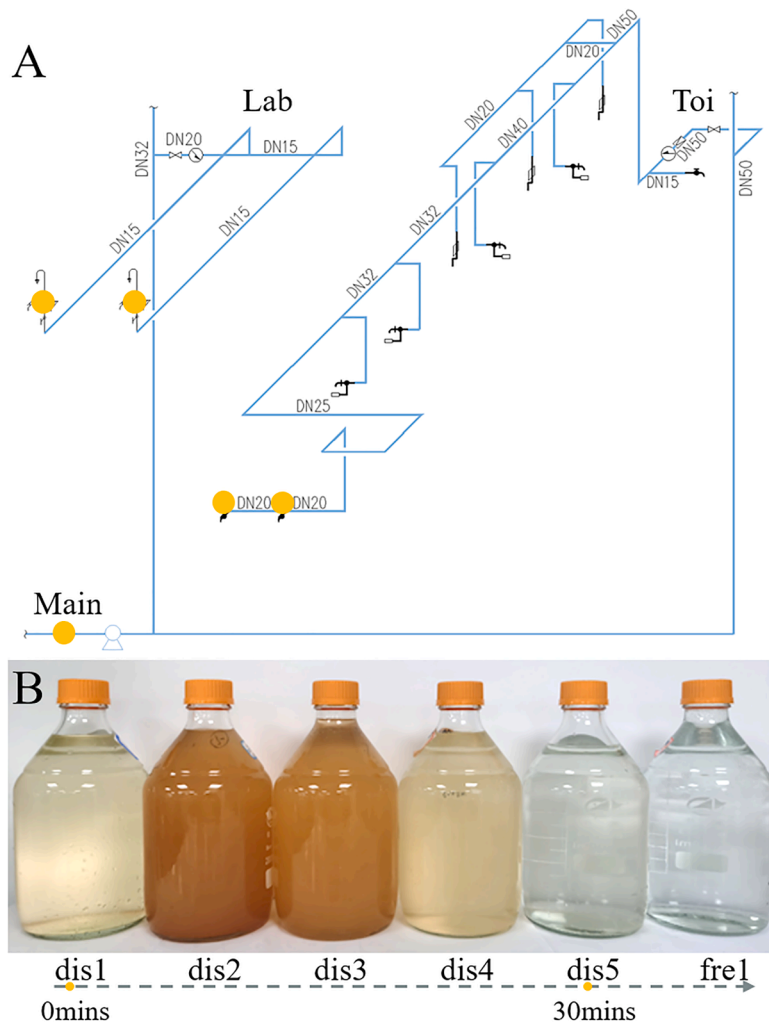
Fig. 1. A) Detailed configuration of the laboratory and toilet plumbing. Sampling points marked in Yellow. The pipe length, velocity, Reynolds number, and shear stress are given in Table 1; B) picture of disturbed samples from laboratory plumbing during restoration of the water supply condition (Lab-dis, heavy discoloration).

The study was conducted in an office building on the campus of the Research Center for Eco-Environmental Sciences, Chinese Academy of Sciences. It is an 8-floor building of 10,000 m² with office and laboratory rooms. The premise plumbing components that distribute water to laboratories and toilets are connected to the water main separately with parallel vertical pipes (Fig. 1A). The configurations of laboratory and toilet plumbing are different, both of which have a vertical plastic-lined galvanized steel pipe and horizontal branch polypropylene-random (PPR) pipes. There are two regular taps for the laboratory plumbing and seven flushing toilets and two taps for the toilet plumbing. The water usage in the laboratory and toilets are also different, which leads to significant differences in hydraulic conditions in the two piping systems (e.g., velocity, Reynolds number, and shear stress, Table 1).

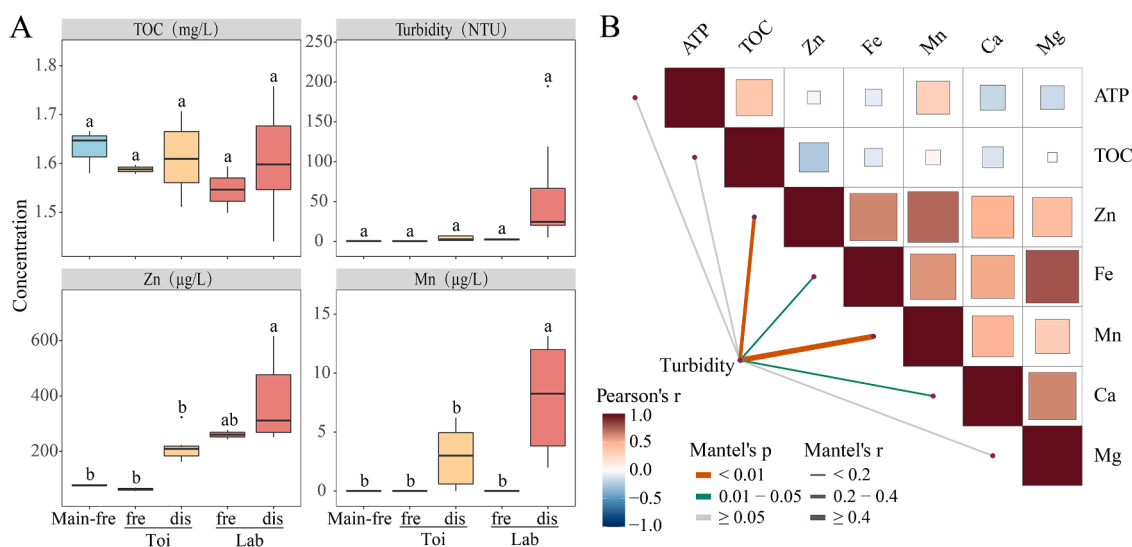
Fig. 2. Comparison and correlation analysis of water quality parameters: A) Boxplots showing the results of total organic carbon (TOC), turbidity, Zn and Mn in different sampling groups. Different lowercase letters on the boxes represent significant differences assessed using ANOVA; B) pairwise comparison among water quality parameters, the color gradient denotes Pearson's correlation coefficients. The correlations of turbidity with other parameters were assessed by Mantel tests. Edge color represents the statistical significance, and edge width corresponds to Mantel's r statistic.

supply (Fig. 2A). The concentrations of both Zn and Mn were significantly higher in the water samples from the laboratory than in those from the toilet. This may be due to the smaller diameter and flow in the laboratory, which offered a higher surface-to-volume ratio and longer retention time. Zn might have been released from vertical galvanized pipes, while Mn would have accumulated in the pipes during regular water supply and been released during restoration of the water supply. Interestingly, it was observed that the Zn in the fresh samples from the laboratory was clearly higher than that from the toilet and main, indicating the considerable contributions from laboratory plumbing but not toilet plumbing to the sharp increase in Zn (78.2 to 260.7 $\mu\text{g/l}$) during regular water supply.

The correlation analysis revealed that turbidity is strongly correlated with Zn and Mn but not with TOC, ATP, and other elements, suggesting that the discoloration may be caused by the release of Zn- and Mn-containing material during the restoration of the water supply (Fig. 2B). The pairwise comparison showed that all metal elements had significant correlations ($p \leq 0.05$, $0.43 \leq r \leq 0.78$), except Mn and Mg ($p > 0.05$, $r = 0.33$). In addition, ATP and TOC were significantly correlated with each other but not with other metals.

It is important to note that laboratory plumbing significantly increased the Zn concentration and Simpson diversity of the planktonic bacterial community during regular water supply (Lab-fre vs. Main-fre, Figs. 2A and 3B), while toilet plumbing did not. Although the number of observed ASVs increased in both Lab-fre and Main-fre to a similar level (Fig. 3C), the bacterial communities of Lab-fre were significantly different from those of Main-fre, but the bacterial communities of Toi-fre were clustered closely together with those of Main-fre (Fig. 4A). In other words, significant changes were observed in laboratory plumbing but not toilet plumbing during regular water supply, which may be because the small water demand and flow velocity in laboratory plumbing resulted in a longer stagnation time than that in toilet plumbing (Montagnino et al., 2022; Proctor et al., 2020; Zlatanović et al., 2017). During the restoration of water supply, the laboratory plumbing lead to significant changes in elemental composition, while the toilet plumbing lead to significant changes in ATP and clearly differences in dominant ASVs (Figs. 5 and 6). This highlights the importance of premise plumbing configurations. It poses significant influences during both regular and interruption of the water supply.

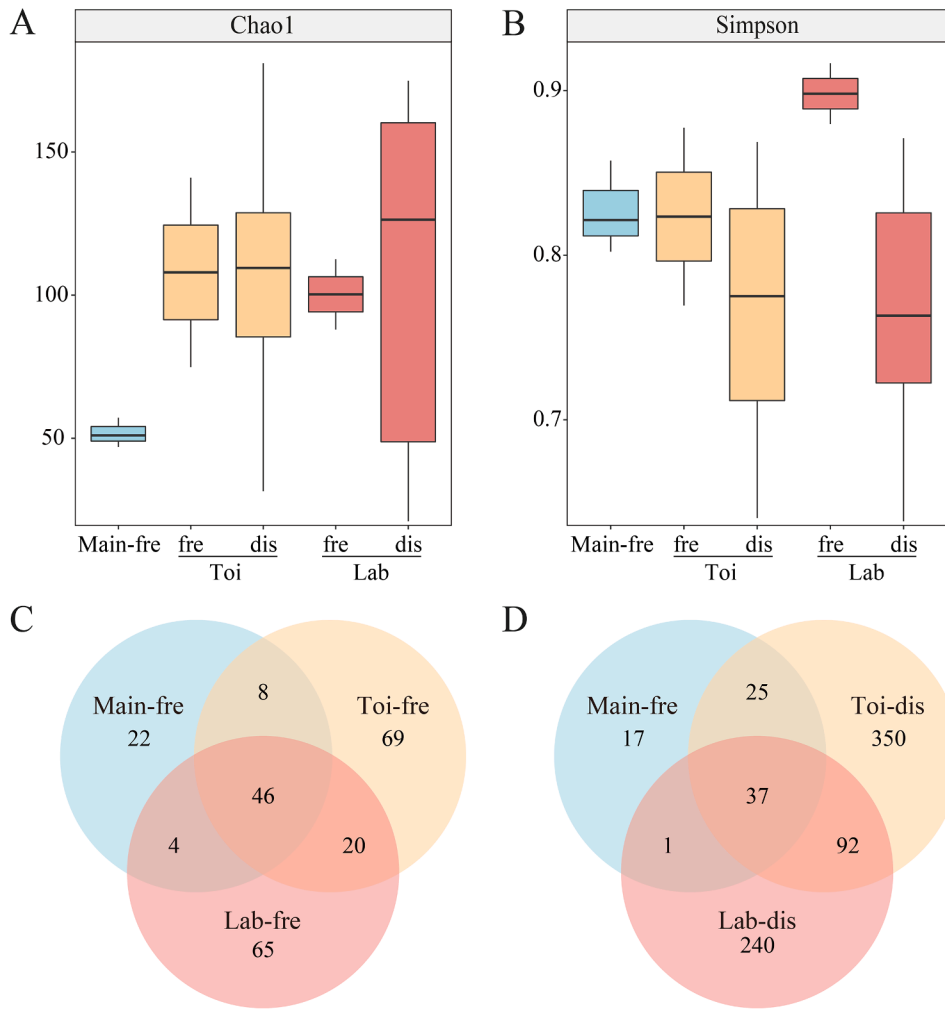
Fig. 3. A) Chao 1 indices of different sampling groups; B) Simpson diversity of different sampling groups; C) Venn diagram among fresh samples; D) Venn diagram among disturbed samples.

showed higher values and larger variations than the toilet samples. The higher species richness in disturbed samples during water supply restoration was better revealed by the Venn diagram in Fig. 3C and 3D.

Interestingly, although the species richness was higher in Lab-dis and Toi-dis, their Simpson diversities were much lower than those in Lab-fre and Toi-fre (Fig. 3B), indicating that the relative abundances of community members in fresh samples were more evenly distributed, while the community of planktonic bacteria during water supply restoration was possibly predominated by a few species. This is directly confirmed by the bacterial community composition results in the following section. Moreover, during regular water supply, toilet plumbing did not influence Simpson diversity, whereas laboratory plumbing clearly increased the Simpson diversity of the bacterial community (Fig. 3B).

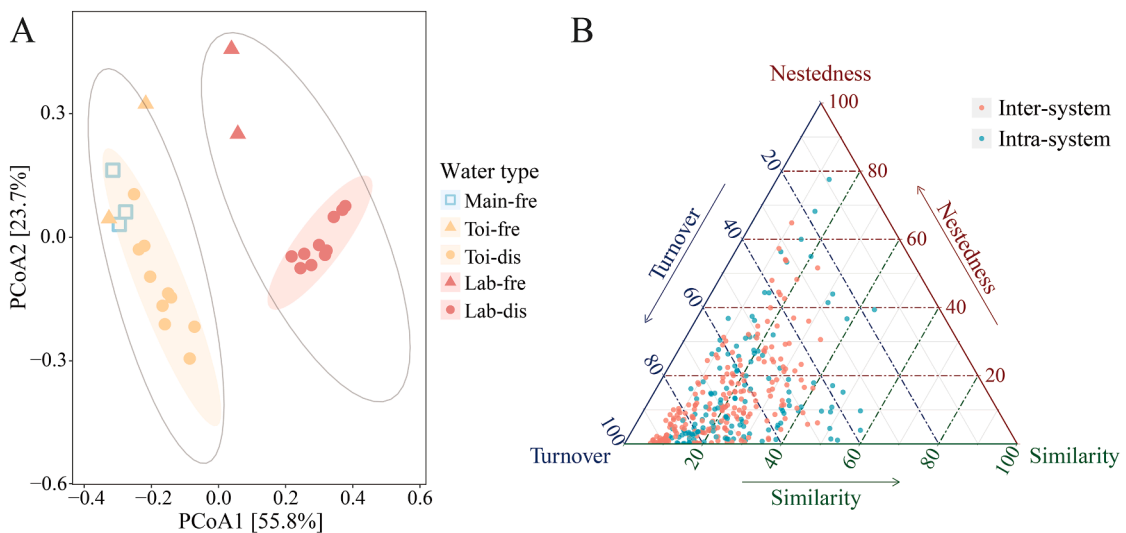
Fig. 4. A) PCoA plot based on Bray-Curtis dissimilarity; B) triangular plots of beta-diversity partitioning (using Jaccard dissimilarity index) comparisons for bacterial communities. Each point represents a pair of samples.

The PCoA plot showed clear clusters of sample groups, indicating the dissimilarity among their bacterial communities (Fig. 4A). According to statistical tests, both plumbing configurations and water supply interruption/restoration significantly influenced the planktonic bacterial community (PERMANOVA, $P < 0.05$, Table S1), while the variances were mostly explained by the former ($R^2 = 0.537$, Table S1). Comparing the fresh samples, the bacterial community of Main-fre is similar to that of Toi-fre (overlapping) but different from that of Lab-fre (different clusters), confirming the significant influences of the plumbing configuration. During the restoration of the water supply, Lab-dis clustered closely together and completely separated from Lab-fre, while Toi-dis is more dispersed and separated from Toi-fre samples. The differences between Lab-dis and Lab-fre are sharper than that of Toi system. This means sharper changes may occur in laboratory plumbing during water supply restoration, which complied with the visually observed discoloration in Lab-dis samples, as mentioned above.

To reveal the underlying mechanisms of variation in microbial assembly, the beta diversity was further partitioned into species turnover and nestedness (Fig. 4B). The average Jaccard pairwise dissimilarity

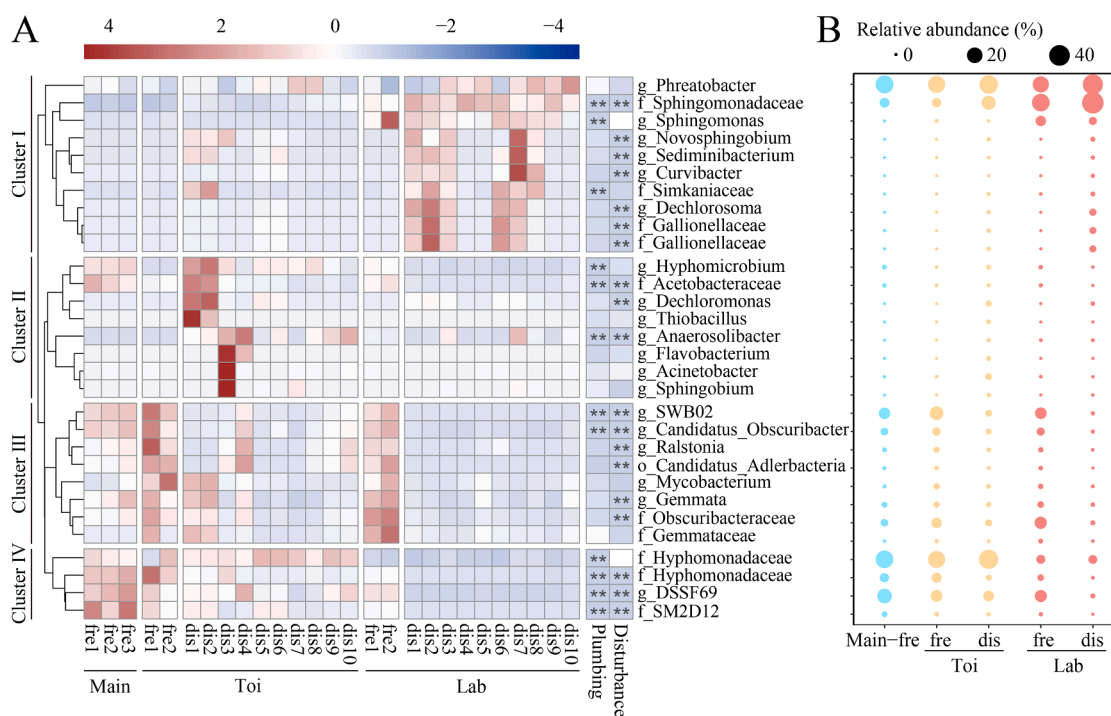
Fig. 5. Relative abundances of the top 30 genera: A) Distribution of the normalized relative abundance of the genera in different samples. Colors from blue to red denote an increase in normalized relative abundance. The significant difference between groups was calculated by Kruskal–Wallis tests (P values: $** < 0.05$); B) Relative abundances of the genera in different sampling groups. The genera were classified into two types and four clusters: affected by disturbance (Clusters I and III) or by both disturbance and plumbing system configuration (Clusters II and IV). The genera of Cluster IV were only less abundant in the Lab-dis group. The genera of Cluster II were mainly found in the Toi-dis group.

At the genus level, the top 30 abundant bacterial genera across all samples are shown as a heatmap in Fig. 5A (normalized relative abundance) and a bubble plot in Fig. 5B (relative abundance). During regular water supply, both laboratory and toilet plumbing promoted community members, such as *Mycobacterium* spp. (0.1% to 1.0%) and *Gemmata* spp. (0.9% to 1.3%), and prohibited community members, such as *DSSF69* spp. (16.7% to 9.9%) and *Hyphomicrobium* spp. (0.4% to 0.1%). In contrast, laboratory plumbing promoted *Sphingomonas* spp. (0.1% to 6.8%), while prohibited *Phreatobacter* spp. (28.1% to 21.9%), but toilet plumbing did not. During the restoration of the water supply, it is remarkable to observe that a few genera were not present in fresh

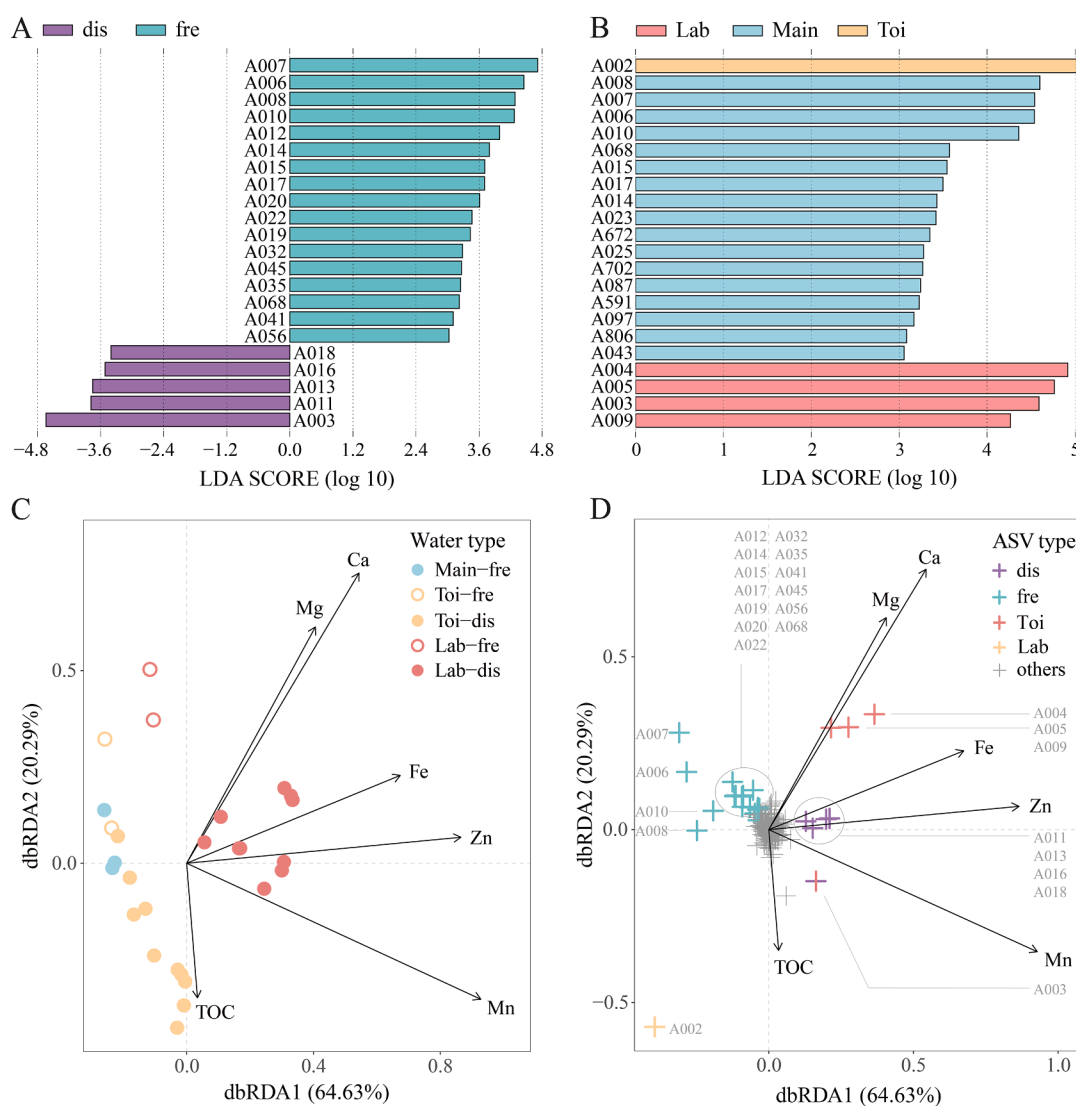
Fig. 6. A) LEfSe analysis selected significantly enriched ASVs during regular water supply (fre) and restoration of water supply (dis); B) LEfSe analysis selected significantly enriched ASVs in water main (Main), toilet (Toi) and laboratory plumbing (Lab); C) distance-based redundancy analysis (db-RDA) of the relationship between the bacterial community and environmental variables; D) db-RDA of the relationship between ASVs and environmental variables.

The LEfSe analysis identified ASVs significantly enriched by regular and interrupted water supply (Fig. 6A) and by premise plumbing with different configurations (Fig. 6B). The taxonomy information of these ASVs is given in Table S3. Remarkably, 3/5 of the ASVs enriched during water supply restoration were assigned as f_Gallionellaceae, the group of which is commonly called iron bacteria. This complies with, presented below, that iron drove bacterial community changes during the restoration of water supply (Fig. 6C, 6D). In addition, all ASVs enriched in laboratory plumbing belonged to f_Sphingomonadaceae, and the key sensitive ASVs in toilet and laboratory plumbing were strongly correlated with Ca and Mg.

The db-RDA plot showed that the first two axes cumulatively explained 84.6% of the total variance (Fig. 6C, 6D). The bacterial community of Lab-dis was mainly driven by metal elements (e.g., Mn), while the bacterial community of Toi-dis was mostly driven by TOC. This was directly confirmed by Mantel tests (Table S4). More specifically, the variations in species between the laboratory and toilet were more related to Ca, Mg, Fe and Zn, whereas the bacterial community changes induced by the disturbance during water supply restoration
