Example of Proof Load Testing from Europe

Chapter 15. Example of proof load testing from Europe

ABSTRACT: This chapter describes the proof load testing of viaduct Zijlweg at a position that is critical for bending moment and at a position that is critical for shear. The viaduct Zijlweg has cracking caused by alkali-silica reaction, and the effect of material degradation on the capacity is uncertain. Therefore, the assessment of this viaduct was carried out with a proof load test. This chapter details the preparation, execution, and evaluation of viaduct Zijlweg. The outcome of the proof load test is that the viaduct fulfils the code requirements, and that strengthening or posting is not required.

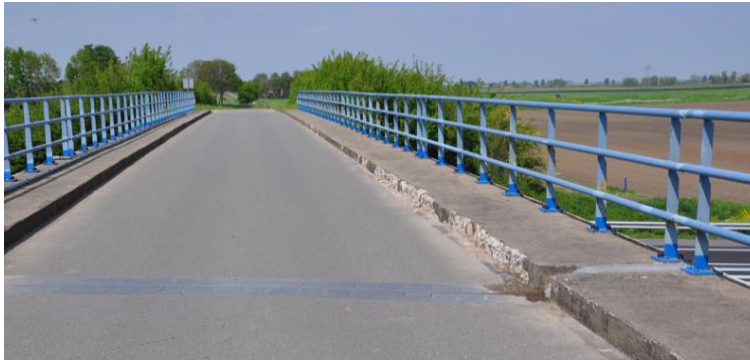
Fig. 8: Top deck

A visual inspection was carried out during the preparation stage of the proof load test. Fig. 8 shows the deterioration of the top deck, present in the pedestrian sidewalk. Fig. 9 shows an impression of the bottom of the deck. The typical cracking pattern of ASR (map cracking) is not clearly visible from the distance at which the inspection was carried out. Closer observations on scaffolding right before the execution of the proof load test allowed for the drawing of the full crack map, see Fig. 10. Fig. 11 shows the small distance remaining in the joint, resulting from the expansion in the longitudinal direction.

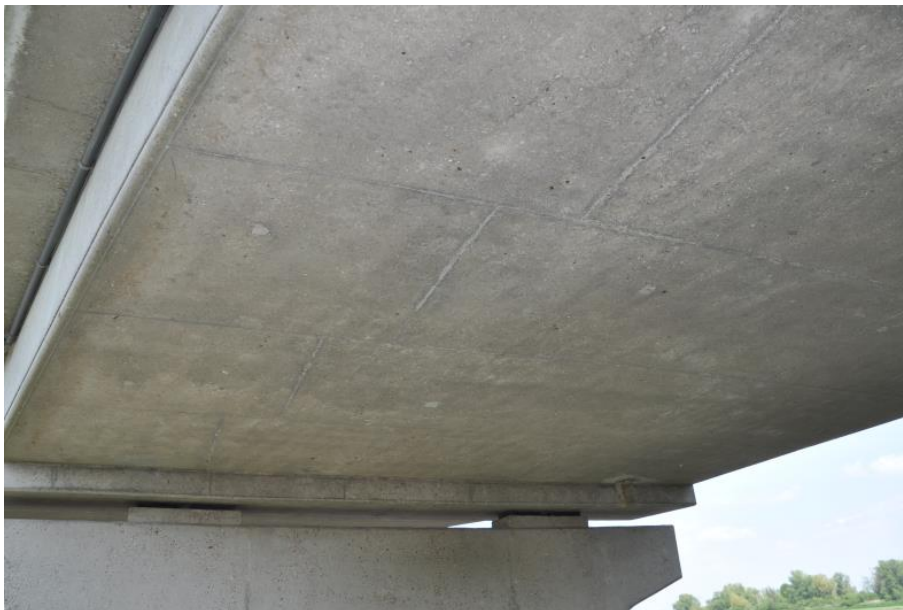
Fig. 9 Bottom of deck.

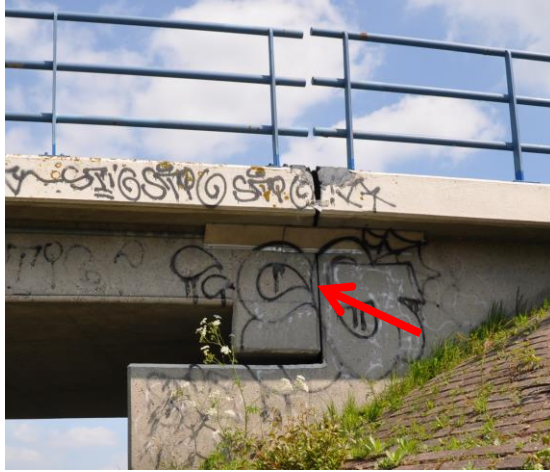
Fig. 11 Expansion joint at the South side of viaduct Zijlweg.

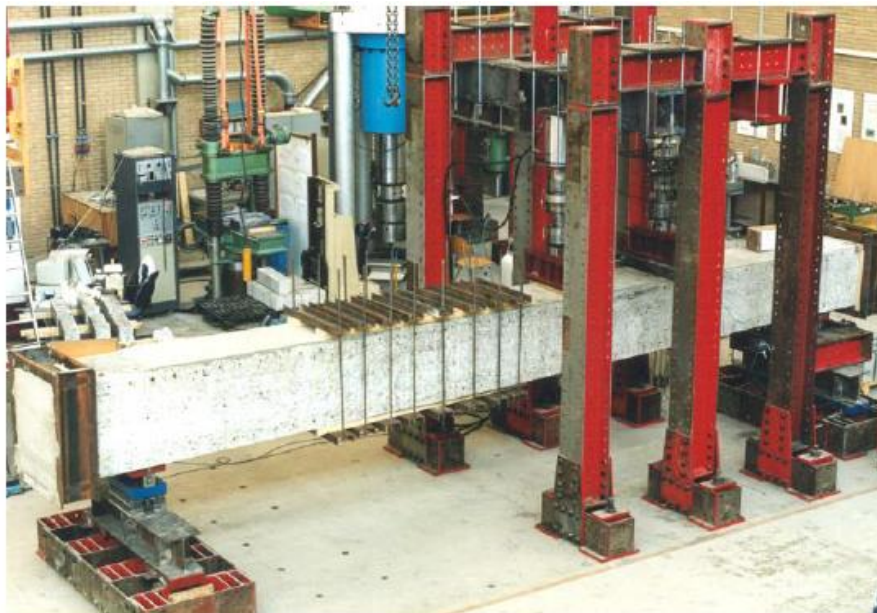
Fig. 12: Testing of beams with ASR-damage in the Stevin Laboratory (den Uijl and Kaptijn 2002). Photograph by J. A. Den Uijl, used with permission.

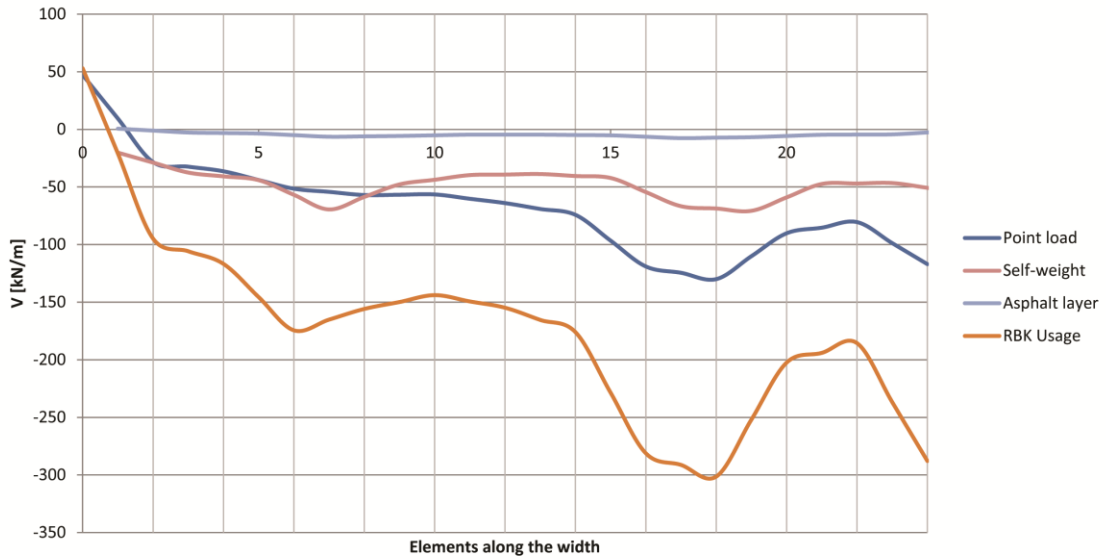
Fig. 15: Sectional shear over width of slab. The x-axis shows the numbering of the elements in the finite element model. Conversion: 1 kN/m = 0.07 kip/ft.

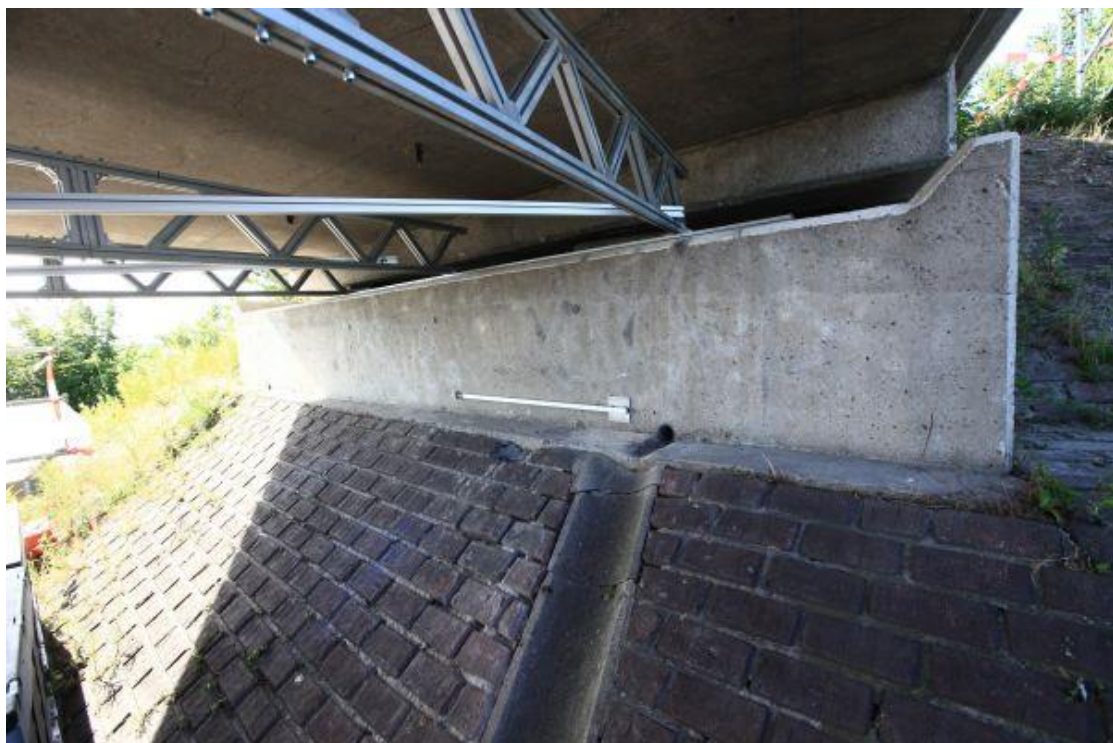
Fig. 18: Position of reference LVDT to measure influence of temperature and humidity. Picture showing support 5.

The strains caused by changes in temperature and humidity are measured by the reference LVDT (see Fig. 18). The information of the ambient temperature can be taken from the Dutch meteorological institute (Royal Dutch Meteorological Institute 2017). The measurement of the temperature of the bridge deck is part of the monitoring system for ASR, as discussed in §2.3.3. During the bending moment test, see Fig. 29a, the bridge deck temperature and ambient temperature increased similarly. The measured strain is inversely proportional to the temperature. As

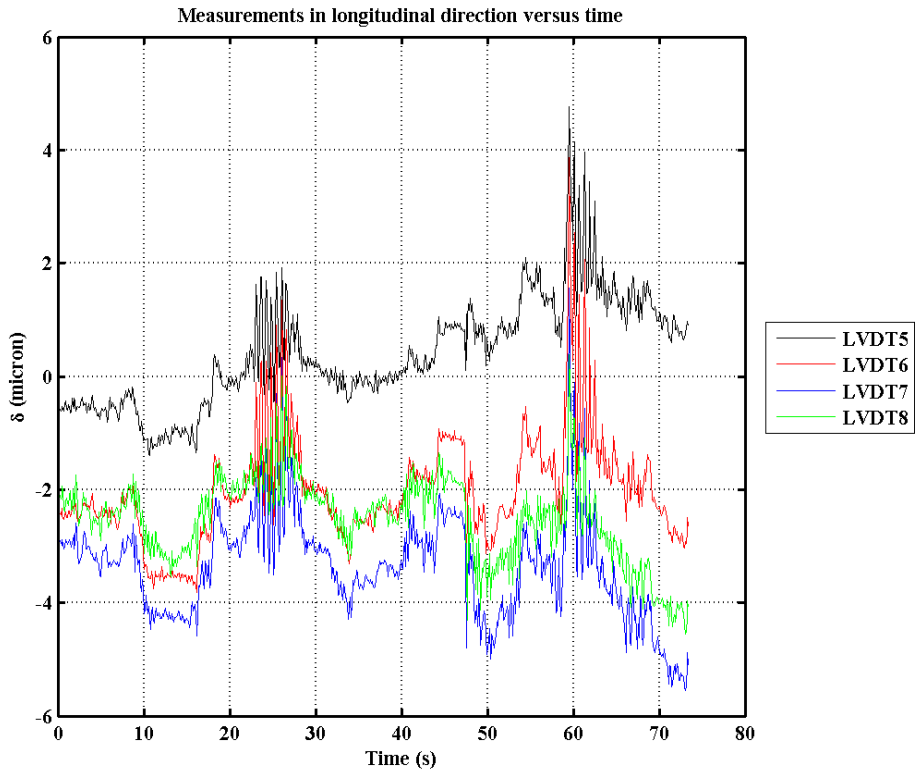
Fig. 19: Measurement of person jumping. Conversion: 1 micron = 4×10^{-5} in.

Two proof load tests were carried out: one proof load test at a flexure-critical position and one proof load test at a shear-critical position. Both tests were carried out in span 4, on June 17th 2015. The proper functioning of all sensors was verified during the afternoon of June 16th. A person jumping on the bridge resulted in small but measurable responses, see Fig. 19, and driving a car over the viaduct resulted in clear responses, see Fig. 20.

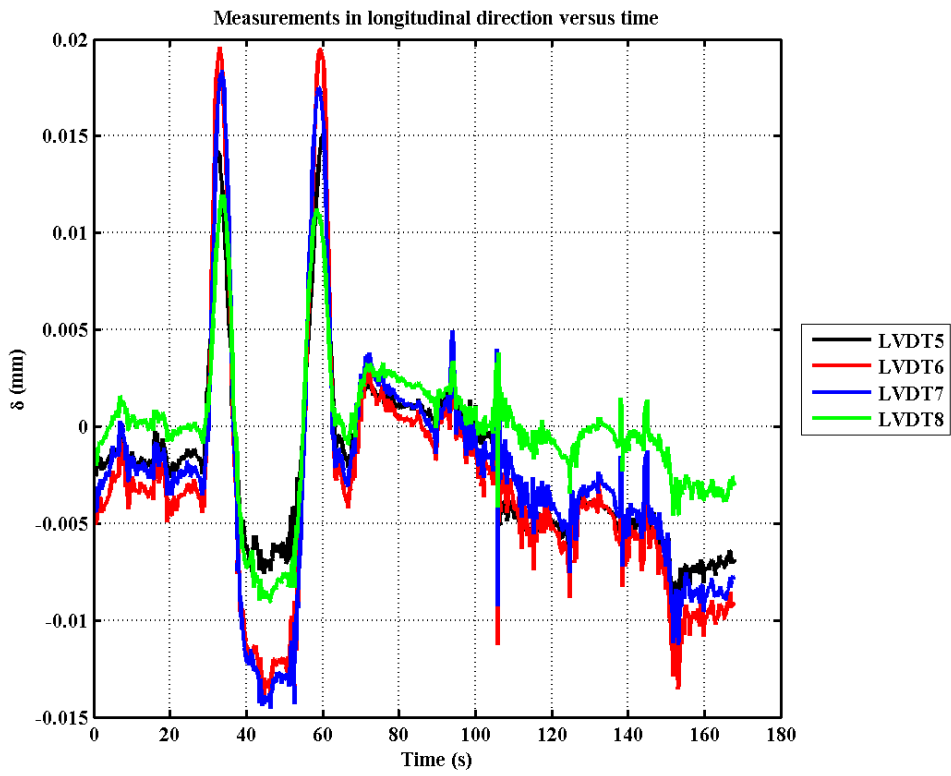
Fig. 20: Measurement of car passing. Conversion: 1 micron = 4×10^{-5} in.

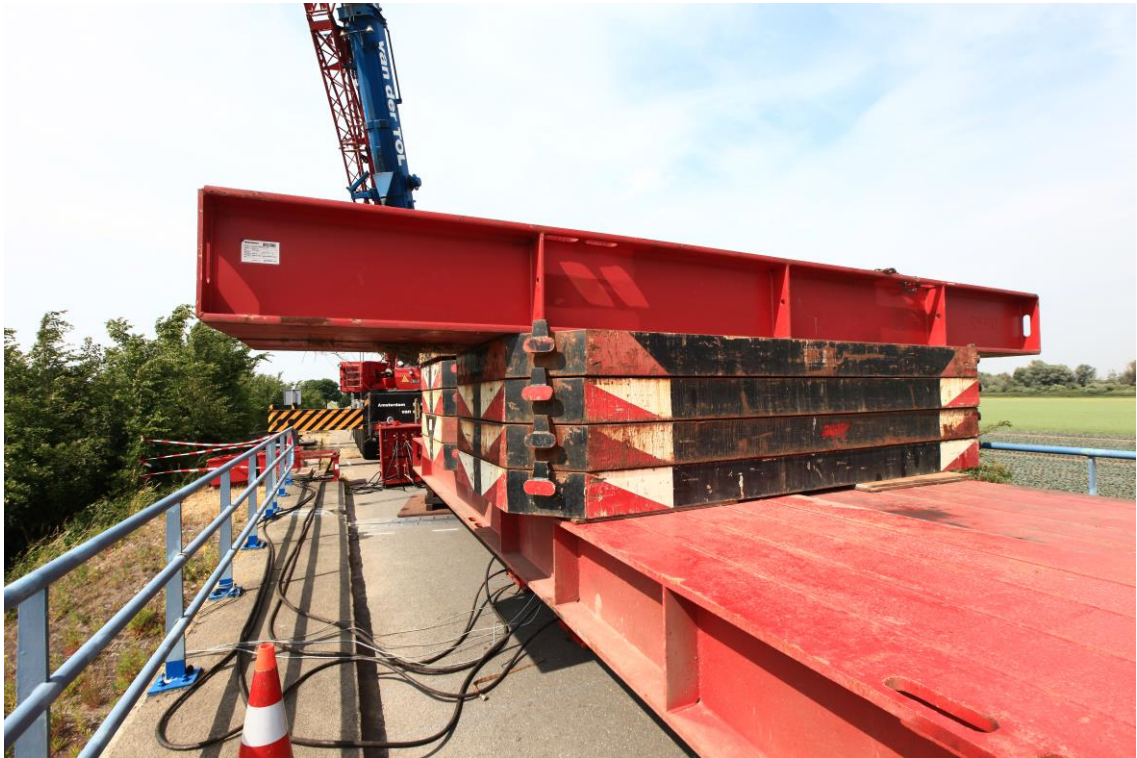
Fig. 21: Setup of the load used on viaduct Zijlweg.

For the proof load tests at the shear- and flexure-critical positions, a setup with a load spreader beam, counterweights, and four hydraulic jacks was used. Fig. 21 shows a photograph of the load application system. Before the beginning of the proof load test, the jacks are not extended, and the load caused by the applied counterweight is carried off at the supports to the substructure. During the proof load test, the load on the jacks can be controlled and the superstructure (reinforced concrete slab) is loaded.

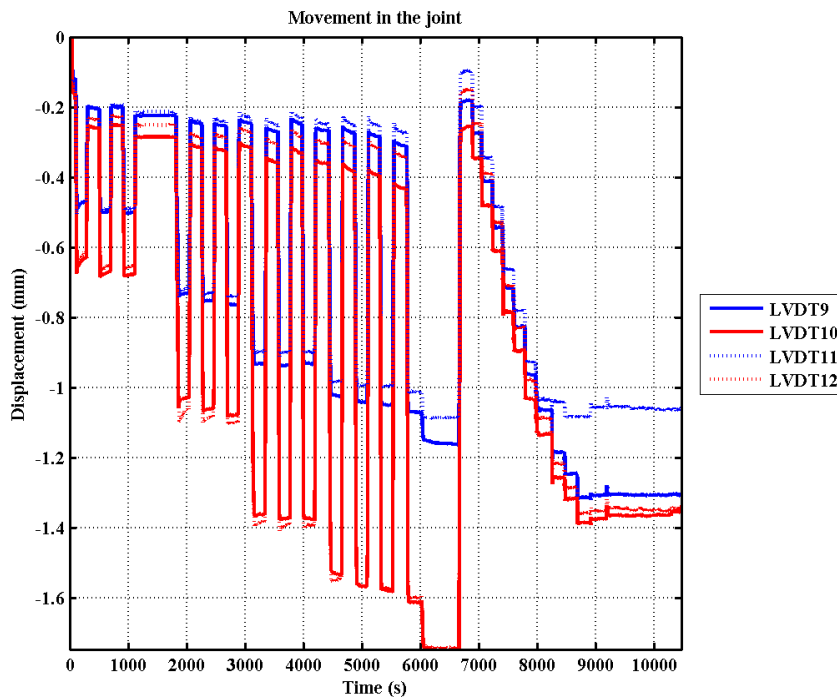
Fig. 28: Movement in the joint during the shear proof load and during removal of the counterweight. Conversion: 1 mm = 0.04 in.

The results of the measurements of the LVDTs applied over the expansion joint are given in Fig. 28. As the measurements are started at the beginning of the proof load test, it makes sense that a negative displacement is measured during the test. The test is carried out with a system of a steel spreader beam, jacks, and counterweights. Prior to the test, all load goes to the supports and affects the joint due to small eccentricities in the setup. During the test, the jacks apply the load to the superstructure, which results in unloading of the joint. The last part of the measurements (7000 s and further in Fig. 28) correspond to the removal of the counterweights (per ballast block), which results in unloading of the joint.

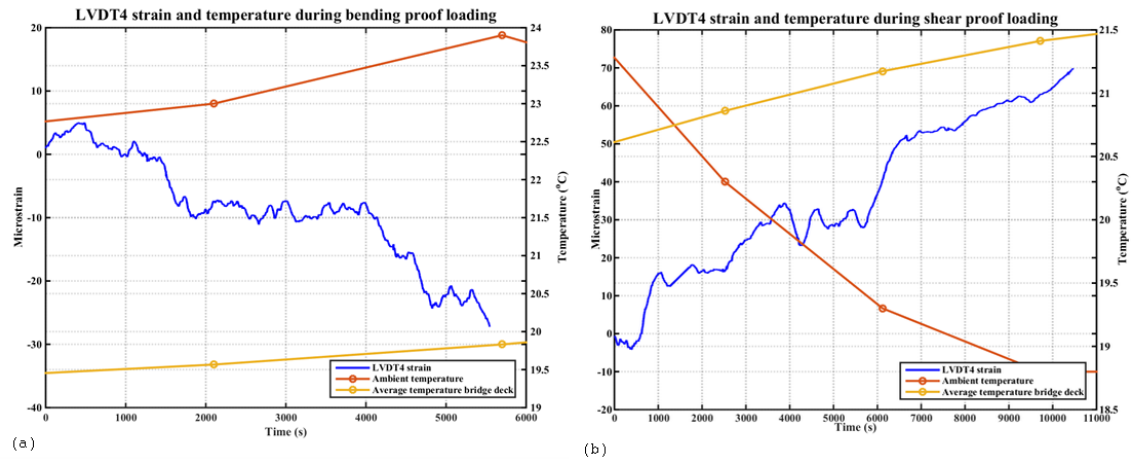
Fig. 29: Reference strain and temperature during: (a) testing at flexure-critical position; (b) testing at shear-critical position.

the temperature increases, the aluminum strip expands. This expansion leads to compression of the LVDT, or negative values.

For the shear proof load test, see Fig. 29b, the observations are different: the ambient temperature decreased but the temperature of the bridge deck increased slightly. The weather conditions explain this behavior: the wind was blowing, reducing the ambient temperature, and at the same time, the sun was shining, warming up the bridge deck. The measurements of the reference LVDT are in correspondence to the ambient temperature.
