Load testing of a deteriorated prestressed concrete girder bridge without plans

Synopsis: In this study, a prestressed concrete girder bridge without plans and with severe levels of deterioration, located in Cali, Colombia, was load-tested to quantify, experimentally, its live-load behavior. The bridge consists of seven prestressed I-girders covered with a reinforced concrete deck, and four diaphragm beams. A geometric survey was performed to obtain the dimensions for a shell-based linear finite-element model (FEM) representing the bridge superstructure. In this survey, it was observed that the diaphragm beams in the span are geometrically inadequate to contribute to the structural system. Based on the experimental modal properties and the design regulations enforced at the time of bridge design and construction, a first update was made. Modifying the effective stiffness of selected elements to model girder deterioration, a second update was performed based on strain-gauge data from three load tests and visual inspection (VI) of the elements. The three models (basic, modal updated, and load-test/VI updated) were compared with the load distribution factor (DF) obtained from the loa

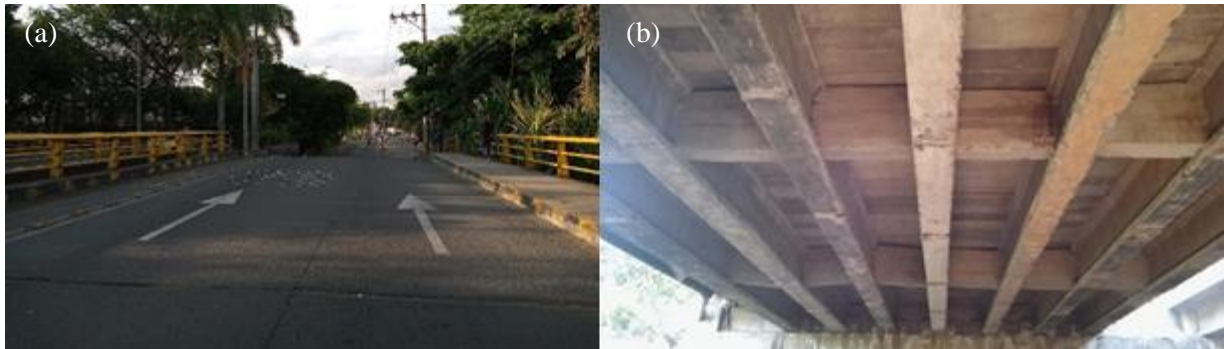
Fig. 1—Overview of bridge tested: (a) traffic flow view; (b) bottom view.

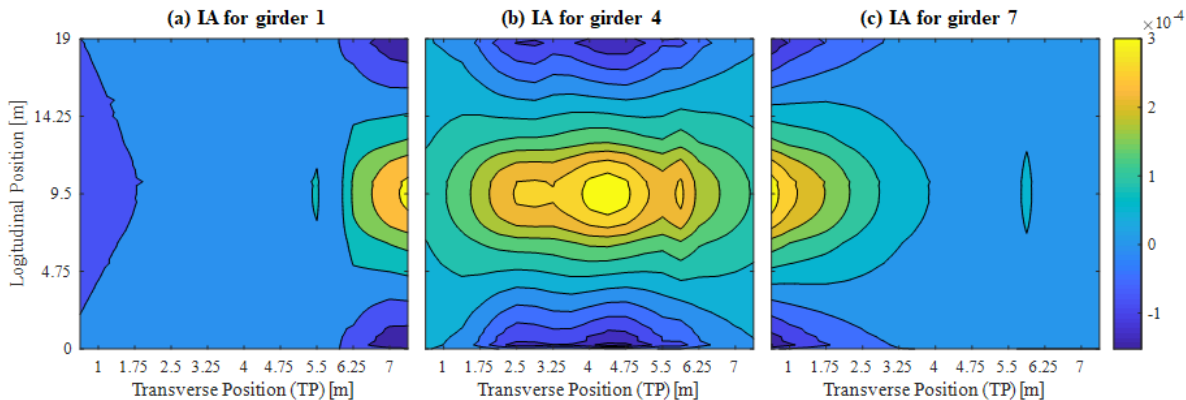
For illustrative purposes, the IAS for girders 1, 4 and 7 are shown in Fig. 8. One truck located in the middle of the span over girders 1, 4 and 7 generated the maximum bending moments in these girders. Thus, these positions were used during the load test. Finally, based on the results of the prestressing force estimate, visual inspection, and as a conservative criterion, a diagnostic load test was performed with a truck weighing less than the design truck.

Fig. 8—Influence areas IA for girders 1, 4 and 7. Units in 1/N [1 kN = 0.2248 kip; 1 mm = 0.0394 in.]

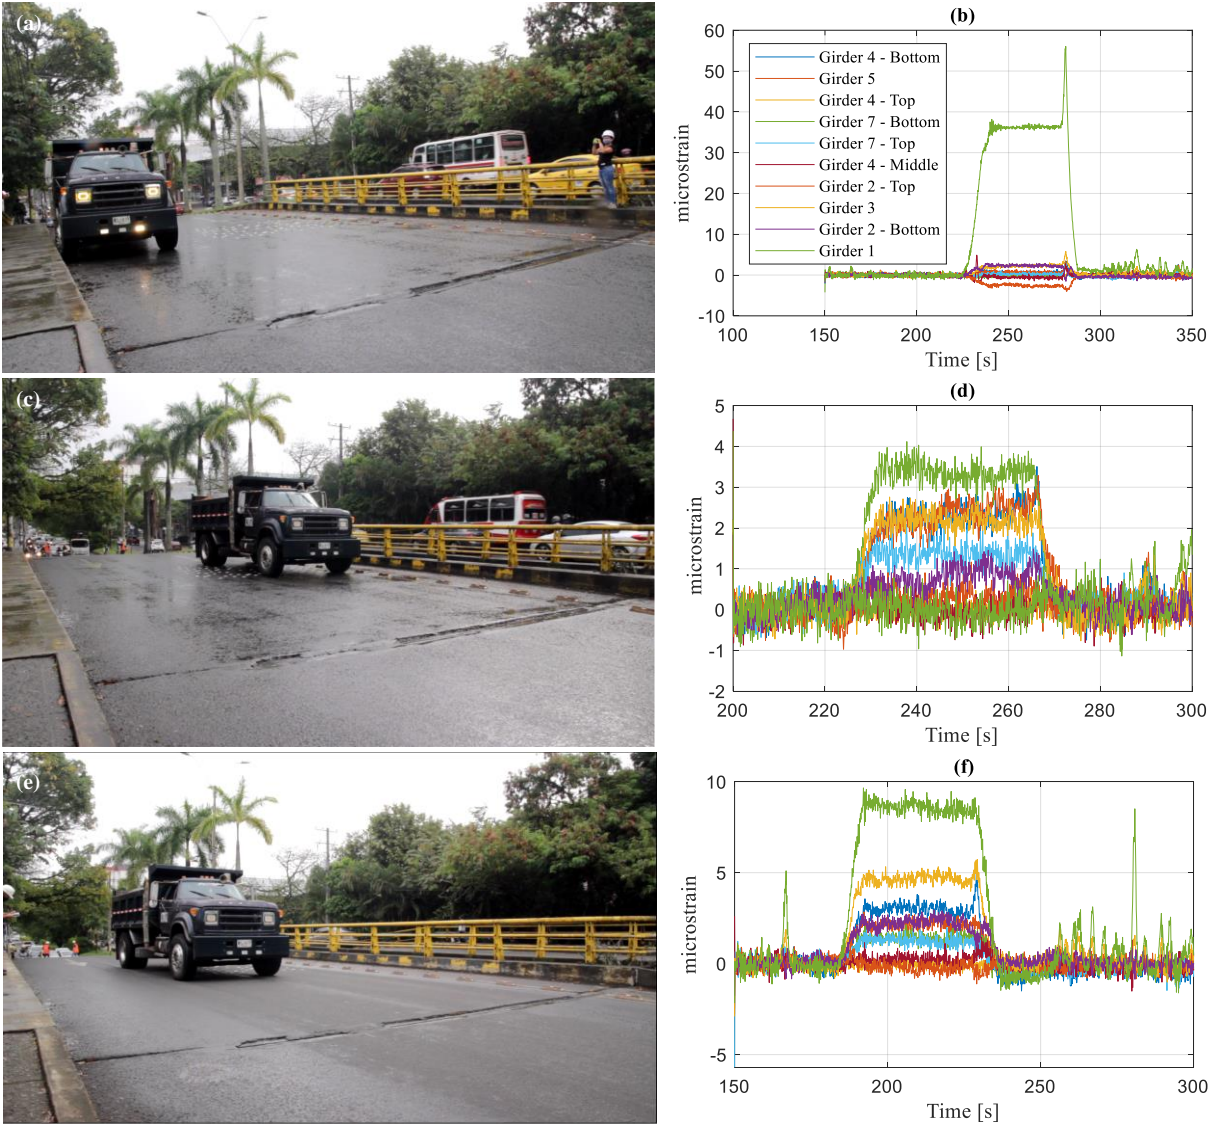
The execution of the load test and results are shown in Fig. 11. The strain versus time plots show how the strain readings return back to their initial values after unloading the bridge. This behavior indicates that the structure remains in its original state (no additional damage was generated with the load tests). The results from the static load L1 show a higher level of strain on girder 1 as compared with the other elements. A first hypothesis for this outcome is that the level of deterioration in girder 2 resulted in a stiffness reduction, so that relatively more load is redistributed to girder 1, which, in turn, results in the higher strain reading. Even in the load test L12, in which the truck was closer to girder 2, the strain in girder 1 is higher than in girder 2. The peak in the strain data from girder 1 during static load test L1 was due to a sudden movement of the truck (abrupt braking). This value is discarded for the analysis as well as the peaks outside the duration of test L12 due to normal traffic flow before and after testing.

Fig. 11—Load test execution and results: (a) truck location L1; (b) strain static load test L1; (c) truck location L2; (d) strain static load test L2; (e) truck location L12; (f) strain static load test L12.

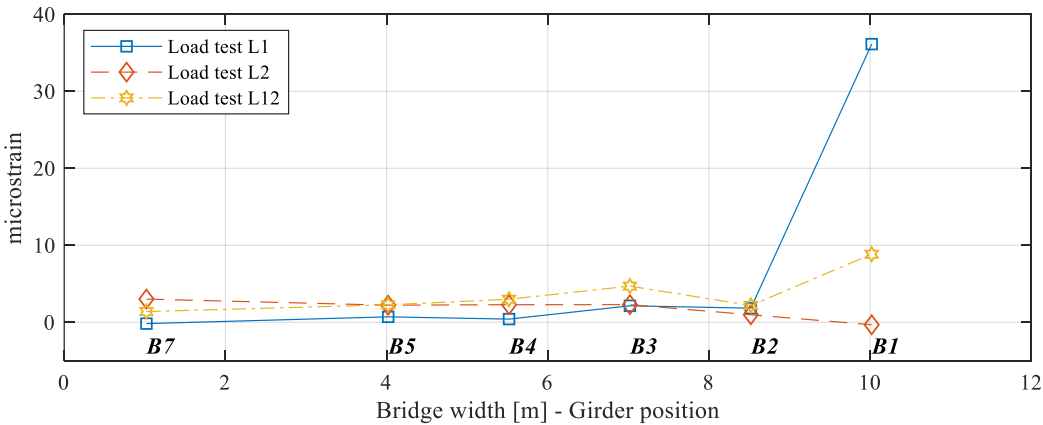
Fig. 12 summarizes the strain results for the three load tests. With this information, the finite element models were updated, and the experimental DFs were calculated.

Fig. 12—Static test transverse strain profile. [1 m = 39.4 in.]

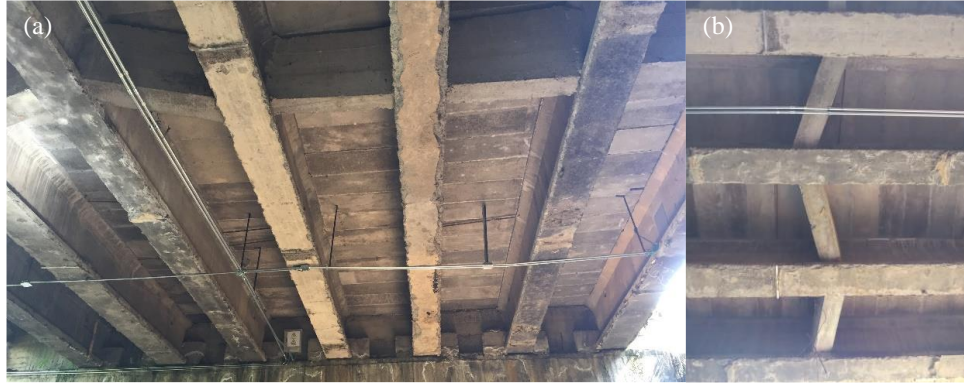
The initial model was updated with the experimental modal information. Based on the survey, it was observed that the diaphragms at third-span were geometrically inadequate to contribute to the structural system (Fig. 14). Therefore, they were removed from the model and assigned as load (mass) only. Also, based on the OMA results, nonstructural elements, such as the curb and the pedestrian platform, contribute to the stiffness of the structure. By including these elements, the FEM changes drastically, and the frequencies and modal coordinates show a better agreement with their experimental pairs. Other properties, such as the vertical stiffness of the bearings, modulus of elasticity of the concrete in the girders and in the deck were updated (Table 4) in an automatic way by minimizing the following objective function (F) (Eqn. 9):

Fig. 14— Diaphragms at first third-span: (a) general view; (b) diaphragms between girders 1 and 4.

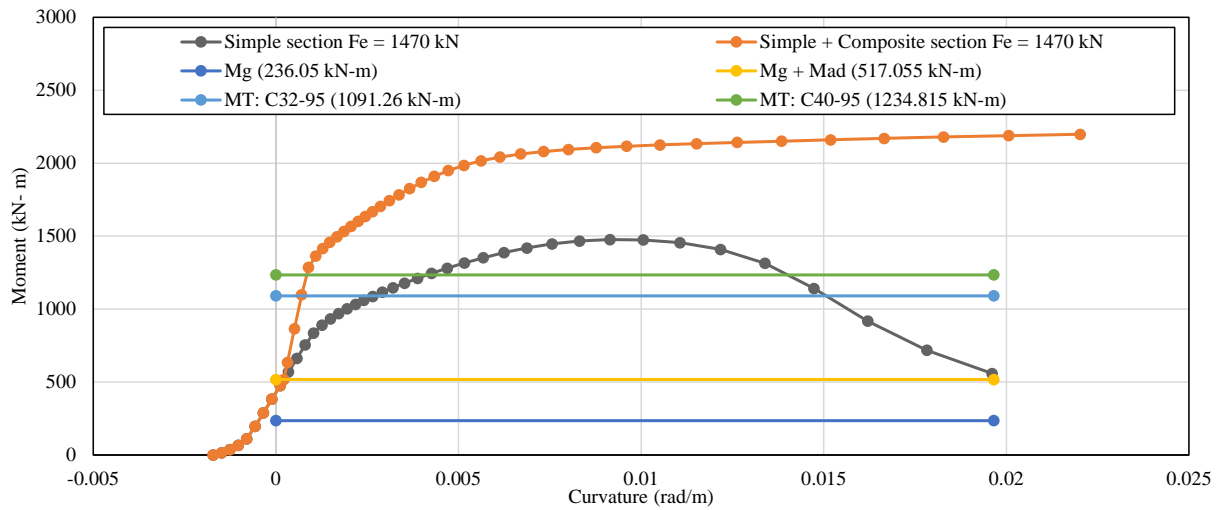
Results in Fig. 15 indicate that the simple section exceeds its linear behavior for the total design load ($MT = M_g + M_{ad} + M_{truck\ load}$ where M_g is self-weight moment of girder, M_{ad} is the moment from superimposed dead load and $M_{truck\ load}$ is the live load moment due to the C32-95 or C40-95 design truck), while the composite section remains within its linear range for the full design load, including the C40-95 truck. This indicates that the loss in prestress force could be larger than originally estimated (15%). Thus, the effective stiffness was changed as a percentage of the gross section until a minimum value of $ME = 0.33$ was reached. For each girder, a cracking section was modeled at crack positions obtained from the visual inspection. the moment of inertia at these locations was changed manually from 100% to 30% of the gross moment of inertia of the composite section (Fig. 16). The calibration with the static load test data was performed only for the L12 test. The other results were compared with the updated model to validate the calibration.

Fig. 15—Moment-curvature diagrams. [1 kN = 0.2248 kip; 1 kN-m = 0.06852 kip-ft]
