Role of Timber Structural Elements in the Seismic Response of Masonry Structures in the Himalayan Region

Additional Graduation Project
Delft University of Technology

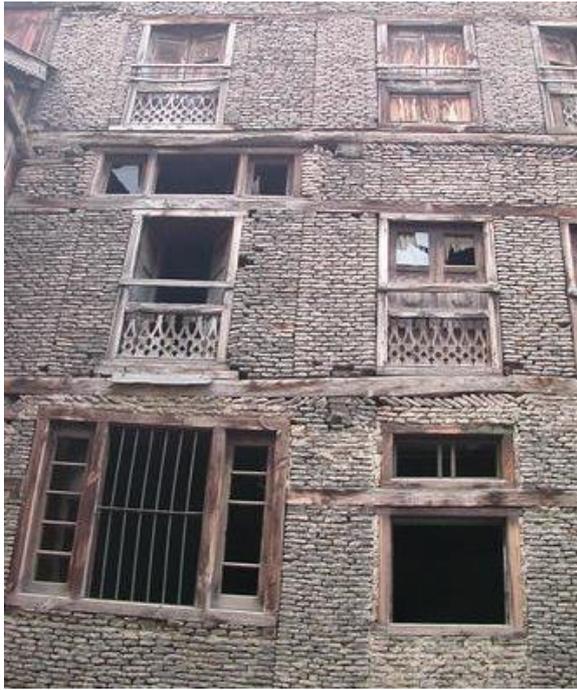
Figure 2.1: Taq building with horizontal timber bands and brick masonry (Jain, 2016)

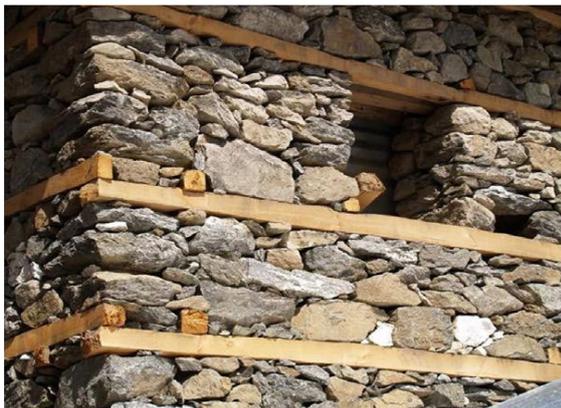
Figure 2.3: Taq wall with dry stone masonry (photo credit: Tom Schacher)

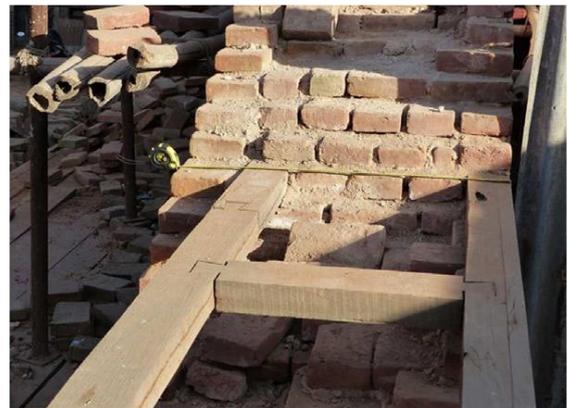
Figure 2.4: Timber ladder (band) with brick masonry (photo credit: Martijn Schildkamp)

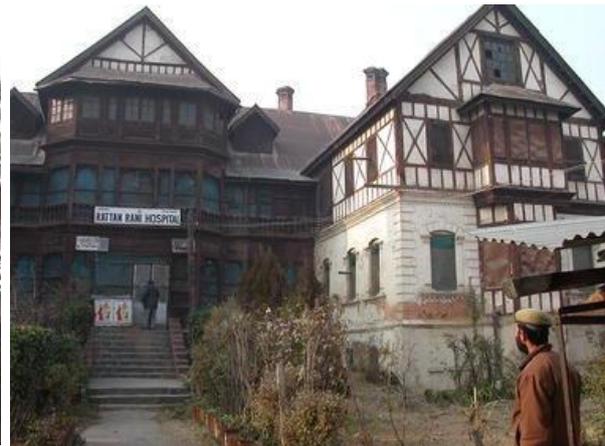
Figure 2.6: Bhatar and Dhajji Dewari used in same structure (Jain, 2016)

Dhajji-dewari is often used in the upper floors of a building in conjunction with another timber laced system – Taq/Bhatar, on the lower floor as can be seen in Figure 2.6. This is done to take advantage of this system’s thinner and thus lightweight walls. There is evidence for the relatively better performance of this construction system compared to other traditional and conventional construction systems, including RC frame structures, after the 1967 and 2005 earthquakes. The pinned connections allow controlled movement leading to larger dissipation capacity for the system (Gani et al., 2021). While modern Dhajji-Dewari constructions in cities have uniform timber cross-sections and symmetrical bracings (Figure 2.7), in villages, often non-uniform bracings with random lengths can be seen to utilise available lengths of wood (Figure 2.8)

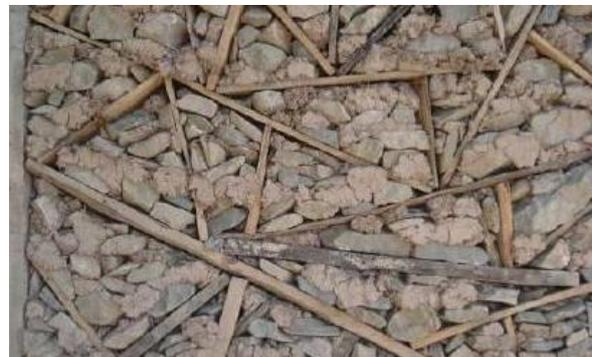
Figure 2.8: Random patterns in timber bracing, possibly to use available sizes of wood (Hicyilmaz et al., 2009)

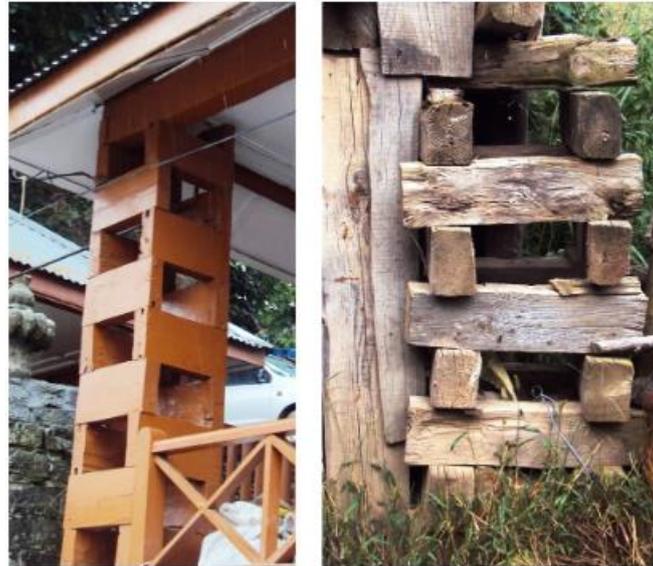
Figure 2.9: Thola columns in Thathara house(a) Thola in a modern construction. (b) An older thola column with rudimentary, unfinished planks and unsophisticated joinery (Rahul et al., 2013)

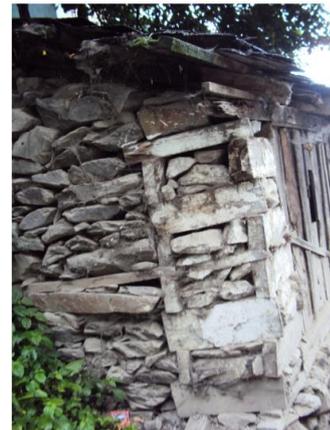
Figure 2.11: Thola with stone masonry infill within (Rahul et al., 2013)

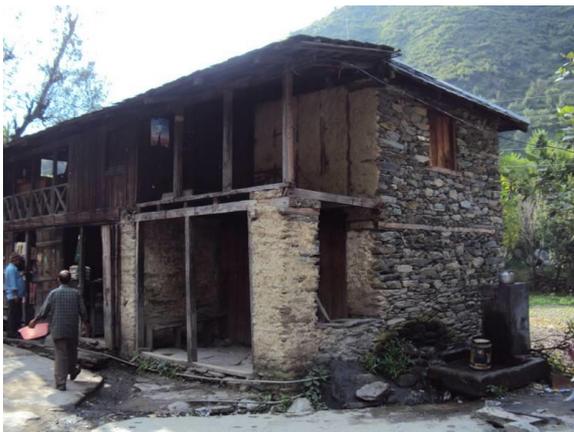
Figure 2.14: Dry stone masonry walls with wooden floor (Sood et al., 2013)

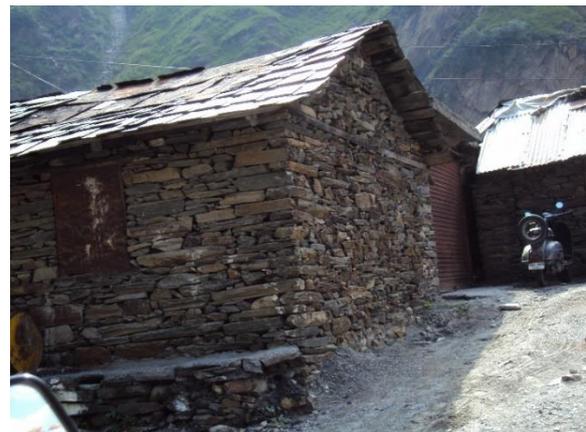
Figure 2.15: Dry stone masonry wall with stone slate sloping roof (Sood et al., 2013)

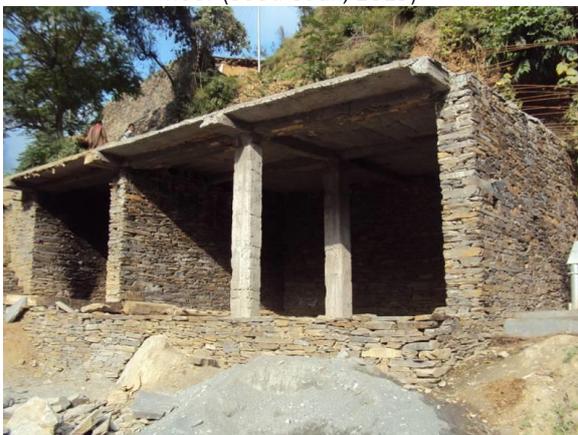
Figure 2.16: RC columns with stone masonry walls and RC slab floor (Sood et al., 2013)

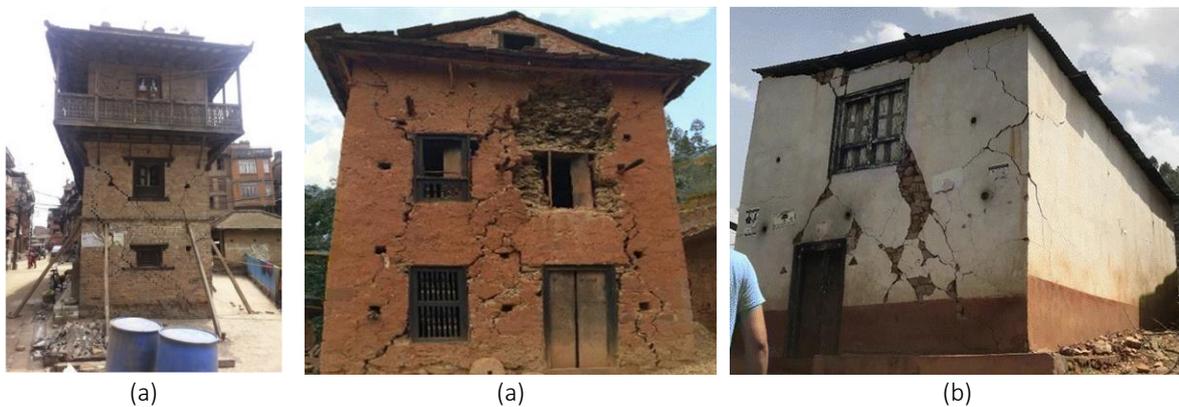
Figure 4.1: In-plane shear damage in walls with openings in (a) in brick masonry building (Shakya & Kawan, 2016), (b) and (c) Stone masonry buildings (Adhikari & D'Ayala, 2020)

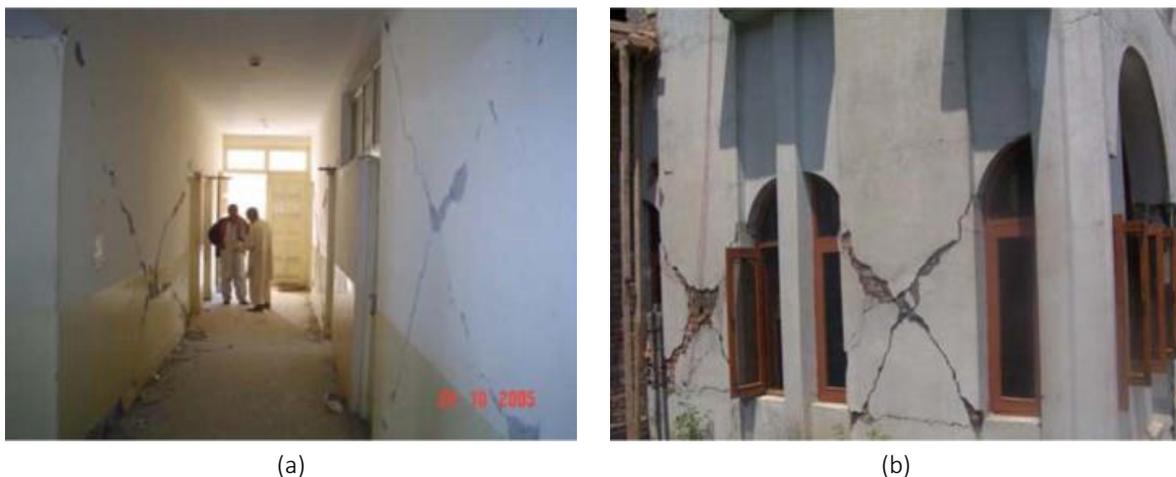
Figure 4.2: (a)-(b) - Diagonal shear failures of masonry wall piers (Naseer et al., 2010)

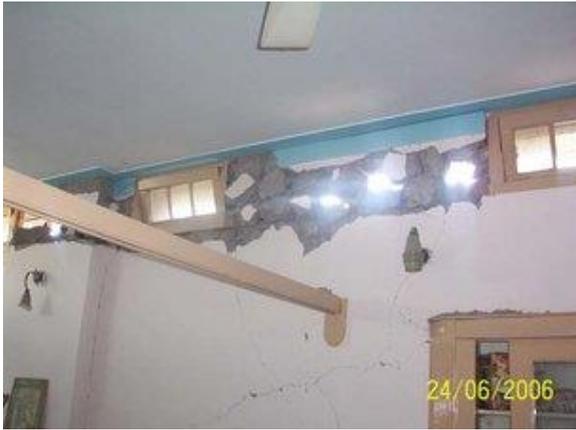
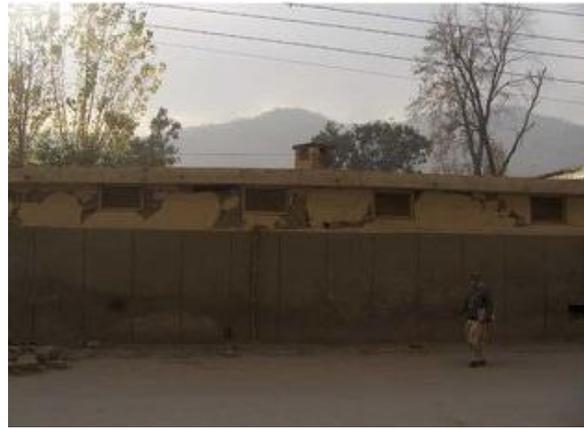
Figure 4.3: (a)-(b) - Damage of masonry piers adjacent to the roof due to multiple ventilators/openings(Naseer et al., 2010)

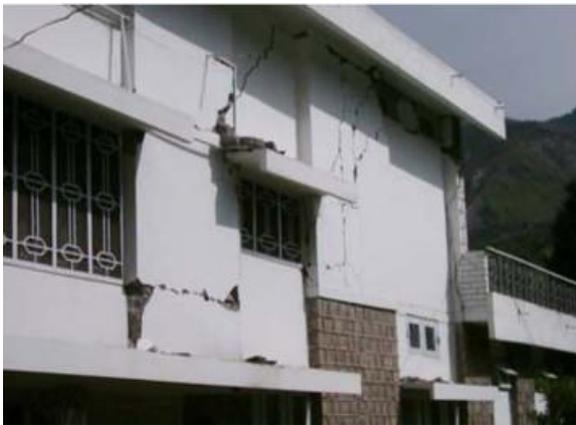
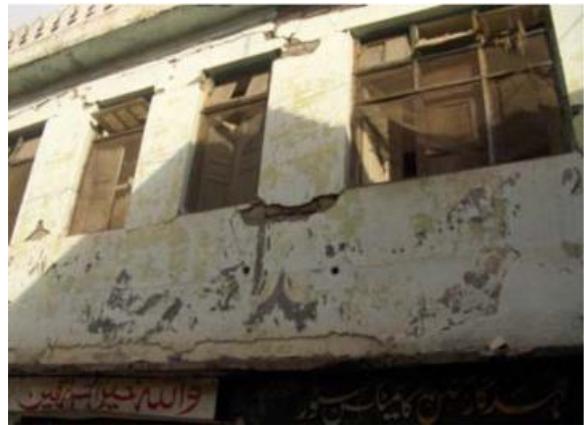
Figure 4.4: (a)-(b) Flexural failure of masonry wall piers (Naseer et al., 2010)

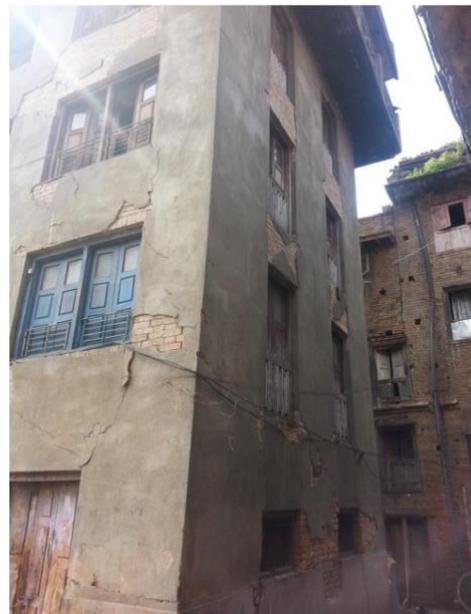
Figure 4.6: Spandrel failure (Shakya & Kawan, 2016)

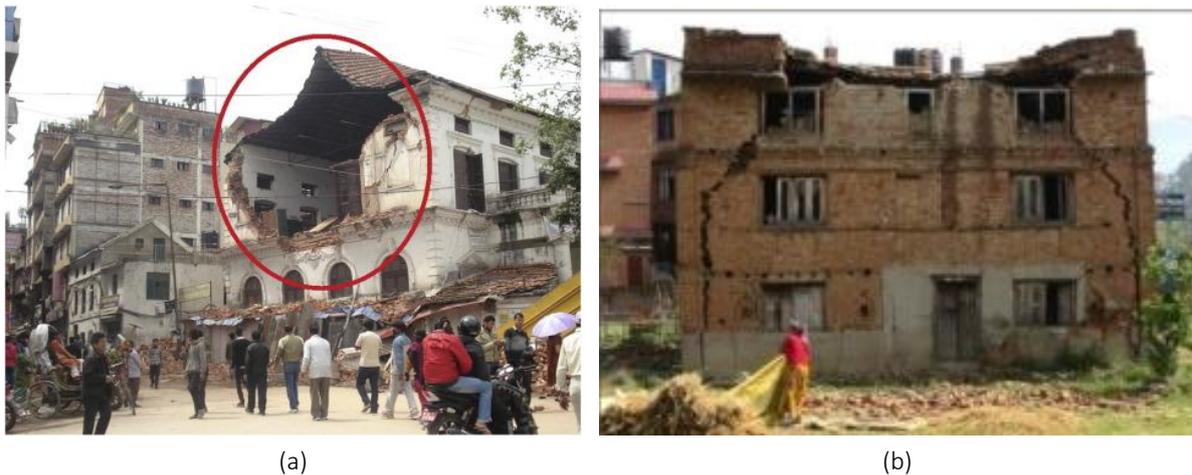
Figure 4.7: (a) – (b) Out of plane collapse of façade wall (Dizhur et al., 2016)

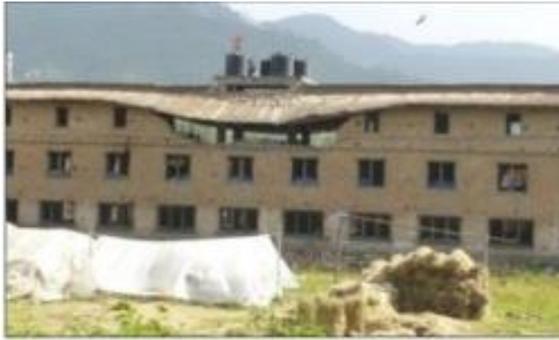
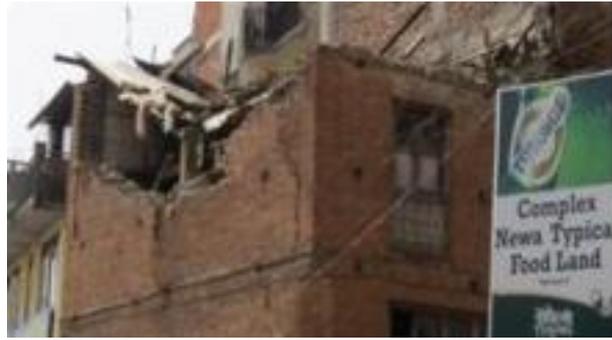
Figure 4.8: (a) – (b) Overturning of façade (Dizhur et al., 2016)

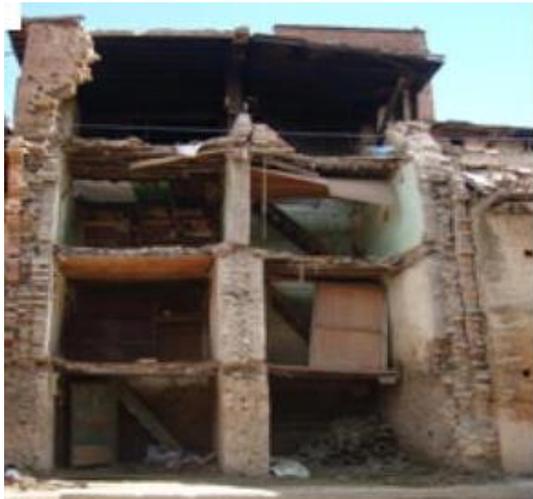
Figure 4.9: Complete collapse of façade (Gautam et al., 2016)

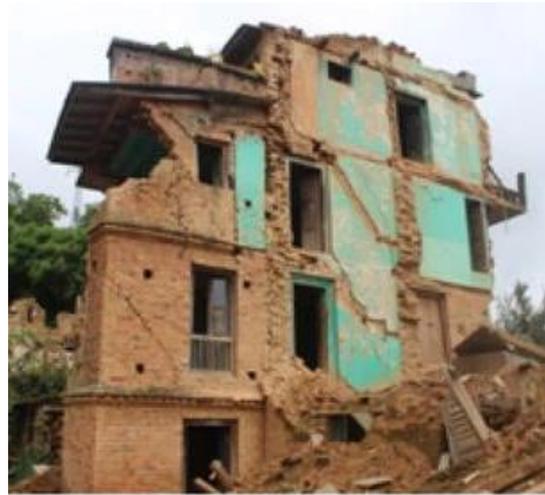
Figure 4.10: Out-of-plane collapse of majority of walls (Gautam et al., 2016)

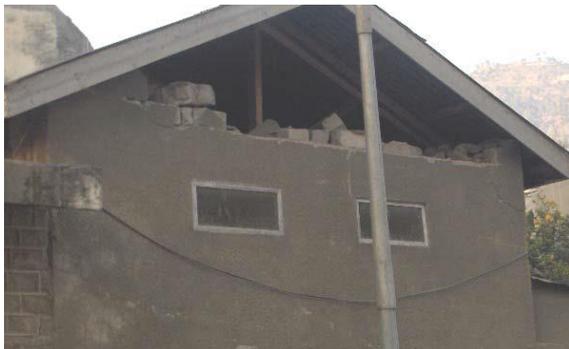
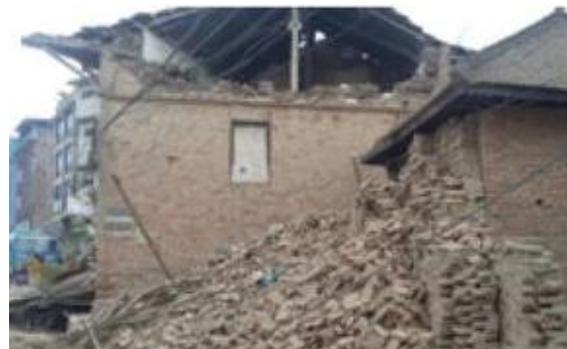
Figure 4.11: Out of plane collapse and overturning of gable masonry (a) (Javed et al., 2006) (b) (Gautam et al., 2016)

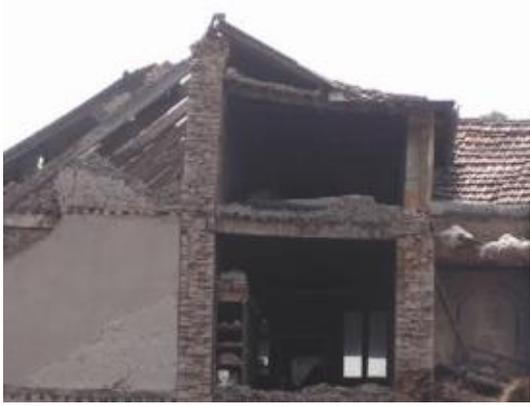
Figure 4.12: OOP collapse of wall due to inadequate connection with roof floor and transversal wall (Rai et al., 2015)

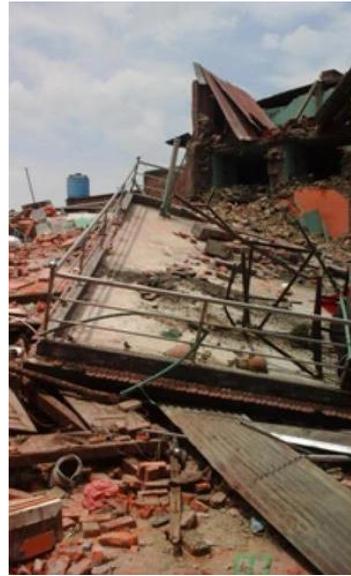
Figure 4.13: Collapse of RC slab on top of masonry walls (Gautam & Chaulagain, 2016)

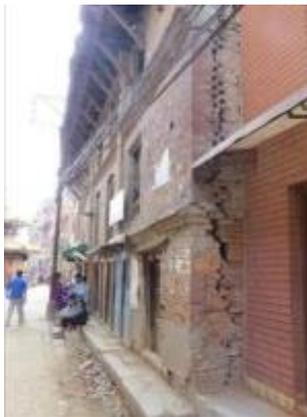
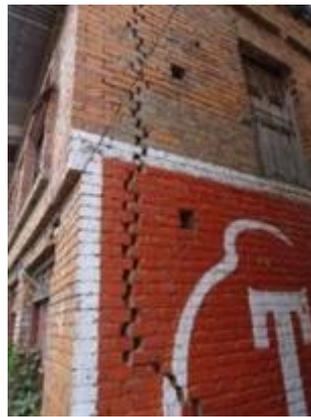
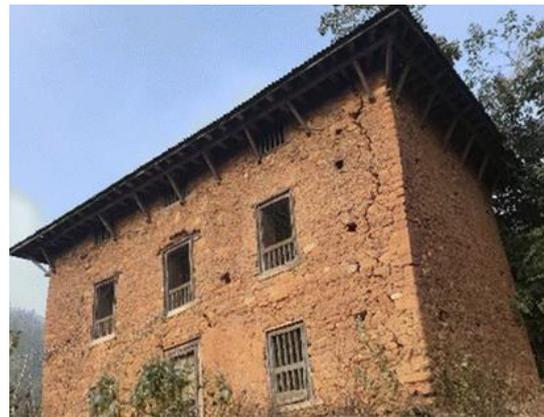
Figure 4.14: Separation of orthogonal wall (a)– (b) Brick masonry (Dizhur et al., 2016) (c) Stone masonry- (Adhikari & D'Ayala, 2020)

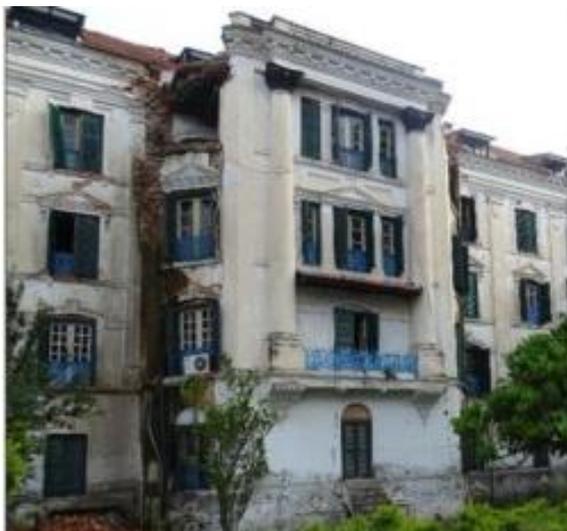
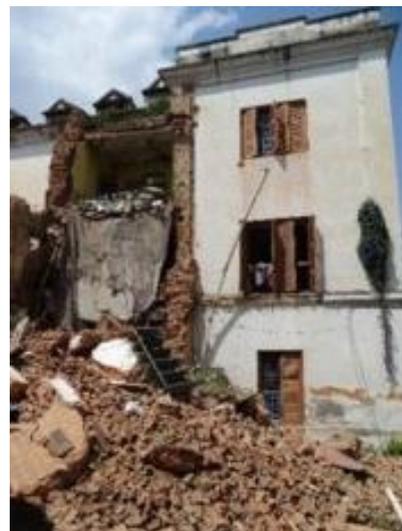
Figure 4.15: Out of plane damage due to asymmetrical plan or protruded part of the building (Dizhur et al., 2016)

Gable overturning was found to be one of the most common types of failure mechanisms to develop in multiple post-earthquake reconnaissance surveys. No vertical load on top of the gable wall, no ties and braces tying the gable to the roof structure and insufficient connection to the perpendicular in-plane walls are some of the factors contributing to the disproportionate contribution of gable wall overturning to failures. In such a circumstance, the gable essentially behaves akin to a parapet wall as observed by Gautam et al. (2016) in Figure 4.11. Improper connections to the perpendicular walls also lead to separation of the out-of-plane wall as observed by Dizhur et al. (2016) and Adhikari and D’Ayala (2020) in Figure 4.14. The thrust from a poorly connected roof might also lead to partial or severe damage to out-of-plane wall (Figure 4.8). Another reason for the failure of the out-of-plane wall is the relatively longer length because the transversal internal walls are not tied to the out-of-plane wall (Figure 4.9). An example of inadequate connection to the roof is where the timber joists are simply embedded or rested on the top of the wall while not being provided a positive connection as seen in Figure 4.12. Asymmetrical plans and protrusions also lead to failure (see Figure 4.15).

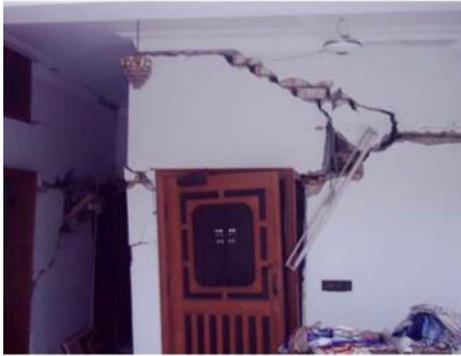
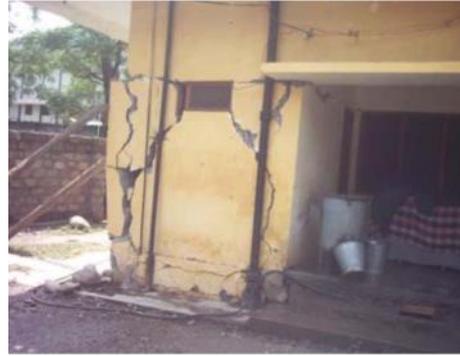
Figure 4.16: Combined in-plane and out-of-plane failure observed in Kashmir after 2005 earthquake (Naseer et al., 2010)

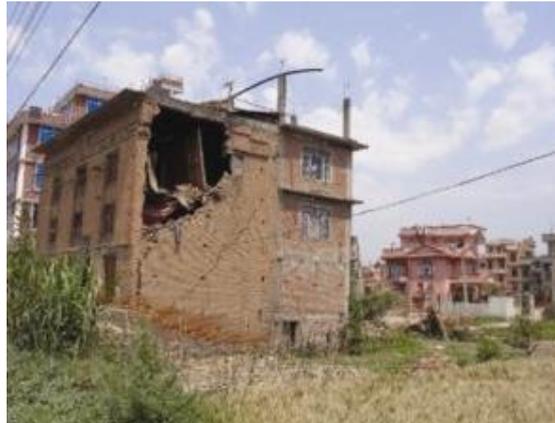
Figure 4.17: Combined in-plane and out-of-plane failure observed at Nikosera in unreinforced masonry after 2015 Gorkha earthquake (Rai et al., 2015)

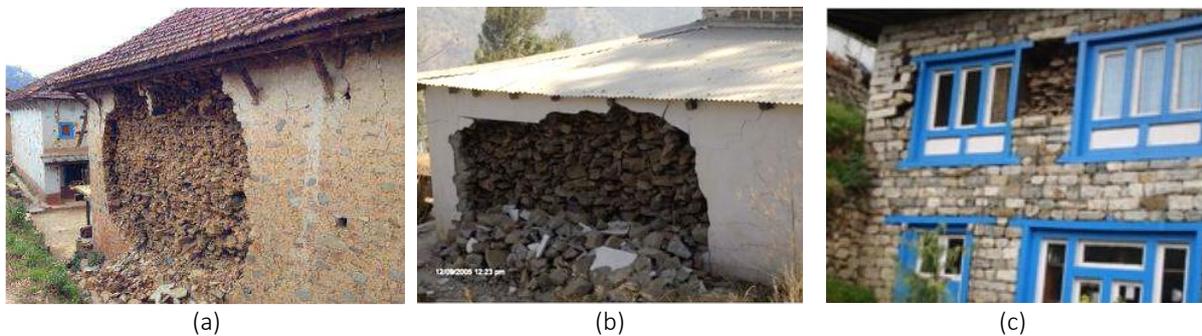
Figure 4.19: Delamination of external leaf of stone masonry wall due to out-of-plane effect (a) after 2015 Gorkha earthquake (Kuffel et al., 2015), (b) after 2005 Kashmir earthquake (Javed et al., 2006), (c) in Solukhumbu after 2015 Gorkha (Nepal) earthquake (Gautam et al., 2016)

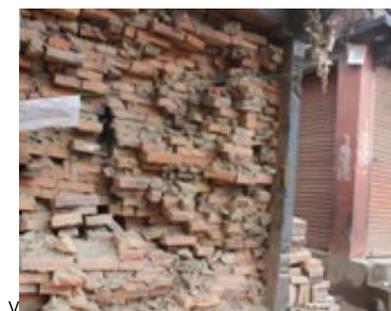
Figure 4.20: Masonry delamination due to (a)-(c) - absence of through stones. (d) - segregated mud mortar

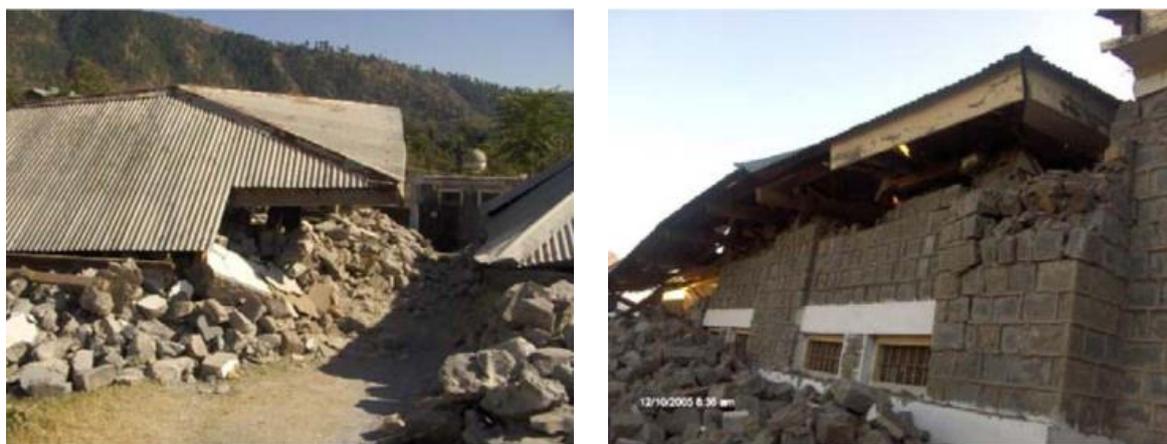
Figure 4.21: Failure due to lateral thrust from inclined roof (Naseer et al., 2010)
 (a) Collapse of masonry wall, (b) Localised damage

Local failures have been observed in the field occurring mainly due to poor construction practices, inferior quality of building materials and insufficient structural details. As seen from the Figure 4.18, the lack of horizontal tie or lace connecting the orthogonal walls adequately results in corner damage. Poor masonry, most commonly absence of pass-through stones in random rubble masonry (Figure 4.19) and poor quality mud mortar (Figure 4.20) lead to delamination of wythes. This effect is exacerbated by out-of-plane movement. Another area of frequently observed local damage is the thrust from the inclined roof that is not connected to the walls appropriately. This lateral thrust results in either partial local damage or complete collapse of the masonry (Figure 4.21).

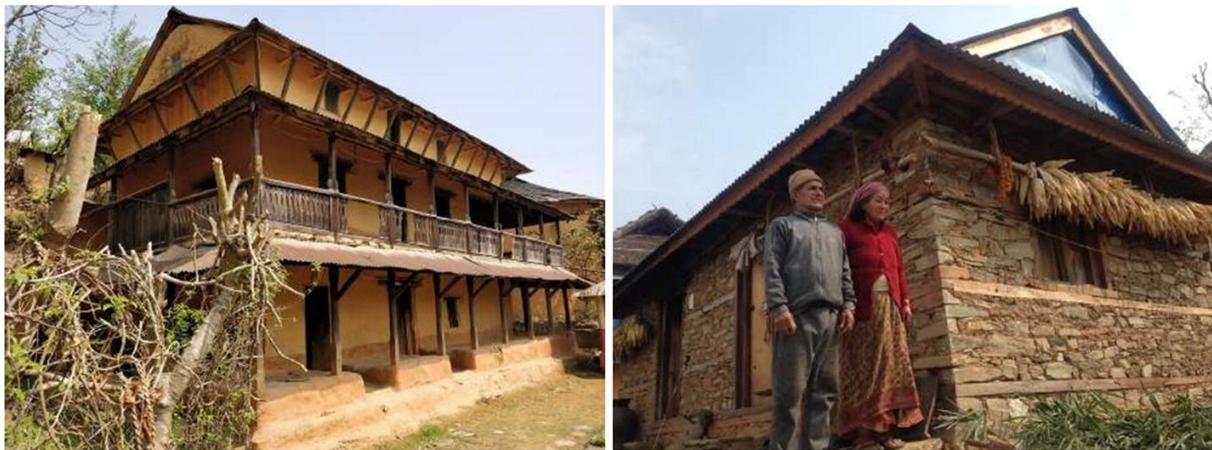
Figure 5.1: Stone masonry houses with seismic resistant features of timber elements

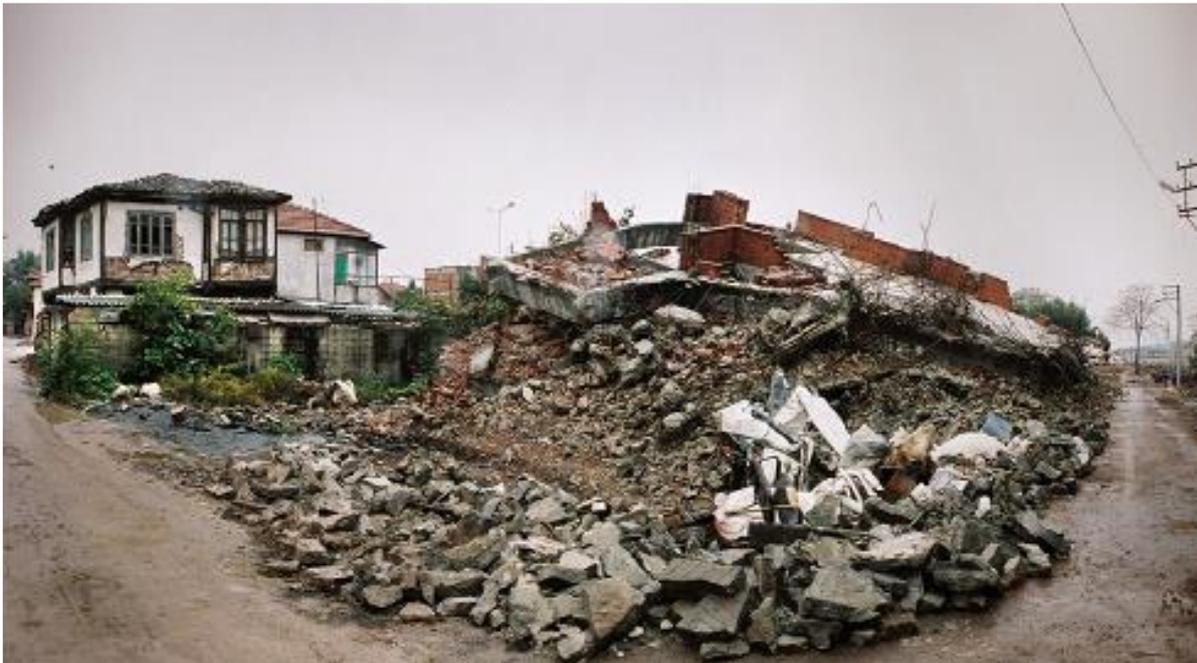
Figure 5.2: A traditional timber-reinforced *himiş* building standing in the backdrop while several multi-storeyed modern RCC buildings suffered pancake collapse in Adapazari after the 1999 earthquake (Langenbach, 1999)

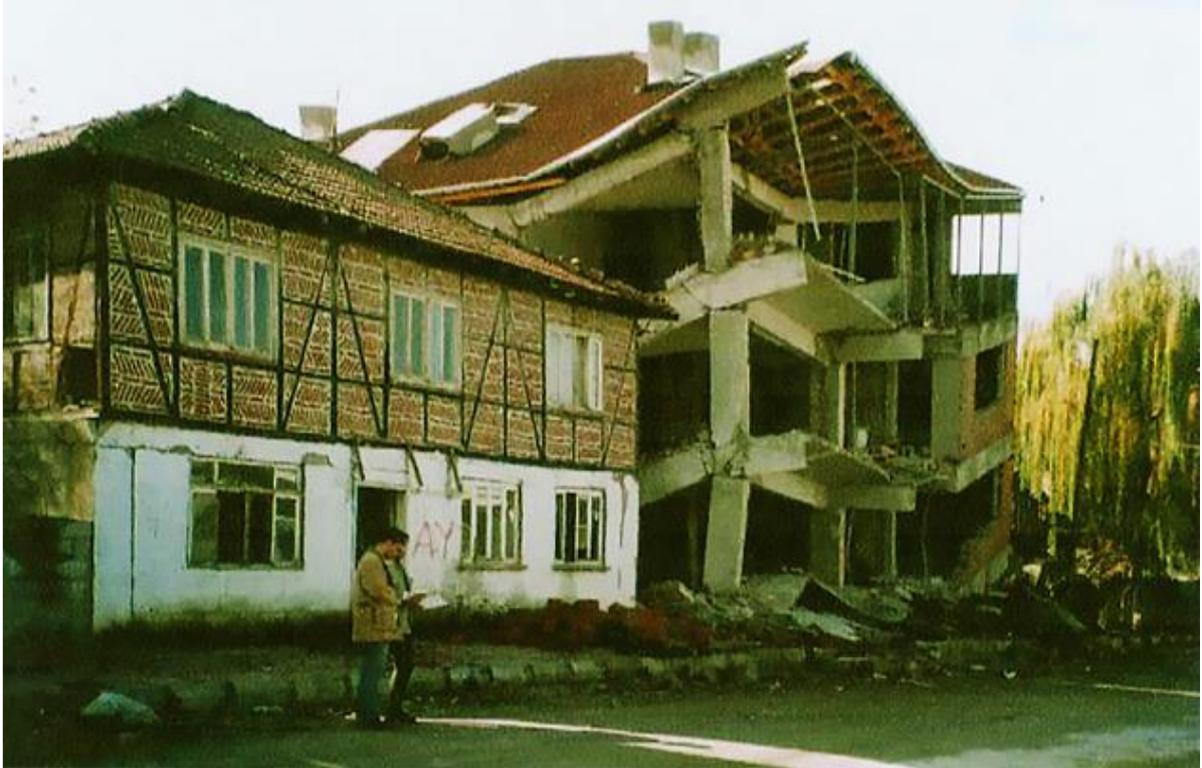
Figure 5.3: A *hımsı* building suffered relatively lesser damage whereas a 4 storeyed RCC building next to it suffered devastation with ground floor collapsing completely after the 1999 Duzce earthquake (Doğangün et al., 2006)

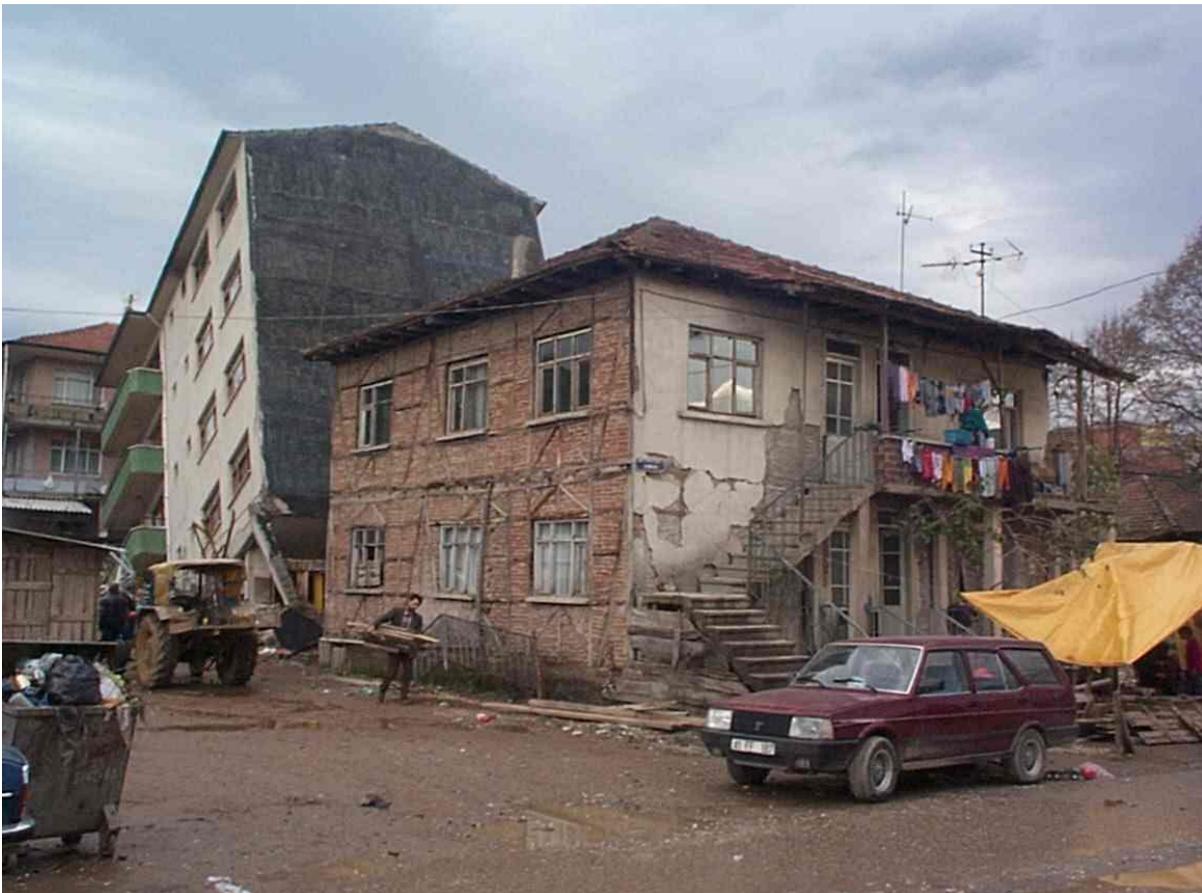
Figure 5.4: A *hımsı*, timber reinforced masonry house survived with very little damage next to a collapsed four-story RC building after the 1999 Duzce earthquake (Doğangün et al., 2006)

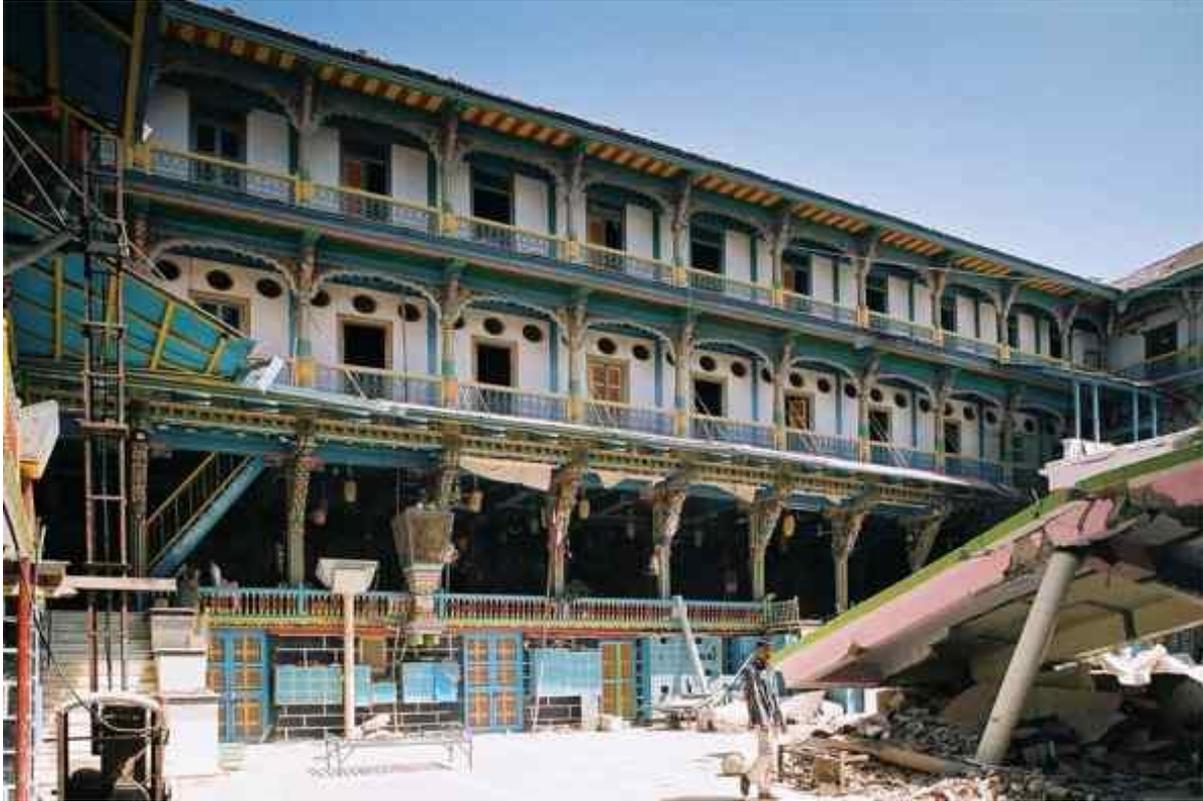
Figure 5.5: Only minor hairline cracks were noticed in the 150 year old timber-masonry Swaminarayan Temple while more modern RCC structure in the complex (visible in the front) collapsed completely after the 2001 Bhuj earthquake (Photo credit : Randolph Langenbach)
