Influence of the behaviour of calcium silicate brick and element masonry on the lateral capacity of structures

10th Australasian Masonry Conference

INFLUENCE OF THE BEHAVIOUR OF CALCIUM SILICATE BRICK AND ELEMENT MASONRY ON THE LATERAL CAPACITY OF STRUCTURES

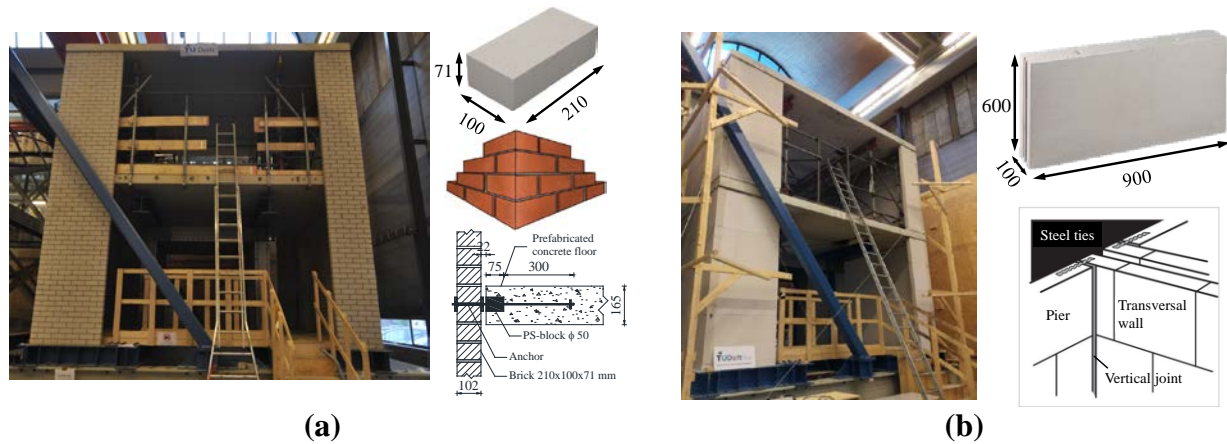
Figure 1: Specimens and main construction details: (a) CS brick masonry assemblage; (b) CS element masonry assemblage.

The CS brick masonry assemblage (Figure 1a) was tested as representative of terraced houses built in 1960-1980 in the northern part of the Netherlands. Small masonry unit having dimensions 210x71x100-mm were used. A running bond pattern was adopted allowing for the interlocking of the bricks at the corners of the transversal walls and the piers. At the first floor level, the floor was connected horizontally to the piers by anchors of 6 mm diameter, cast in the floor and masoned in the piers. The narrow piers were connected by three anchors, while the wide piers by five anchors. These anchors are commonly used as horizontal buckling or wind load support of the pier, and they are not designed to withstand any vertical load. At the second floor level, the floor was laid on both the loadbearing transversal walls and the piers.

The CS element masonry assemblage (Figure 1b) was tested as representative of terraced houses built in 1980-2000 in the northern part of the Netherlands. Large masonry unit having dimensions 897x643x100-mm were used for the facade piers, while unit having dimensions 897x643x120-mm were used for the transversal wall. The masonry was made in stretcher bond. In order to ensure verticality of the wall, a kicker layer made of small masonry unit was adopted at the bottom of the masonry walls both at the ground and first floor. The connection between the façade piers and the transversal wall consisted of a vertical joint; additionally steel ties were placed in the bed joint in correspondence of the vertical joint. Both at the first and second floor level, the floor slabs were laid on both the loadbearing transversal walls and the piers.

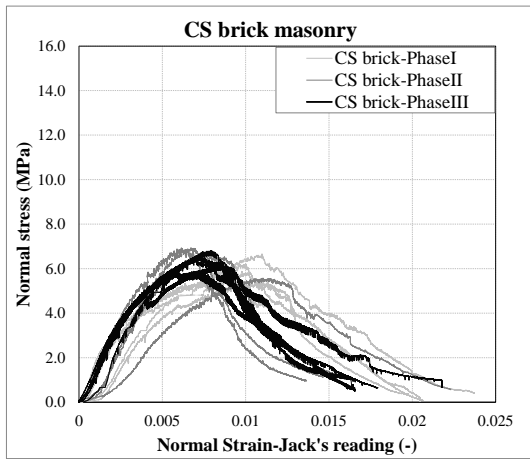
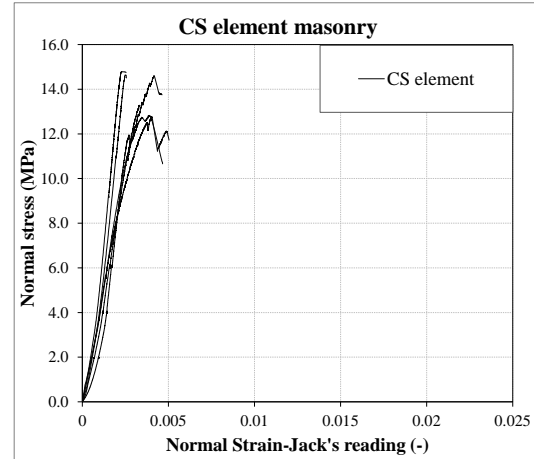
Figure 2: Stress-strain relationship in compression: (a) CS brick masonry; (b) CS element masonry.

The material properties of calcium silicate masonry were selected to represent Dutch masonry used in the construction of terraced house before and after 1980. The compression, bending and shear properties of both masonry specimens were investigated in dedicated experimental campaigns (Esposito et al. 2016, Jafari et al. 2017). The test were mainly performed by following the European standard EN 1052, however a displacement controlled procedure was adopted to obtain an indication of the post-peak behaviour. Table 1 lists the mean material properties for the CS brick and element masonry and their constituents. The CS element masonry showed a higher compressive strength and Young's modulus with respect to the CS brick masonry. In both cases, the pre-peak stage was characterised by linear-elastic followed by a hardening behaviour until the peak. After the maximum stress was reached, a softening behaviour was observed for the calcium silicate brick masonry, while a brittle failure was reported for the element masonry. Both the out-of-plane masonry flexural strength parallel to the bed joint and the initial shear strength resulted higher for the CS element masonry with respect to the CS brick masonry. Consequently the bond between masonry unit and mortar can be considered stronger in the case of CS element masonry.

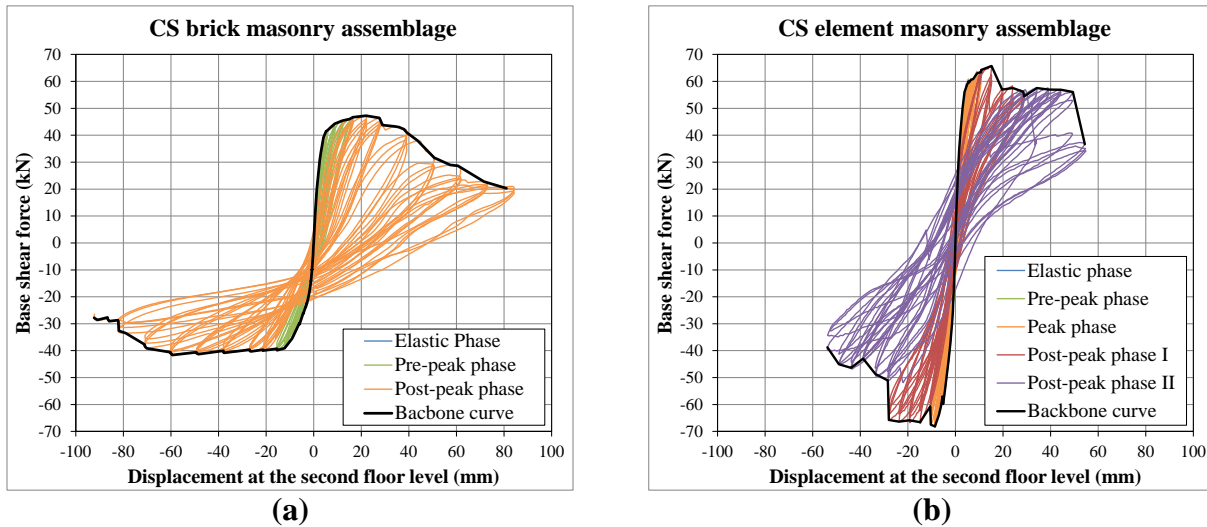
Figure 4: Capacity curve: (a) CS brick masonry; (b) CS element masonry.

Figure 4 shows the response of the CS brick and element masonry assemblages in terms of base shear force versus displacement at the second floor level d_2 . By comparing the two curves, it is possible to note that the CS brick masonry assemblage shows an higher displacement capacity, while the CS element masonry assemblage shows an higher maximum base shear force. In both cases a reduction of 20% in base shear force was achieved during the post-peak phase, but the test was continued until major damage (or even collapse) in the wide piers was observed. For the

CS brick masonry assemblage the 20% reduction in base shear force was obtained at a displacement of $d_2 = +43$ mm and $d_2 = -80$ mm, while for the CS element masonry assemblage it was reached at a displacement of $d_2 = -28$ mm and $d_2 = +50$ mm.

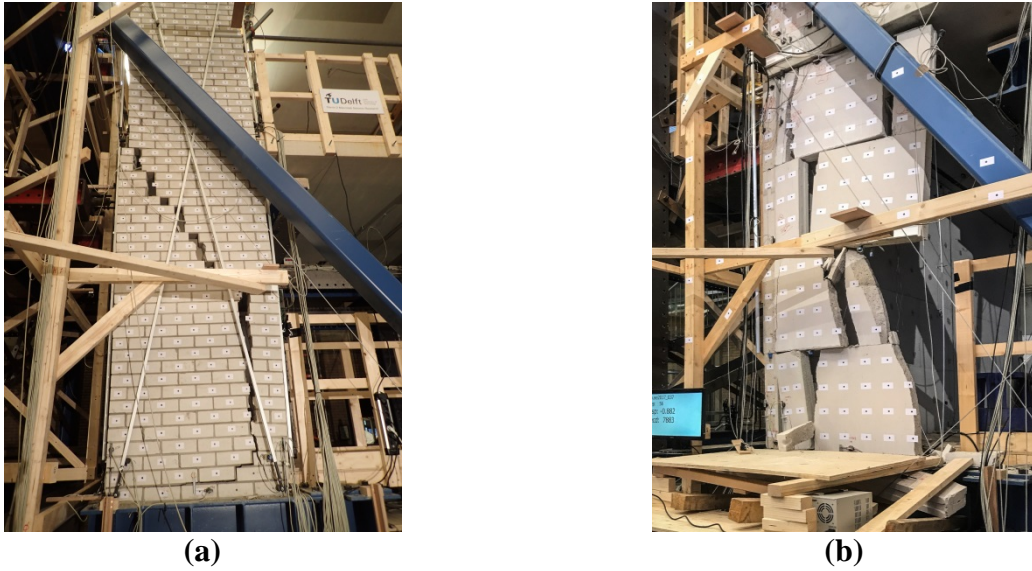
Figure 5: Main damage in the wide piers at the ground floor: (a) CS brick masonry assemblage ($d_2 = 82$ mm); (b) CS element masonry assemblage ($d_2 = 54$ mm).

In both cases, the failure mechanism was mainly governed by the in-plane damage of the facades piers at the ground floor (Figure 5, Figure 6). First, cracks occurred at the joint between the concrete floor and the masonry walls. Subsequently, diagonal/vertical cracks occurred in the wide pier P1 and P3 at the ground floor, while the rest of the structure was only slightly damaged. During the post-peak phase and prior to major damage in the narrow piers, the wide piers were subject also to a reduction in cross section that led to a further reduction in capacity. Both for the brick and element masonry the diagonal/vertical cracking occurred first in the head and bed joints. However, in the case of the CS element masonry assemblage, large out-of-plane deformation up to collapse of the piers occurred; this is caused by the large size of the masonry units.

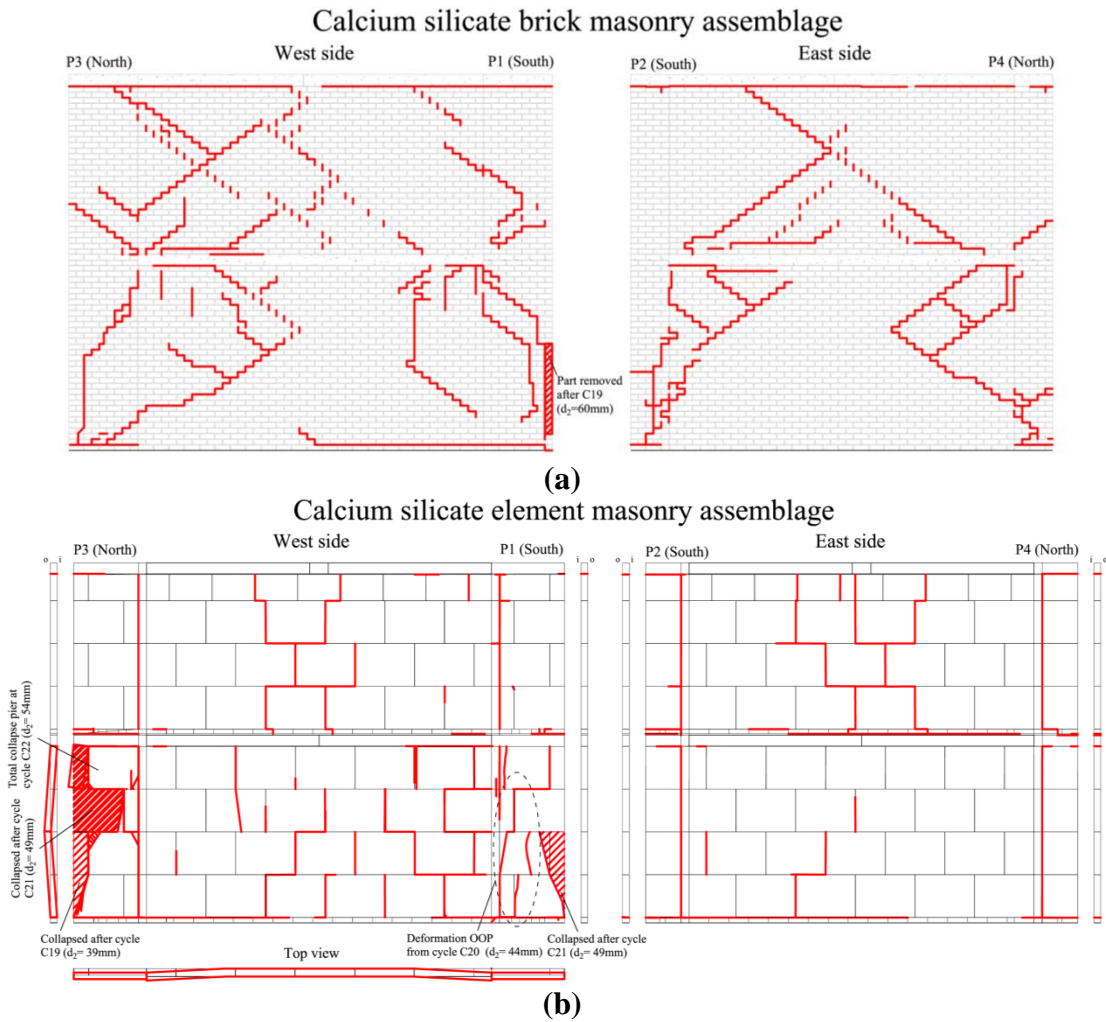
Figure 6: Crack pattern: (a) CS brick masonry; (b) CS element masonry.

By accommodating the in-plane deformation of the piers, the transversal walls deformed out-of-plane showing the effectiveness wall-to-wall connection in both cases. In the case of the CS brick masonry assemblage the running bond allowed a strong connection between the piers and the transversal walls and promoted the flange effect, which is of importance for the base shear capacity (Esposito et al., 2017a). In the case of the CS element masonry assemblage, although cracking occurred in correspondence of the vertical joints at approximately the peak load, the connection was still effective. This was caused by the presence of the steel ties and by the sliding friction mechanism at the vertical joint governed by the high friction coefficient of the CS element masonry. Additionally, the extensive damage of the pier and the detachment of masonry pieces that interlocked within the open cracked promoted local deformation at the end of the transversal wall for a length of approximately 1 m from each wide pier (Figure 6b).
