# KATOENVEEM

MERWE-VIERHAVEN, ROTTERDAM

MSc III Heritage & Architecture

Architectural, Building Technology & Cultural Value Analysis

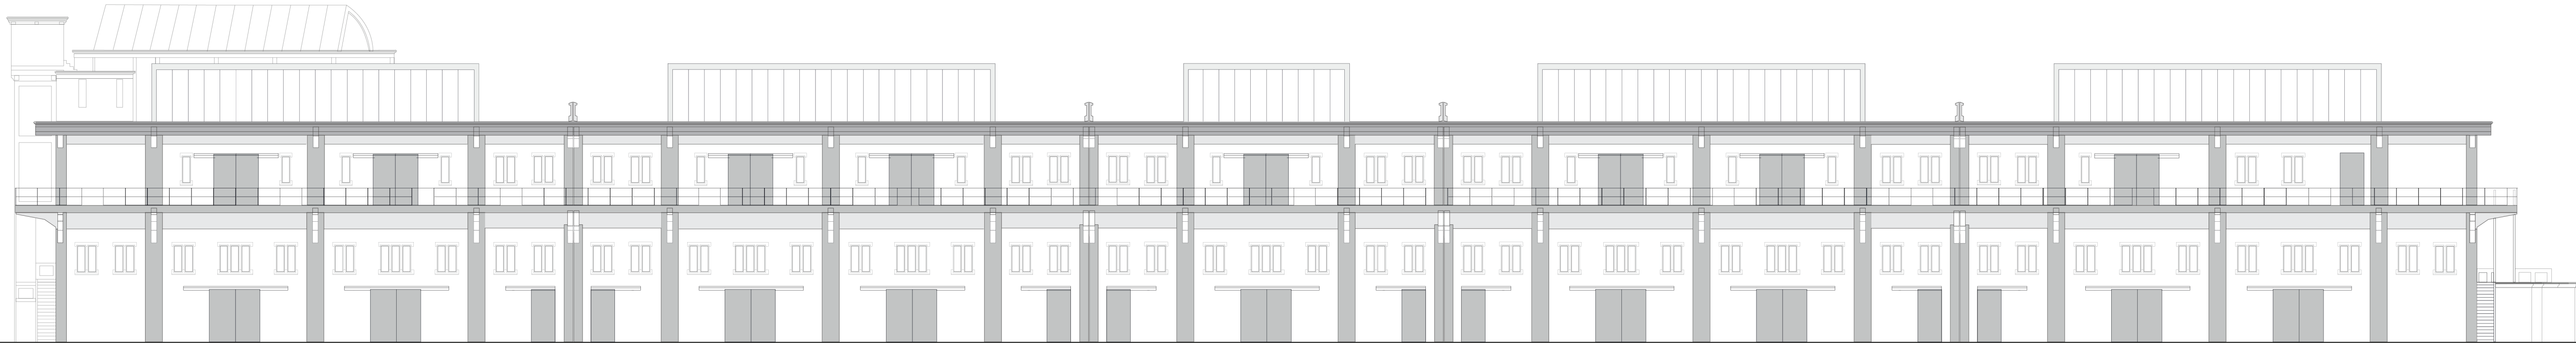
1. Demolished office building
2. Non original openings
3. Elevator shaft with spiral staircase
4. Sealed openings
5. Non original garage door
6. Heavily damaged original staircase

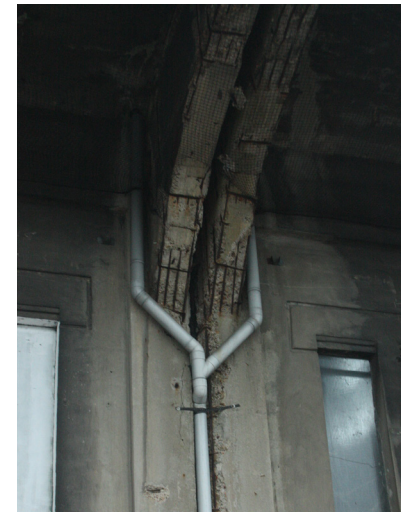
*Dilatation between compartments*

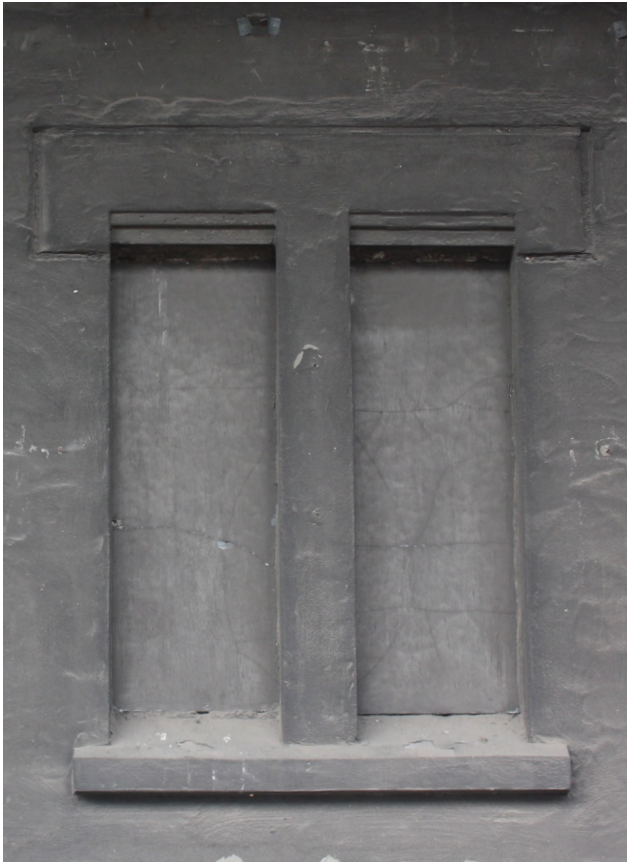
All window articulation is cast within the structural formwork. The expression of the window is made by line work cast in the surface. Suggesting a lintel.

The window detail is simply made because of the functional character, just to close the void. The cement window frame holds the glass. The question remains if the glass can easily be replaced?

1. Articulation in concrete face. To suggest a constructive lintel.
2. Original: wired glass
3. Angled windowsill - part of formed concrete
4. Water leaking gap
5. Exterior material : light cement layer 10mm
6. Cement window frame

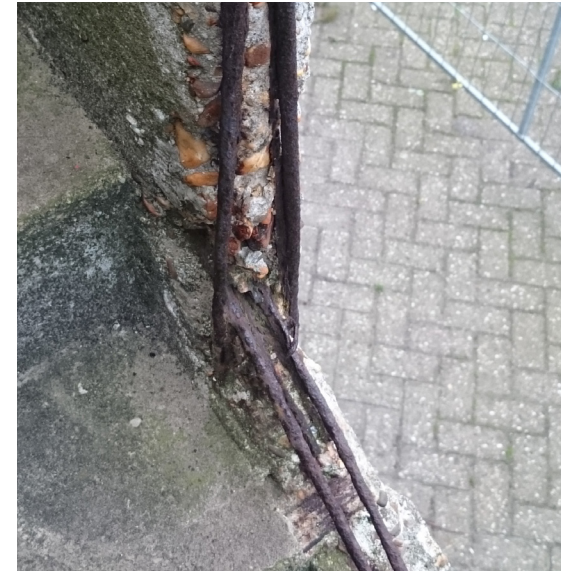
*Image 3 - Reinforcement of exterior stair.*

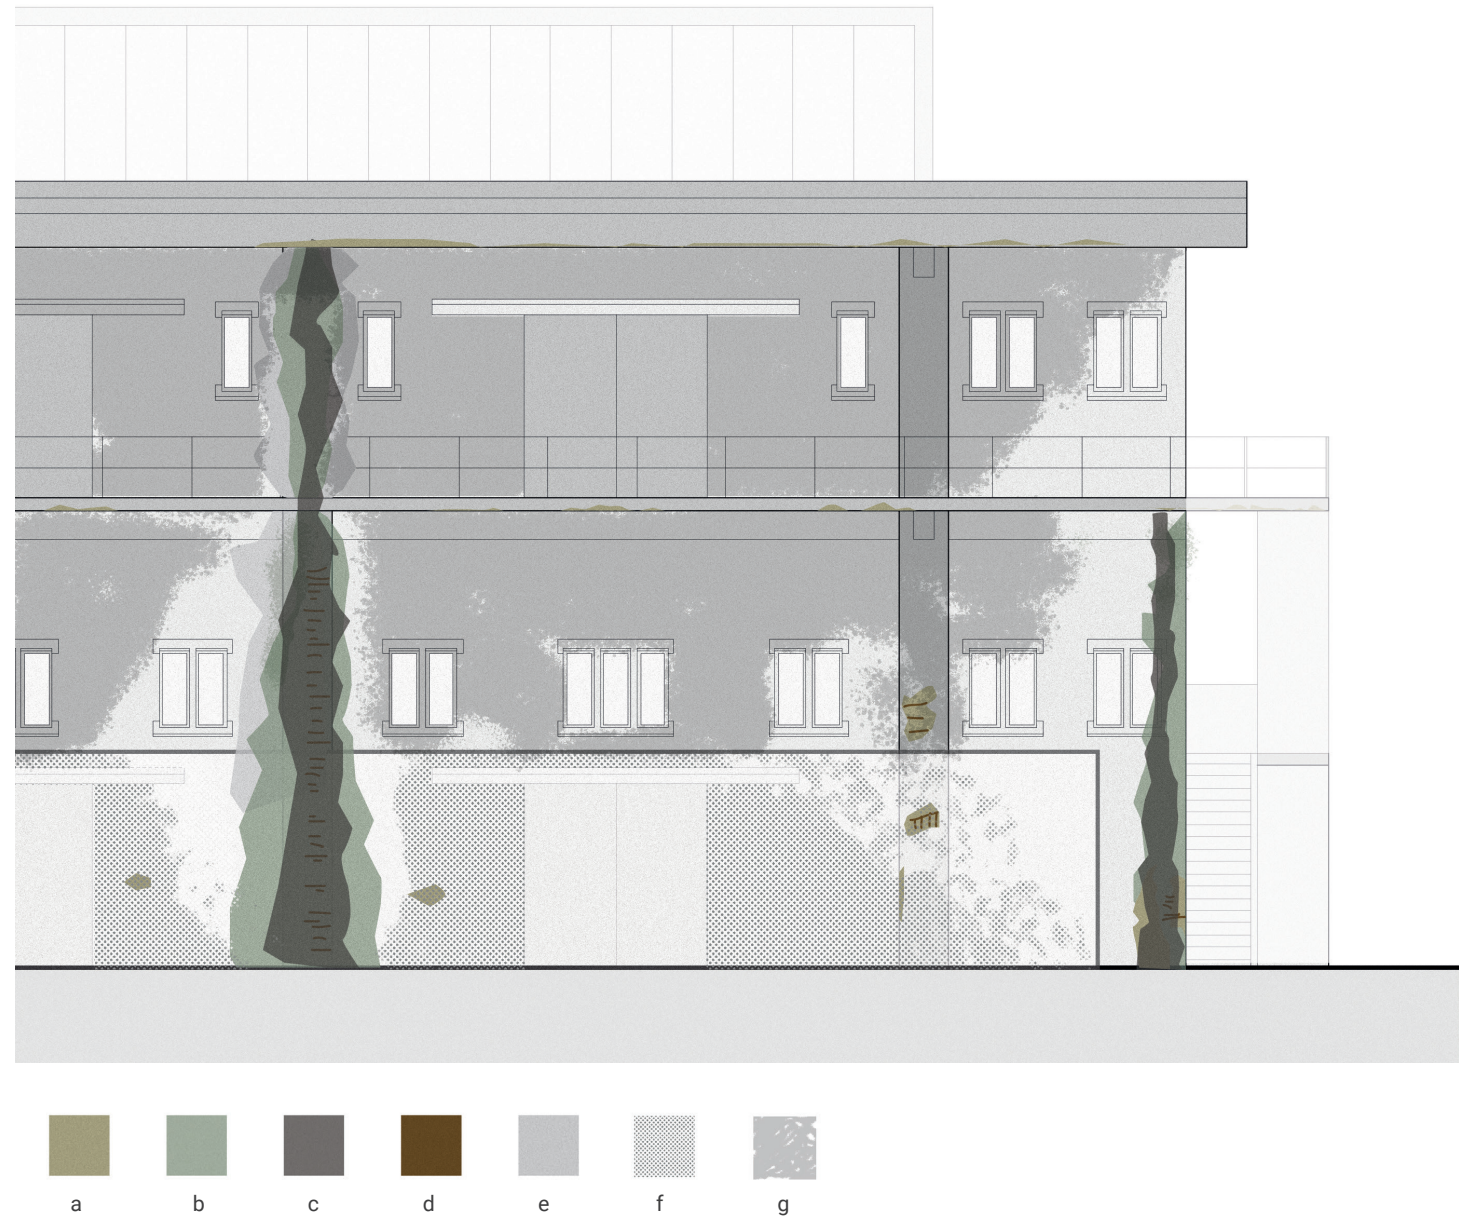
- a. Spalling of concrete
- b. Green; Linchen, moss, Algae.
- c. Wet Surface
- d. Rust in reinforcement
- e. Areas of salt damage
- f. White paint previous conservation attempts
- g. Black surface; industrial deposit of air pollution.

Damages inventory obtained by visual inspection of the building  
Drawing by L. van Straalen

The exterior surfaces are in bad condition, most weathering damages to the concrete surface. The most restoration work has to be done to the balconies, with a focus on the supporting beams. The structure itself is in a good condition, especially in the interior beams give room for possibilities. The services of the building are not operational anymore but most of the remains are still visible.

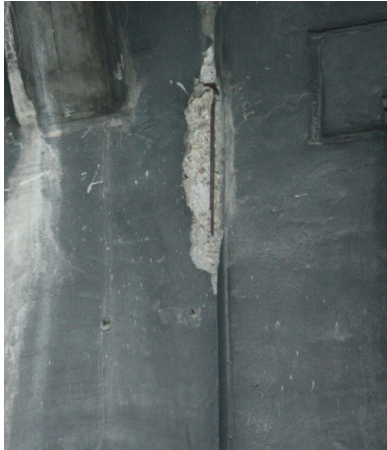
1 Spalling of concrete

Spalling of concrete [1] is a result of carbonation induced corrosion of the reinforcement. Due to contact with water the reinforcement starts to rust [2]. This not only negatively effects the loadbearing capacity of the construction as the diameter of rebar is reduced, but also the stresses that are caused by the rust can cause the surface to crack [3]. Cracks first appear parallel to the corroding reinforcement. This later leads to spalling of concrete and further exposure of the already damaged reinforcements.<sup>1</sup> Since the damage is caused by a presence of water, it is important to have a flawless drainage system. There

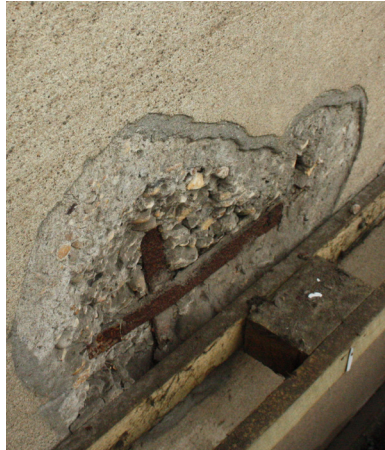
2 Corrosion of the reinforcement

is a lot of leakage from rainwater pipes, which further accelerates the deterioration of the material. The proximity of the site to river however also affects the building due to (salt) water spray. Water carried in small particles through the air enables salts to easily reach the building. Since the prevailing wind direction in the Netherlands is southwestern (see annex 2), wind often blows over the water towards Katoenveem and thus causes the damage to spread. The type of damage caused by salts [4] can be different from carbonation induced corrosion, as the reinforcements shows rather 'pitted' type of damage and

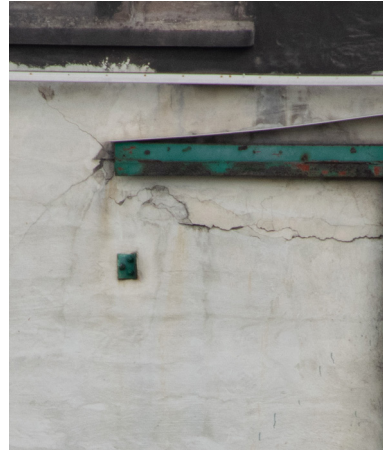
3 Cracks

a rust layer is not always formed.<sup>2</sup> The reaction with salts does not increase the volume of reinforcement, and therefore cracks and spalling are not always present. However, the structural strength of the concrete can be severely affected.
