RESTORING A SMALL BOAT BASIN DAMAGED BY THE 1964 ALASKA EARTHQUAKE

Norman L. Arno
Supervisory Civil Engineer
U. S. Army Engineer District, Alaska, Anchorage, Alaska

ABSTRACT

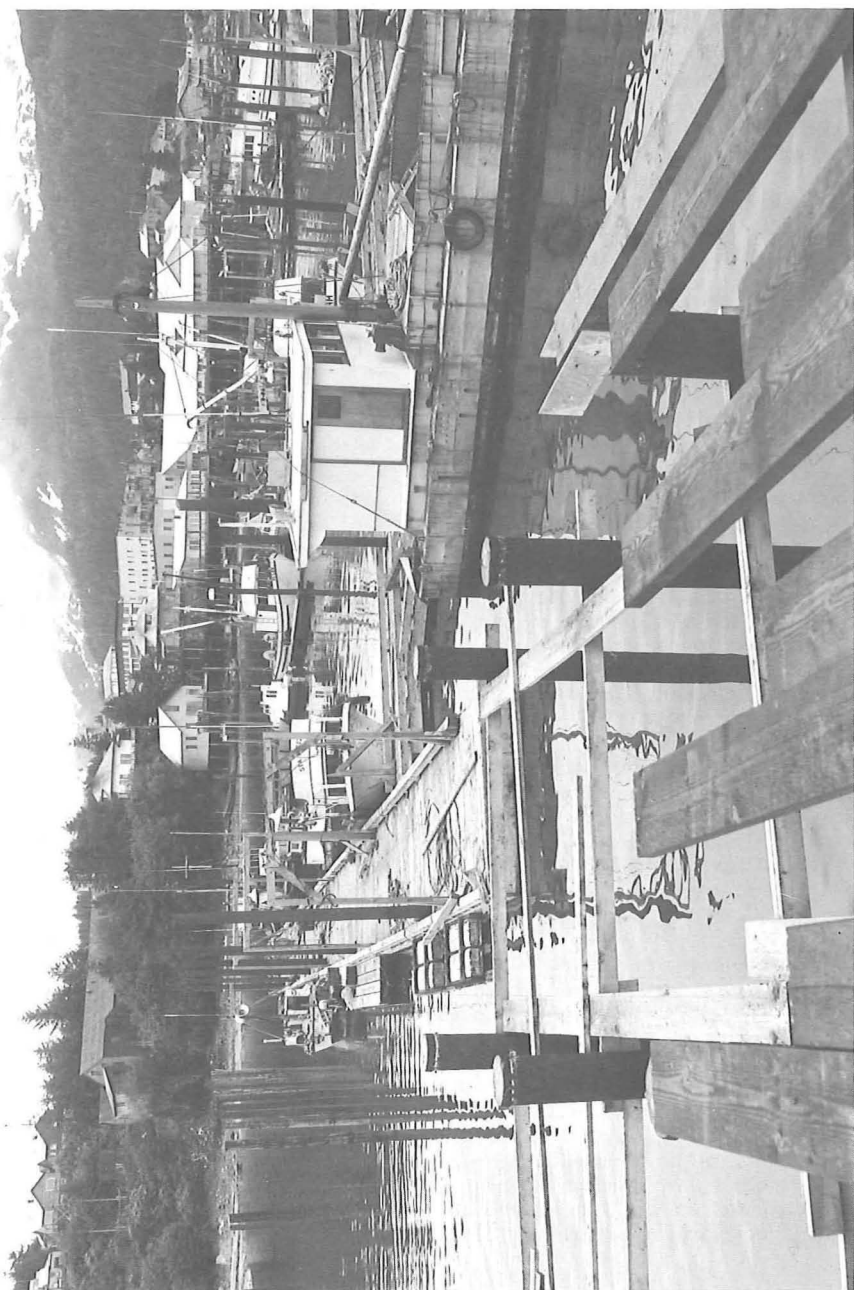
Photo 6. 26 June 1965, Float installation

On 21 April 1965 the float installation construction began. Here again we had an unwelcome surprise. The most easterly line of floats was found to lie over a rock outcrop which precluded pile-driving in this area. Extensive probings were made to determine the limit of the rock and it was found to extend to the stall floats on the second most easterly line of floats. Because of the small boat basin configuration it was impossible to revise the float layout without jeopardizing its capacity and future most desirable float configuration. The float installation contract was therefore modified by change order to include drilling in the rock to receive the necessary piles. This was time-consuming but necessary so future development would not be jeopardized. The contractor was able to utilize his pile-driving equipment efficiently on the floats not requiring drilling as well as the approaches and new public dock while waiting for arrival of his rock-drilling equipment which was located at Kodiak, about 300 miles away. As soon as the equipment completed necessary work at Kodiak it was started to Cordova by tow across the Gulf of Alaska. Here again an unpleasant surprise awaited. On the way to Cordova the drill barge sank and the project was delayed. The contractor was able to purchase another drill barge in southeastern Alaska and haul it to Cordova, finally completing float installation in August 1965.
