# Effect of mixed in crystallization modifiers on the resistance of lime mortar against NaCl and Na<sub>2</sub>SO<sub>4</sub> crystallization

Sanne J.C. Granneman<sup>1\*</sup>, Barbara Lubelli<sup>1</sup> and Rob P.J. van Hees<sup>1,2</sup>

<sup>1</sup>Delft University of Technology, Faculty of Architecture and the Built Environment, Delft, The Netherlands

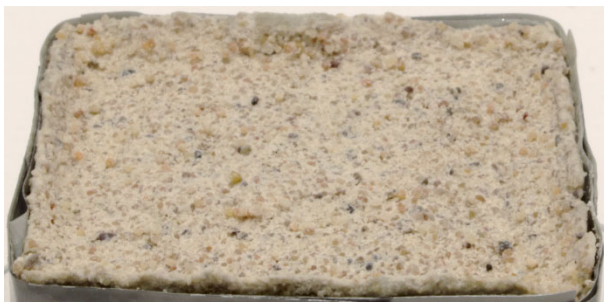
Figure 3A shows the surface of a reference specimen contaminated with sodium chloride at the end of the salt crystallization test. During the test the reference specimens showed moderate efflorescence and severe material loss. Deterioration of the surface occurred in the form of sanding. This type of damage is typical for this salt, and is similar to the type of damage development as observed in practice [24]. As it can be observed in Figure 4, the damage developed linearly in time and seems not to depend on the total salt content present in the specimen.

**Figure 3:** Reference (A, C) and additivated (B, D) specimens at the end of the 5th cycle (105 days, ~ 15 minutes after rewetting and brushing). A and B show the surfaces of the reference and ferrocyanide additivated mortars contaminated with sodium chloride, respectively. The reference shows sanding of the surface, whereas the specimen with ferrocyanide only shows a large amount of efflorescence, which appeared immediately after rewetting. C and D show the surfaces of the reference and borax additivated mortars contaminated with sodium sulfate, respectively. The reference specimen shows clear damage (scaling after the first test cycle, sanding after the following test cycles) to the whole surface, whereas the specimen with borax only shows minor damage (sanding) to the lower left corner.

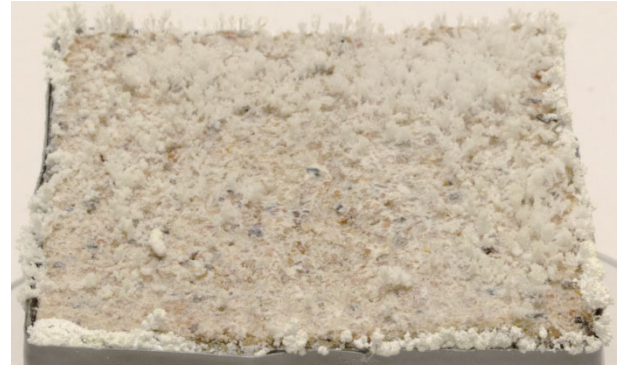
B

Figure 3B shows the surface of a mortar additivated with ferrocyanide at the end of the crystallization test. Differently than in the case of the reference specimen, during the test the mortar specimens additivated with ferrocyanide showed a large amount of efflorescence and no or only

minor material loss. Ferrocyanide stimulates the appearance of efflorescence, as it can be clearly seen in Figure 3B: this picture, taken approximately 15 minutes after rewetting and brushing of the surface, shows the rapid formation of new sodium chloride efflorescence. As more efflorescence results in less crystallizing salts inside the pores of the material, this may also have contributed to limit the damage.

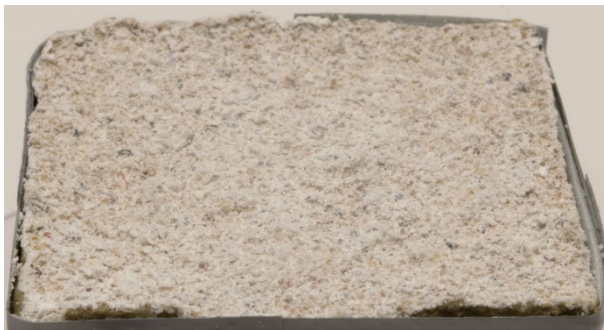
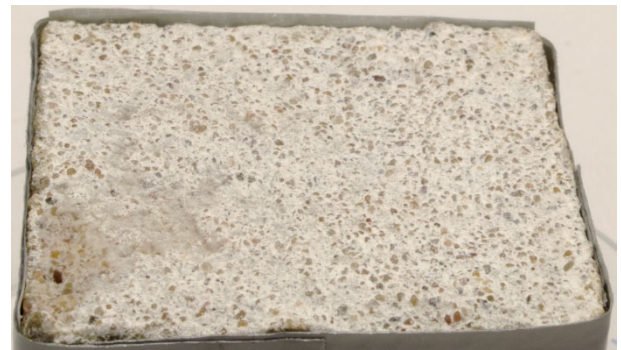
Differently from the reference specimens, the specimens additivated with borax show only minor material loss, localized in a small area of the surface (compare Figures 3C and D), at the end of the crystallization test. Furthermore, in these specimens damage occurred in the form of sanding. The absence of damage can (at least in part) be attributed to the fact that more efflorescence developed on the additivated specimens than on the reference ones: more efflorescence results in less crystallization inside the pores of the material and consequently in less damage.

At the end of the salt crystallization test, the reference specimens contaminated with sodium sulfate show considerable material loss. The material loss was most severe during the cycle in which damage occurred for the first time; in the following cycles damage developed more slowly. Two of the reference specimens contaminated with sodium sulfate (REFR and REFT) developed damage directly after the first rewetting with liquid water at the end of the first cycle and before the brushing. This damage can be attributed to the rapid crystallization of mirabilite crystals (at high supersaturation), following the dissolution of anhydrous sodium sulfate (expected at the drying conditions used in the test, see Figure 2) during re-wetting [25, 26]. The third of the reference specimens (REFQ) was left undamaged after the first cycle; this was also the only reference specimen showing efflorescence at the end of cycle 1, fact which might explain why no severe damage occurred in this case until cycle 2. In all reference specimens, damage occurred at first in the form of scaling of the entire surface. Later on, damage developed in the form of sanding of the outer layer. As can be seen in Figure 5, in the
