Renovation techniques for fatigue cracked orthotropic steel bridge decks

Proefschrift

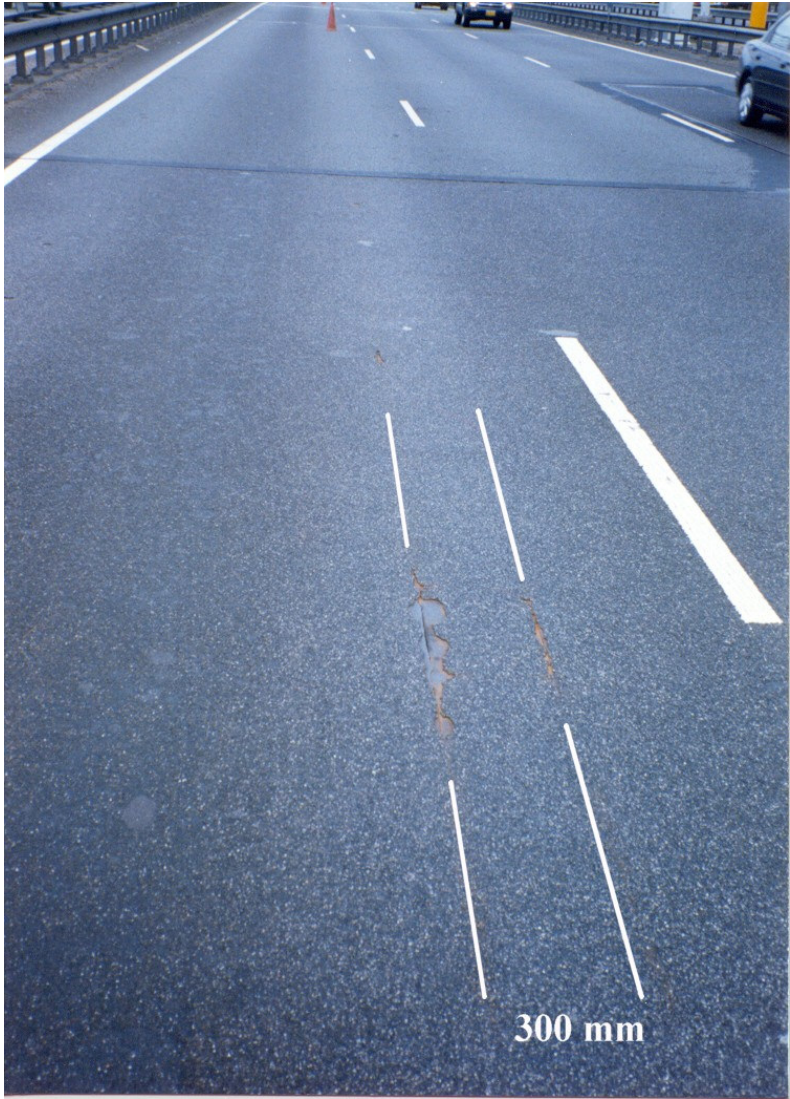
Cracks become visible when they have a length of approximately 10 cm at the top surface of the deck plate see also paragraph 8.5.2. In this stage of the crack growth process the steel plate on both sides of the cracks is not deformed and the crack is more difficult to see, because it really is a hairline crack with small dimensions. The first visible indication of deck plate fatigue cracks are often brown lines on the epoxy surfacing at the location of the trough webs, indicating corrosion of the steel deck plate. If the epoxy wearing surface is not significantly damaged, but a brown discolouration from corrosion of the steel deck plate is visible, the epoxy surfacing can be removed locally with a chisel, to inspect the steel deck plate under the epoxy surfacing.

Figure 2-11: Visual observation of deck plate cracks in movable bridge

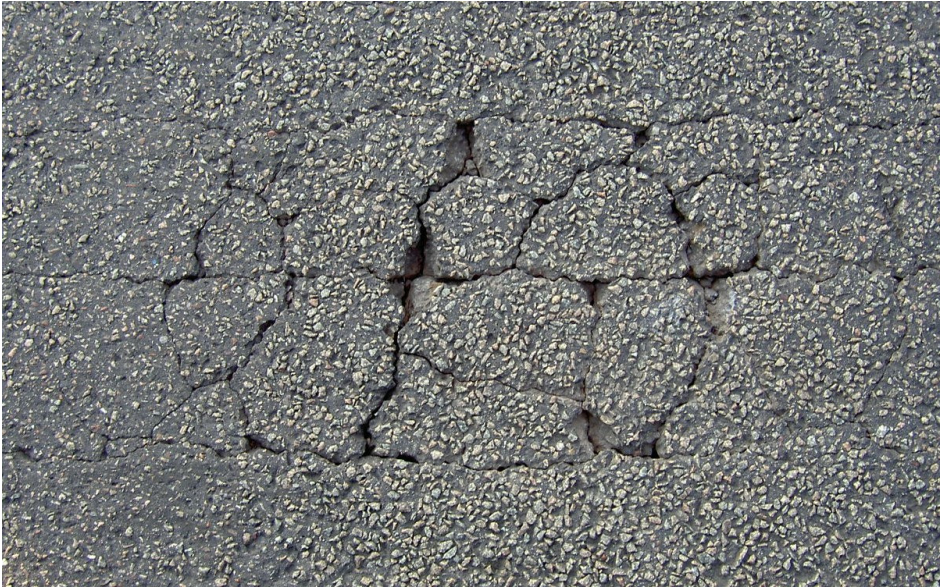
Figure 2-14: Visual observations possibly indicating deck plate crack

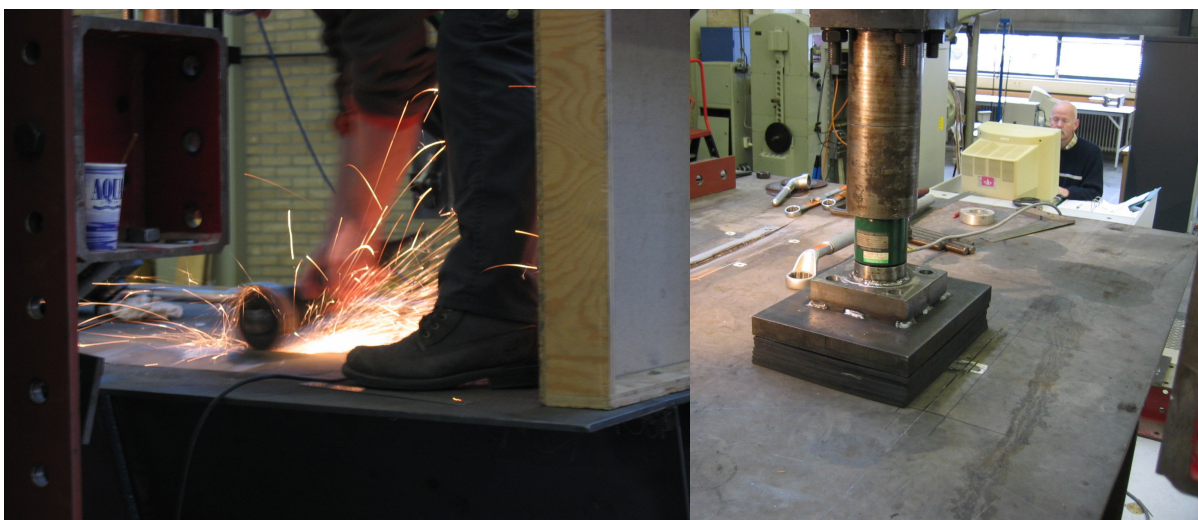
Figure 4-25: Making cracks (left), load application (right)

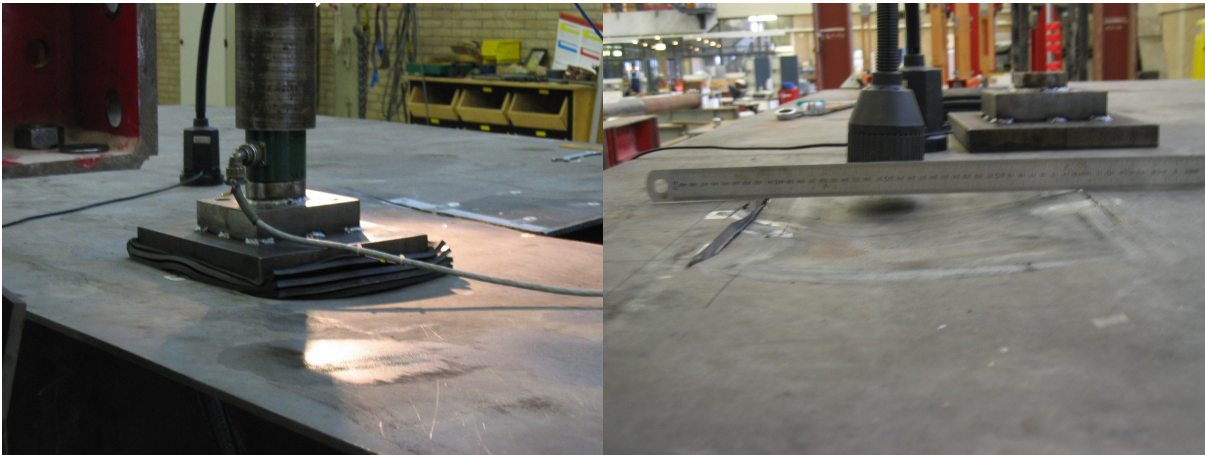
Figure 4-27 shows the rubber layer compressed at the maximum load of 439 kN, and a photograph of the deformation after unloading. The maximum load of the testing device was 439 kN. Regarding the rather strange shape at the top of the deflection-load curve, the software assumes that loads above 400 kN will not be applied in that particular testing machine. The load that was actually applied on the bridge deck was slightly above 400 kN, a maximum of 439 kN, according to the testing machine display. The software has recorded a load of 400 kN in the test file, although it was higher in reality. For loads up to 400 kN, the curve is correct, for loads above 400 kN an indication is given by grey dots.

Figure 4-27: Compression at maximum load (left), deformation after unloading (right)

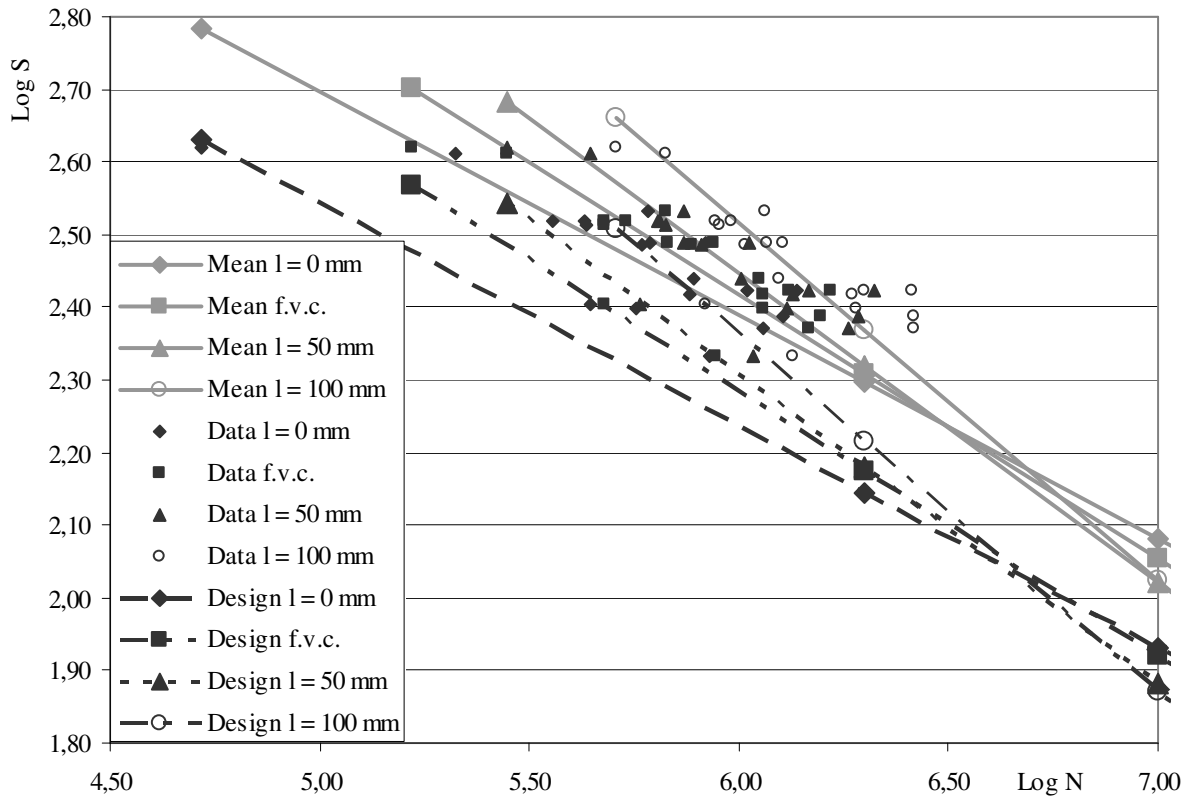
For analysis 1 and 2 with different slopes m for the different crack sizes, the calculation procedure gives strange results. Figure 4-40 shows the results of analysis 1 based on different slopes m and the total set of 18 data points. With an increasing crack length, from 0 to 100 mm, the derived slope of the regression line decreases from approximately 2.5 to 3.5. In Figure 4-40 the derived regression lines for different crack size definitions cross each other. Due to these different slopes the detail classification decreases with increasing crack size, as shown in Figure 4-41, for the classification according to the NEN format. Decrease of the fatigue strength with increasing crack growth is impossible. Therefore the analysis should be based on one determined slope m for the curves of all crack size definitions. This slope m is based on the test data, which is thought to be more accurate than the standard slope $m = 3$ from fatigue codes.

Figure 4-40: Fatigue S-N curves - deck plate cracks – analysis type 1

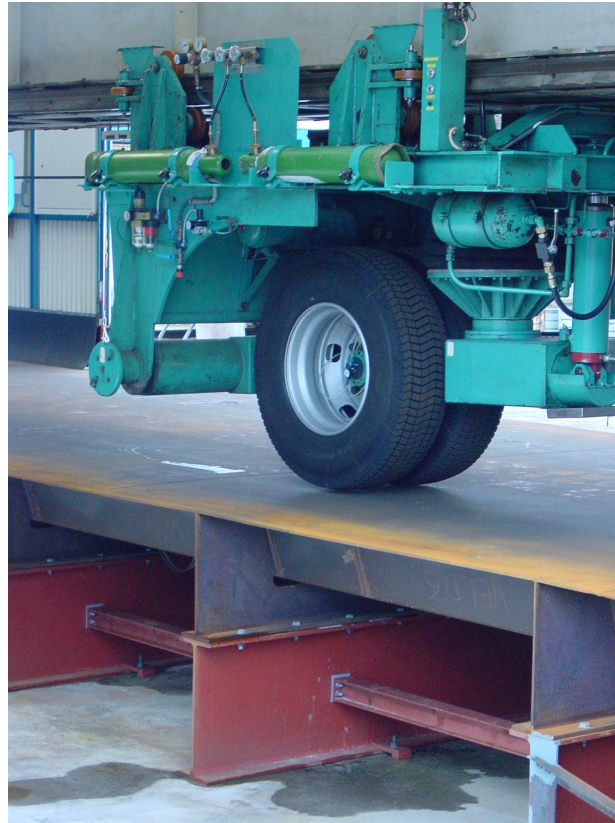
The movement of the loading carriage is effected with two steel cables and an electric motor. The total running length of the loading carriage is about 12 m and the maximum speed is around 20 km/h although lower speeds are also possible. To reach this speed, acceleration and deceleration take approximately 4 m, so a 4 m measuring length remains where the carriage has a constant speed.

Figure 4-46: Loading carriage of the Lintrack

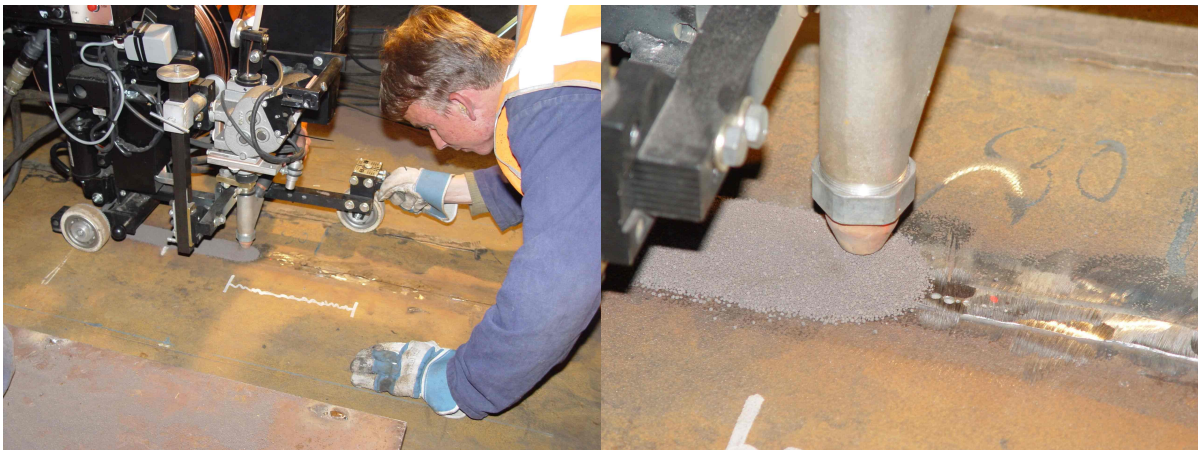
With the submerged arc welding technique (SAW) the creation of the weld is automated. There are three advantages of submerged arc welding; the process is fast; the welding takes place only from the top of the deck plate, and the weld shrinkage is relatively small. A disadvantage is that due to the automated procedure only straight cracks can be repaired with this technique. Because experience with the submerged arc welding technique on fatigue cracked deck plates was limited a research program was set up to develop this technique and establish the best repair parameters.

Figure 5-1: Submerged arc welding

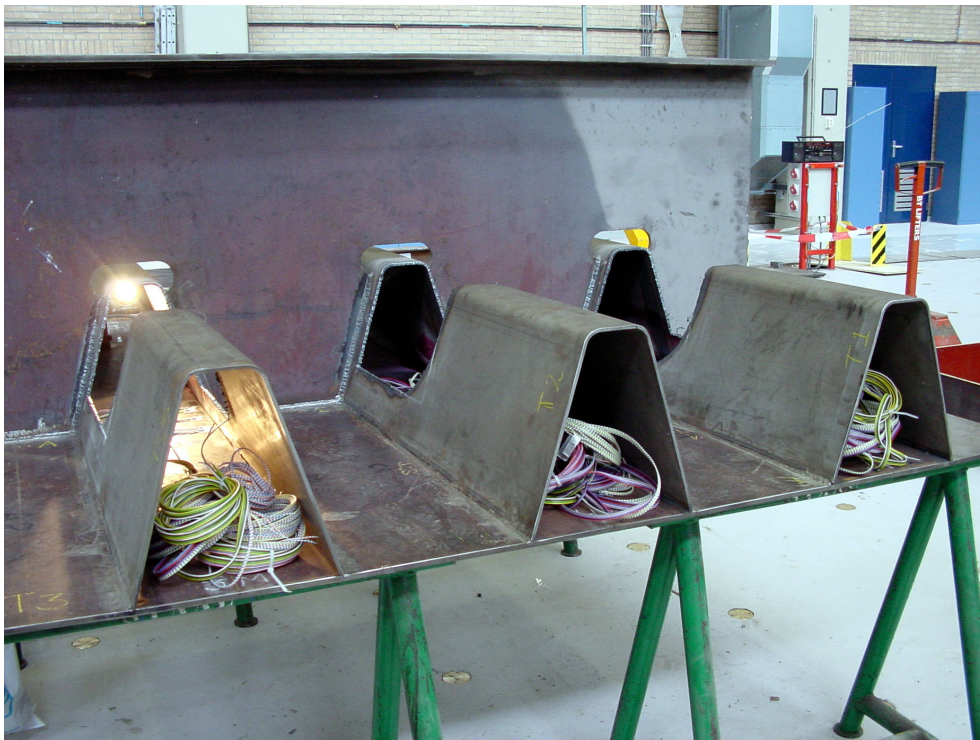
Figure 6-31: Accessibility underside deck plate to attach strain gauges

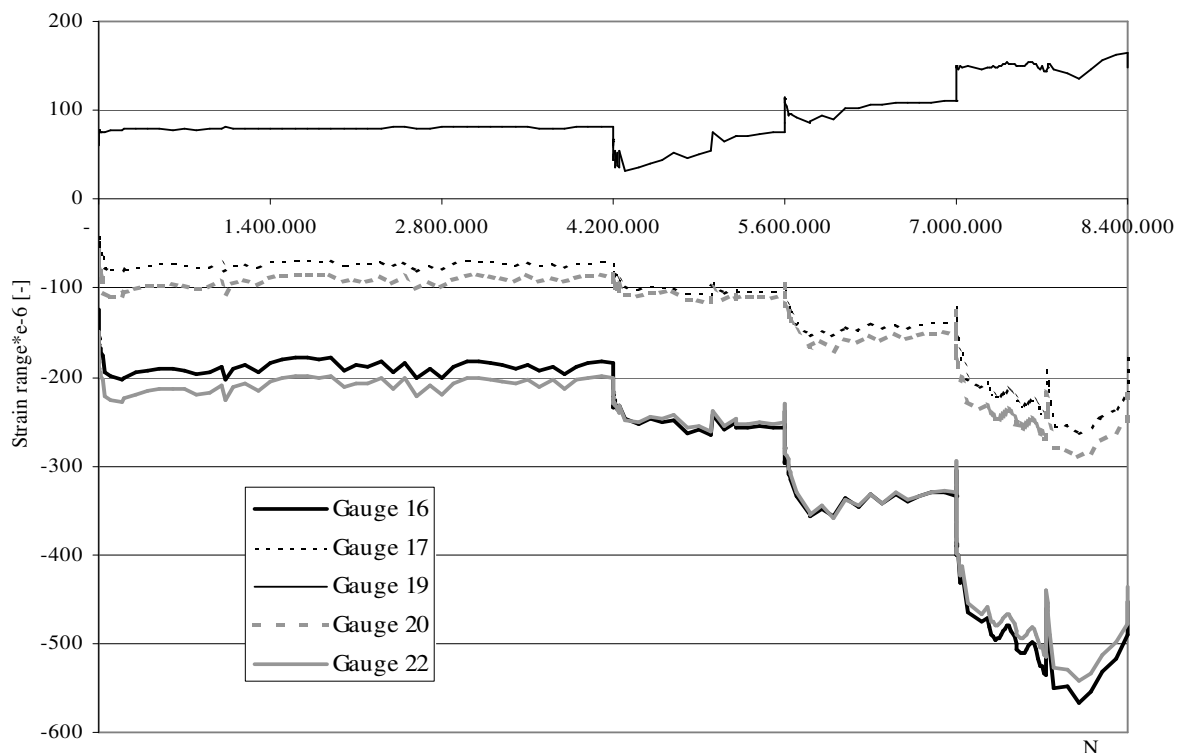
Figure 6-45: Results - some strain ranges on steel during fatigue test on TNO panel

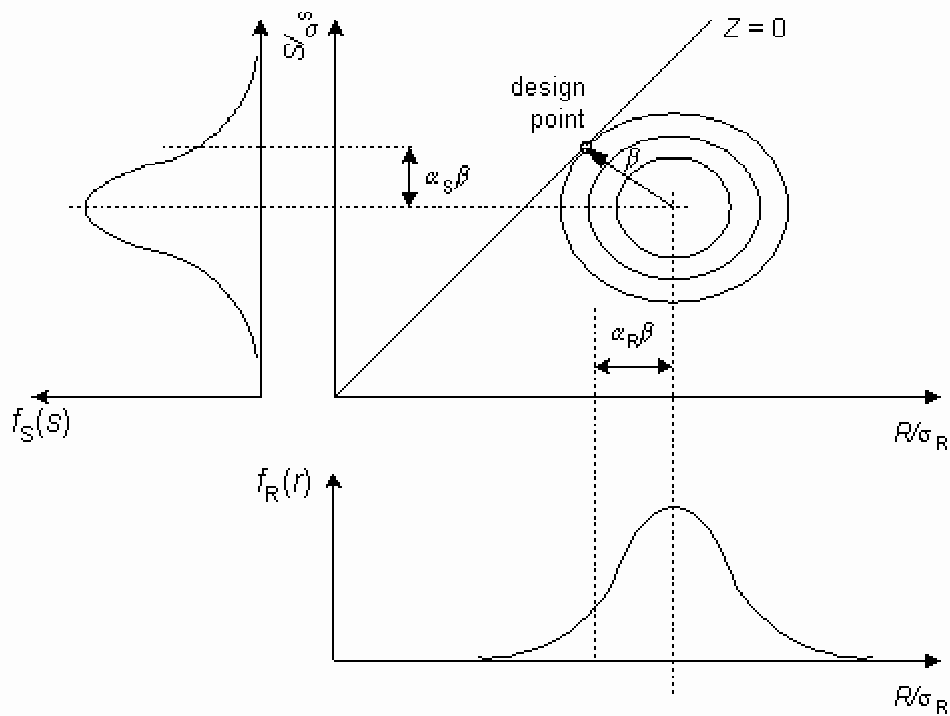
Figure 8-4: Location of the design point on the failure boundary $Z = 0$ (Van Straalen, 1999)

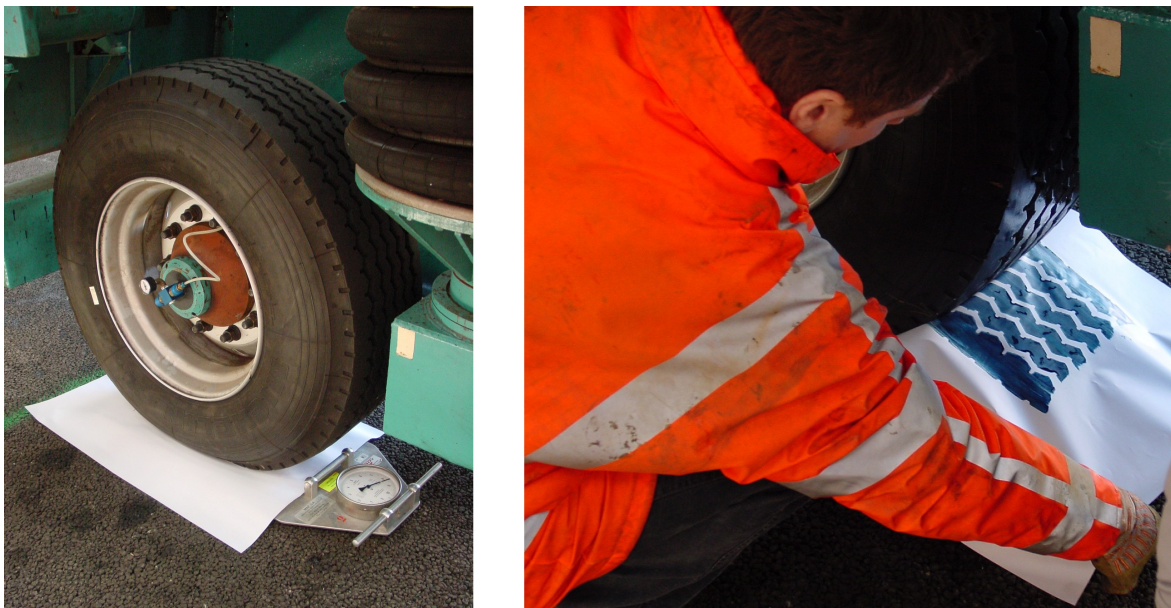
Figure A-14: Contact area measurements
