## **Bridging Laboratory Testing and In-Service Coating Performance for Structural Aerospace Applications**

Ph.D. thesis

**Keywords:** Corrosion; Structural Aircraft Coatings; Chromate; Chromate-free Inhibitors; Artificial Ageing; In-service Performance

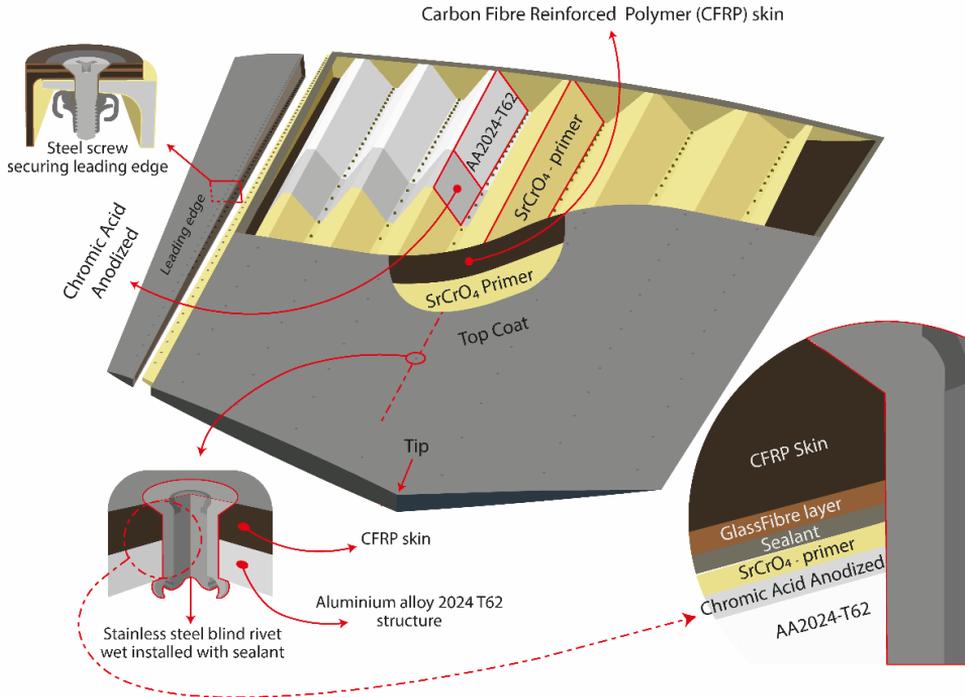
Figure 2.1 Structural overview of inspected aircraft part

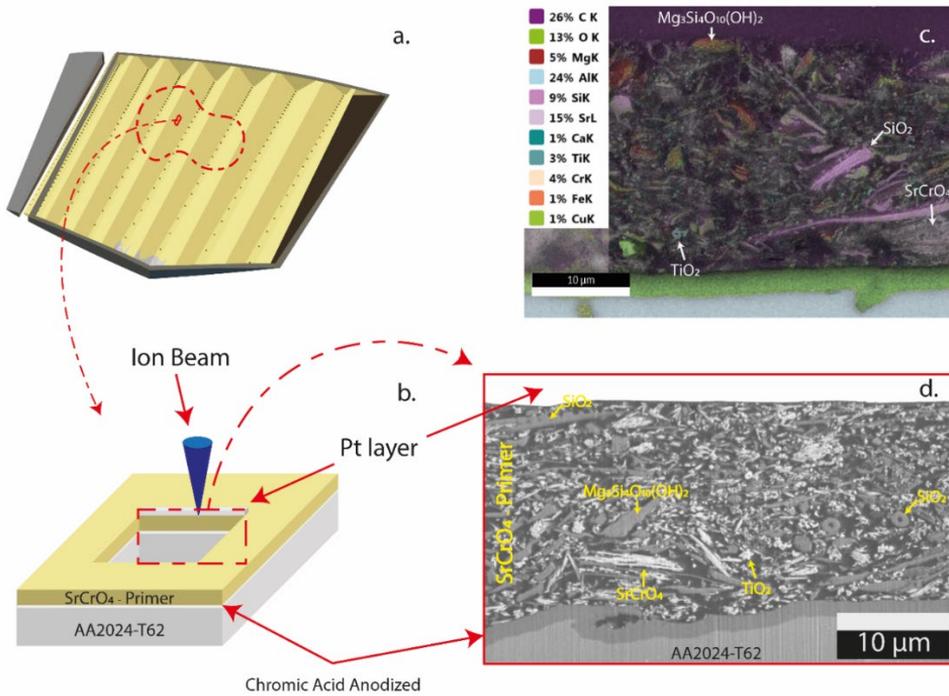
*Figure 2.2 Cross-sectional view of an intact coating achieved through FIB milling: (a) sample location within the overall aircraft part studied; (b) FIB-milling preparation method; (c) cross-sectional EDX mapping image; (d) cross-sectional BSE microscopic image*

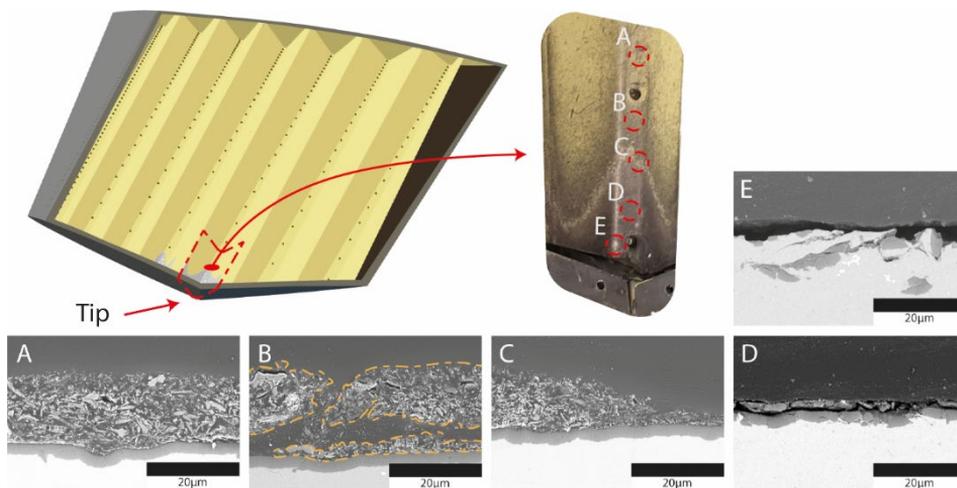
*Figure 2.3 SEM cross-sectional images illustrating distinct degradation stages observed in eroded areas at the tip: (a) intact coating; (b) adhesive and cohesive failure; (c) coating partly eroded; (d) only anodized layer intact; (e) local erosion down to bare metal*

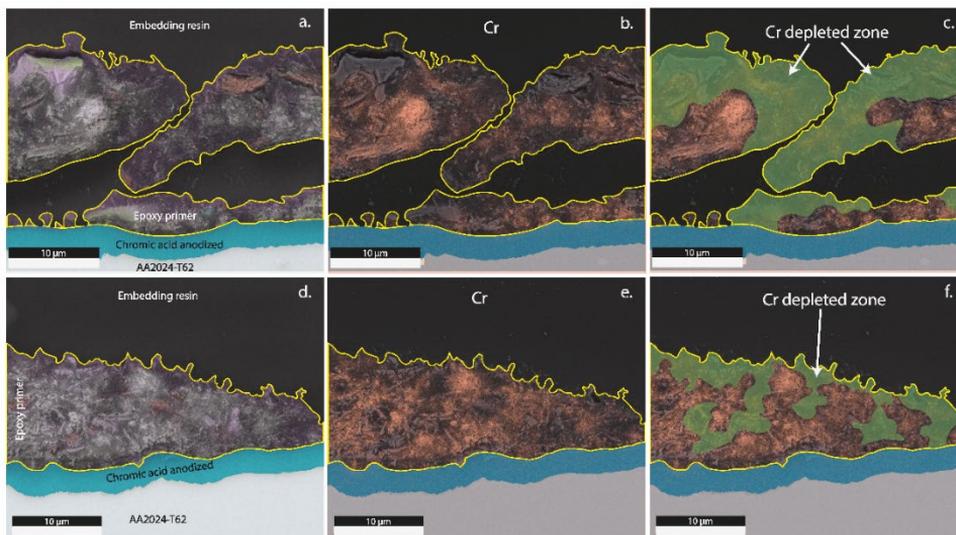
*Figure 2.4 SEM-EDX images revealing the coating conditions in eroded areas: (a) exhibiting adhesive and cohesive failure, accompanied by its corresponding image (b) illustrating chromium distribution; (c) revealing the chromium-depleted zone; (d) showcasing the coating erosion interface, along with its corresponding image (e) highlighting chromium distribution and in (f) the chromium-depleted zone.*

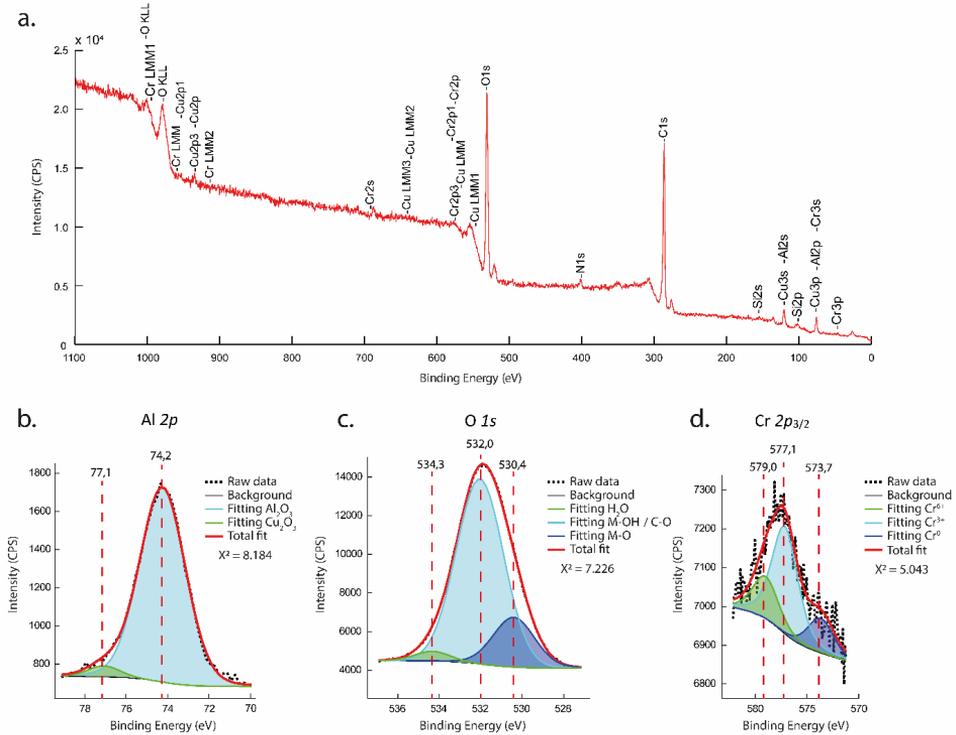
*Figure 2.5 XPS survey spectrum (a), including fitted outcomes in the high resolution spectra, obtained from the region at the tip of the investigated aircraft component, elucidating the elements (b) aluminium, (c) oxygen and (d) chromium.*

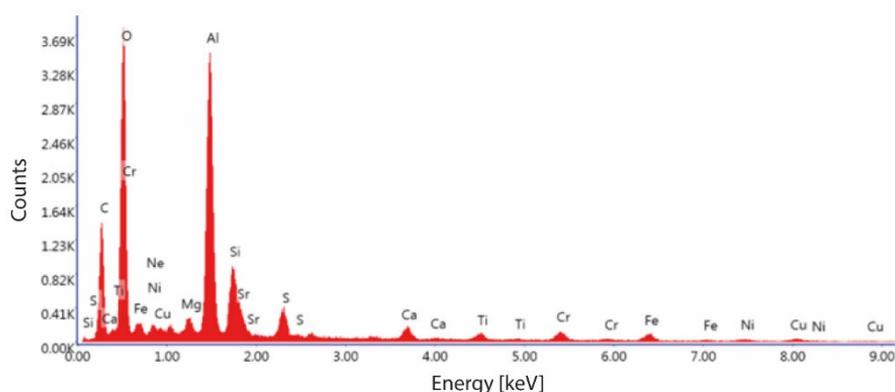
*Figure 2.6 EDX analysis of grey deposited dust discovered in the eroded areas of the aircraft component*

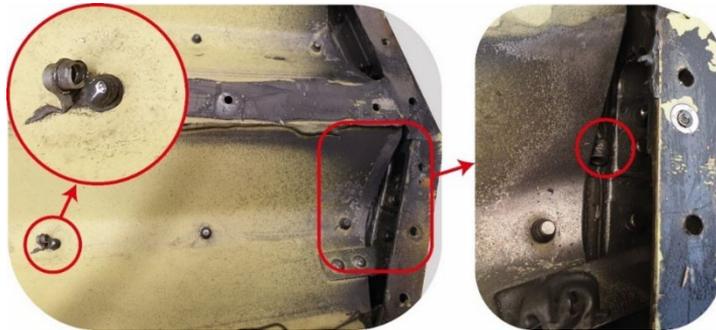
Figure 2.7 Pieces of stainless steel blind rivets, found at the tip of the aircraft part investigated

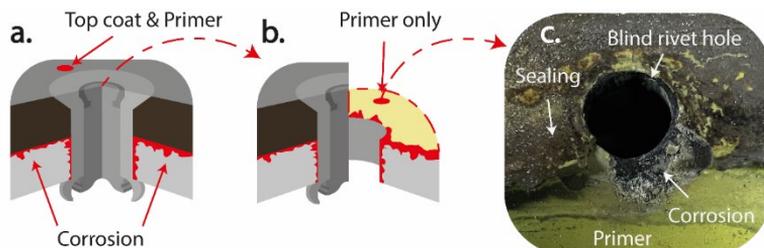
Figure 2.8 Corrosion evident near the stainless steel blind rivet, utilized for connecting the CFRP skin to the aluminium structure, featuring (a) a cross-sectional view of a blind rivet; (b) the specified field of view for image (c); (c) highlighting the corrosion attack in and around the rivet hole.

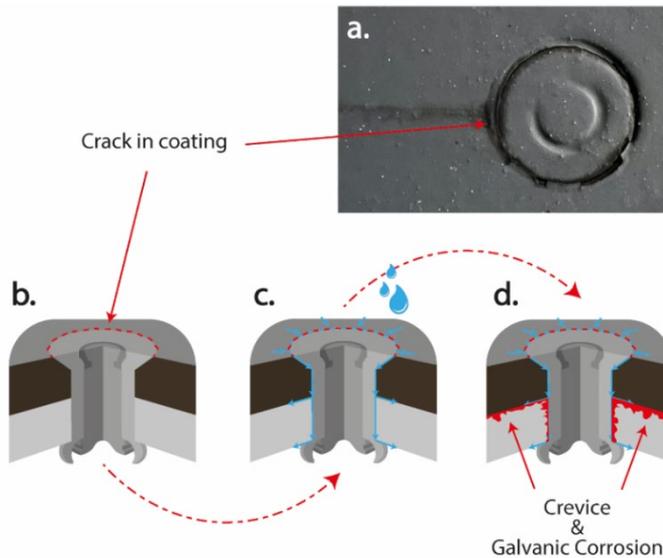
*Figure 2.9. Visualization of cracks encircling stainless steel blind rivets and a corrosion tail (a) depicting the hypothesized sequence; (b) initiation of a crack in the coating surrounding the rivet; (c) infiltration of moisture through the crack, penetrating around the rivet into the part; (d) resulting in corrosion of the aluminium structure.*

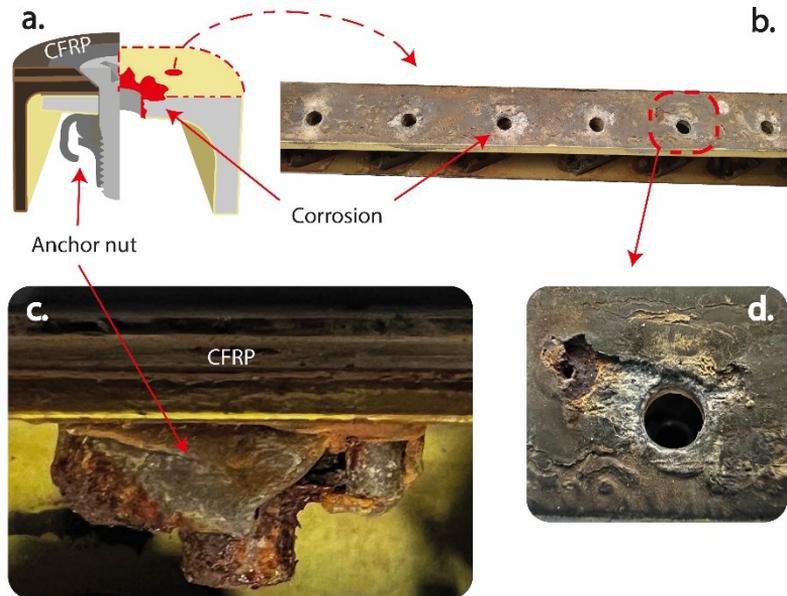
Figure 2.10. Corrosion observed at the aluminium leading edge spar of #5903, with (a) illustrating the design detail; (b) highlighting corrosion of the aluminium spar; (c) depicting corrosion on the anchor nut; and (d) offering a close-up view of corrosion around a fastener hole.

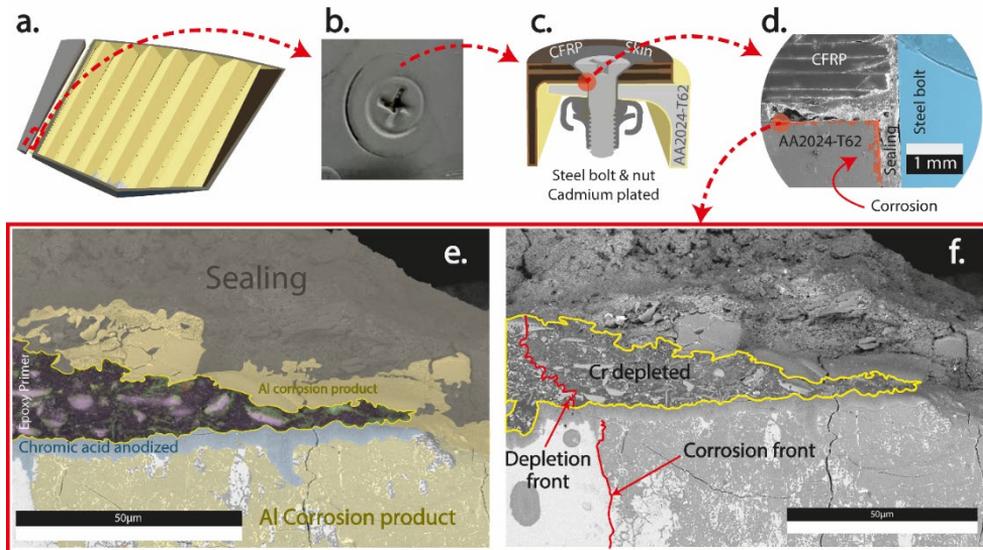
Figure 2.11. SEM image of a cross-section of corrosion on the aluminium spar, where (a) presents the area of interest; (b) top view with a fastener installed; (c) graphical cross-section of an installed fastener; (d) low-magnification SEM image of a cross-section of an installed fastener; (e) high-resolution SEM image including a graphical clarification of the substances observed; (f) SEM image including a clarification of the Cr-depletion zone and corrosion front.

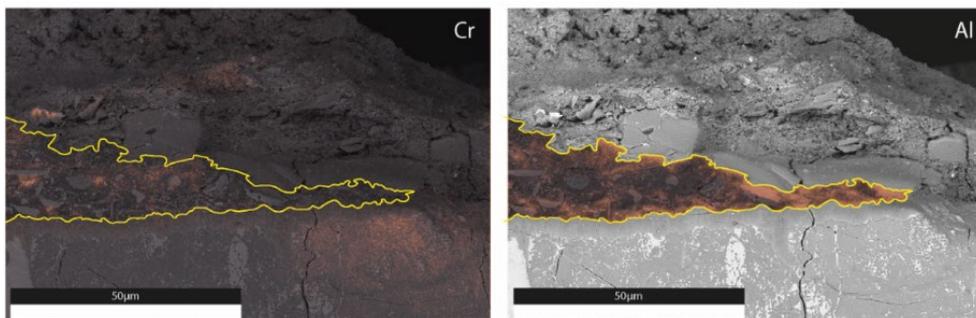
Figure 2.12. EDX images showing Cr and Al distribution of the corroded aluminium spar

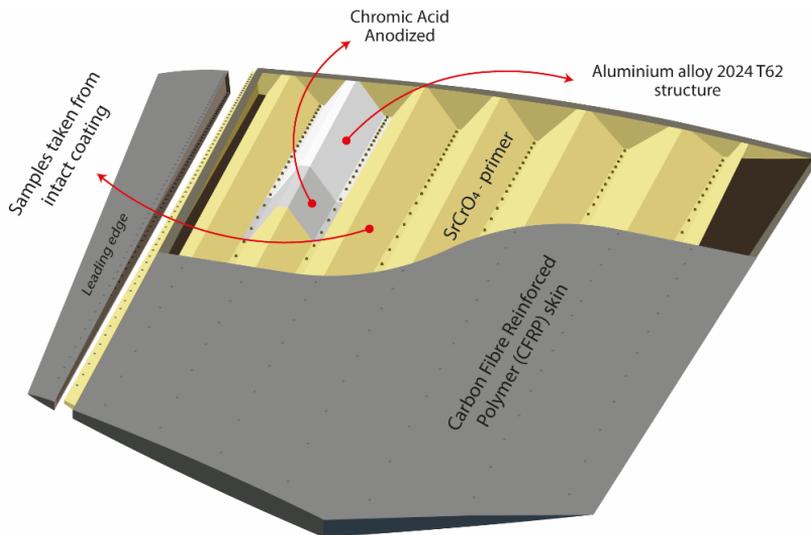
Figure 3.1 Structural overview of selected aircraft part

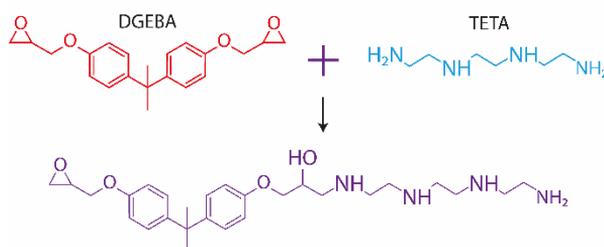
*Figure 3.2 Schematic representation of the epoxy matrix constituted by DGEBA resin and TETA hardener in the coating under investigation*

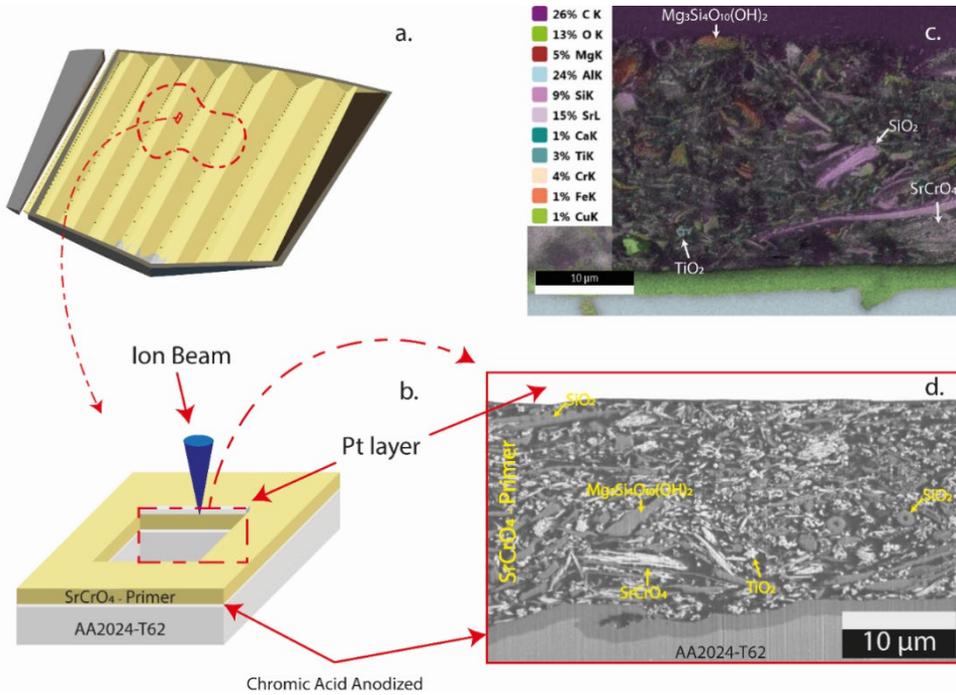
Figure 3.3 Cross-sectional view of an intact coating achieved through FIB milling: (a) sample location within the overall aircraft part studied; (b) FIB-milling preparation method; (c) cross-sectional EDX mapping image; (d) cross-sectional BSE microscopic image [17]

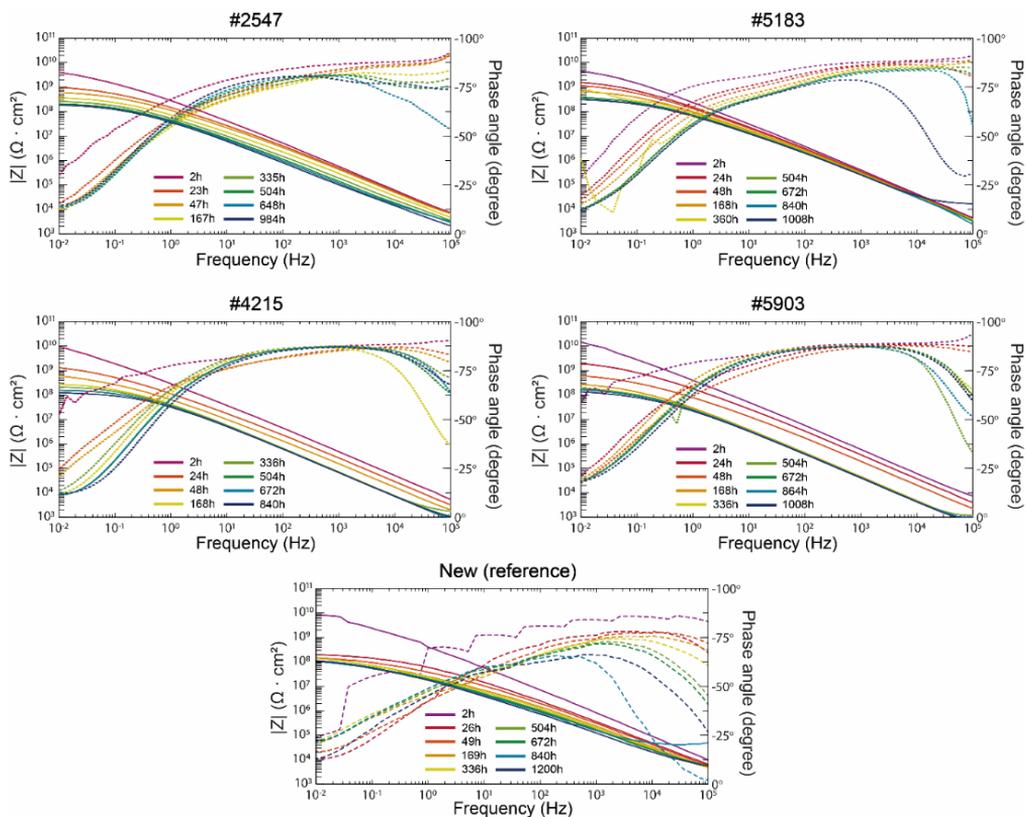
Figure 3.4 EIS Bode plots recorded after various immersion times (in hours) in 0.1M NaCl for coatings #2547, #4215, #5183, #5903 and a newly applied coating as a reference

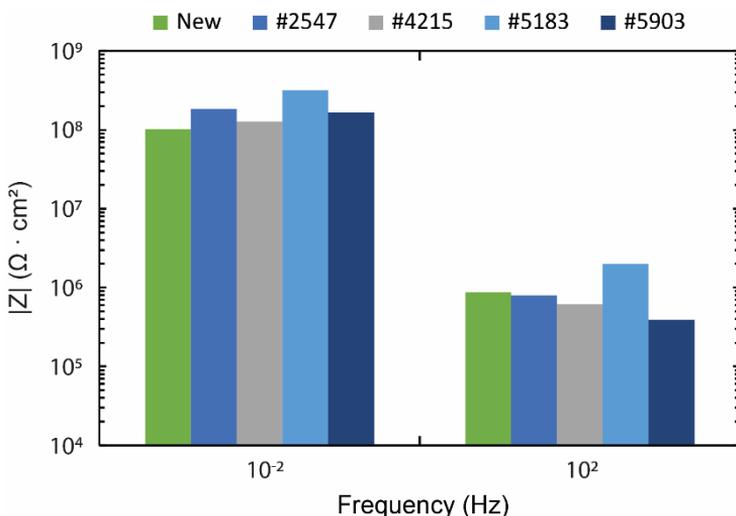
Figure 3.5  $|Z|$  at completion of the immersion test (840+ hours) in 0.1M NaCl of the reference coating and coatings #2547, #4215, #5183 & #5903

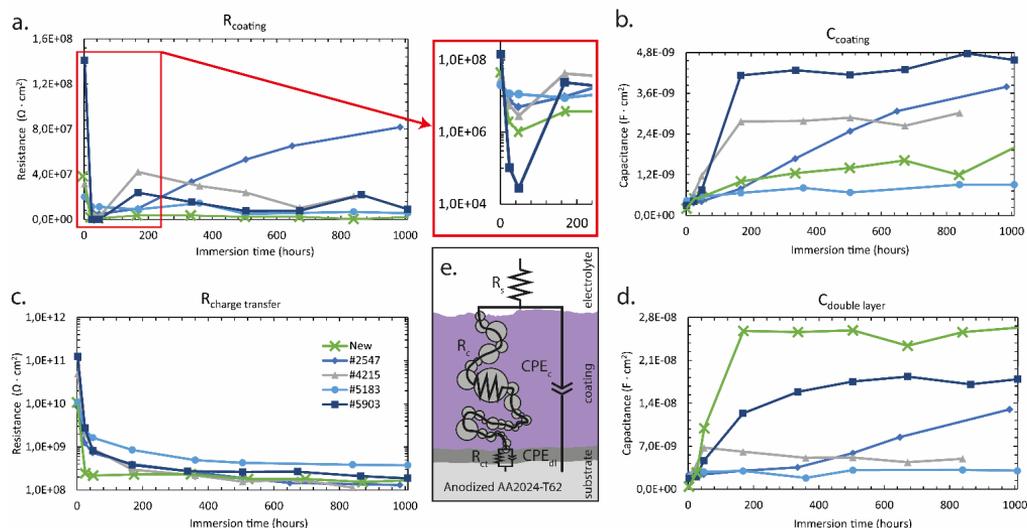
Figure 3.6. Temporal evolution of fitted parameters during immersion tests. (a) Pore resistance  $R_c$ , (b) effective coating capacitance  $CPE_c$ , (c) charge transfer resistance  $R_{ct}$  and (d) effective double-layer capacitance  $CPE_{dl}$  and (e) corresponding equivalent electrical circuit

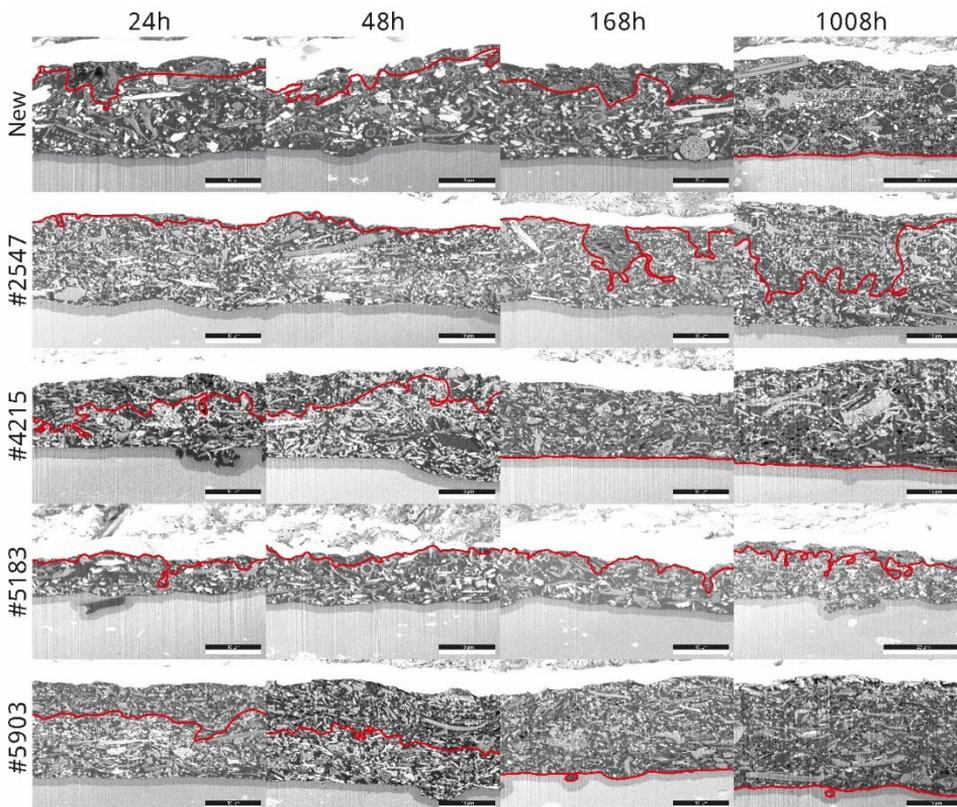
*Figure 3.7 SEM images of FIB-milled coated samples at varying immersion times, with the red line indicating the depletion front of strontium chromate particles for coatings #2547, #4215, #5183 and #5903*

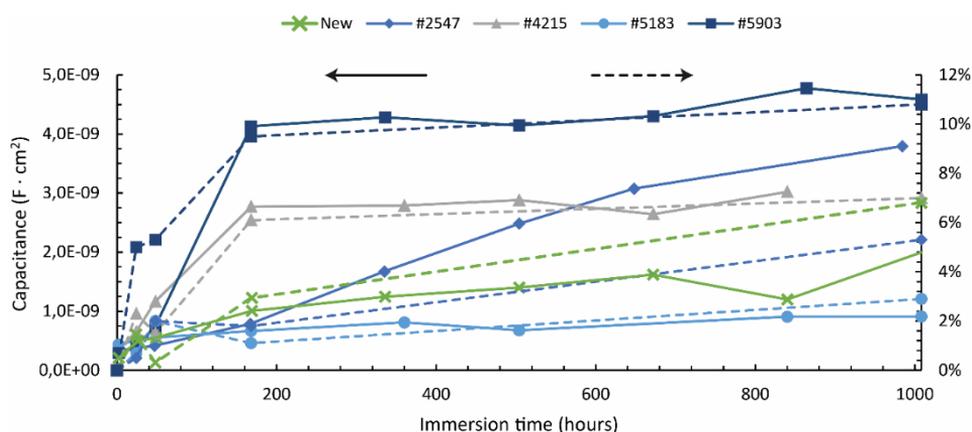
Figure 3.8 Temporal evolution of coating capacitance (continuous lines) of aged aircraft components during immersion in 0.1M NaCl, juxtaposed with the time-dependent release of strontium chromate (dashed lines)

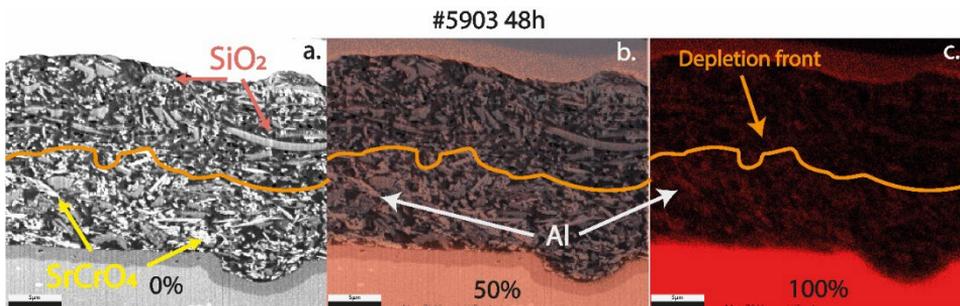
Figure 3.9 SEM-BSE image of a cross section from coating #5903 following 48h immersion in 0.1M NaCl overlaying with a (a) 100%, (b) 50% or (c) 0% transparent EDX image illustrating the distribution of aluminium within an epoxy coating

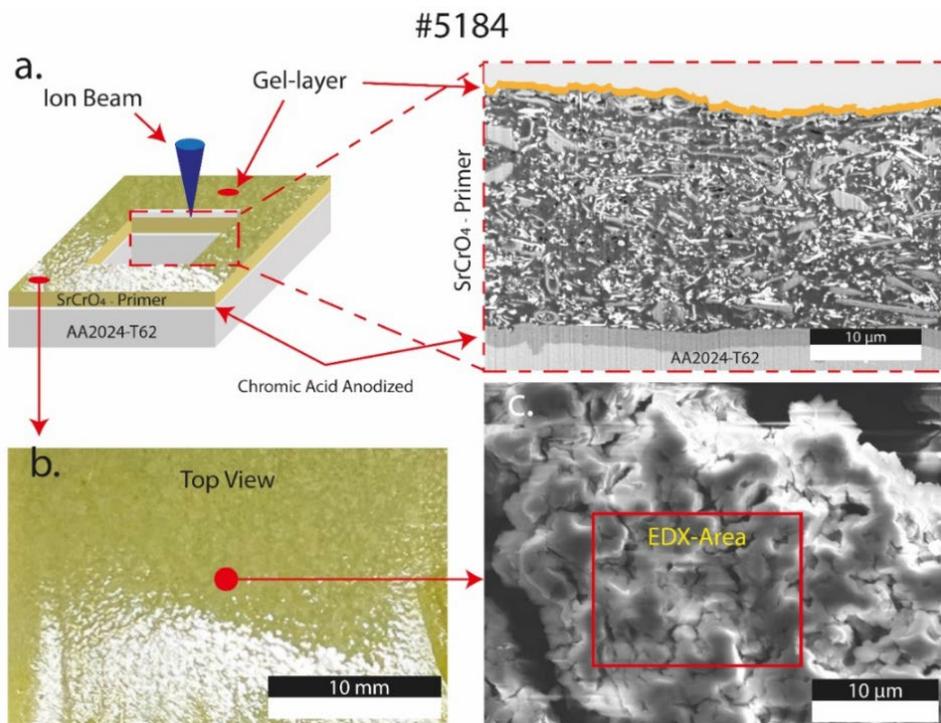
Figure 3.10 Gel-like substance observed on top of coating #5184 after 1008 hours of immersion testing. (a) Cross-sectional view of the coating obtained through FIB milling, with the location of the detected gel schematically highlighted in orange; (b) Top view of the coating, displaying the presence of the gel-layer; and (c) SEM image of the extracted (dried) gel-like substance, indicating the area where EDX analysis was conducted<sup>1</sup>

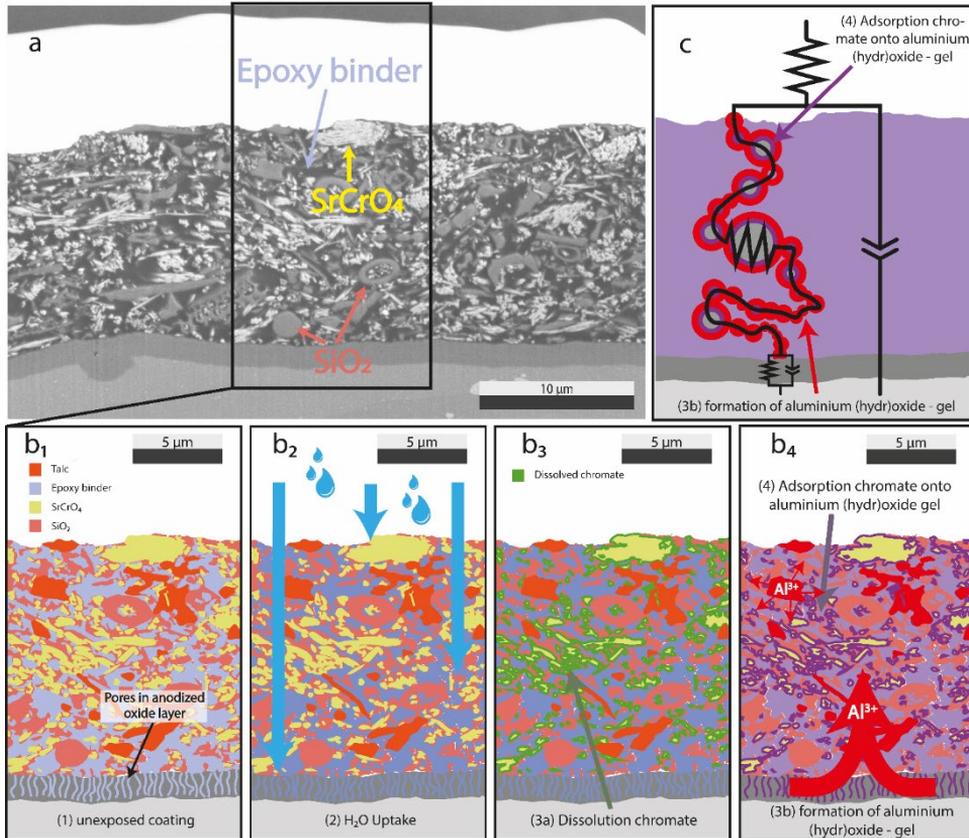
*Figure 3.11 Graphical representation of mechanisms influencing coating degradation during immersion in electrolyte. (a) SEM-BSE image indicating the region of interest, (b<sub>1</sub>) unexposed coating, (b<sub>2</sub>) water uptake in coating, (b<sub>3</sub>) subsequent dissolution of strontium chromate, (b<sub>4</sub>) dissolution of Al ions forming aluminium (hydr)oxide gel with the adsorption of chromate, (c) electrochemical representation corresponding to image (b<sub>4</sub>).*

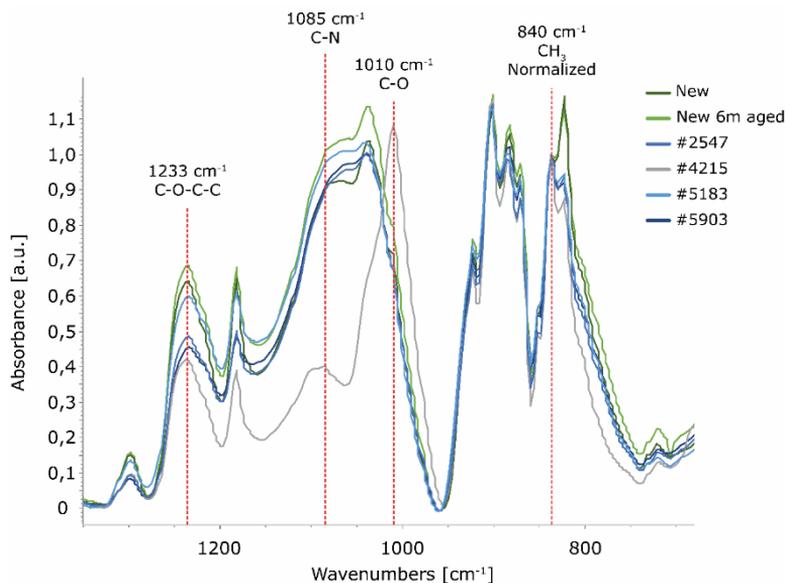
Figure 3.12 ATR-FTIR spectra, spanning the range of 1350 – 650  $\text{cm}^{-1}$ , depicting aircraft coatings after service as well as pristine coatings. All spectra are normalized at the peak at 840  $\text{cm}^{-1}$

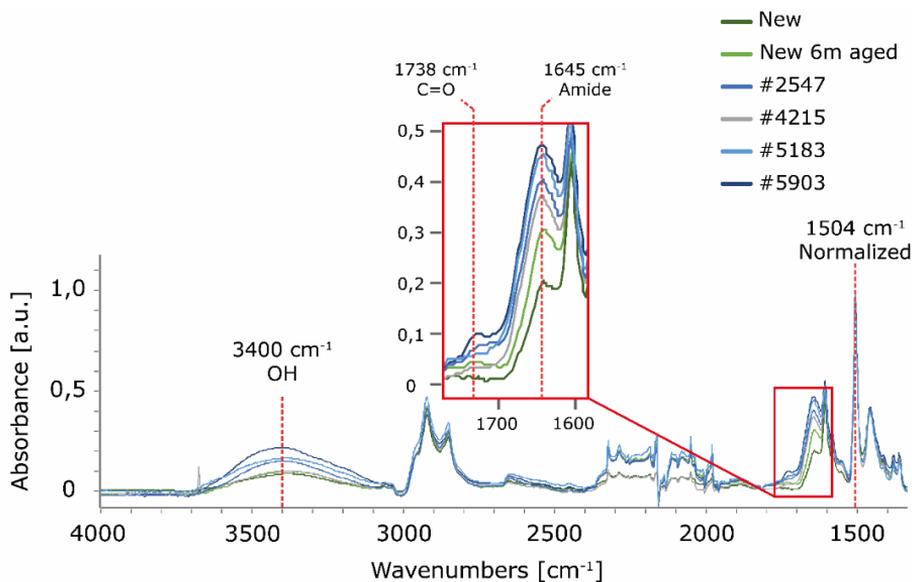
Figure 3.13 ATR-FTIR spectra (4000 – 1325  $\text{cm}^{-1}$ ) comparing aged aircraft coatings after service with a pristine coating, highlighting the impact of thermo-oxidation at 1738  $\text{cm}^{-1}$  & 1645  $\text{cm}^{-1}$ , indicating the growth of hydroxide within the coating. Spectra are normalized at the peak at 1504  $\text{cm}^{-1}$

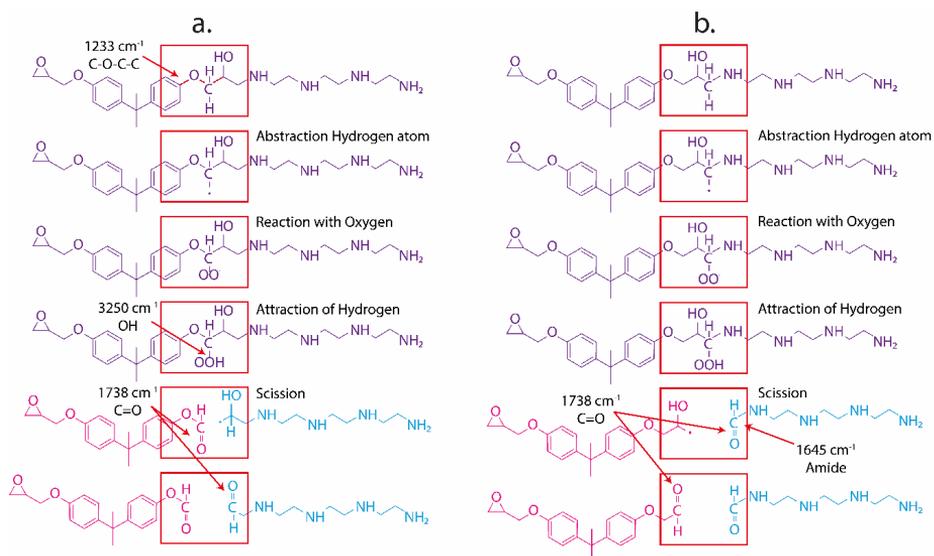
Figure 3.14 Thermo-oxidation reaction at the DGEBA resin (a) and the TETA hardener (b), depicting the progression from an unaffected polymer chain to a fully oxidized chain and elucidating the impact on the FTIR absorbance bandwidth

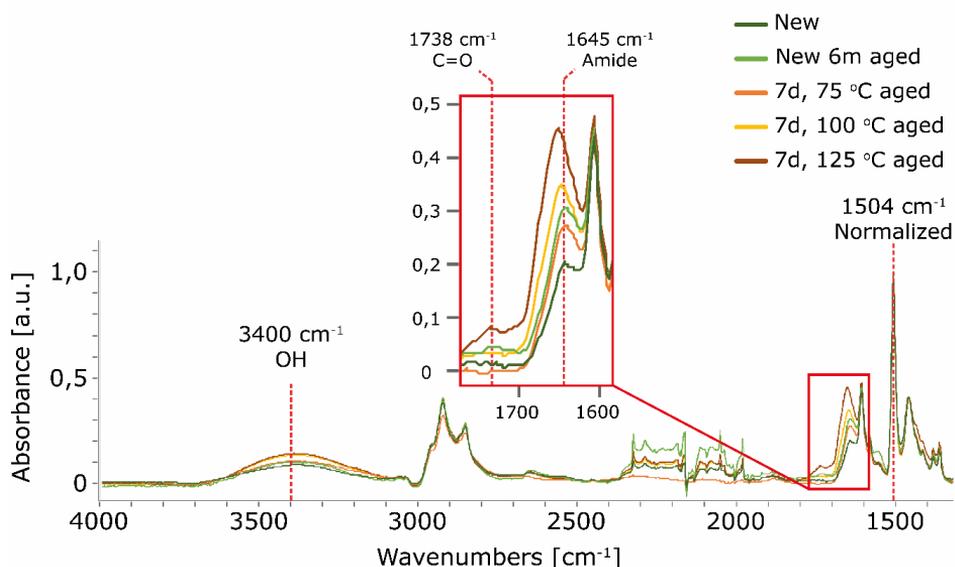
Figure 3.15 ATR-FTIR spectra (4000 – 1325  $\text{cm}^{-1}$ ) comparing thermally-aged coatings with newly applied coatings, highlighting the impact of thermo-oxidation at 1738  $\text{cm}^{-1}$  and 1645  $\text{cm}^{-1}$  and showcasing the growth of hydroxide within the coating. Spectra are normalized at 1508  $\text{cm}^{-1}$

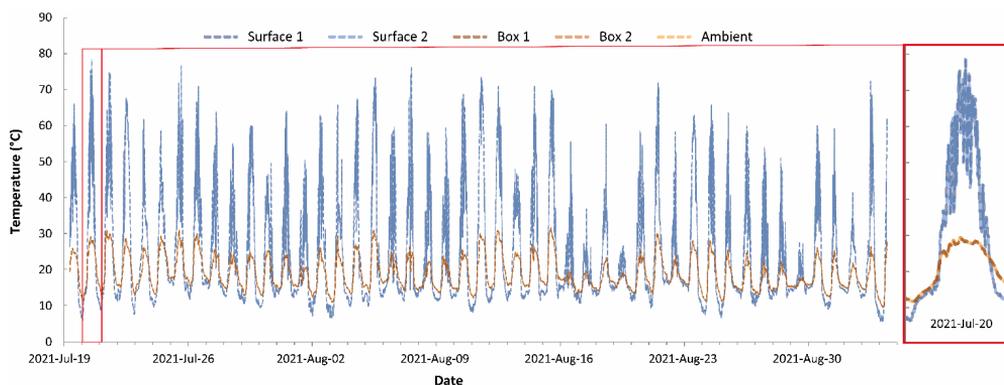
*Figure 3.16 Temperature evolution of the matte-coated surface in relation to ambient temperature and the temperature inside the box*

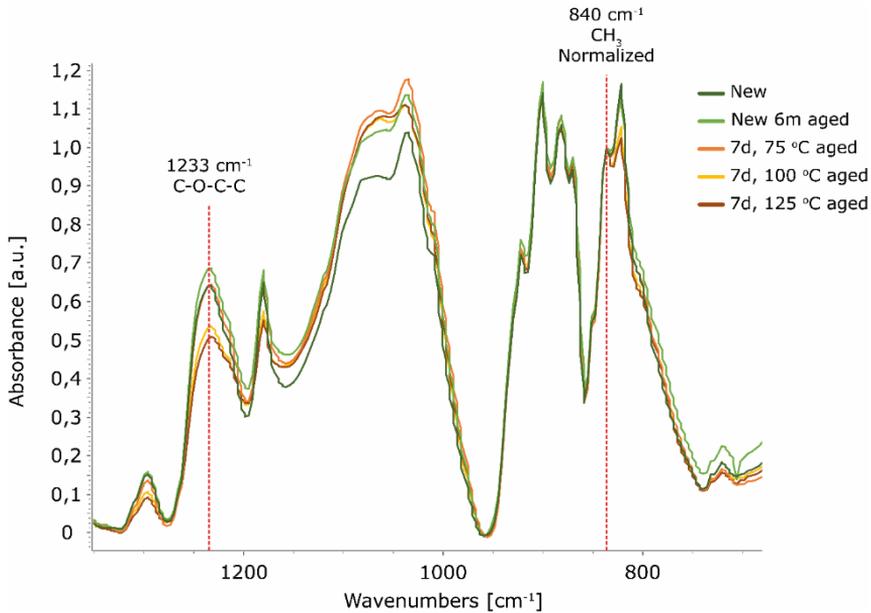
Figure 3.17 ATR-FTIR spectra, covering the range of  $1350\text{--}650\text{ cm}^{-1}$ , showcasing thermally aged coatings in comparison to newly applied coatings. All spectra are normalized at the peak at  $840\text{ cm}^{-1}$

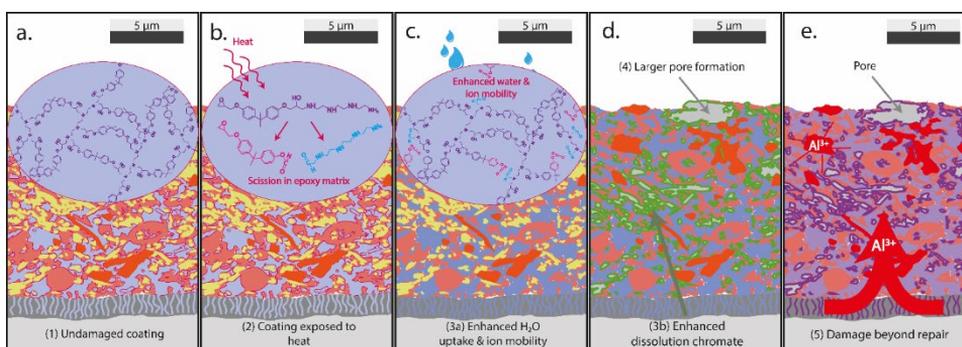
*Figure 3.18 The impact of thermal exposure on coating degradation: (a) intact epoxy matrix; (b) scission during exposure; (c) resulting enhanced ion mobility and water uptake; (d) accelerated dissolution of strontium chromate; (e) consequent formation of larger pores, irreparable by the formation of aluminium (hydr)oxides*

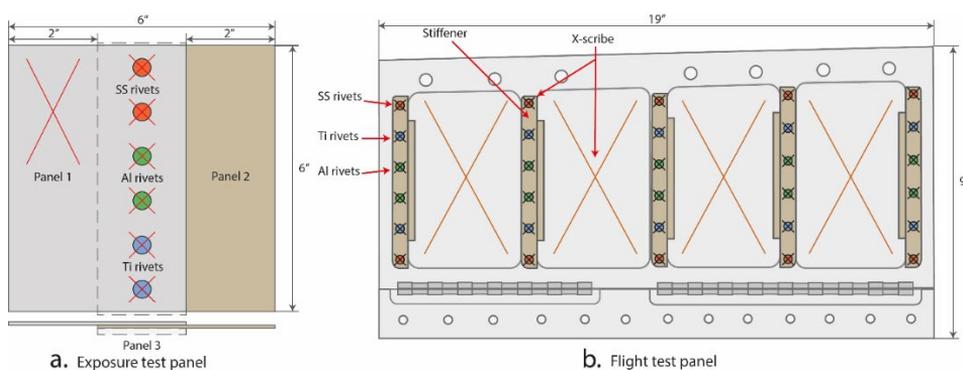
*Figure 4.1 Panel configuration; a) Panels used for outdoor exposure and cyclic salt spray testing, b) Example of a flight test panel (dimensions in inches).*

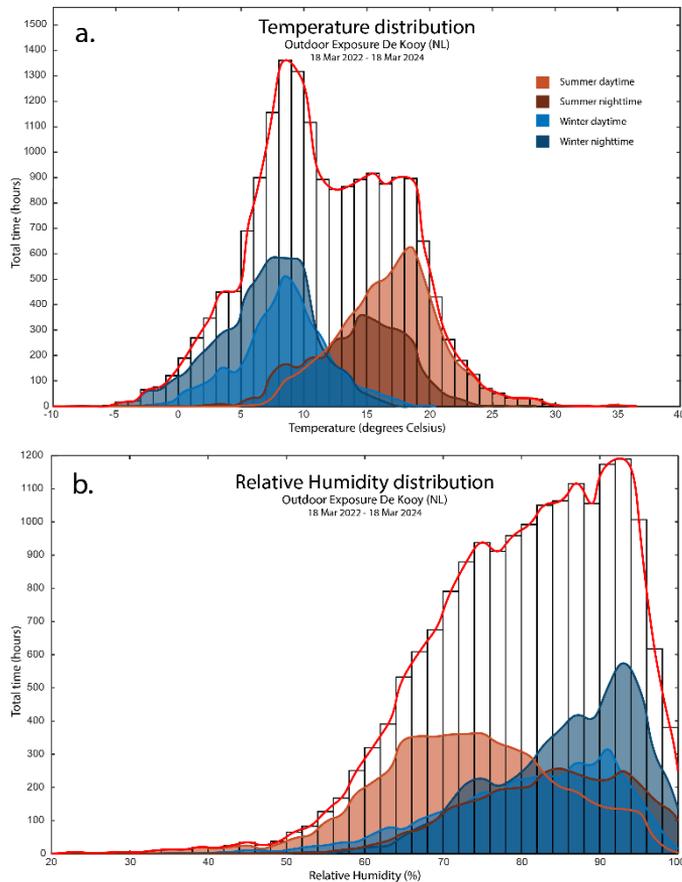
Figure 4.2 Environmental data during the 2-year outdoor exposure test at Naval Air Station De Kooy : (a) temperature and (b) relative humidity variation over the exposure period, categorized by season and day- vs. nighttime conditions.

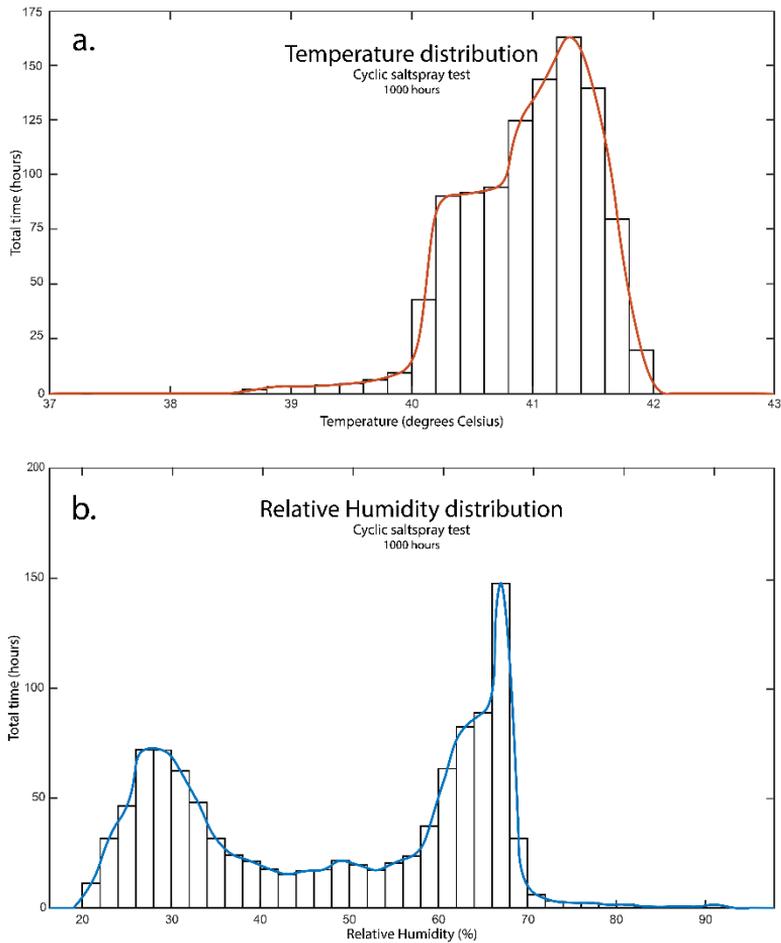
Figure 4.3 Environmental conditions during the cyclic salt spray test: (a) temperature and (b) relative humidity variation throughout the test.

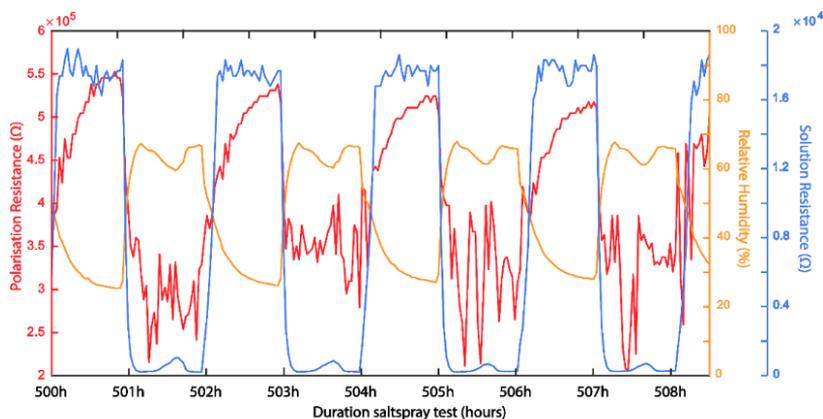
Figure 4.4 Relative humidity, solution resistance and polarization resistance between 500 and 508 hours during CSST.

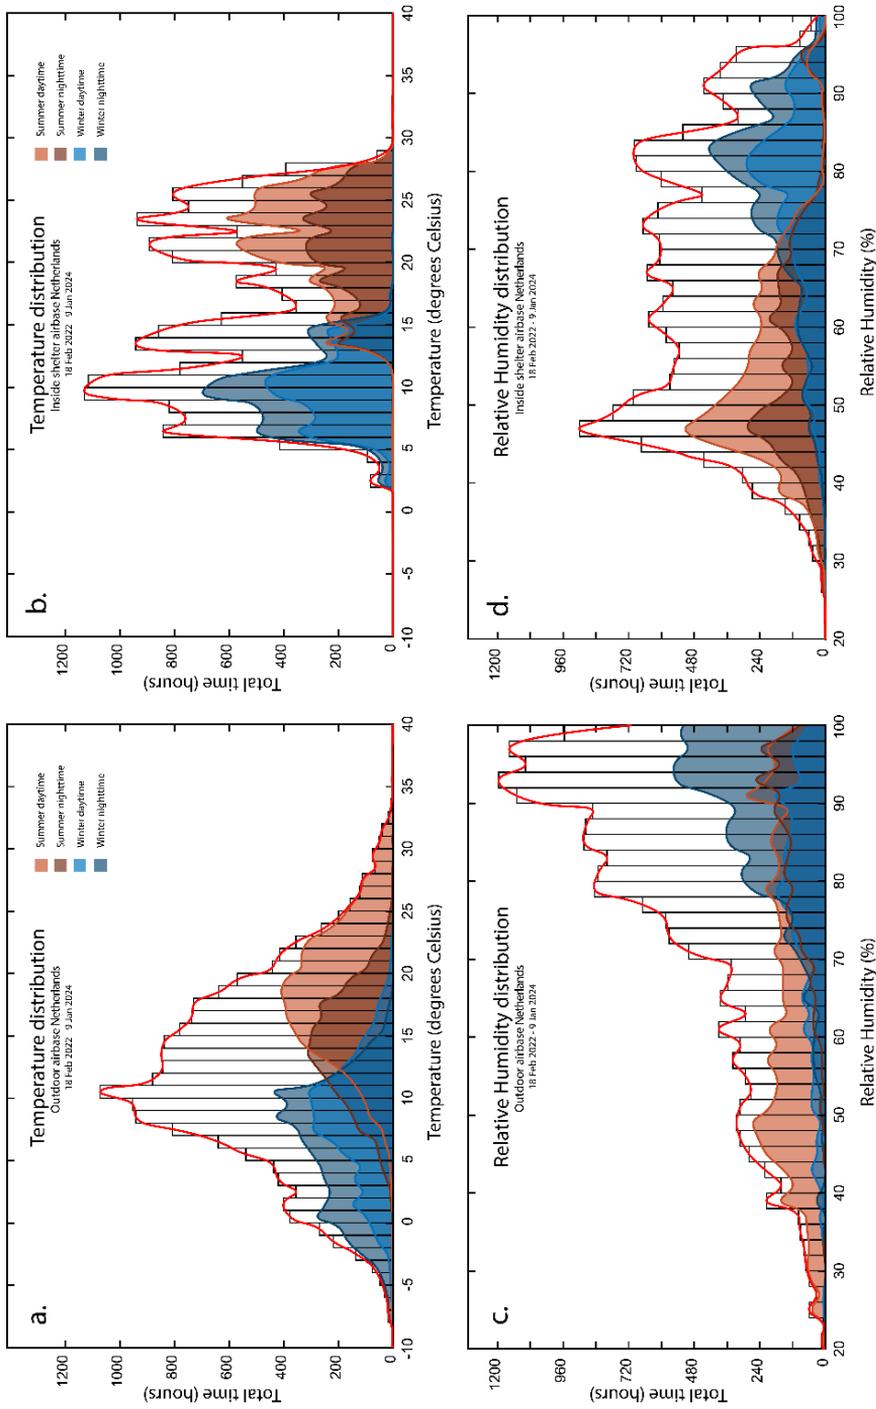
Figure 4.5 Comparison of Environmental Conditions Between Outdoor Airfield and Shelter: (a) Temperature Distribution at the Airfield; (b) Temperature Distribution in the Shelter; (c) Relative Humidity Variation at the Airfield and (d) Relative Humidity Variation in the Shelter, presented

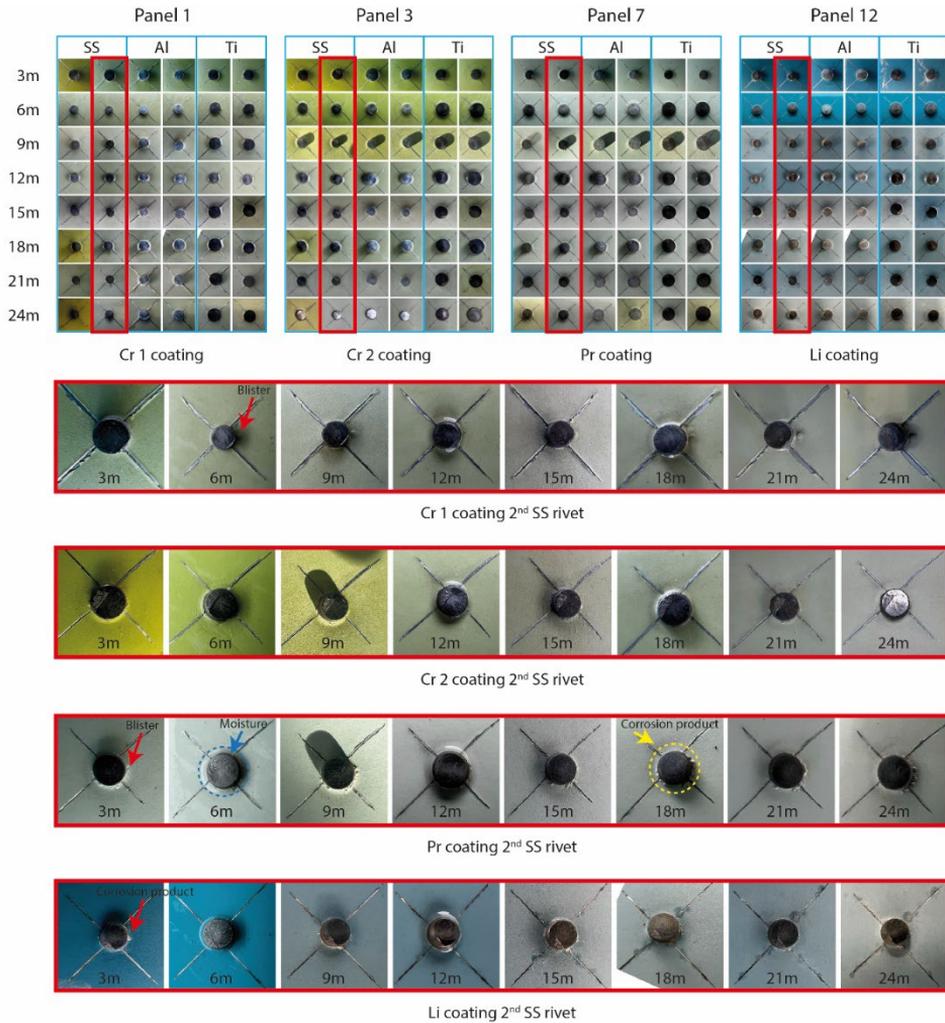
Figure 4.6 Visual inspection results of outdoor exposure test panels with detailed images showing corrosion progression over time around X-scribed stainless-steel rivets for chromium, praseodymium and lithium coating systems.

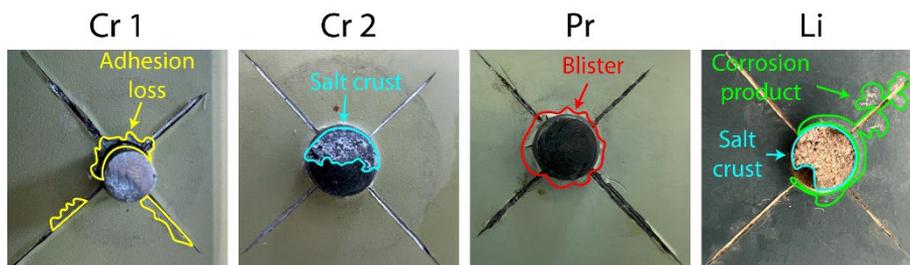
Figure 4.7 Corrosion observed around X-scribed stainless-steel rivets after 1000 hours of CSST for chromium, praseodymium and lithium coating systems.

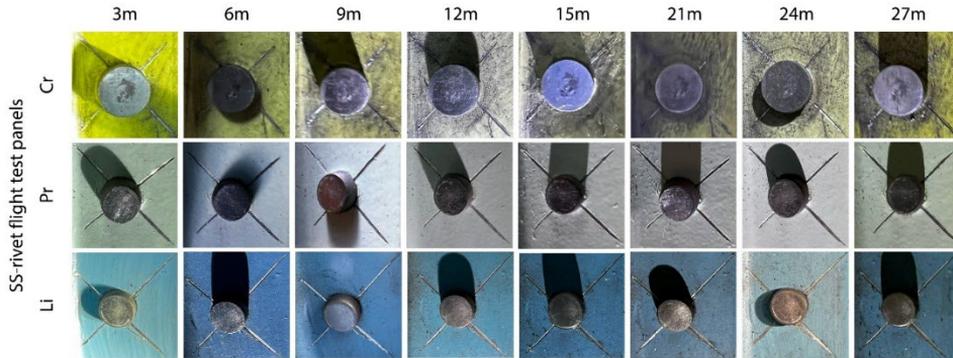
Figure 4.8 Corrosion progression over time observed around X-scribed stainless-steel rivets during flight testing for chromium, praseodymium and lithium coating systems.

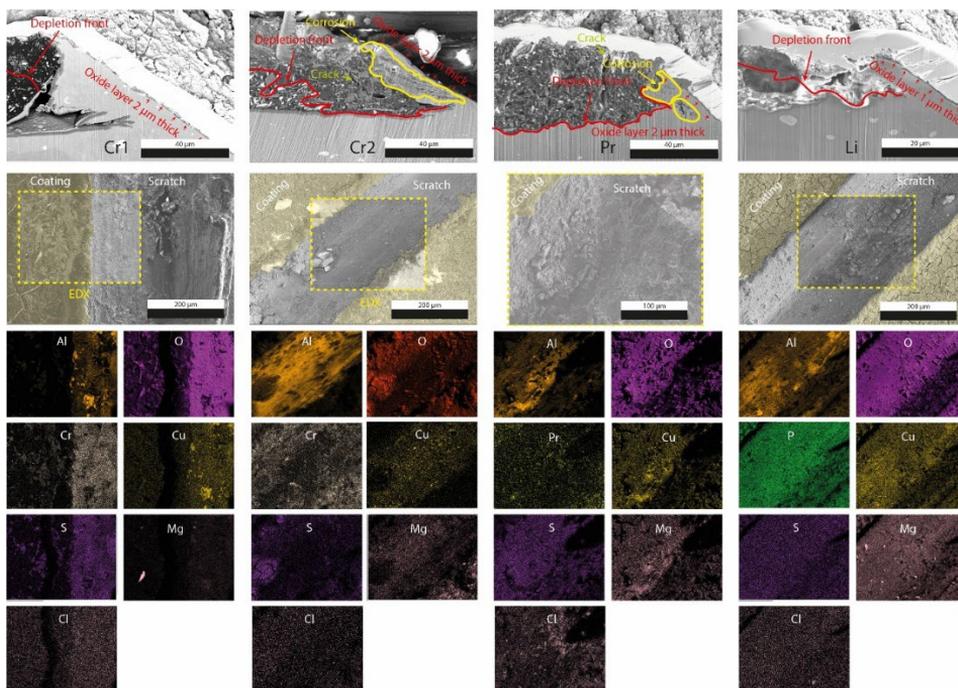
Figure 4.9 SEM and EDX analysis of X-scribed area after outdoor exposure comparing chromium, praseodymium and lithium coating systems.
