## **Bridging Laboratory Testing and In-Service Coating Performance for Structural Aerospace Applications**

Ph.D. thesis

**Keywords:** Corrosion; Structural Aircraft Coatings; Chromate; Chromate-free Inhibitors; Artificial Ageing; In-service Performance

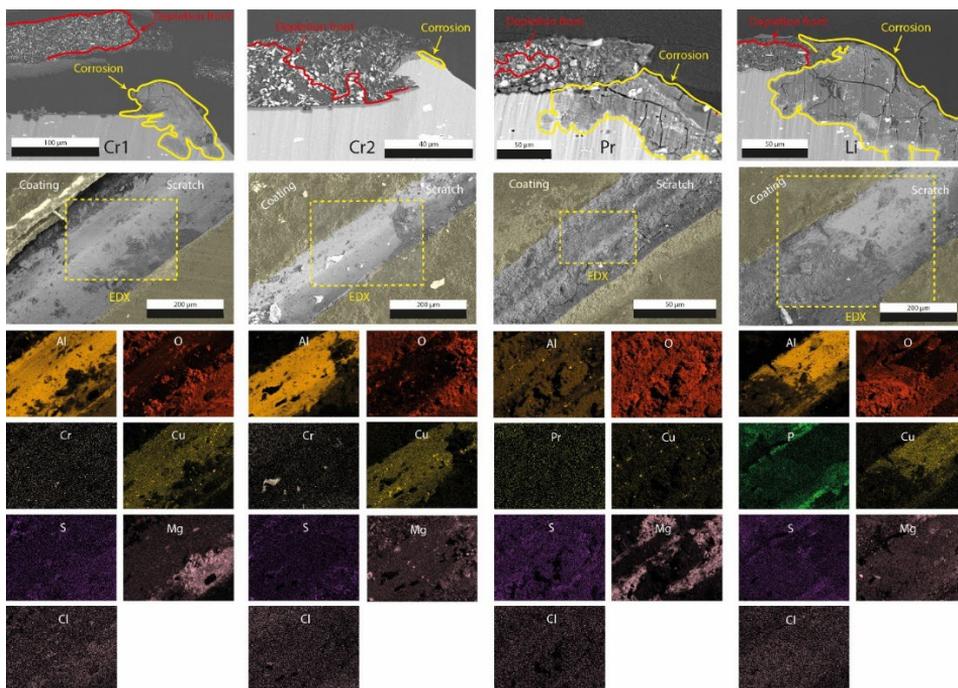
Figure 4.10 SEM and EDX analysis of X-scribed area after CSST comparing chromium, praseodymium and lithium coating systems.

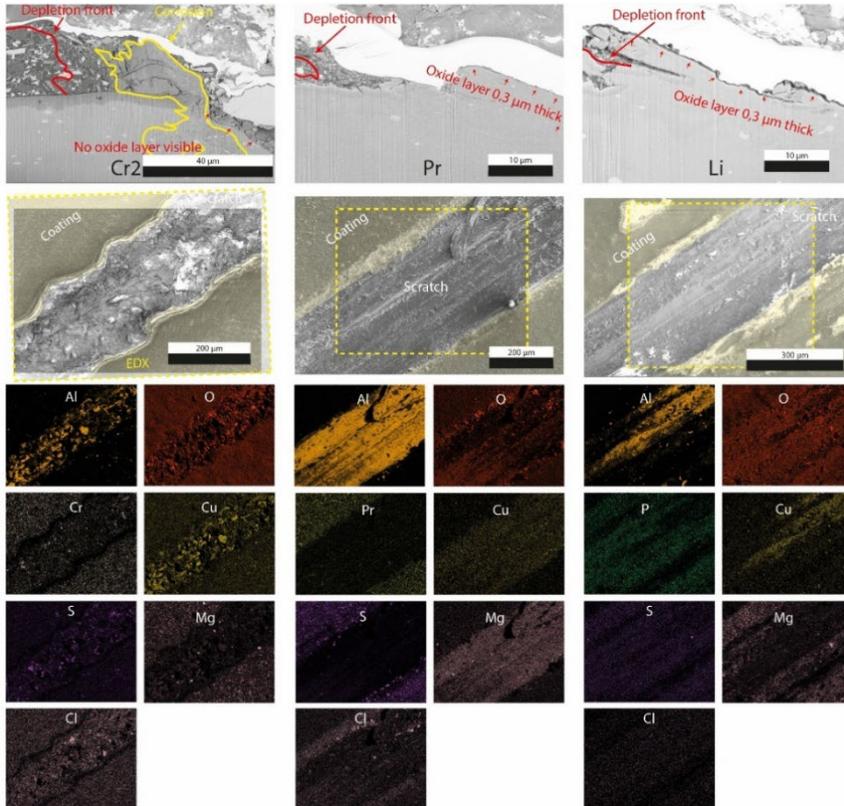
Figure 4.11 SEM and EDX analysis of X-scribed area after flight test comparing chromium, praseodymium and lithium coating systems.

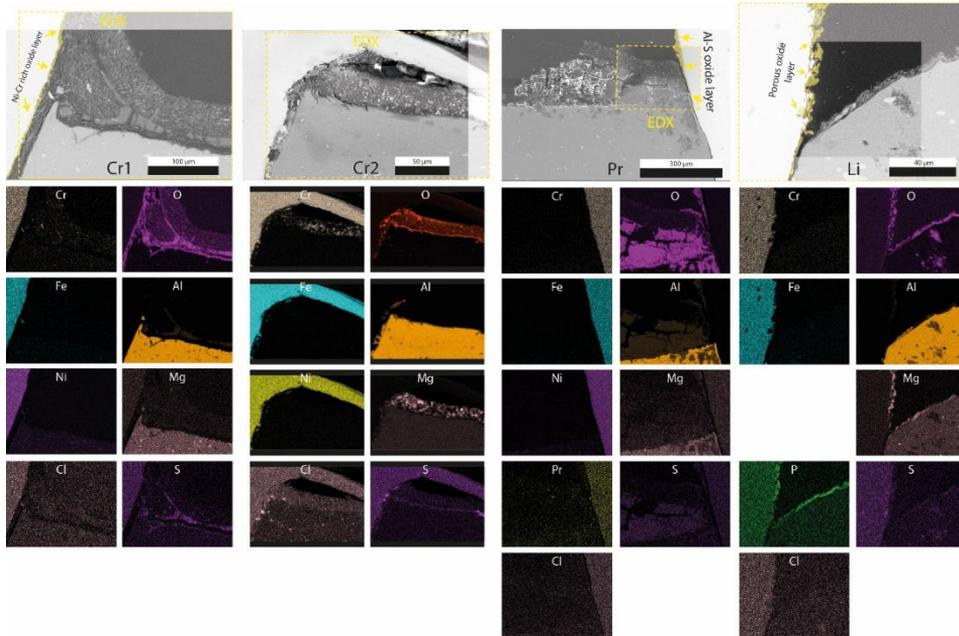
Figure 4.12 SEM and EDX analysis of stainless-steel rivet cross-section after outdoor exposure comparing chromium, praseodymium and lithium coating systems (Al-Al coupled panel).

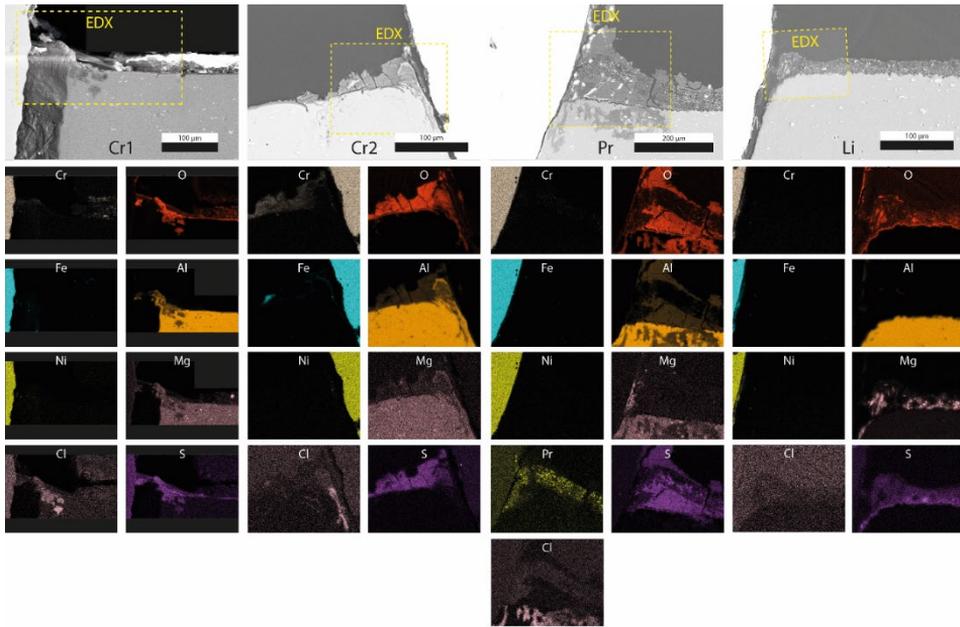
*Figure 4.13 SEM and EDX analysis of stainless-steel rivet cross-section after outdoor exposure comparing chromium, praseodymium and lithium coating systems (Al-CFRP coupled panel).*

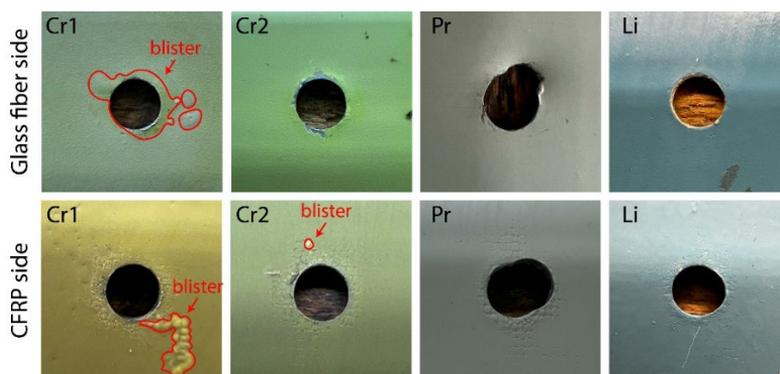
Figure 4.14 Overview of lap-joint facing areas around stainless-steel rivets between CFRP and aluminium panels with different coating systems after outdoor exposure

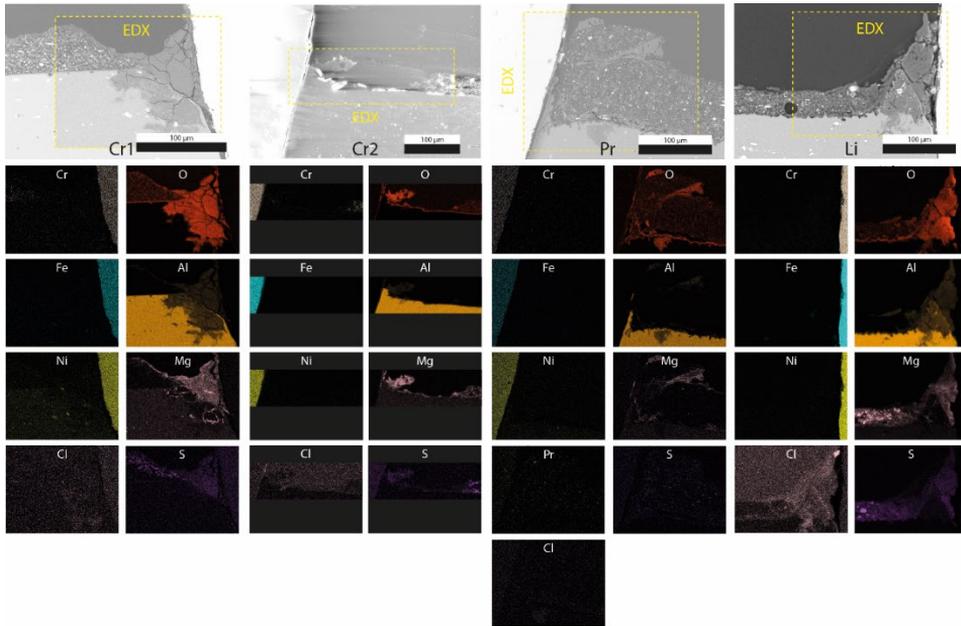
Figure 4.15 SEM and EDX analysis of stainless-steel rivet cross-section after CSST comparing chromium, praseodymium and lithium coating systems (Al-CFRP coupled panel).

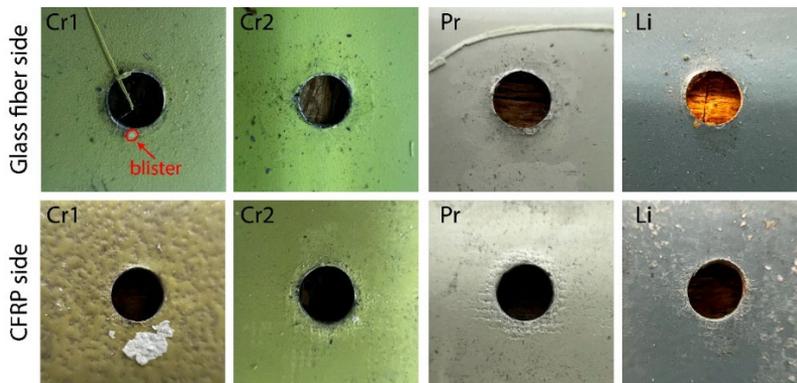
Figure 4.16 Overview of lap-joint facing areas around stainless-steel rivets between CFRP and aluminium panels comparing chromium, praseodymium and lithium coating systems after CSST

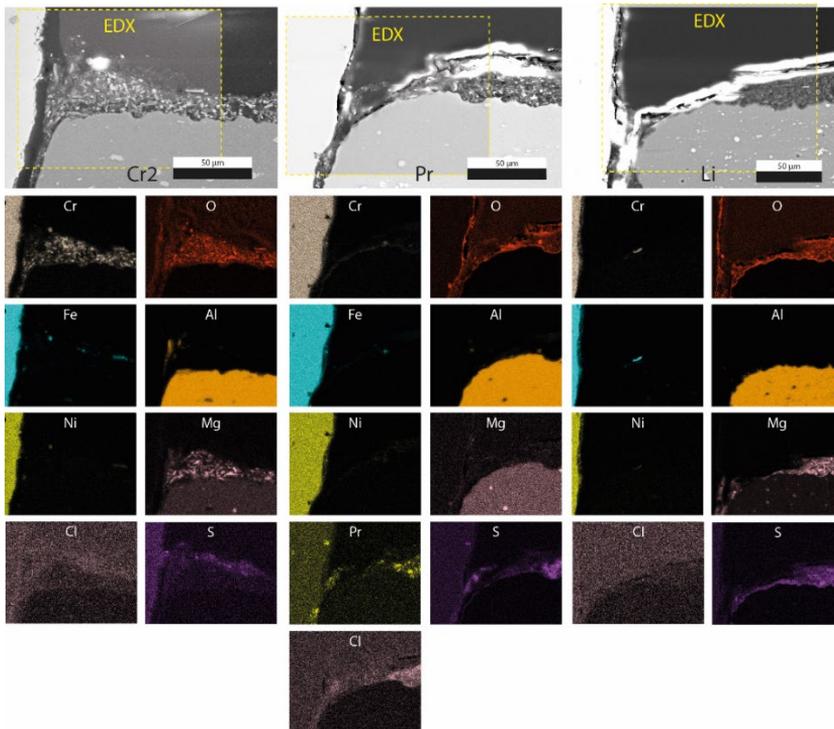
*Figure 4.17 SEM and EDX analysis of stainless-steel rivet cross-section after flight test comparing chromium, praseodymium and lithium coating systems (Al-stiffener and Al-coupled panel)*

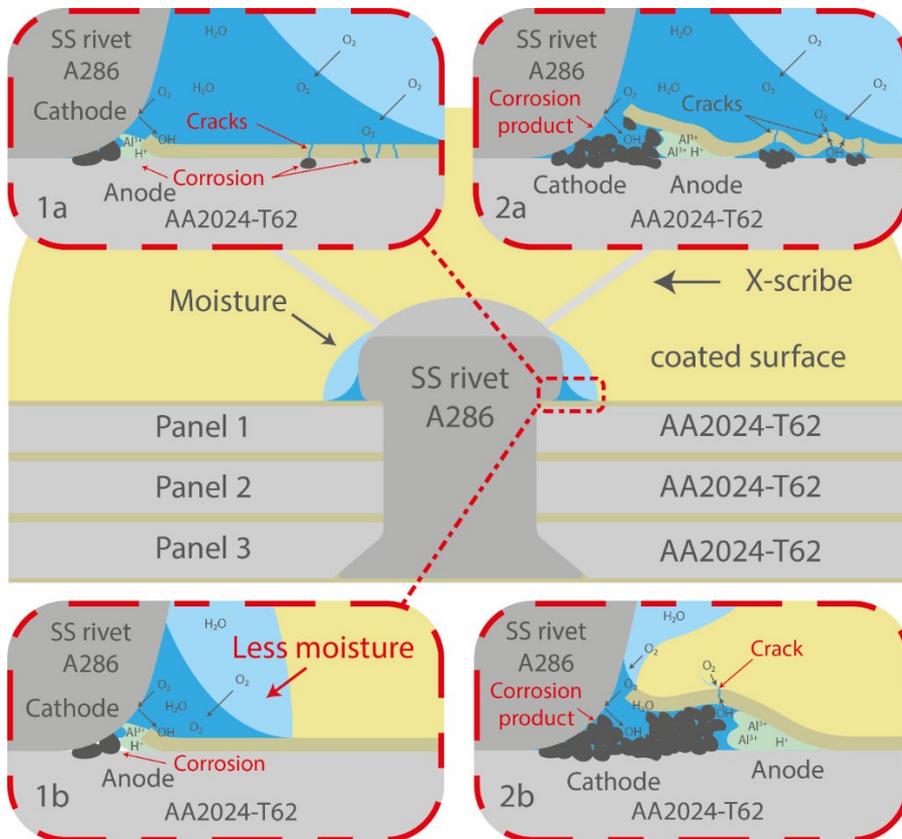
Figure 4.18 Schematic representation of the corrosion mechanisms around stainless-steel rivets in the praseodymium coating system: (1a) and (2a) depict the proposed corrosion mechanisms during outdoor exposure, whereas (1b) and (2b) represent the proposed corrosion mechanisms during CSST.

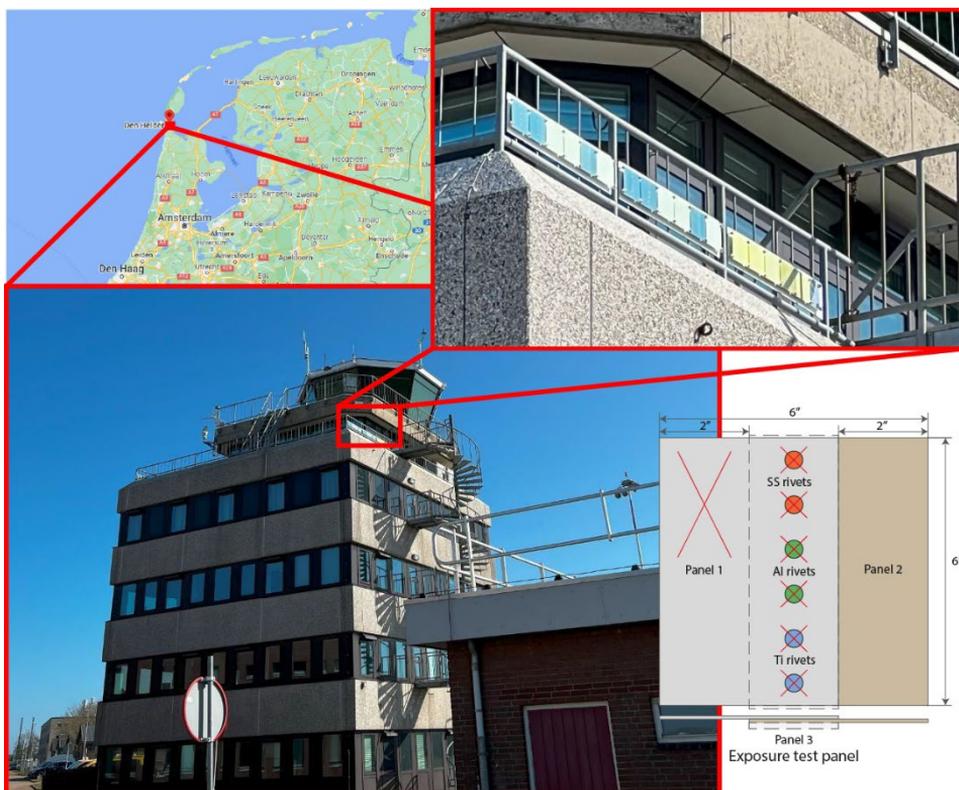
Figure 5.1. Exposure panel mounted on the air traffic control tower at Naval Air Station De Kooy in Den Helder, The Netherlands, during outdoor exposure testing.

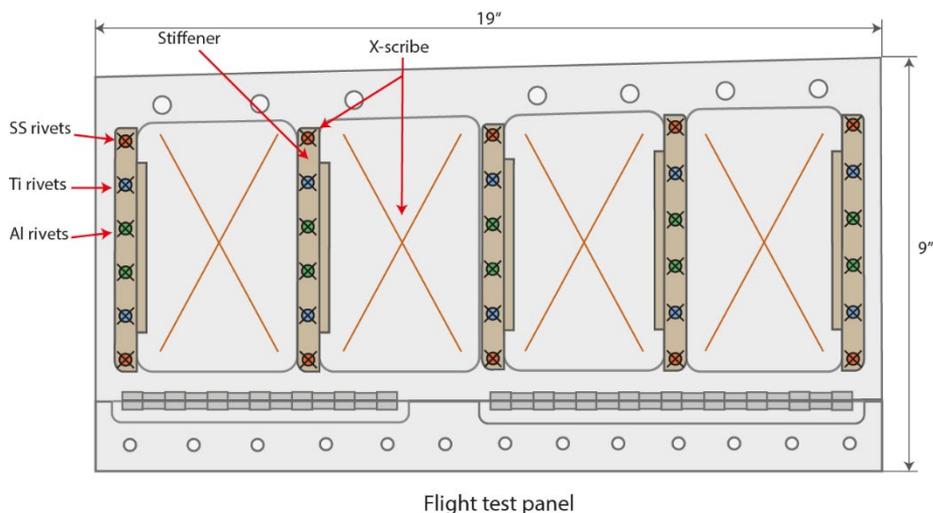
Figure 5.2. Schematic example of a flight test panel configuration (dimensions in inches).

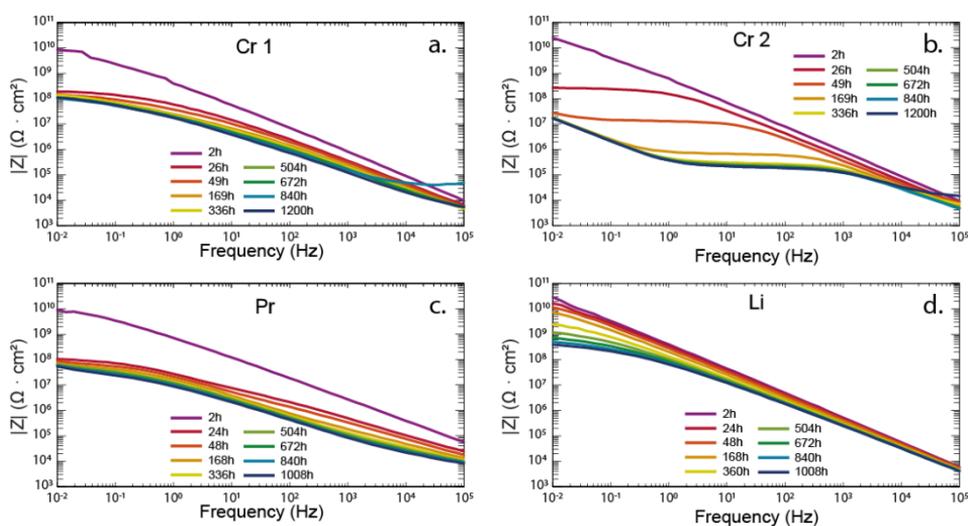
Figure 5.3. Impedance modulus  $|Z|$  plots for: (a) chromate-1; (b) chromate-2; (c) praseodymium and (d) lithium coating system during immersion in 0.1M NaCl aqueous electrolyte.

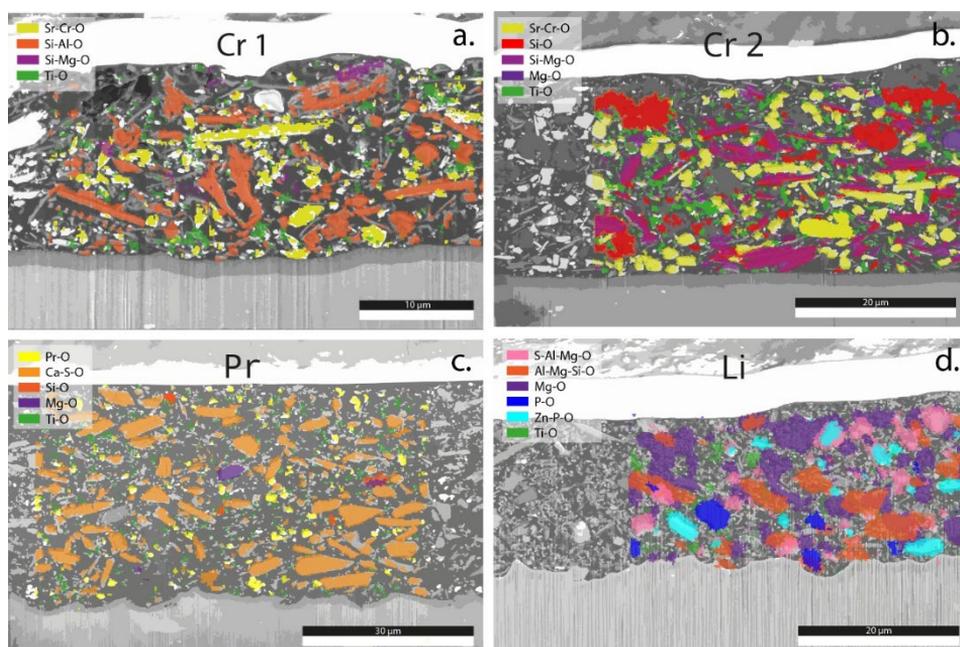
Figure 5.4. SEM-EDX analysis of PFIB-Milled cross-sections of (a) chromate-1, (b) chromate-2, (c) praseodymium and (d) lithium coating system after 24 hours of immersion in 0.1M NaCl aqueous electrolyte.

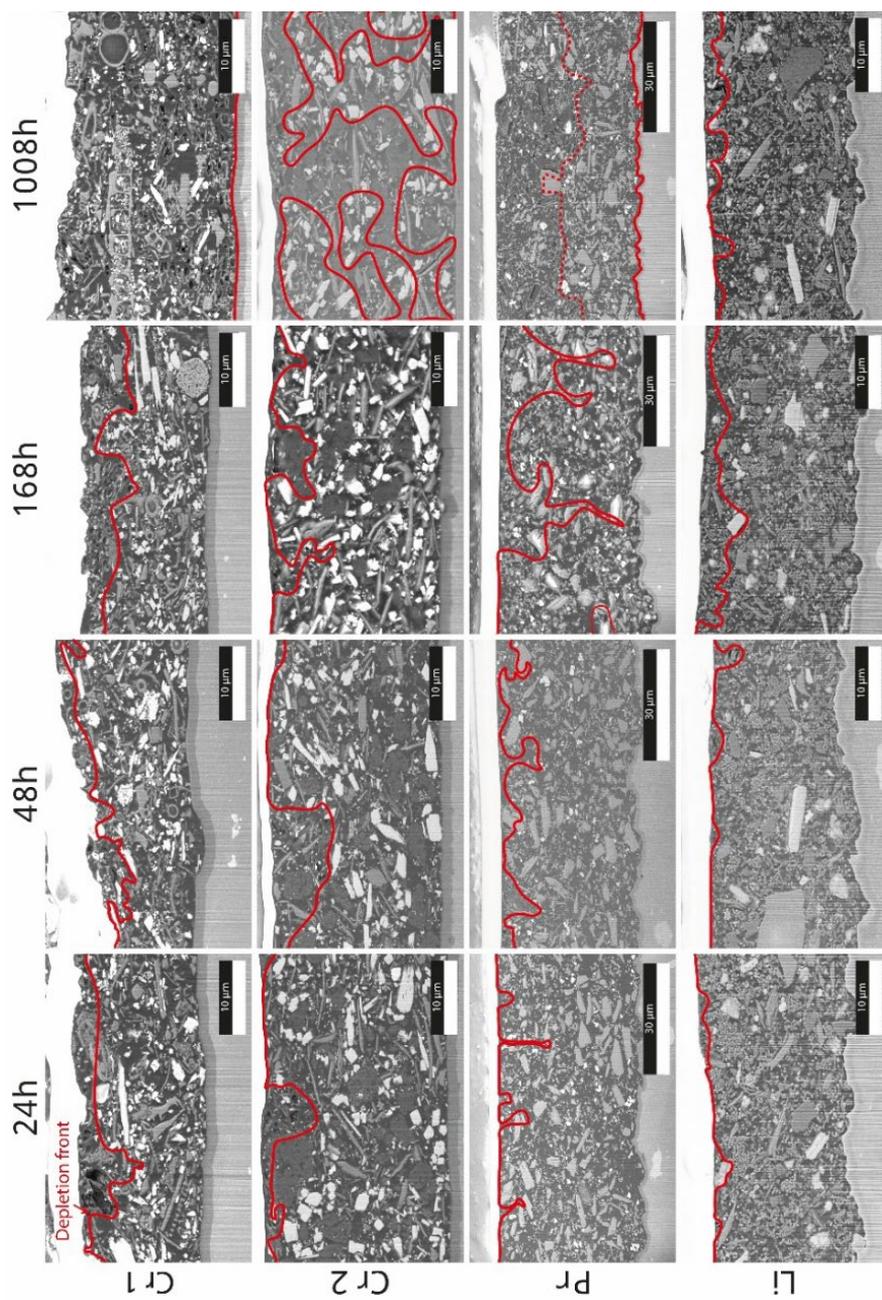
Figure 5.5. SEM analysis of PFIB-milled cross-sections of organic coatings after various immersion times in 0.1M NaCl aqueous electrolyte. The red line marks the depletion front within the coating in each image. Magnifications vary slightly to ensure full coating thickness is visible for each coating

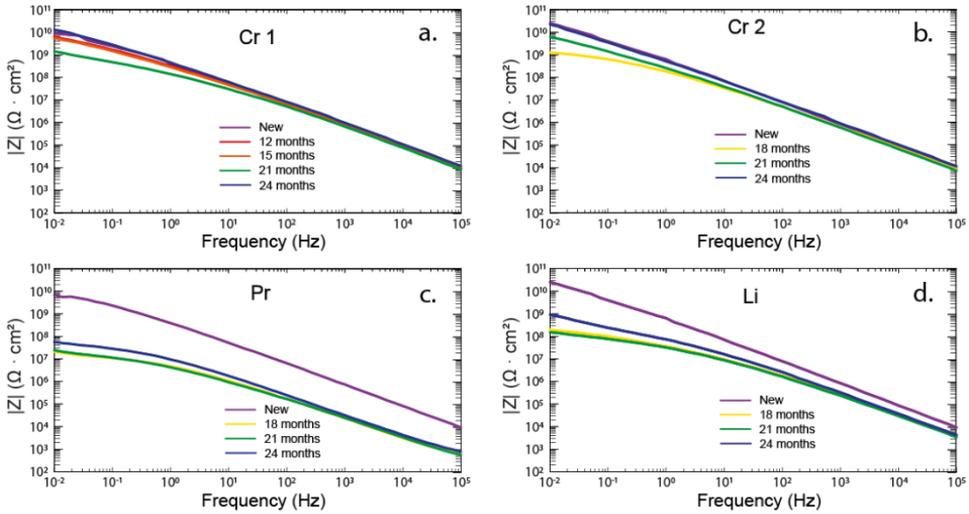
Figure 5.6. Impedance modulus  $|Z|$  plots for: (a) chromate-1; (b) chromate-2; (c) praseodymium and (d) lithium coating system during outdoor exposure.

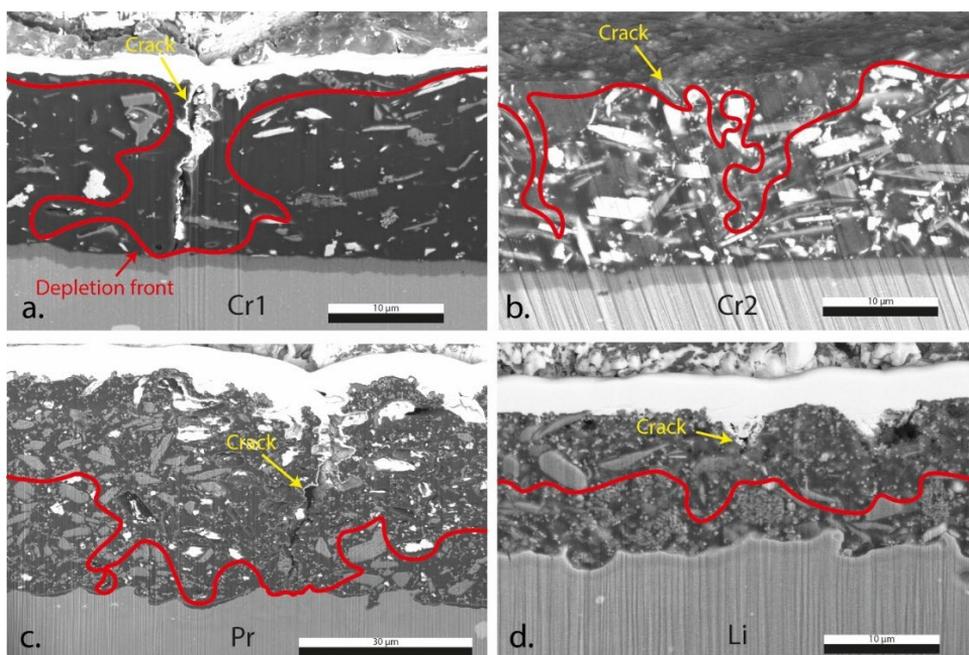
*Figure 5.7. SEM images of PFIB-Milled cross-sections of (a) chromate-1, (b) chromate-2, (c) praseodymium and (d) lithium coating system after unsheltered outdoor exposure, the red lines indicate the depletion front of the leached inhibitors within each coating. Magnifications vary slightly to ensure full coating thickness is visible for each coating system.*

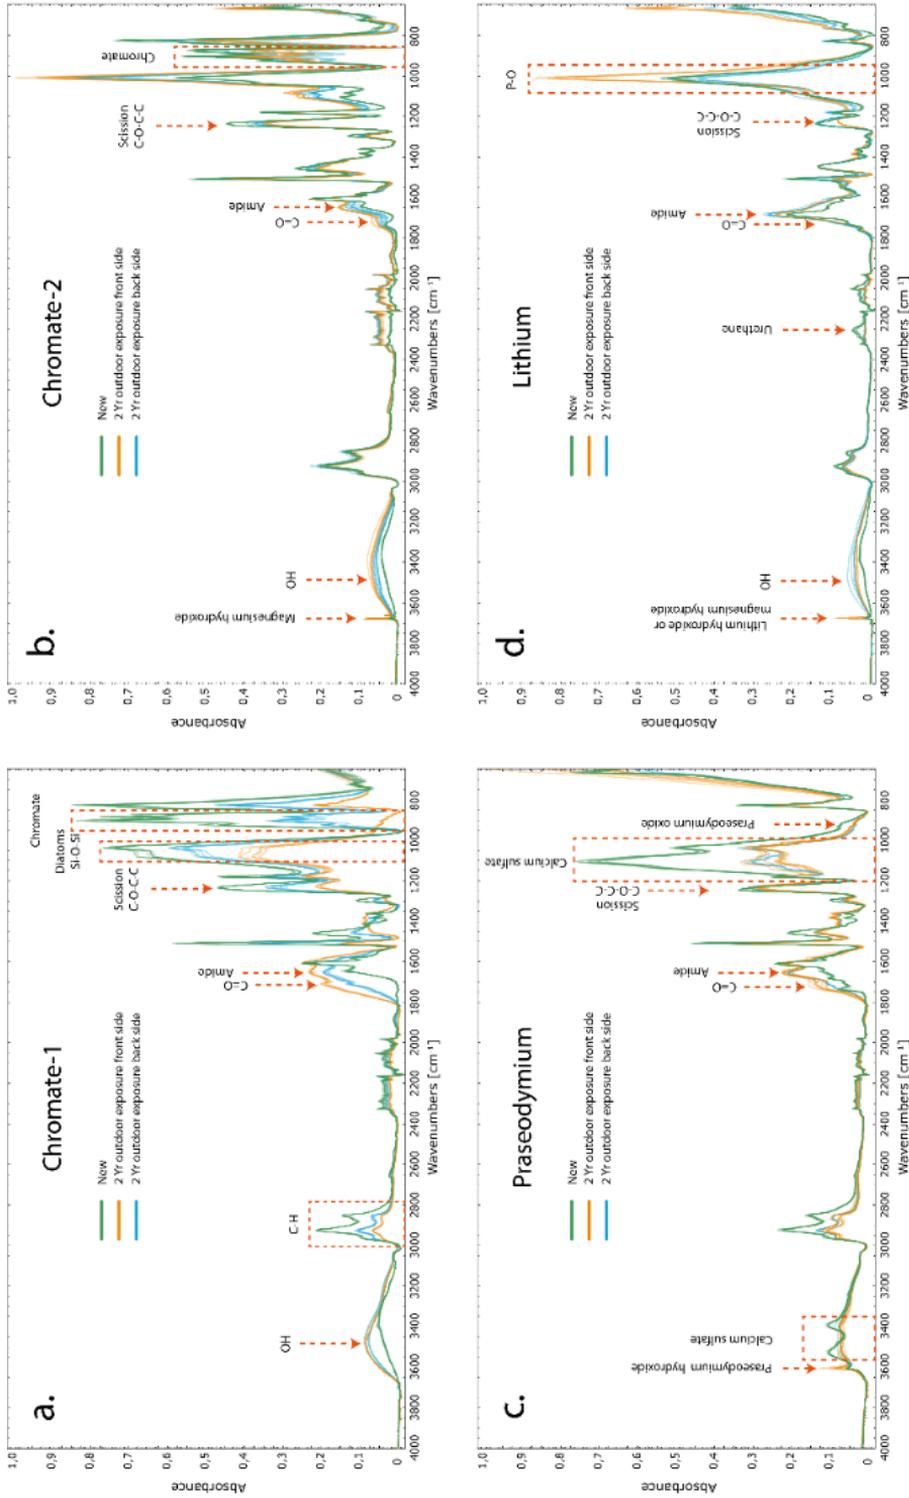
Figure 5.8. ATR-FTIR spectra of (a) chromate-1, (b) chromate-2, (c) praseodymium, and (d) lithium coating systems, illustrating the chemical composition changes by comparing newly applied coatings with those exposed to outdoor conditions.

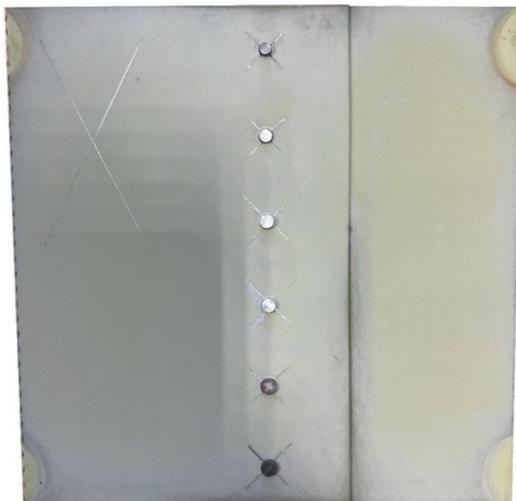
*Figure 5.9 Chromate-1 panel after two years of outdoor exposure at Naval Air Station De Kooy, showing the chalking effect after environmental weathering.*

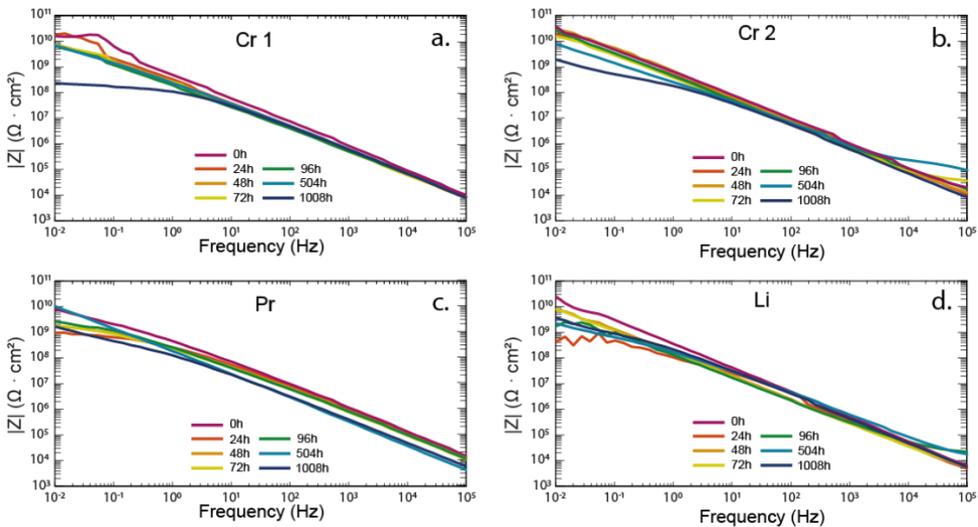
Figure 5.10: Impedance modulus  $|Z|$  plots for a: (a) chromate-1; (b) chromate-2; (c) praseodymium and (d) lithium coating system during CSST.

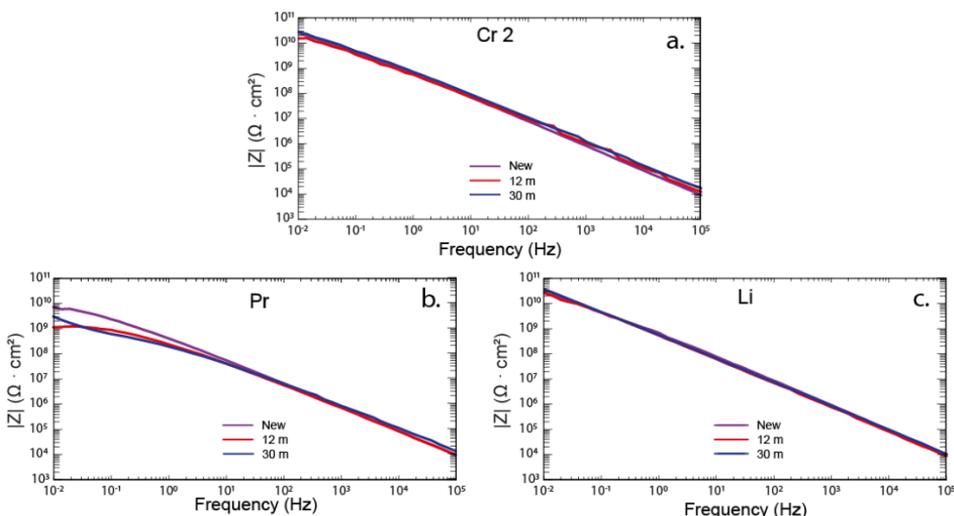
Figure 5.14 Impedance modulus  $|Z|$  plots for: (a) chromate-2; (b) praseodymium and (c) lithium coating system during flight testing.
