Report on pile test results at Maasvlakte II

Vibro piles

Report on pile test results at Maasvlakte II Vibro Piles

Author: Kevin Duffy

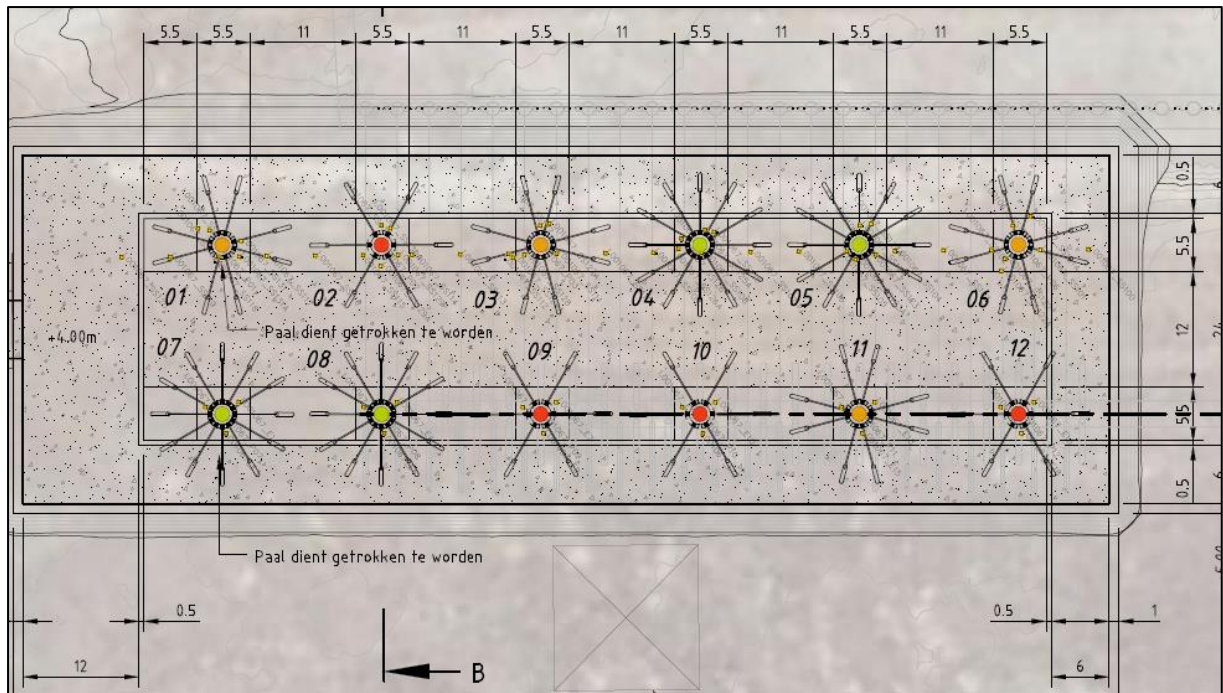
Figure 1.2: Site plan of the pile test site. In orange: vibro piles P01, P03, P06, P11; in green: screw injection piles P04, P05, P07, P08; in red: driven precast piles: P02, P09, P11, P12

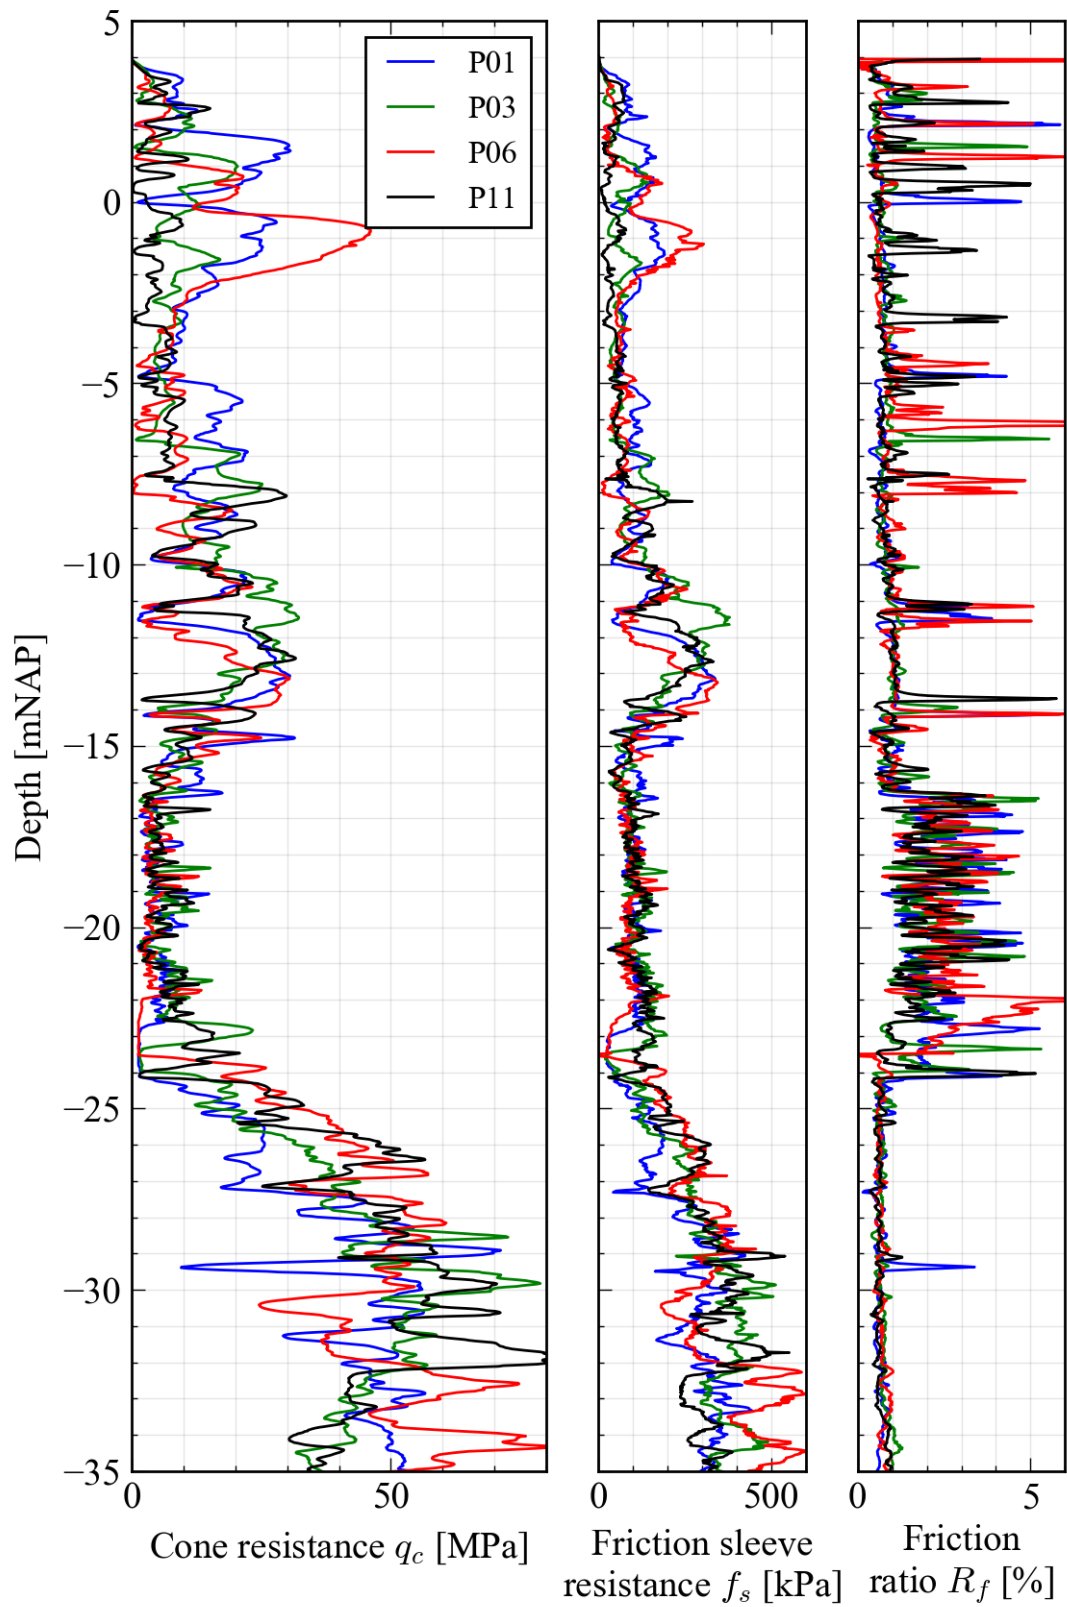
Figure 2.1: Plot of the CPTs along the central axis of each pile

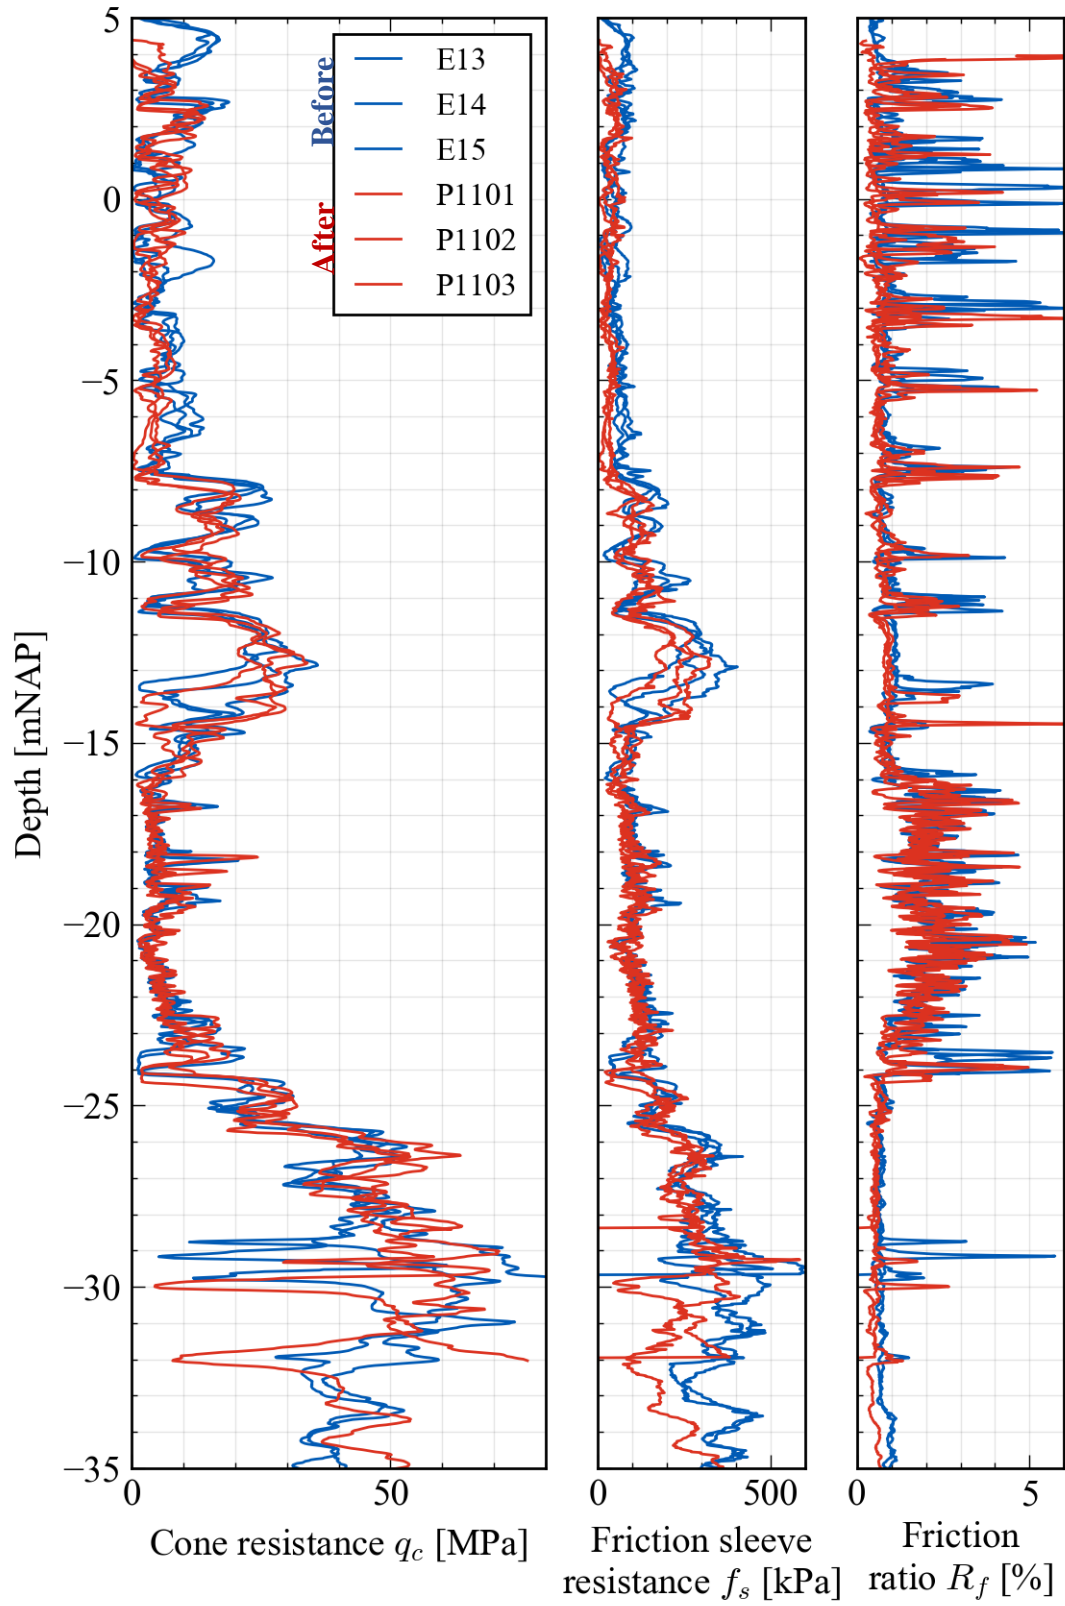
Figure 2.2: Comparison of CPTs around P11 executed before pile installation (i.e. CPTs E13, E14 and E15; in blue) and executed after installation (i.e. CPTs P1101, P1102, P1103; in red)

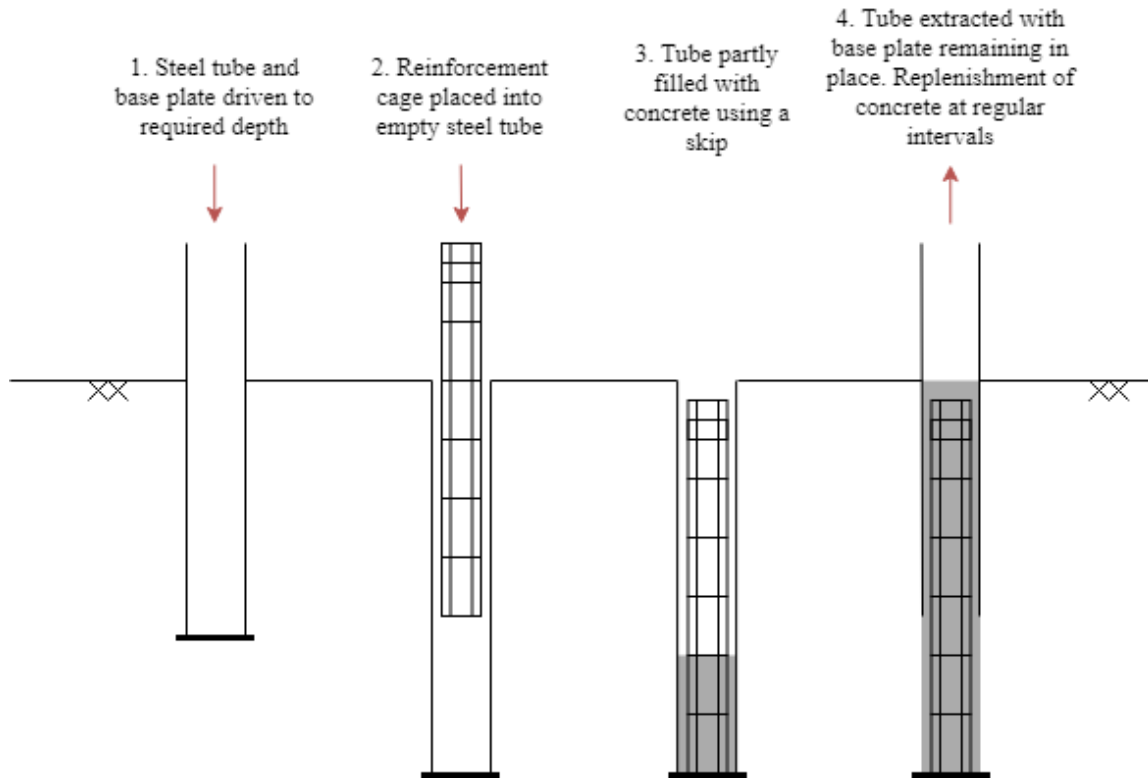
Figure 3.3: Installation procedure for the vibro piles

The reinforcement cage was placed within the empty hammered-in-place auxiliary tube using two cranes (Figure C.4) in order to avoid damage to the fibre optic instrumentation affixed to the reinforcement. Once placed within the auxiliary tube, the reinforcement cage was left resting directly on the base plate and was not suspended in any form. Immediately after the placement of the reinforcement cage, concrete was poured into the auxiliary tube and the tube was retracted using a reverse hammering action supplied by the same IHC S-120 hammer, with the concrete in the auxiliary tube being replenished at regular intervals. No pre-lining of the reinforcement with highly liquid concrete was applied (in Dutch: *vertinnen*) and no additional downward hammer blows were applied to compact the concrete after its pouring. A schematic of the installation process can also be seen in Figure 3.3.

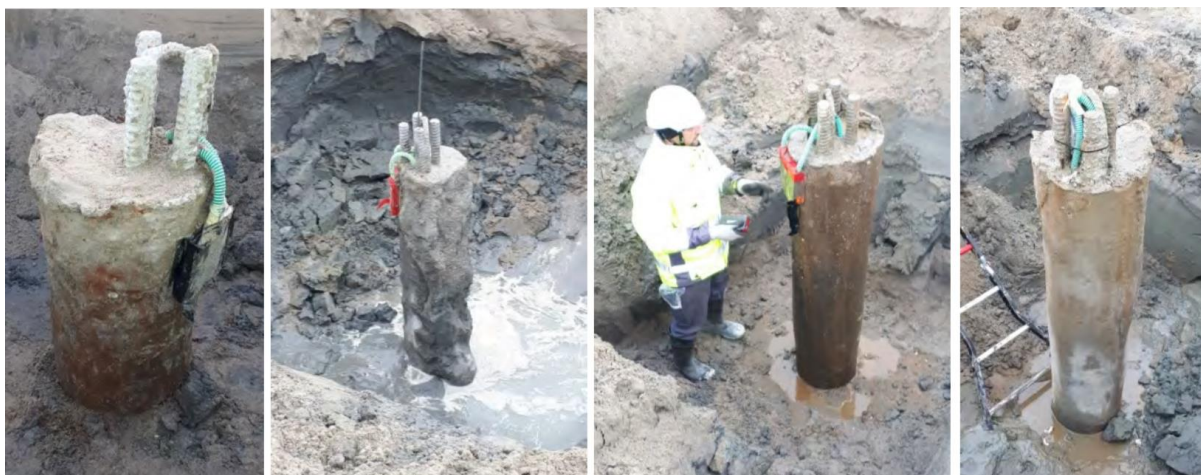
Figure 3.4: Pile heads of the four vibro piles immediately after installation. Note the non-centric placement of some of the reinforcement (Photos: Gust van Lysebetten, WTCB)

During inspection of the pile heads, it was found that the reinforcement was not centrally positioned at the pile head (Figure 3.4), most likely as a result of the reinforcement resting directly on the base plate. To provide further support to the pile head under the loading of the test frame, a steel sleeve with a length of two metres was placed around the upper part of each pile, with a hole drilled through the wall of the sleeve to allow the passage of the fibre optics (Figure 3.5). The pile cap was then placed over this steel sleeve, described in more detail in Section 4.1.

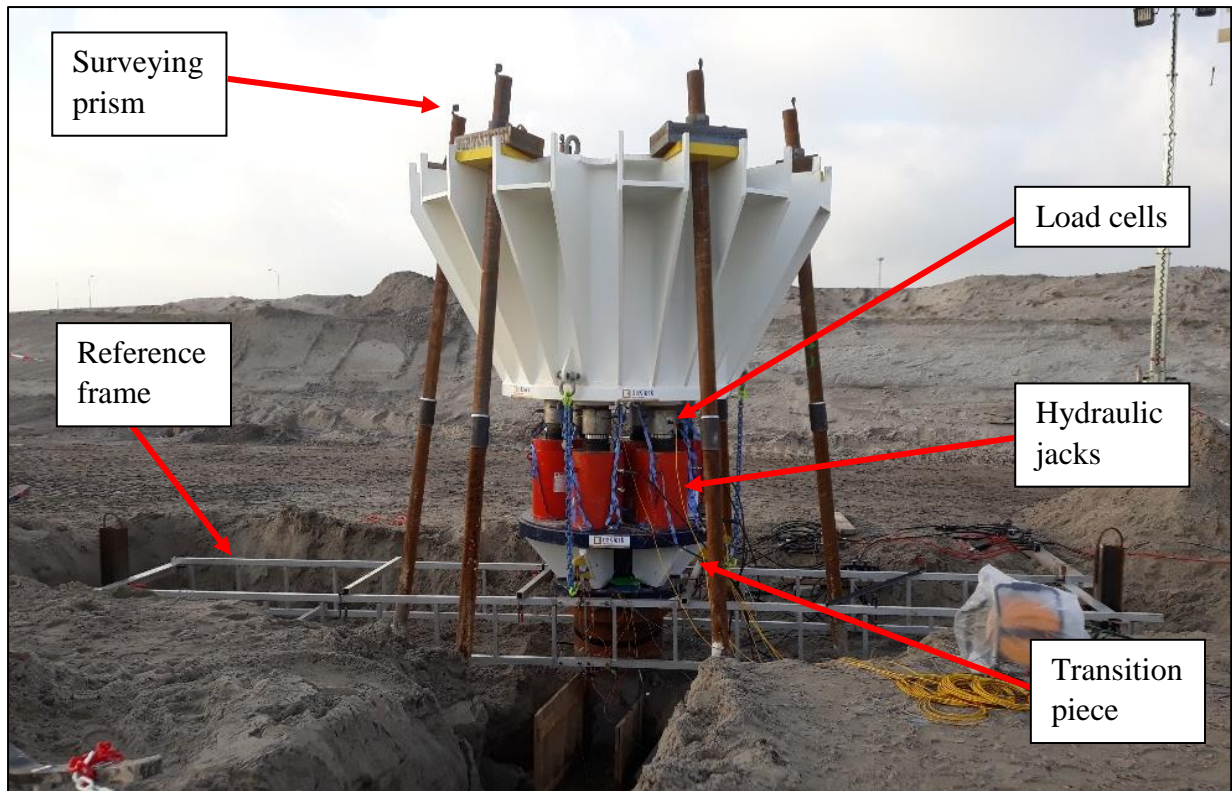
Figure 4.1: Reaction frame & reference frame

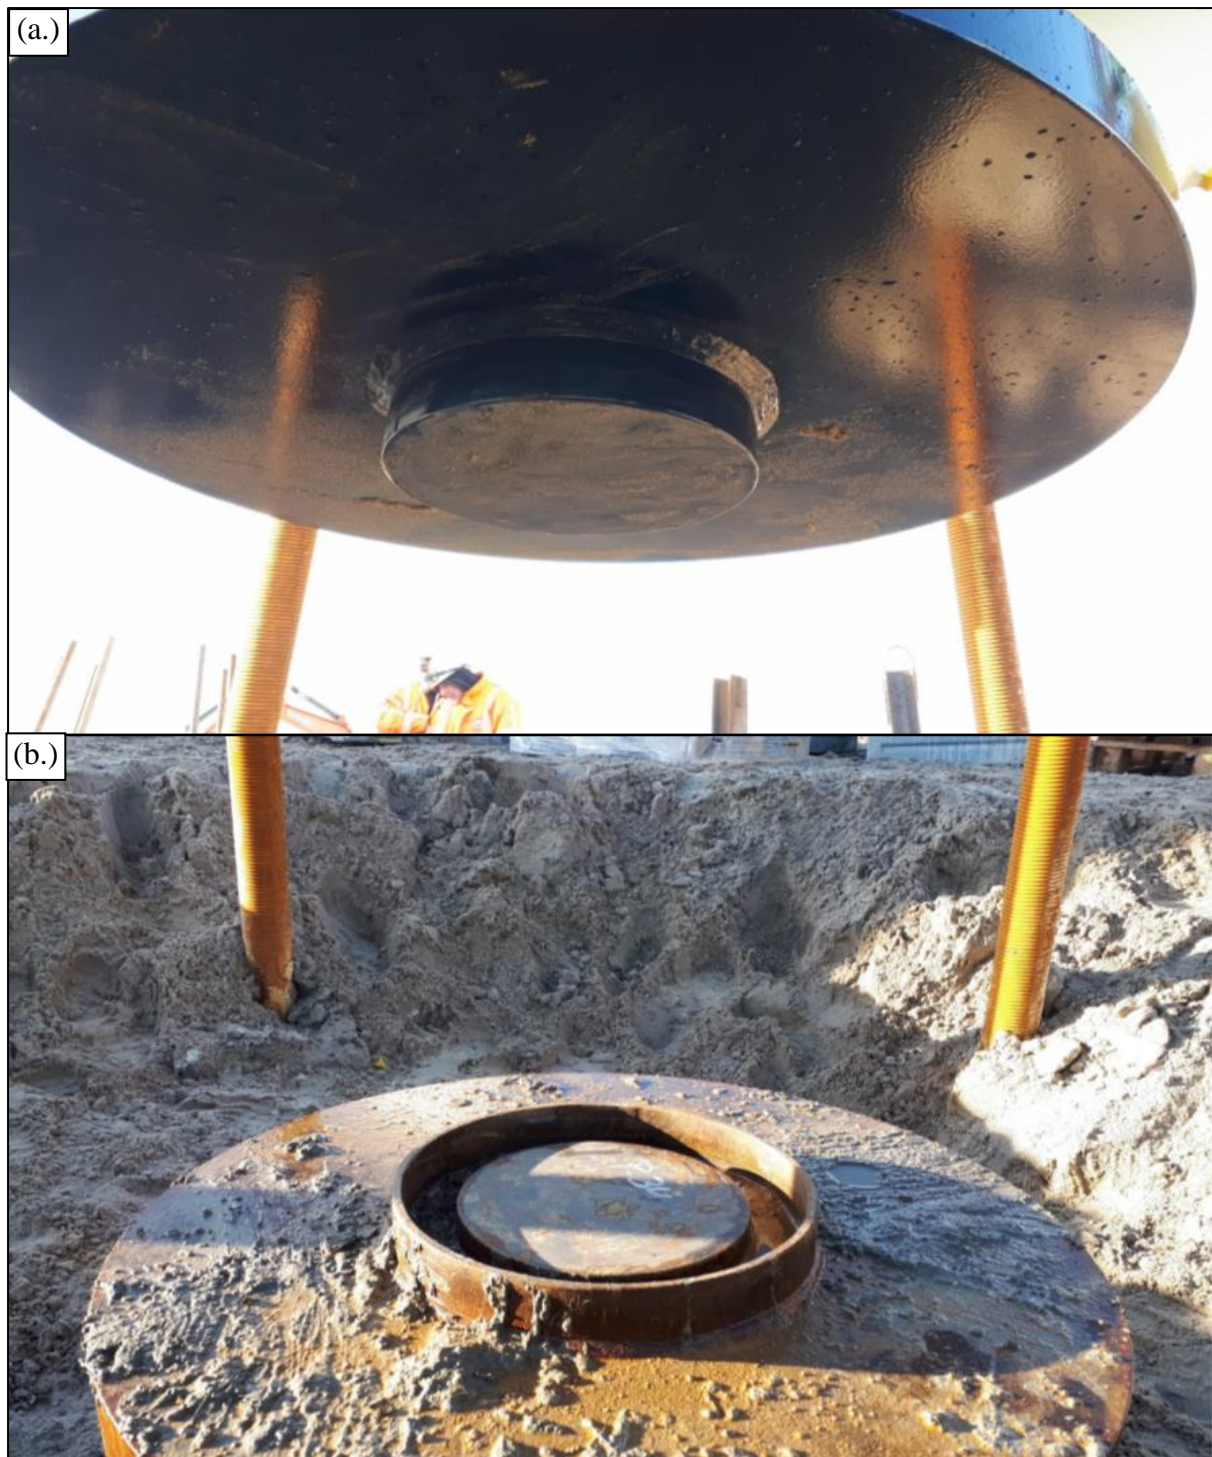
Figure 4.3: Interface between the reaction frame and the pile cap: (a.) underside of the transition piece (b.) top of the pile cap (Photos: Gust Van Lysebetten, WTCB)

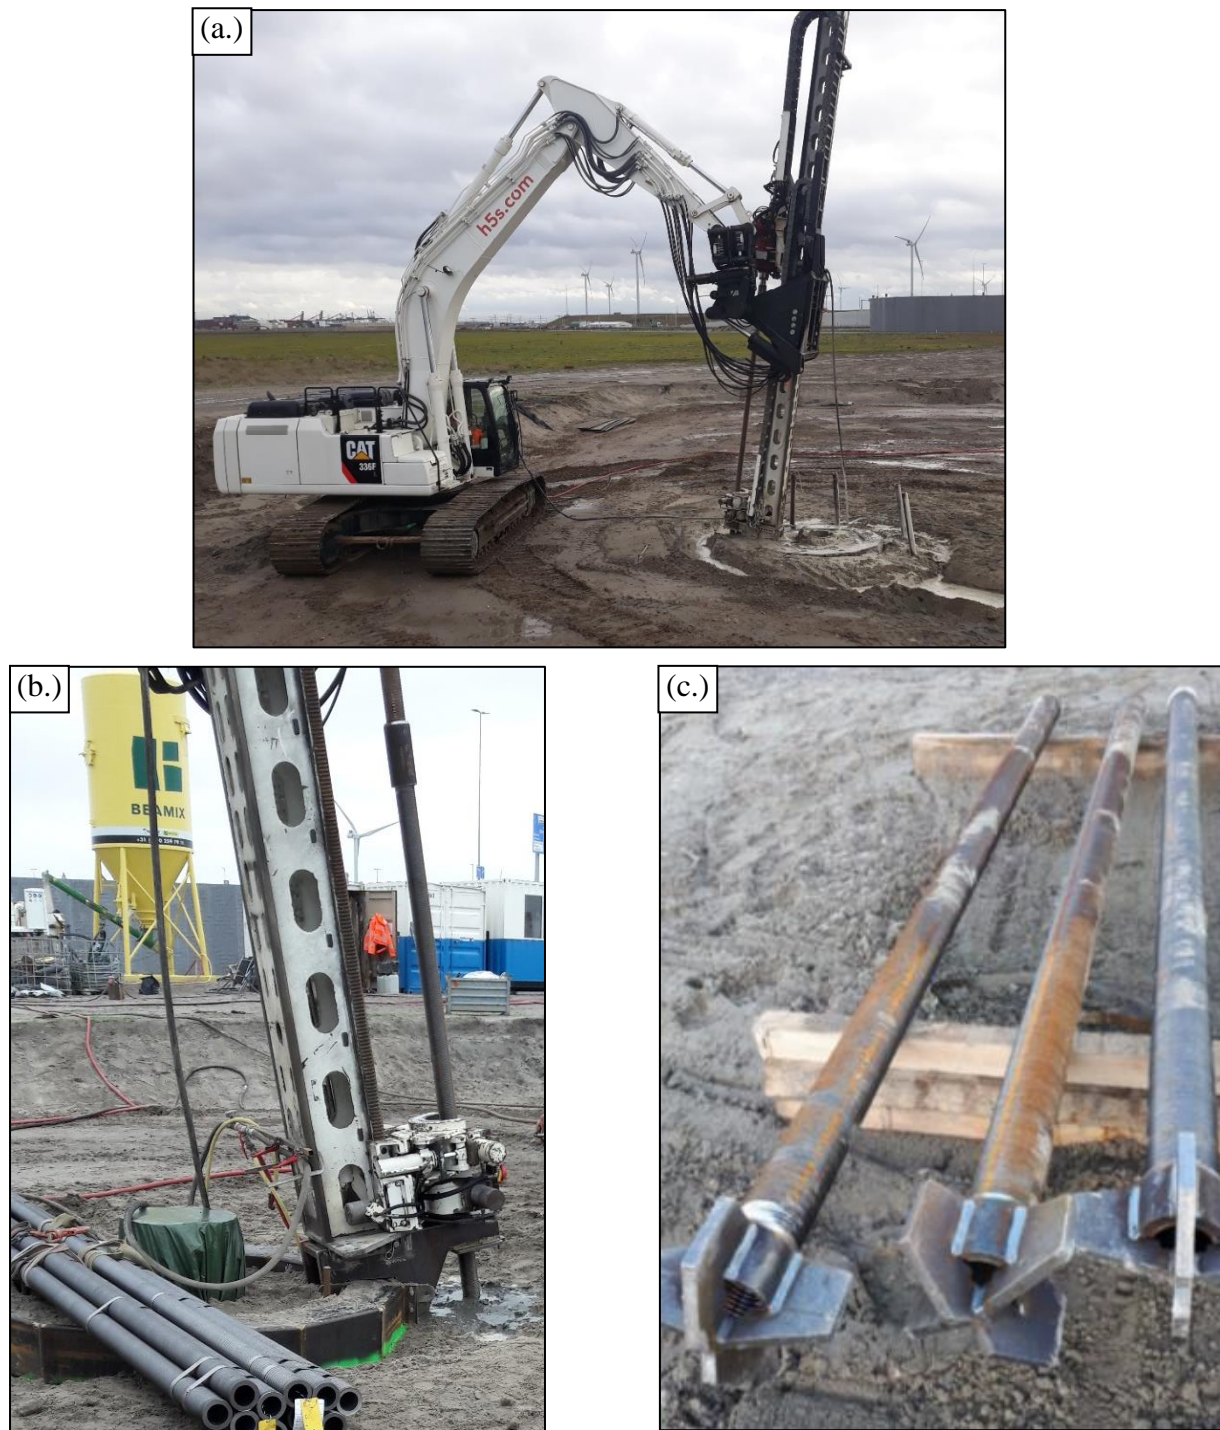
Figure 4.5: (a.) Installation of the grout anchors around the test pile (b.) Close up of the installation process, highlighting the use of the anchor guide frame in order to install the anchors at the correct position (c.) screw tip of the grout anchors (photo: Gust van Lysebetten, WTCB)

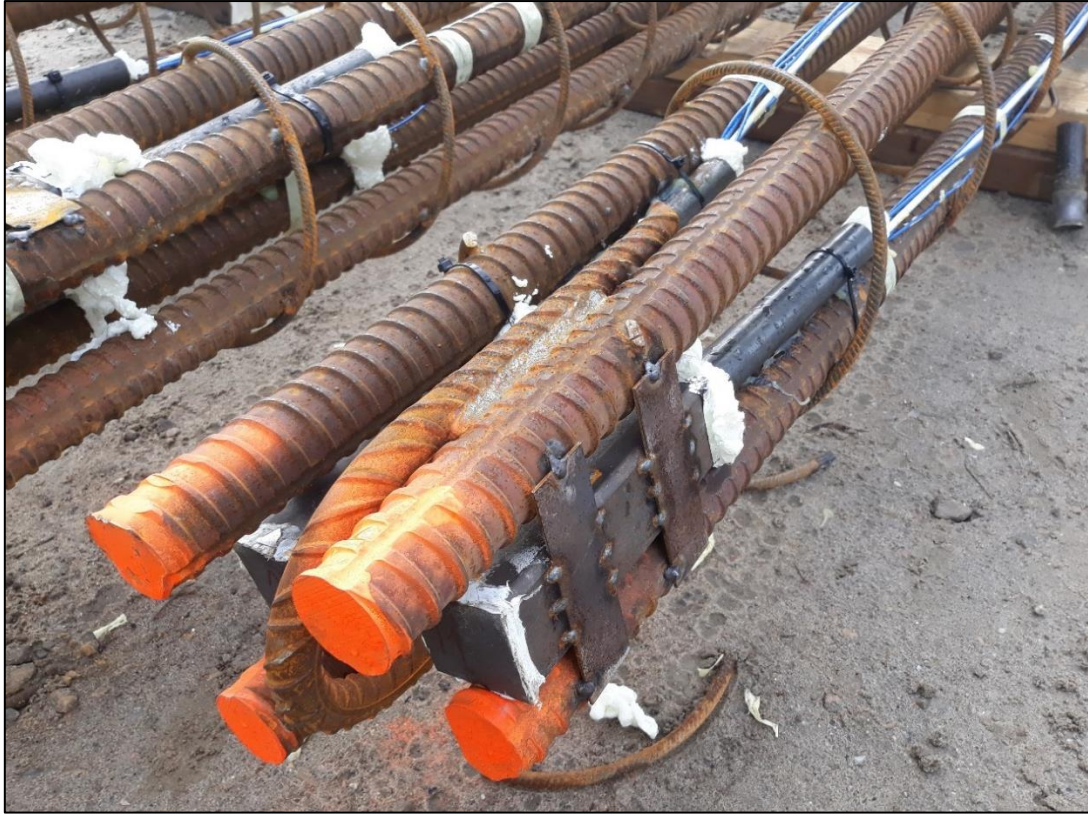
Figure 4.9: The instrumented reinforcement cage in advance of its insertion into the auxiliary tube. Note the two protective metal boxes at the tip of the reinforcement cage.

The ends of both the BOFDA and FBG cables were stored in two metal boxes at the top of the reinforcement cage to avoid any damage that may arise during the insertion of the reinforcement cage and concrete pouring (Figure 4.9). During the lifting of the reinforcement cage, care was taken to ensure no striking of the reinforcement cage against other objects (such as the head of the auxiliary tube) and the use of two cranes (for further details on the lifting procedure, see Section 3.2) mitigated the amount of bending in the reinforcement cage, and consequently, the fibre optics. Following the installation of the reinforcement cage and the placement of the concrete, a sleeve was placed around the pile head (Figure 3.5) along with the pile cap, between which the fibres were able to exit the pile (Figure 4.11).

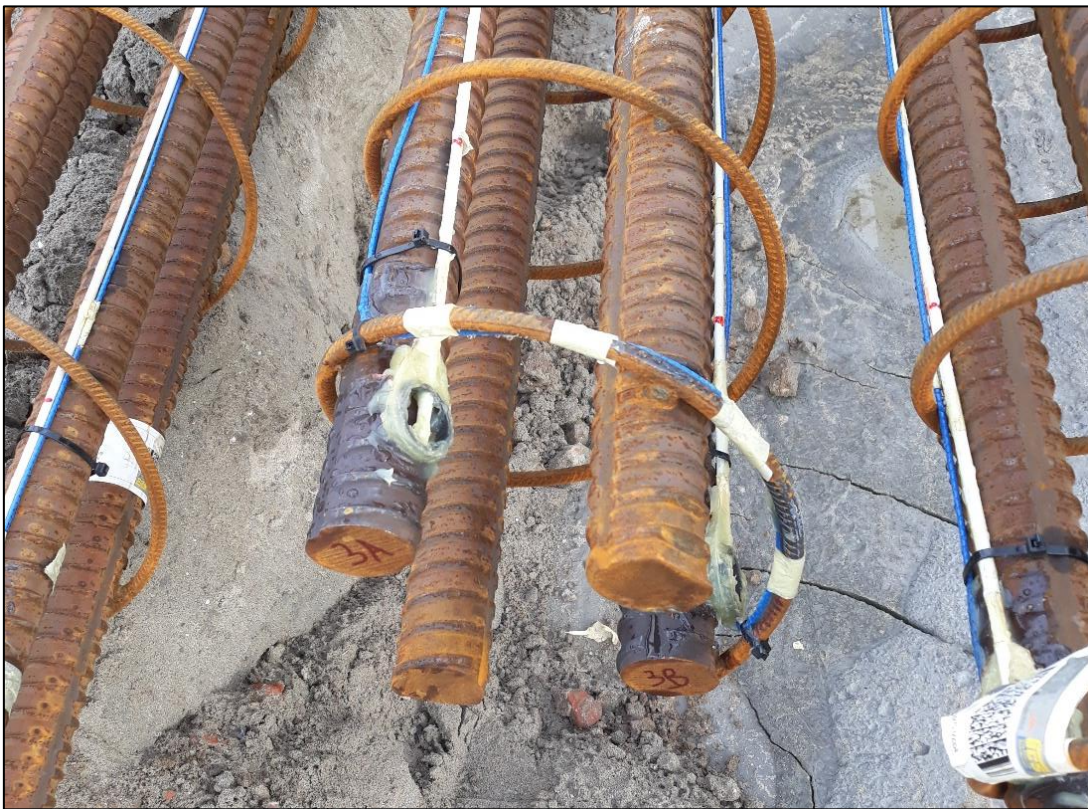
Figure 4.10: Close-up of the base of the reinforcement cage. Note the loop in the BOFDA cable (blue cable) across the spiral reinforcing. The FBG cable (white) terminates at the end of the reinforcement cage

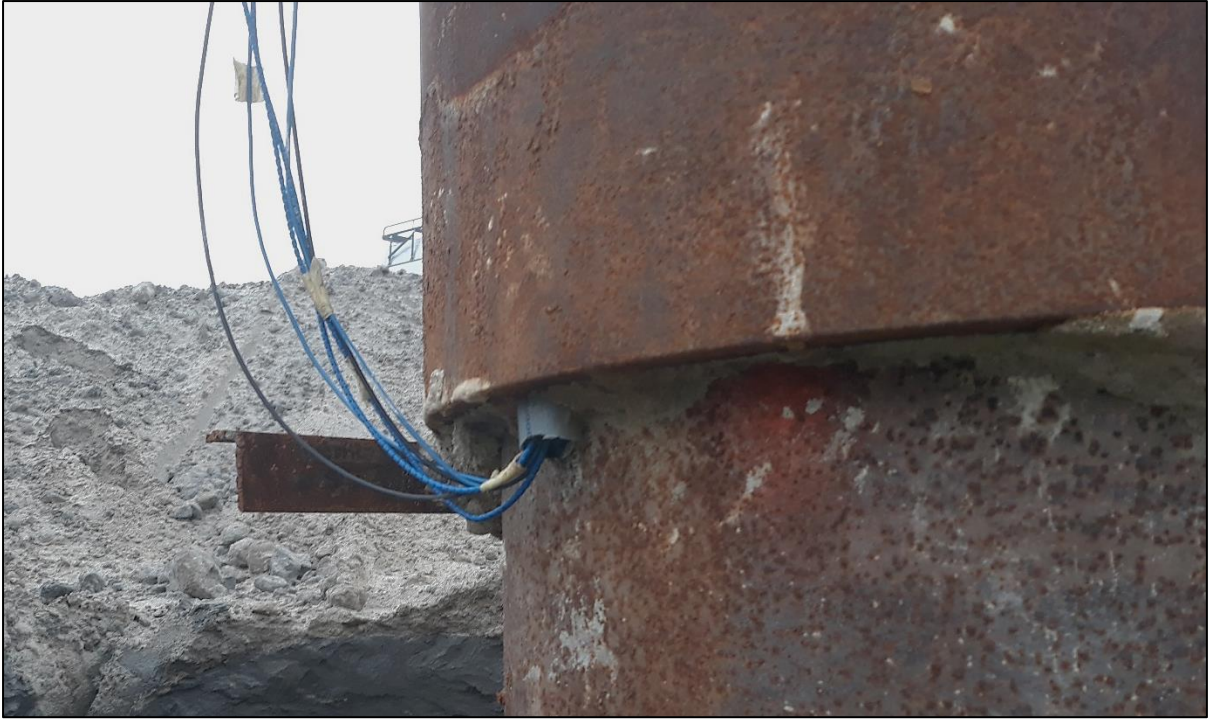
Figure 4.11: Egress point for the fibre optics between the pile cap and pile sleeve. Grout was used to fill the annular space between the pile cap and pile sleeve, with a PVC facilitating the safe passage of the fibre optics through the annular space

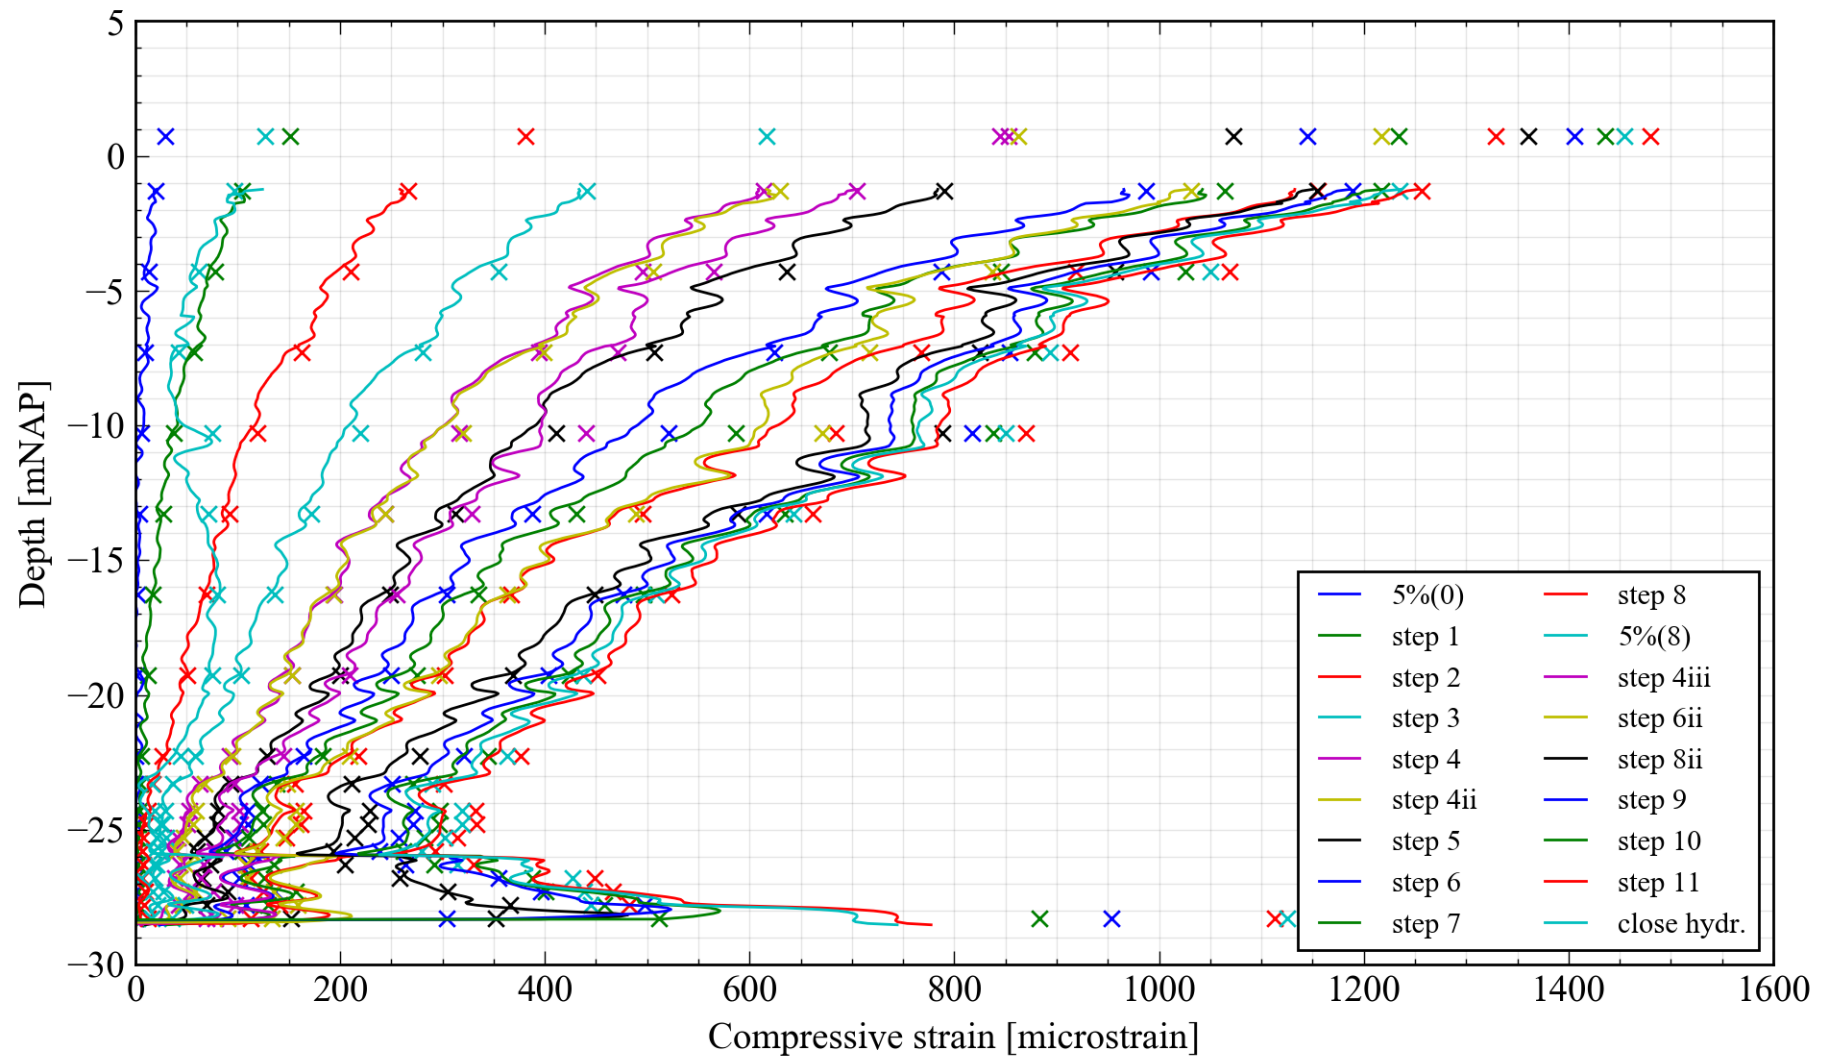
Figure 5.11: Strain versus depth profile for P01 at the end of each load step. Note that the BOFDA measurements are indicated by a continuous line whereas FBG readings are indicated by a discrete point

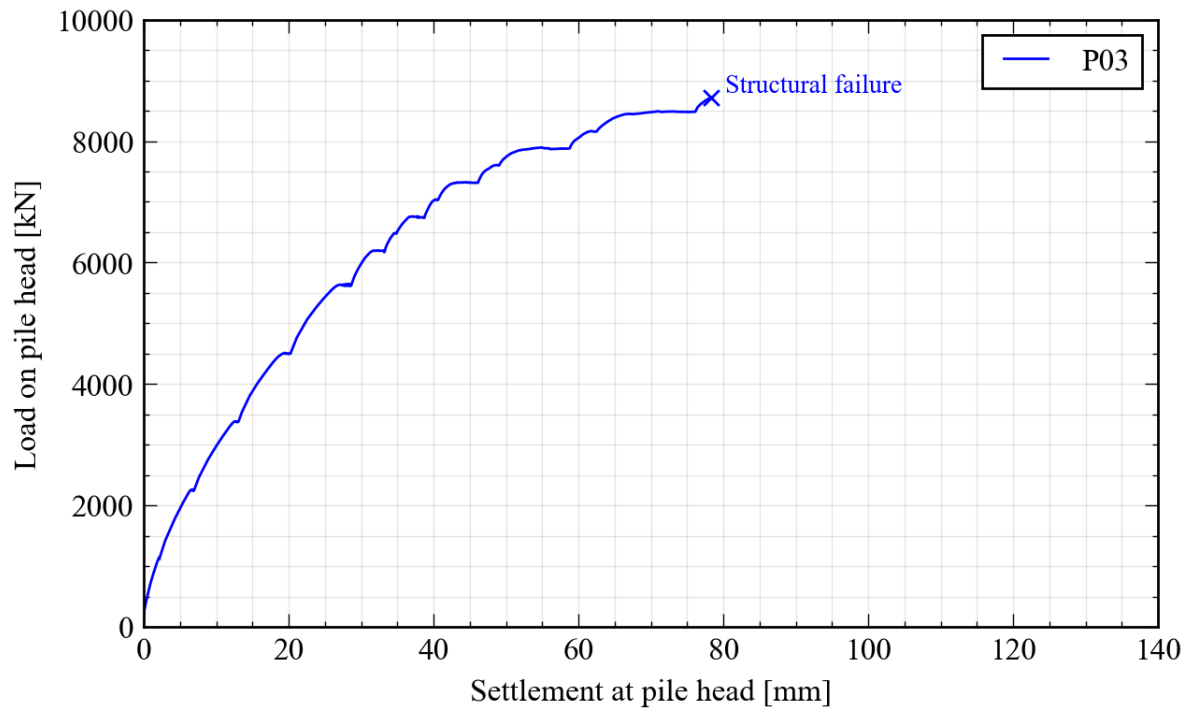
Figure 5.20: Plot of load versus settlement at pile head for P03. Note that the structural failure and breakage of the fibres resulted

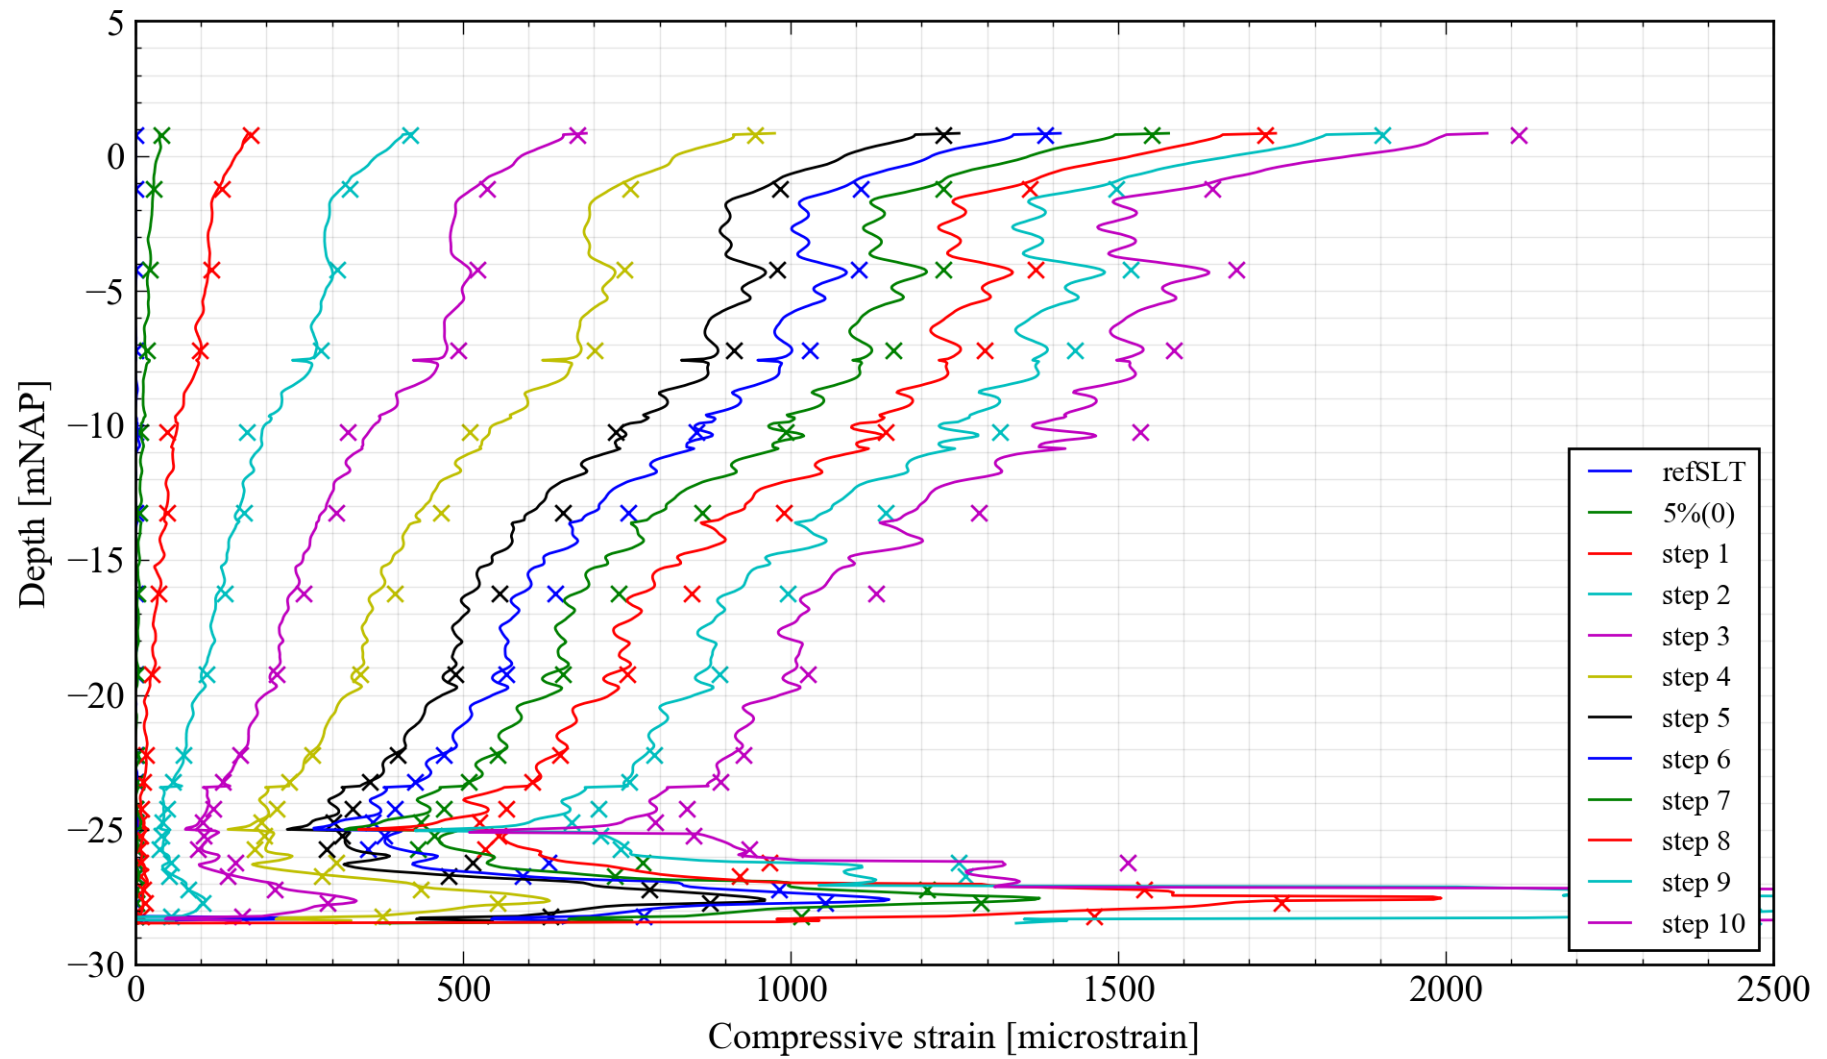
Figure 5.24: Strain versus depth profile for P03 at the end of each load step. Note that the BOFDA measurements are indicated by a continuous line whereas FBG readings are indicated by a discrete point

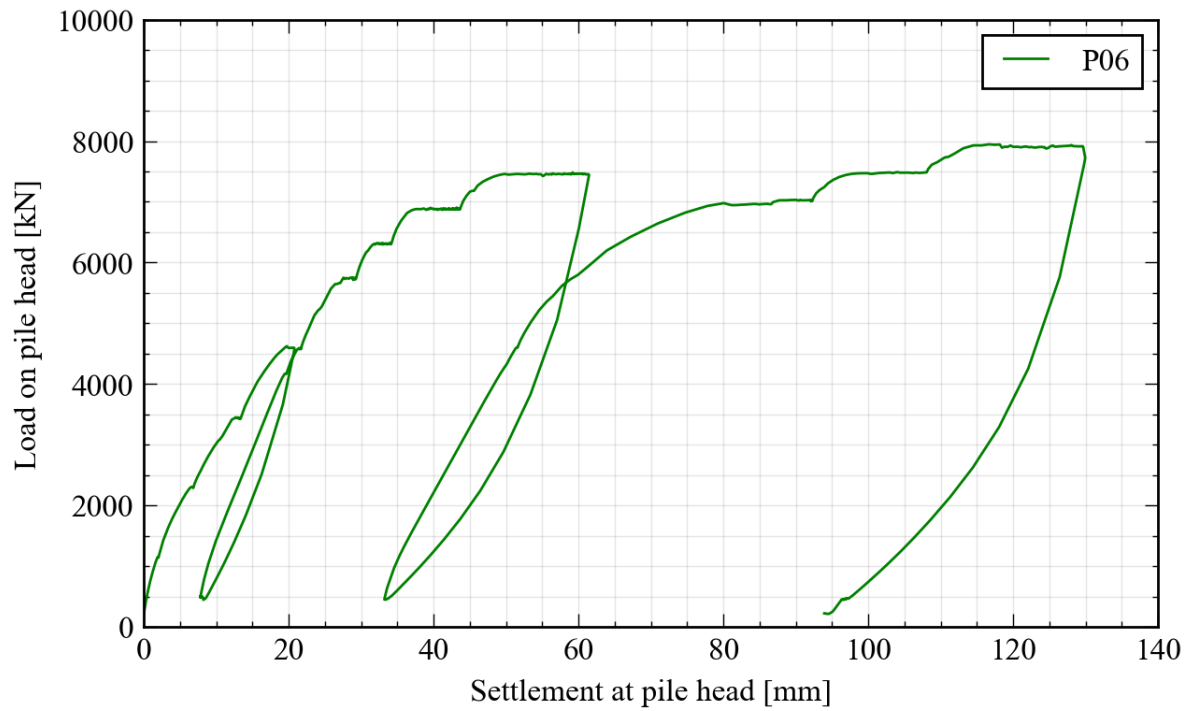
Figure 5.31: Plot of load versus settlement at pile head for P06

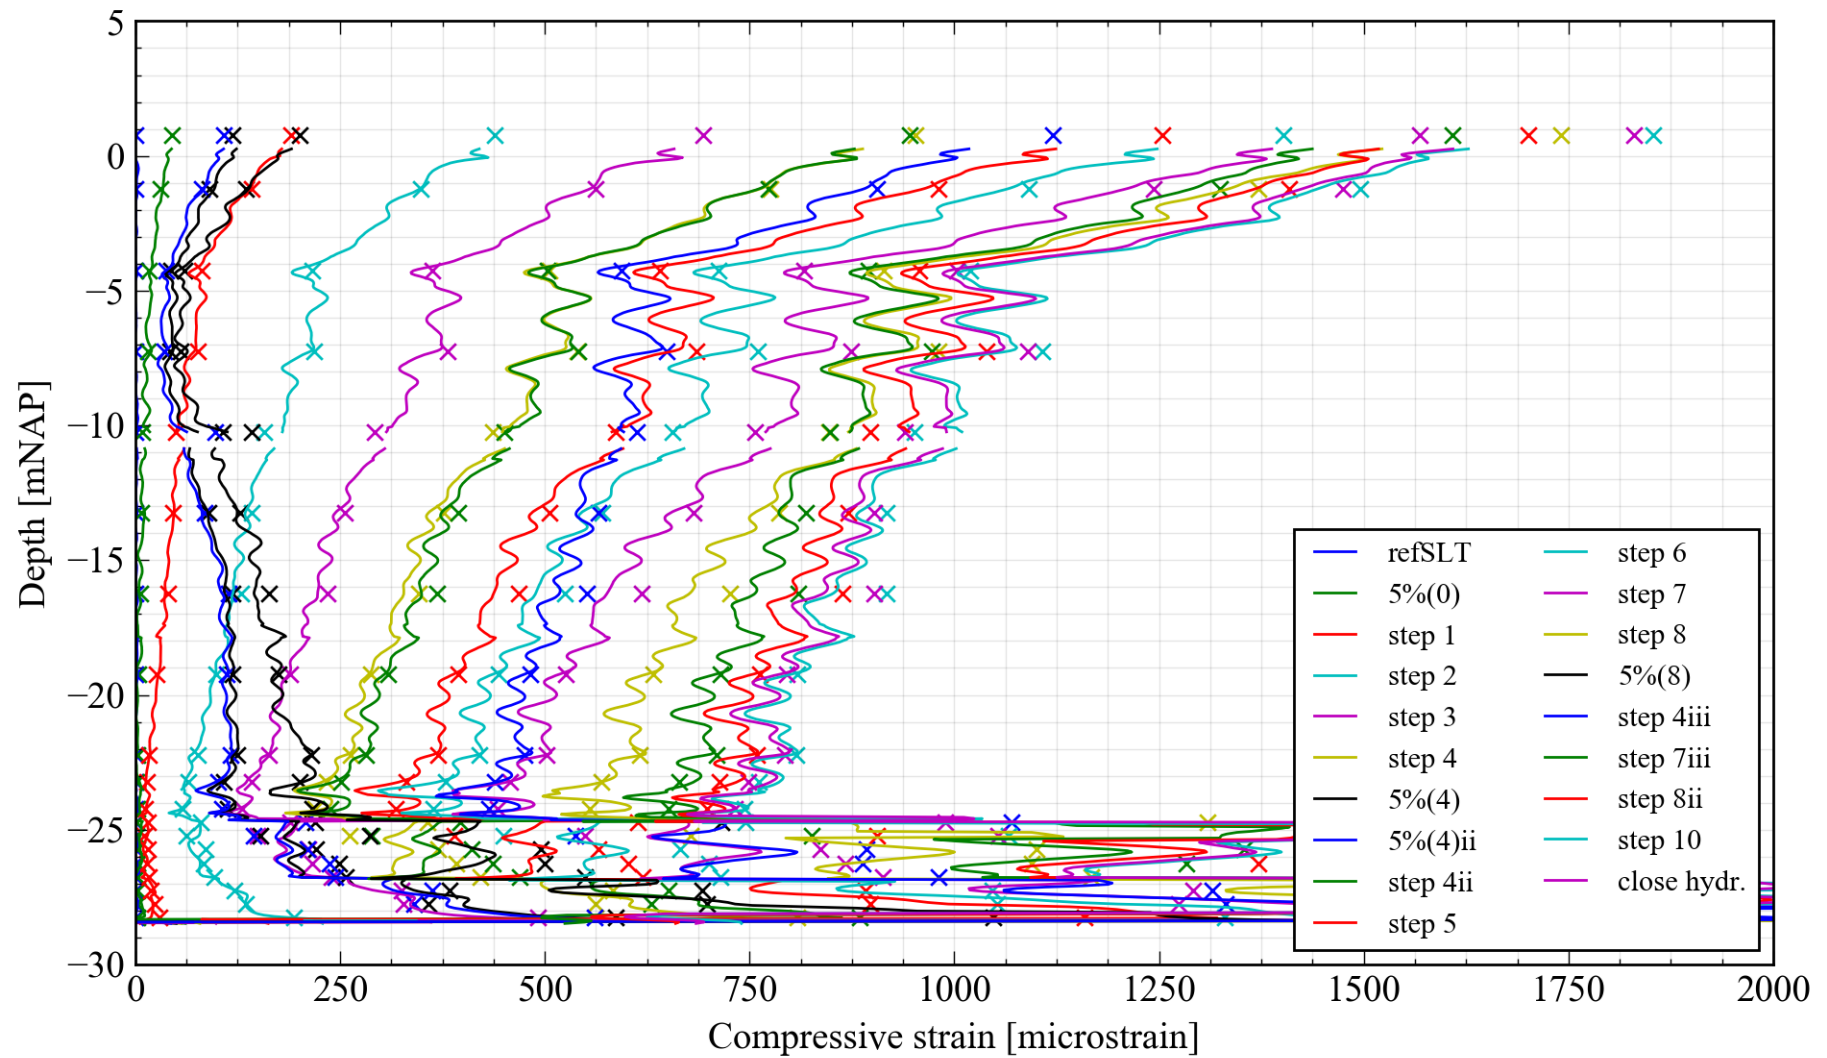
Figure 5.35: Strain versus depth profile for P06 at the end of each load step. Note that the BOFDA measurements are indicated by a continuous line whereas FBG readings are indicated by a discrete point

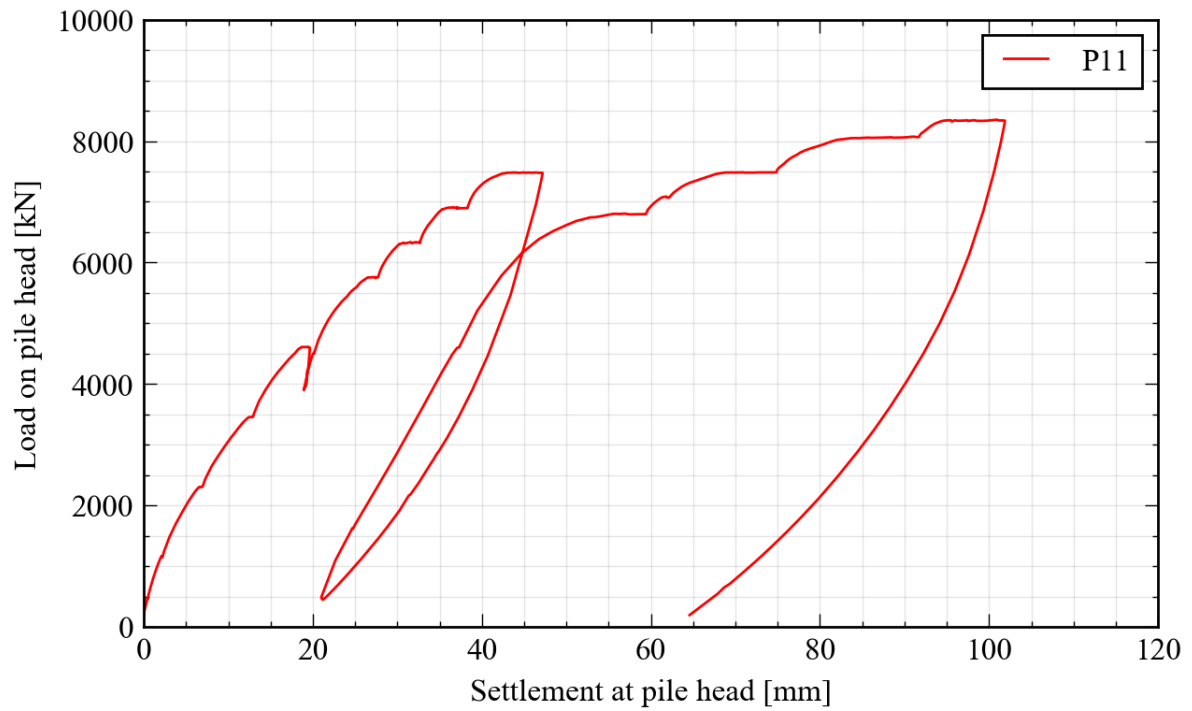
Figure 5.42: Plot of load versus settlement at pile head for P11
