Report on pile test results at Maasvlakte II

Vibro piles

Report on pile test results at Maasvlakte II Vibro Piles

Author: Kevin Duffy

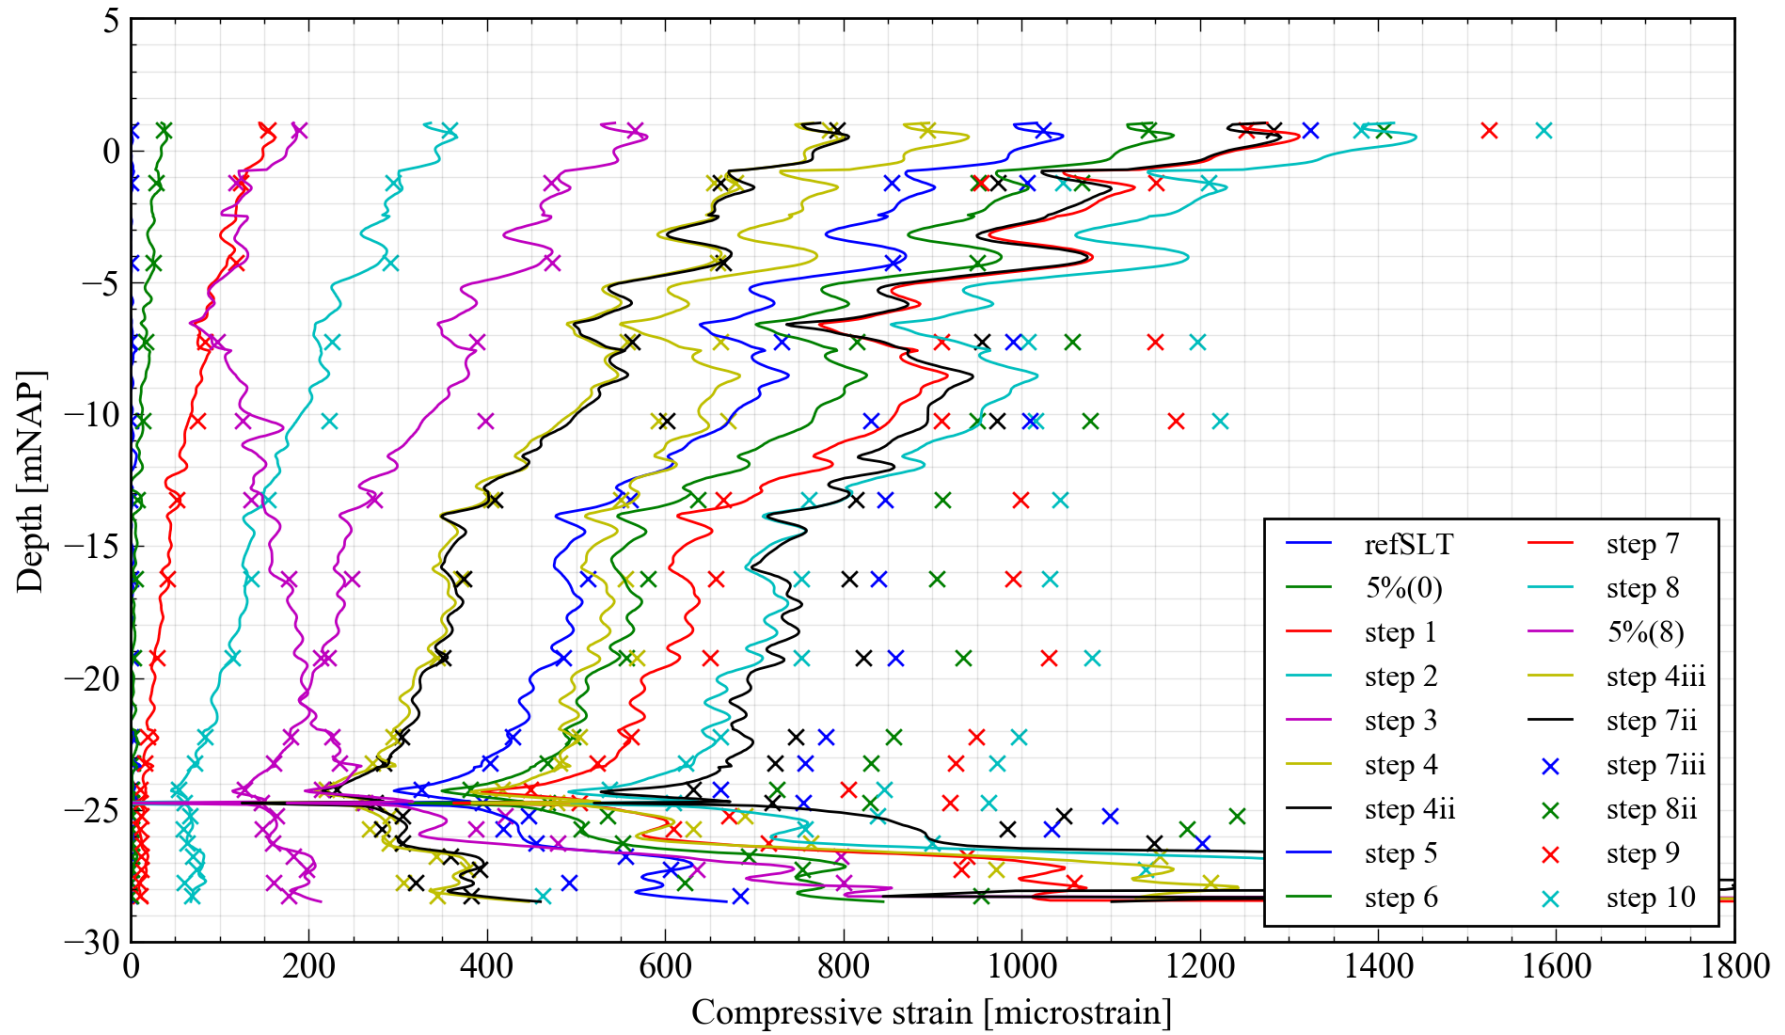
Figure 5.46: Strain versus depth profile for P11 at the end of each load step. Note that the BOFDA measurements are indicated by a continuous line whereas FBG readings are indicated by a discrete point

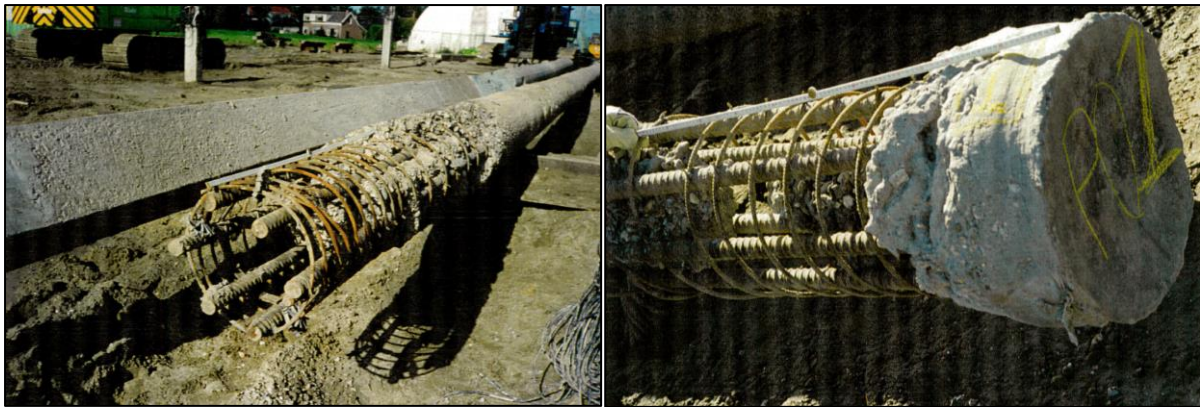
Figure 6.1: Photos of the piles after tension tests at the Gaag viaduct in Schipluiden. Noticeable deterioration of concrete towards the pile tip was observed (Geerling and Janse, 1997)

This problem has been observed in previous projects (BieTec B.V. Consultancy (2015), Geerling and Janse (1997), van Weele and Lencioni (1999)) where noticeable deterioration of concrete quality towards the pile base was observed (e.g. Figure 6.1) and numerous factors (be it a combination thereof or otherwise) have been identified as the possible cause of this segregation, notably with regards to the composition of the concrete mix (such as its workability and cohesiveness) and the placement of the reinforcement cage.

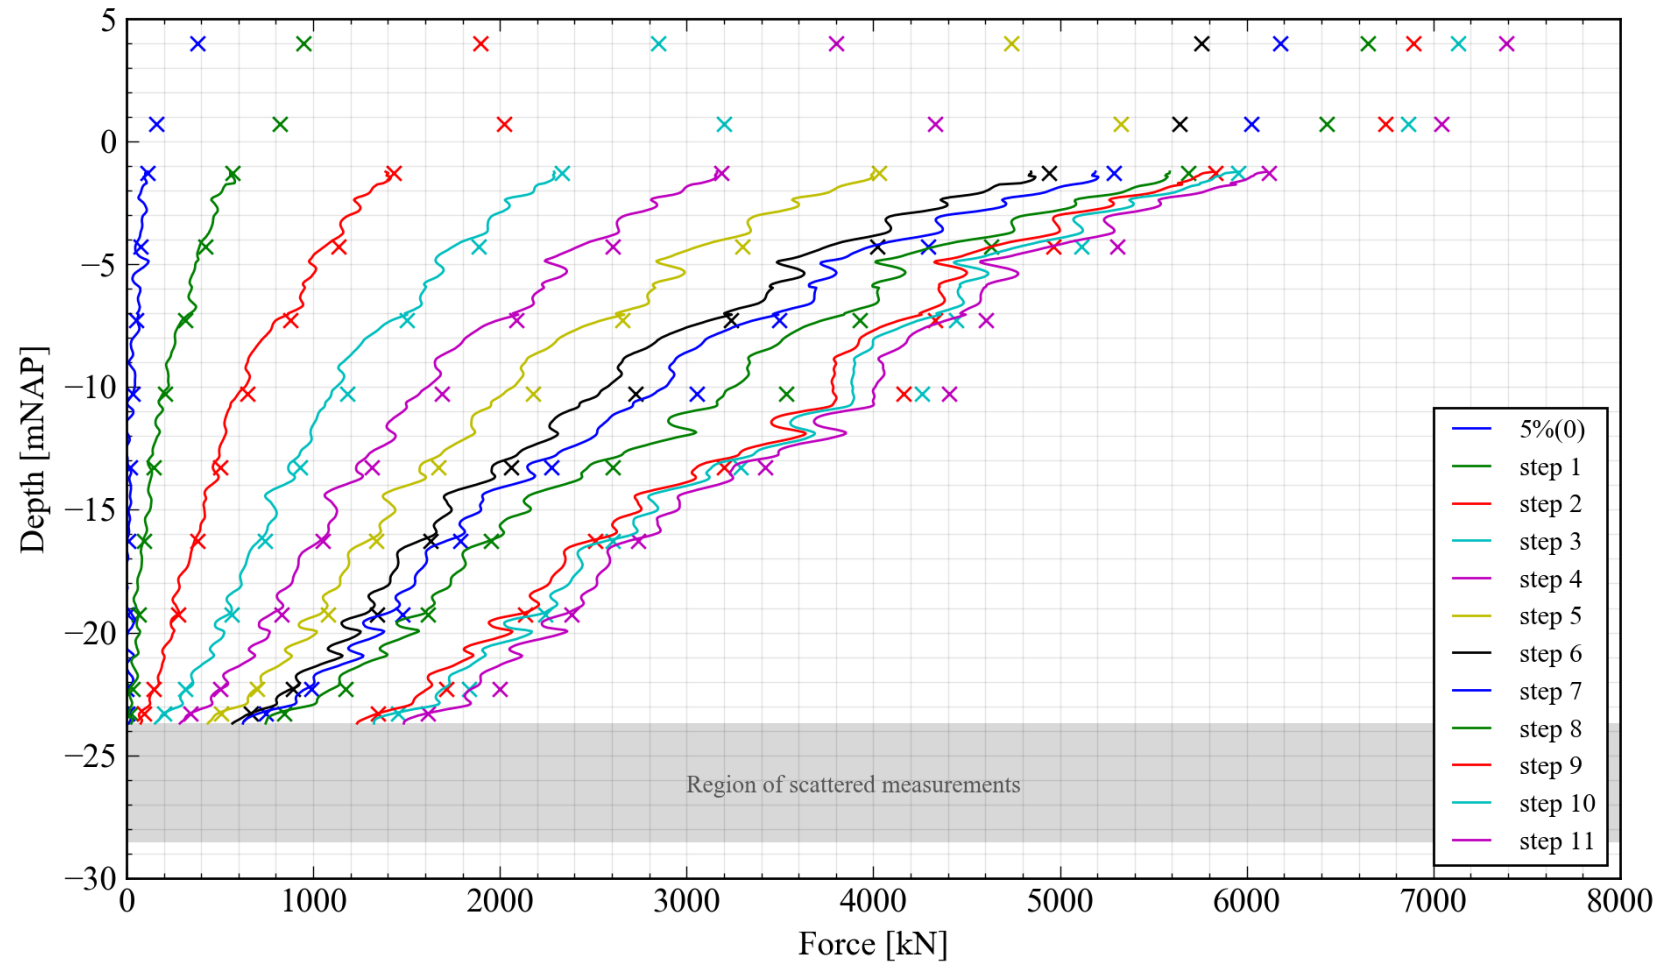
Figure 6.6: Force-depth profile of P01, taking the forces in the gauges at the end of the load step. Note that the BOFDA measurements are indicated by a continuous line whereas FBG readings are indicated by a discrete point and the force measured by the load cells has also been included as discrete points at NAP +4m. Steps within an unload/reload cycle have been omitted

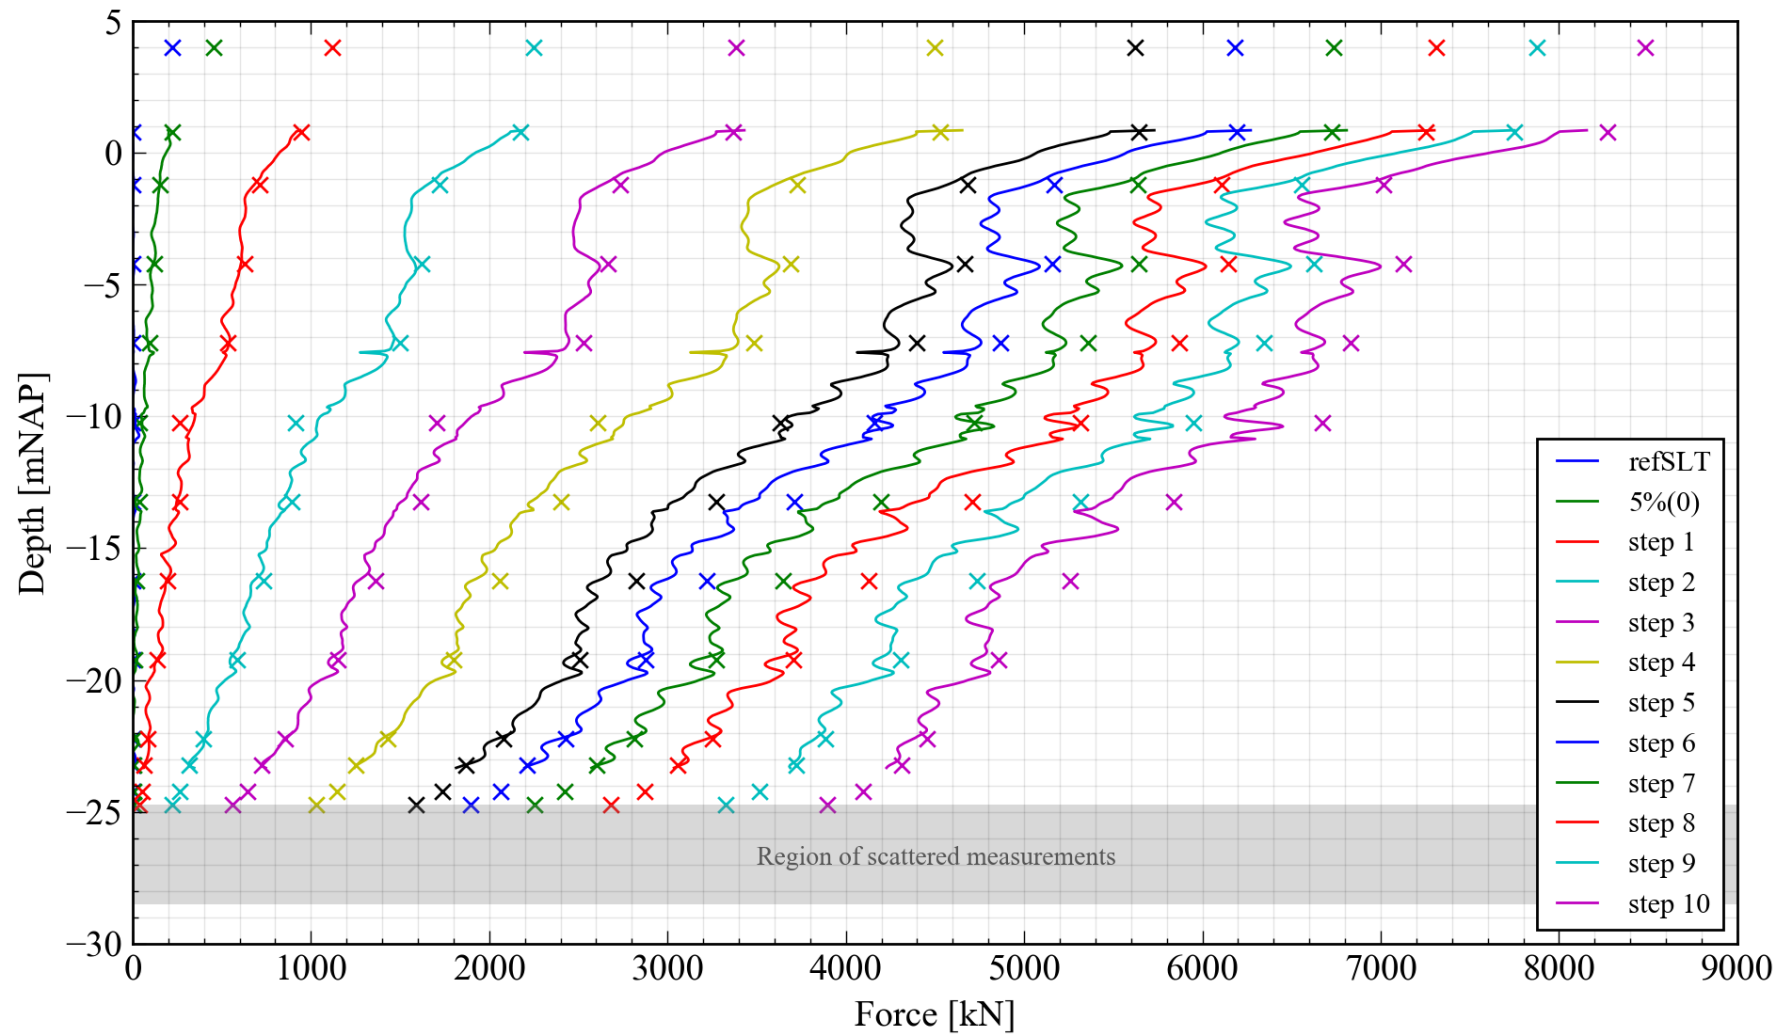
Figure 6.7: Force-depth profile of P03, taking the forces in the gauges at the end of the load step. Note that the BOFDA measurements are indicated by a continuous line whereas FBG readings are indicated by a discrete point and the force measured by the load cells has also been included as discrete points at NAP +4m. Steps within an unload/reload cycle have been omitted

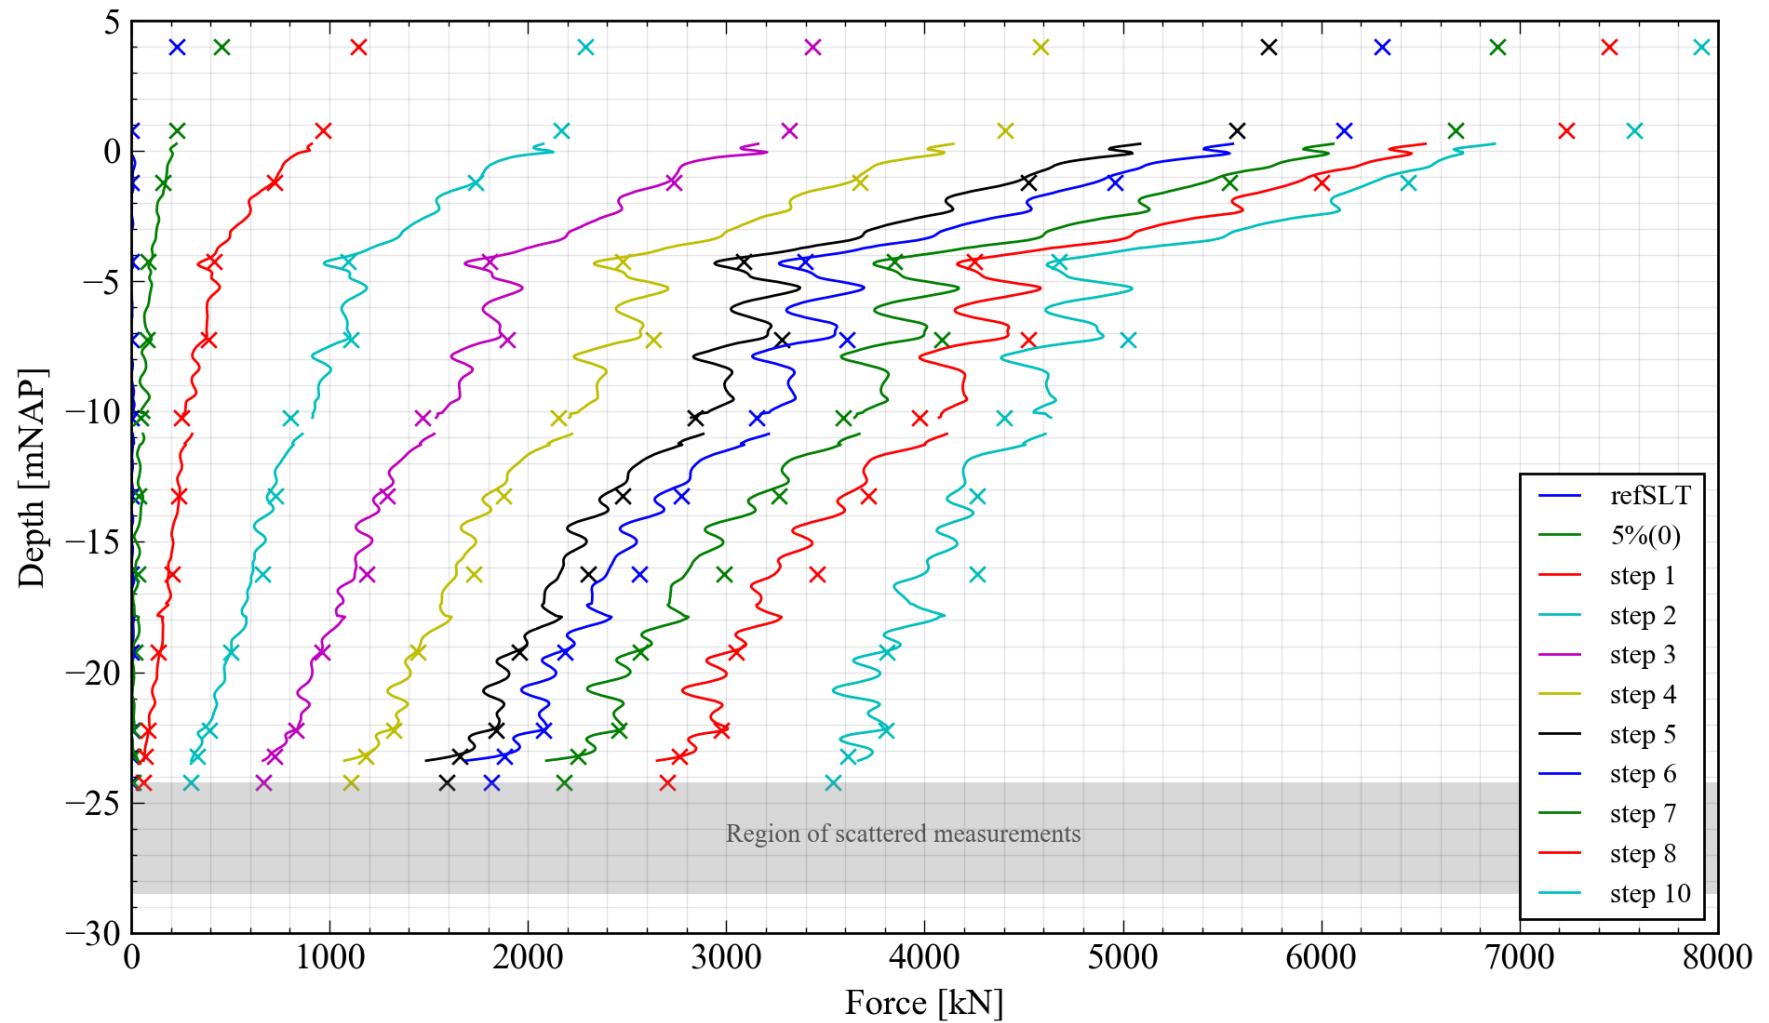
Figure 6.8: Force-depth profile of P06, taking the forces in the gauges at the end of the load step. Note that the BOFDA measurements are indicated by a continuous line whereas FBG readings are indicated by a discrete point and the force measured by the load cells has also been included as discrete points at NAP +4m. Steps within an unload/reload cycle have been omitted. The measurement gap in the BOFDA readings at approx. NAP -10.5m is as a result of the coupling sleeve on the reinforcement distorting the readings. This has been corrected for in the FBG measurement

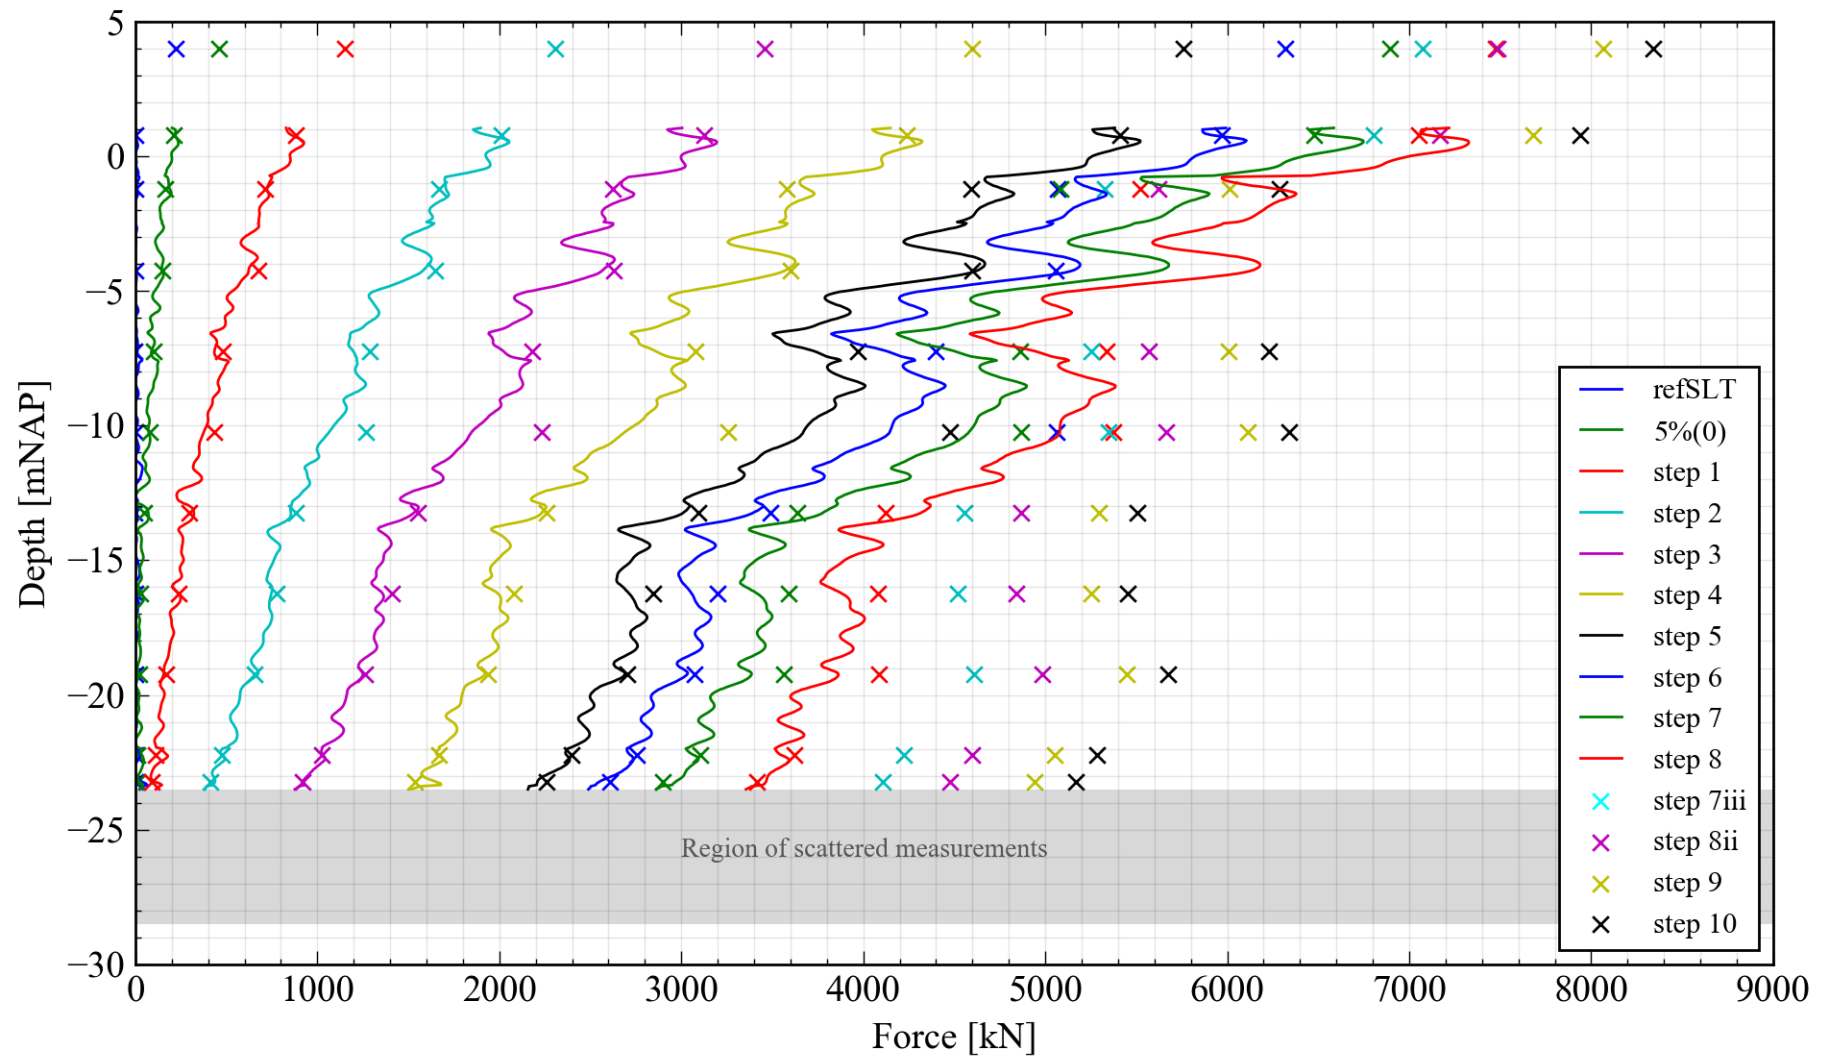
Figure 6.9: Force-depth profile of P11, taking the forces in the gauges at the end of the load step. Note that the BOFDA measurements are indicated by a continuous line whereas FBG readings are indicated by a discrete point and the force measured by the load cells has also been included as discrete points at NAP +4m. Steps within an unload/reload cycle have been omitted

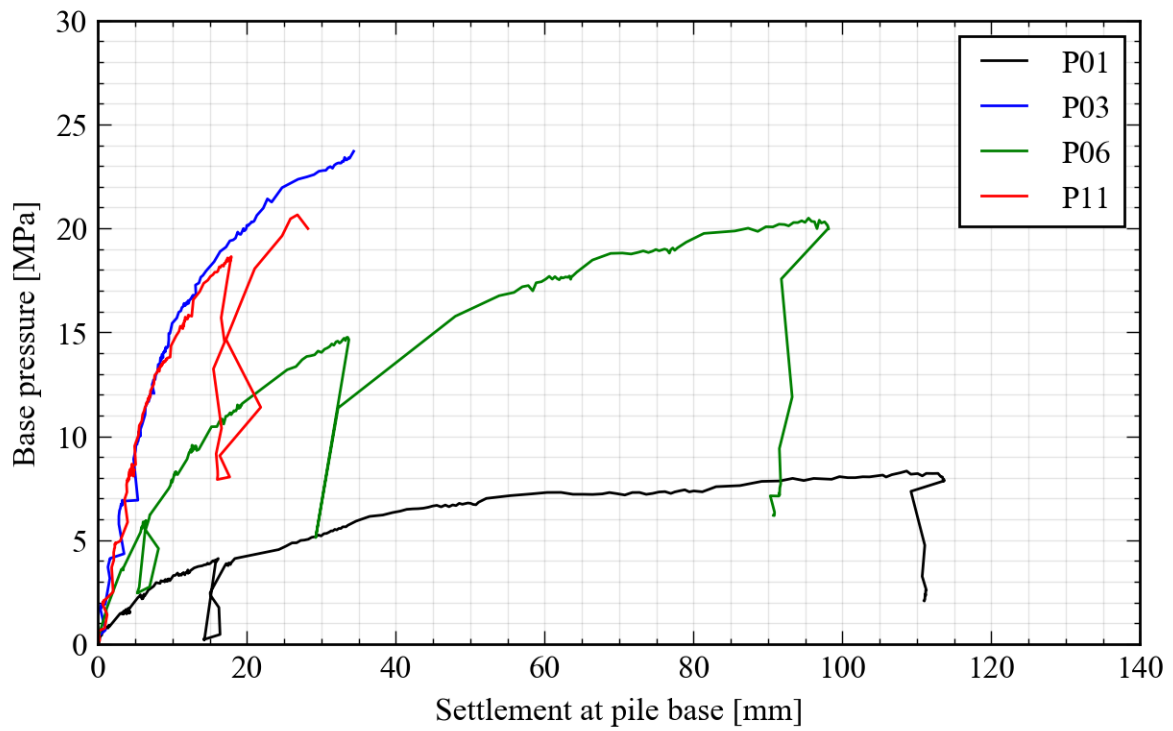
Figure 6.10: Mobilisation of the base capacity for all vibro piles (BOFDA measurements)

Patently, piles P03 and P11 develop the stiffest response of the four vibro piles, reaching a base stress of approximately 24MPa and 28MPa respectively, with both piles exhibiting almost identical stiffnesses. However, structural breakage in pile P03 resulted in the premature structural failure of the pile and was unable to reach a pile base settlement of $0.1D_{eq}$. Nonetheless, the base response of both piles is similar up until a base settlement of 7% of the equivalent pile diameter.

Weaker responses are evident in P01 and P06, substantially so in the case of P01. For pile P01, a peak base resistance of 8MPa was observed and for P06, a peak base resistance of 21MPa was attained. The resulting pile class factor α_p for both piles (Table 6.3) is in the range of 0.40-0.54, redolent of a continuous flight auger pile, as opposed to an α_p of 0.67 for P11, which is more in keeping with a driven precast pile according to the current NEN 9997-1 prescriptions.

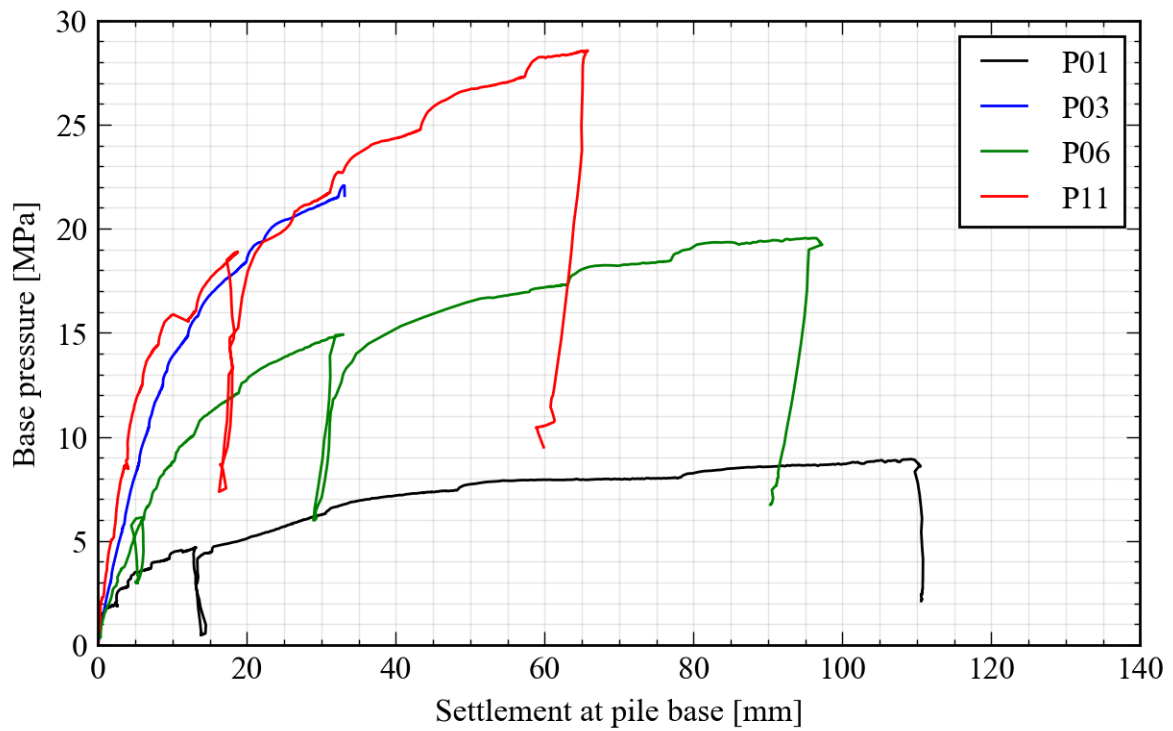
Figure 6.11: Mobilisation of the base capacity for all vibro piles (FBG measurements)

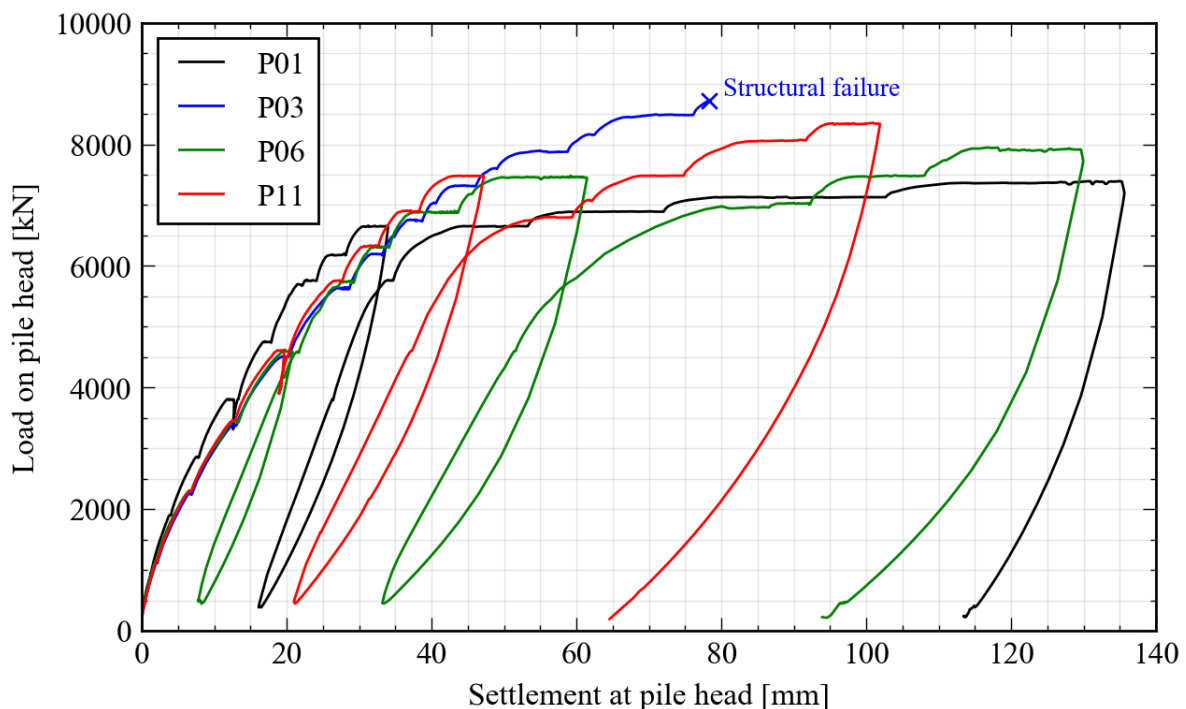
Figure 7.1: Load vs. settlement response of all vibro piles

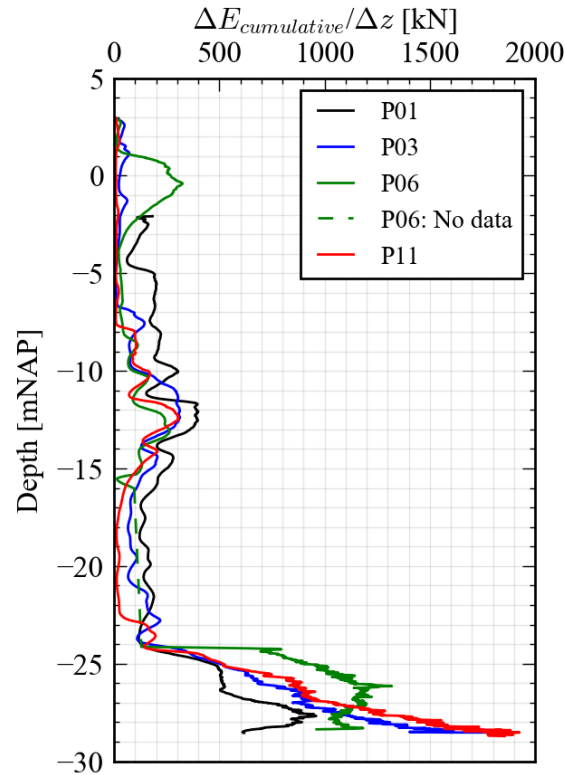
Figure 7.2: Change in imparted hammer energy with depth for the vibro piles

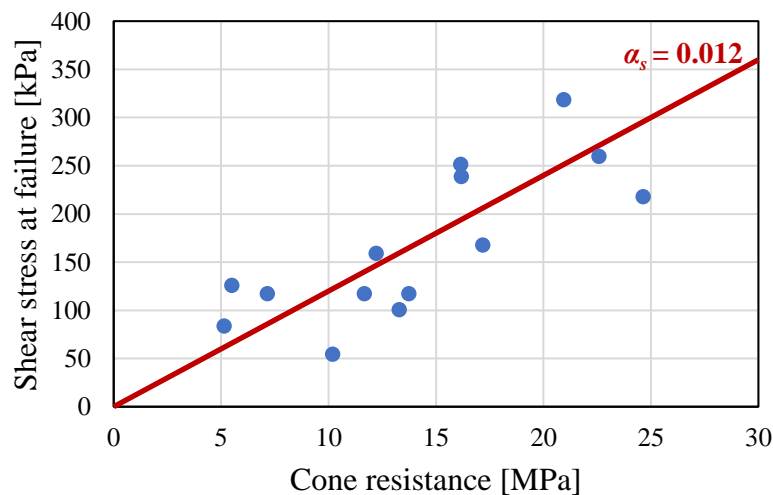
Figure 7.4: Range of shaft resistances along the pile shaft at pile failure ($s_b = 0.1D_{eq}$) plotted against the corresponding average cone resistance of that shaft increment
