The remaining capacity of the timber foundation of a historical quay wall with relieving platform

A case study of the Maaskade

Master Thesis

in Civil Engineering: Building Engineering - Structural Design

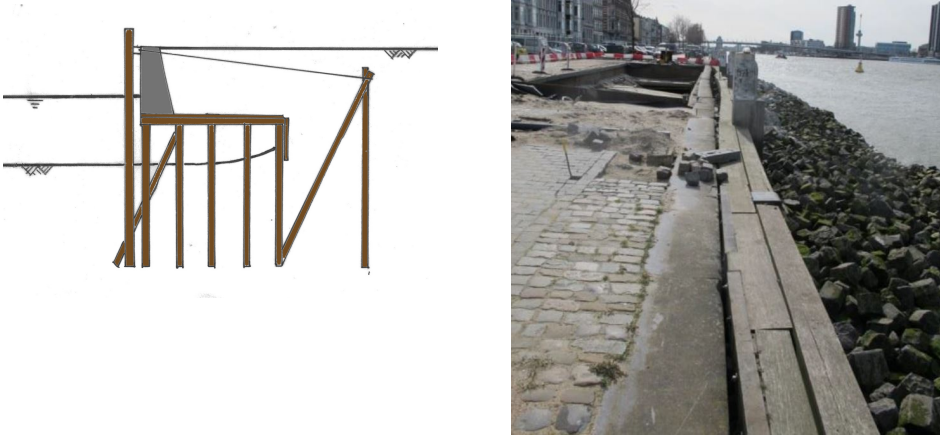
Figure 1.1: A quay wall with relieving platform (left), inspection of the failure of the Maaskade (right) [6] .

Quite possibly one result of this combination is the partial collapse of the Maaskade in the centre of Rotterdam in December 2015. Over a width of approximately 40 metres, the wall broke and the soil behind it was able to flush away (see figure 1.1). The conclusions of the inspection afterwards included a poor to very poor connection of the piles with the timber floor structure, broken timber capping beams and fungal decay on the horizontally placed timber elements [6]. This has been the direct motive of the research in this thesis.

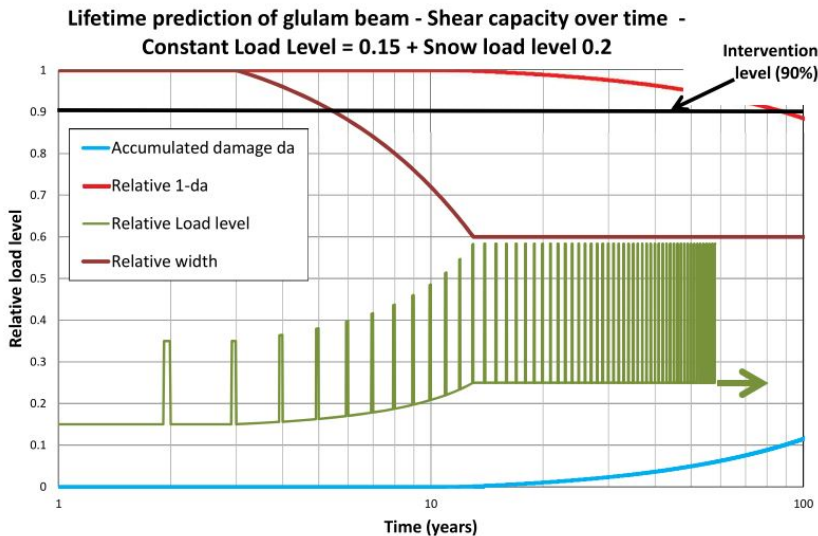
Figure 2.13: Damage evolution of a delaminating glulam beam, where the intervention level is reached after approximately 87 years. Figure from (van de Kuilen, Gard, 2013) [34].

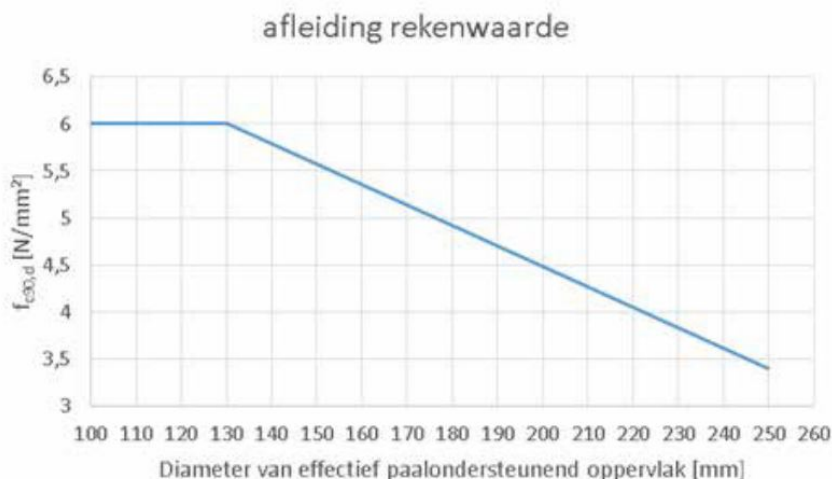
Figure 2.15: Compressive strength perpendicular to the grain in a capping beam at a joint with the pile. Strength on the x-axis, diameter of the effective pilesupporting area on the beam-pile connection on the y-axis. Figure from the F3O guideline, page 50 [37].

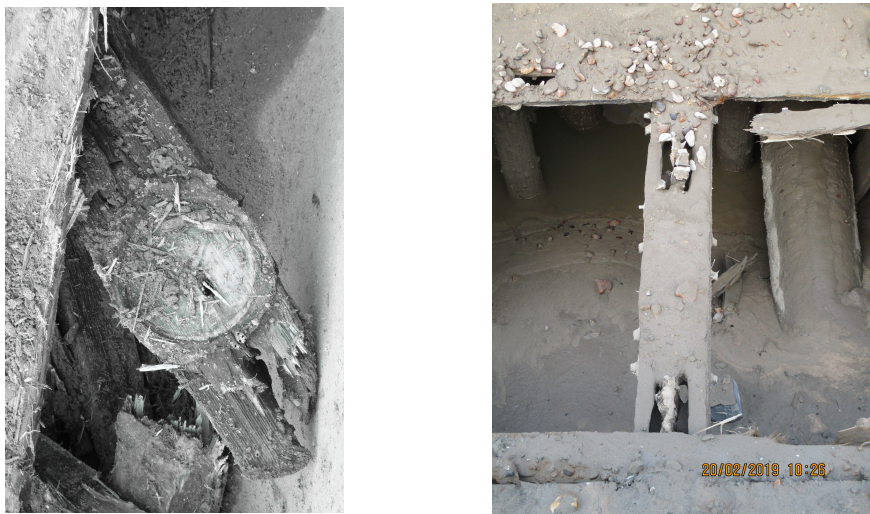
Figure 5.7: State of softwood. Left: clearly visible connection places are less deteriorated. Right: Bad state of mortise and tenon joints.

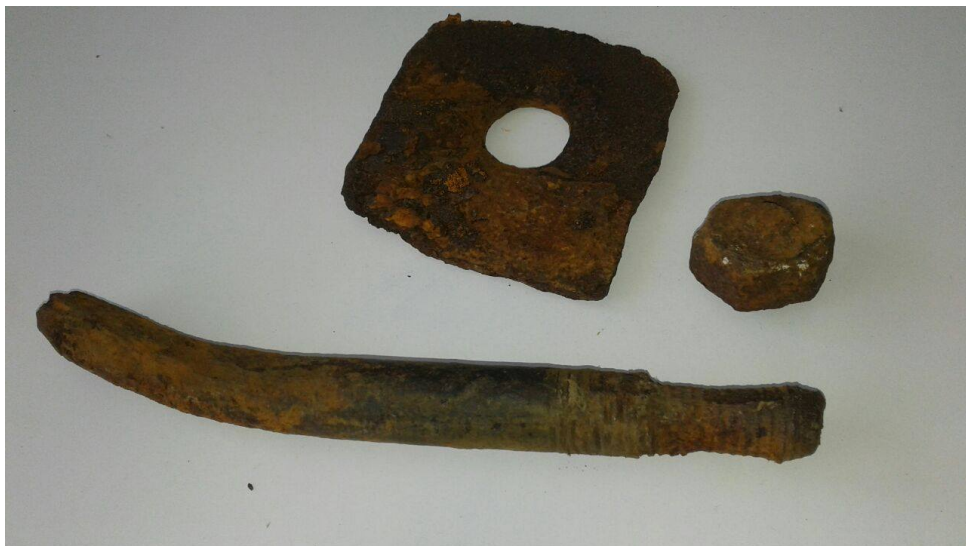
Figure 5.10: Overview of 3 different steel parts. Note the poor state of the threaded end of the bolt.

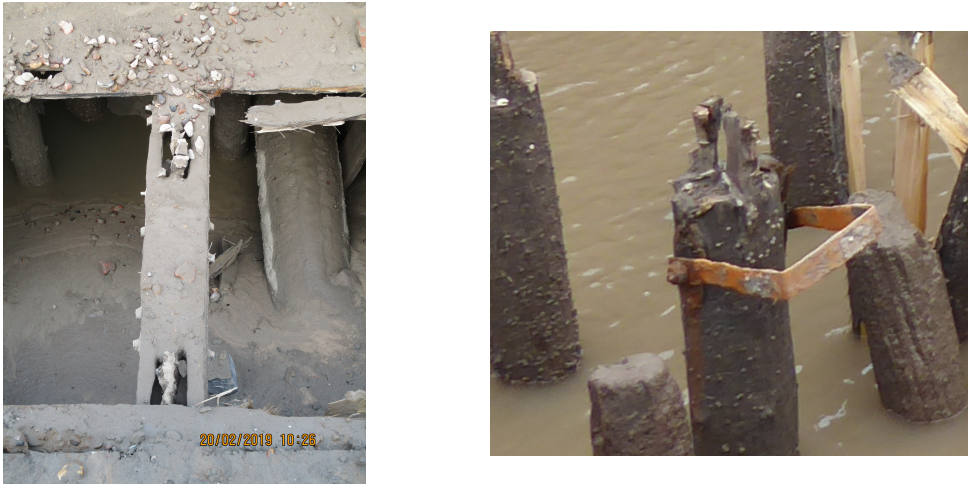
Figure 6.11: Left: Standard Mortise and Tenon joint (e.g. pile row 3). Right: Braced Mortise and Tenon joint (e.g. pile row 2).

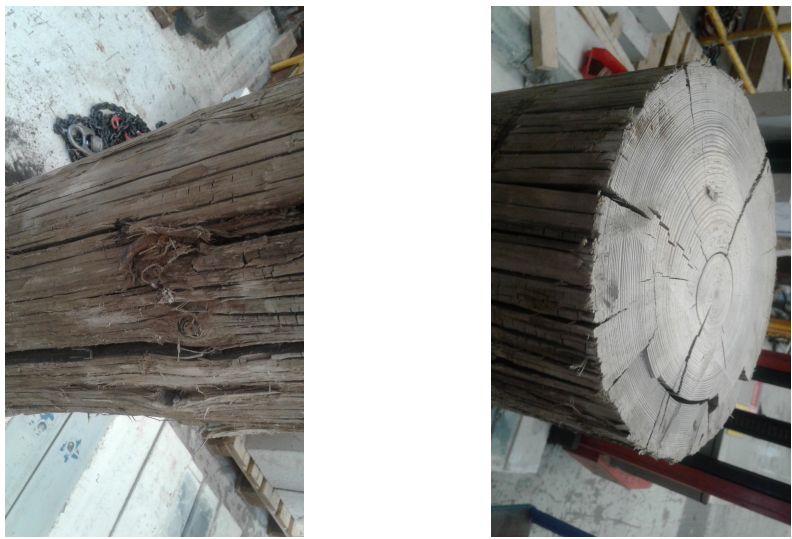
Figure B.44: Close-ups of the failing testpiece PKO0120 (left), after testing (right).

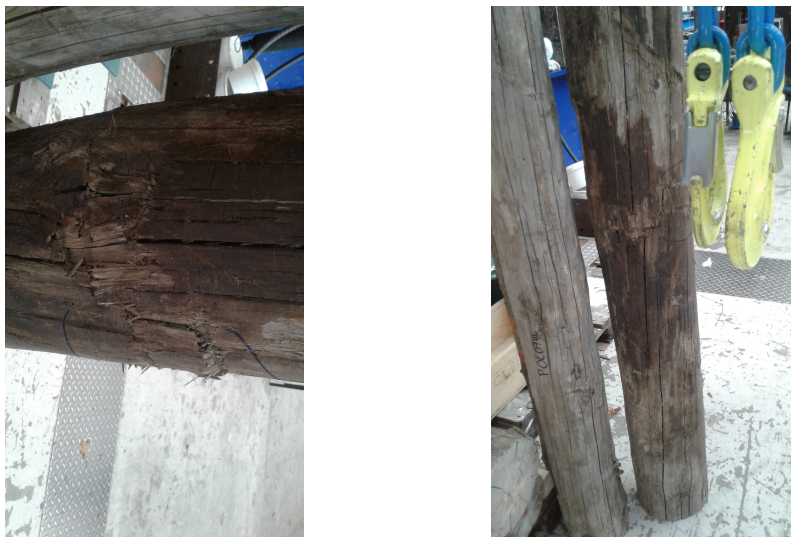
Figure B.73: Close-ups of the failing testpiece POC0721.
