## Plasters with mixed-in crystallization inhibitors: Results of a 4-year monitoring of on-site application

Journal of Cultural Heritage

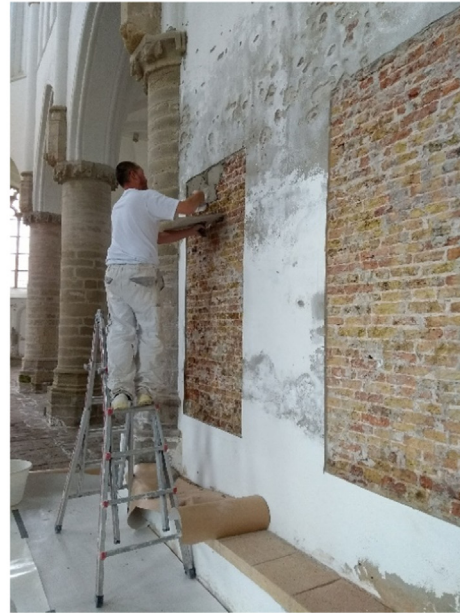
Fig. 1. Left: Plan of the church with indication of the location of the test area; Right: application of the plaster on the test area.

Two types of plaster have been applied, both with and without mixed-in inhibitor. An inner wall in the apse of the church (Fig. 1 left) has been selected as location for their application. The plas-

ters were applied on the two sides of the same wall, to minimize as much as possible differences in external conditions. Each plaster was applied on two adjacent areas, each area being about 1 m wide and 2 m high (Fig. 1 right).

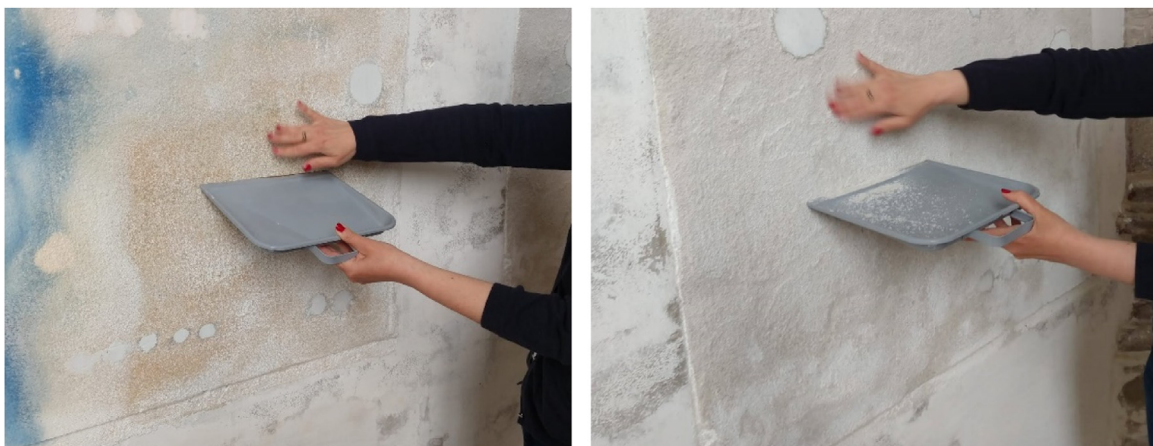
**Fig. 9.** Left: Panel A1: No loss of cohesion of the plaster; Right: Panel A2 significant sanding of the plaster; Situation 48 months (t48) after the application.

Decay, in the form of loss of cohesion (sanding), was observed in panel A2, between 120 and 170 cm height, 48 months after the application of the plaster. In contrast, no loss of cohesion is observed in panel A1 up to 48 months (Fig. 9).
