# Operational transitions in railway infrastructure

Master thesis

MSc. Transport, Infrastructure & Logistics

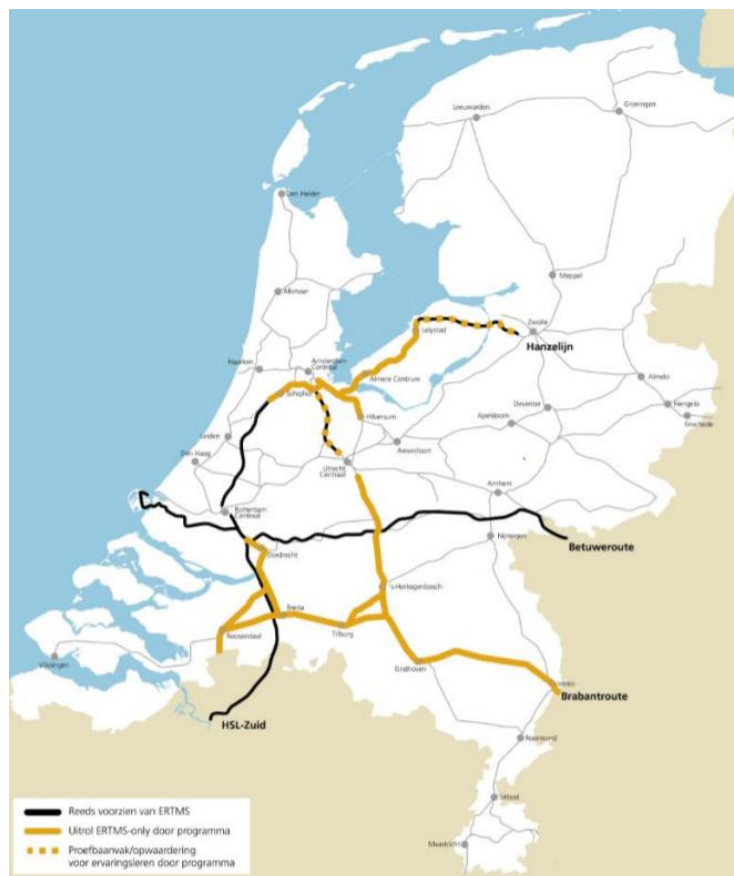
Figure 1 ERTMS transition strategy until 2030 (Ministry of Infrastructure and Water Management, 2018b)

Roughly two methods can be used to increase the interoperability of trains on the rail network. On the one hand, trains are equipped with multiple ATP systems and are designed to run under multiple power supply systems, if required. New trains are equipped with multiple ATP systems (CAF, n.d.), or they are designed to allow easy retrofitting of new systems. The most recent generation of sprinter rolling stock for NS is equipped with ERTMS and ATB-EG (Via a STM-module). Dutch Railways (NS) is currently also tendering for ERTMS baseline 3 to be retrofitted into their existing VIRM double decker fleet (NS, 2020). Furthermore, a large majority of electric locomotives owned by freight railway companies operating in the Netherlands (most notably, the Bombardier TRAXX F140 MS, Siemens ES64F4 and Siemens Vectron) are equipped with multiple ATP systems and power supply systems to allow international operation of freight trains (Bombardier, 2017; Hoppe, Matschek & Müller, 2006; Siemens, n.d.). Operators with locomotives that lack ERTMS equipment can apply to

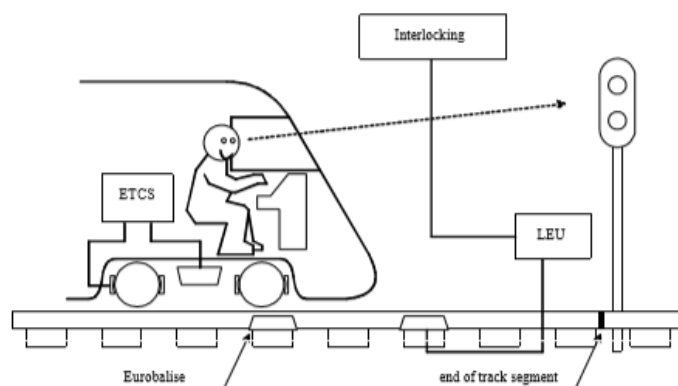
Figure 6 ETCS level 1 principles (ERA, 2016)

Under ETCS level 1, eurobalises or beacons are used for transmitting data from the Lineside Electronic Unit (LEU) to the on-board ETCS unit (Figure 6). A LEU is used to translate the lineside signal aspects or information from the interlocking system into movement authorities (ERA, 2016; Rhein & Ziering, 2002). When a train passes a eurobalise, the eurobalise transmits data on its location and on the train direction to the on-board ETCS unit, which is used to

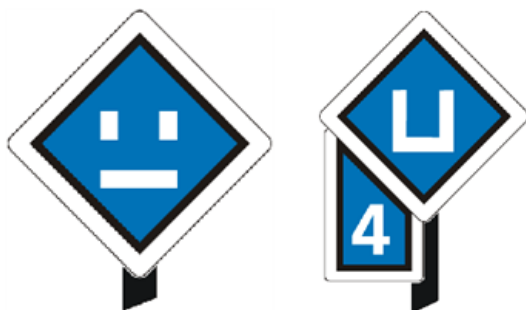
Figure 10 Signs indicating 'power off' left and 'power on' right'

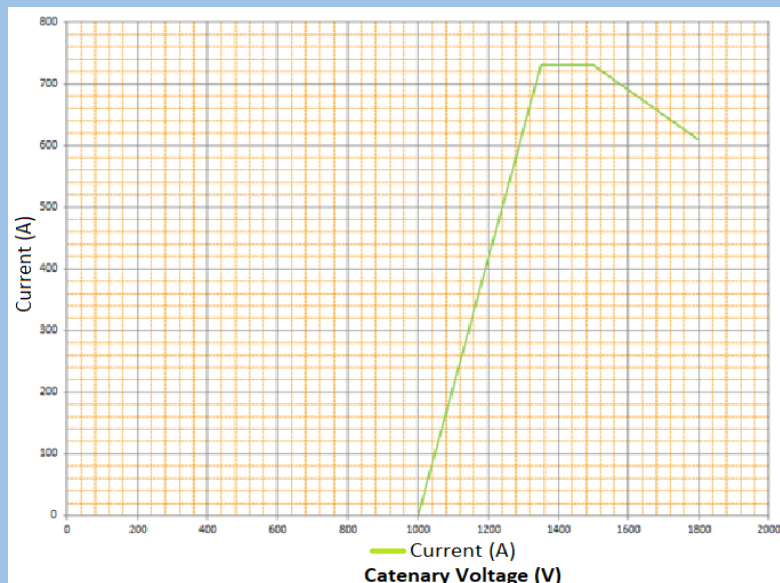
Figure 13 Line amperage limiter (based on CAF Civity train) (CAF, 2014)

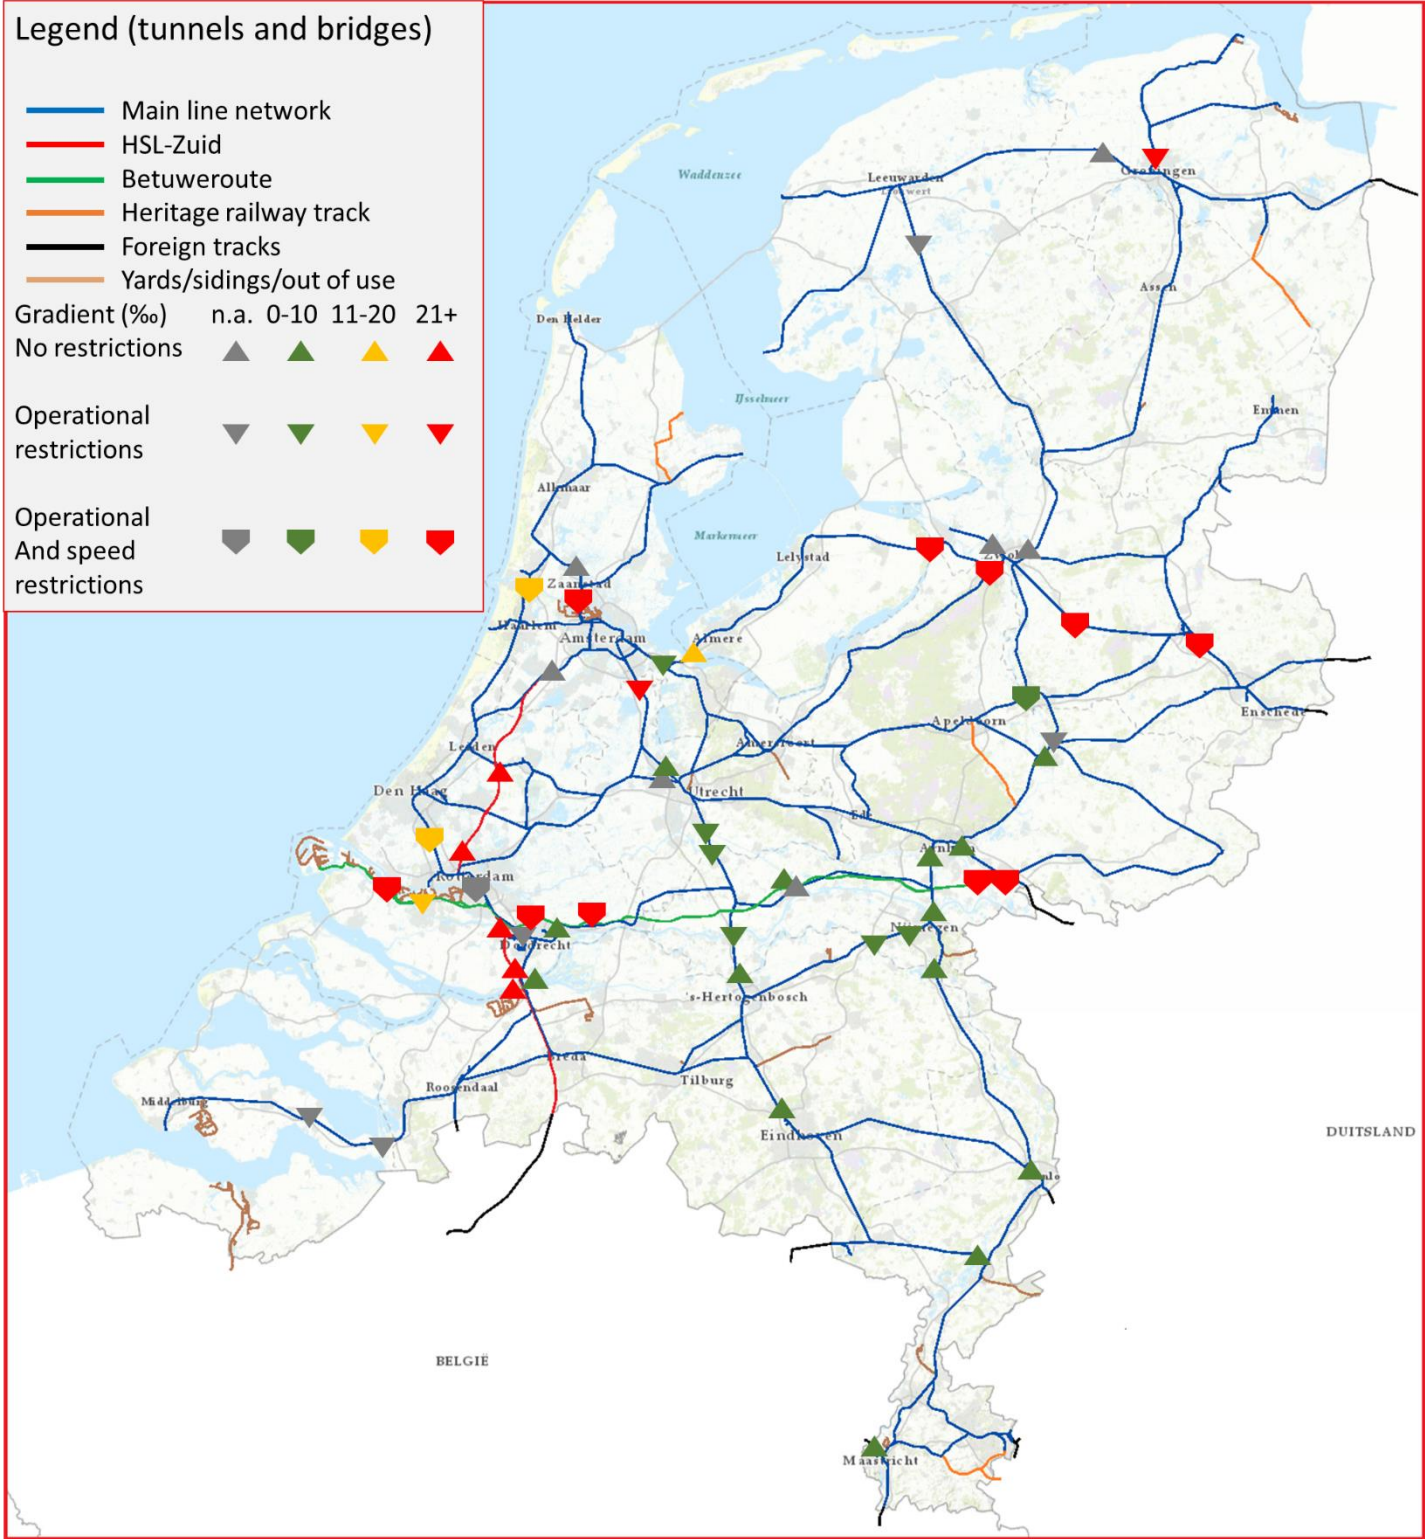
Figure 14, Gradients at tunnels and bridges

Based on this analysis, three categories of structures with gradients can be distinguished, gradient without any extra operational restrictions, gradients with operational restrictions (either L and H signals or X/G signals) and gradients with operational restrictions and speed restrictions. In Figure 14 all gradients at tunnels and bridges are shown. Figure 15 shows all gradients at fly-overs and dive-unders. Gradients are indicated with various colours, depending on how steep they are. For some gradients, data on the exact gradient angle is lacking. These gradients are indicated in grey.

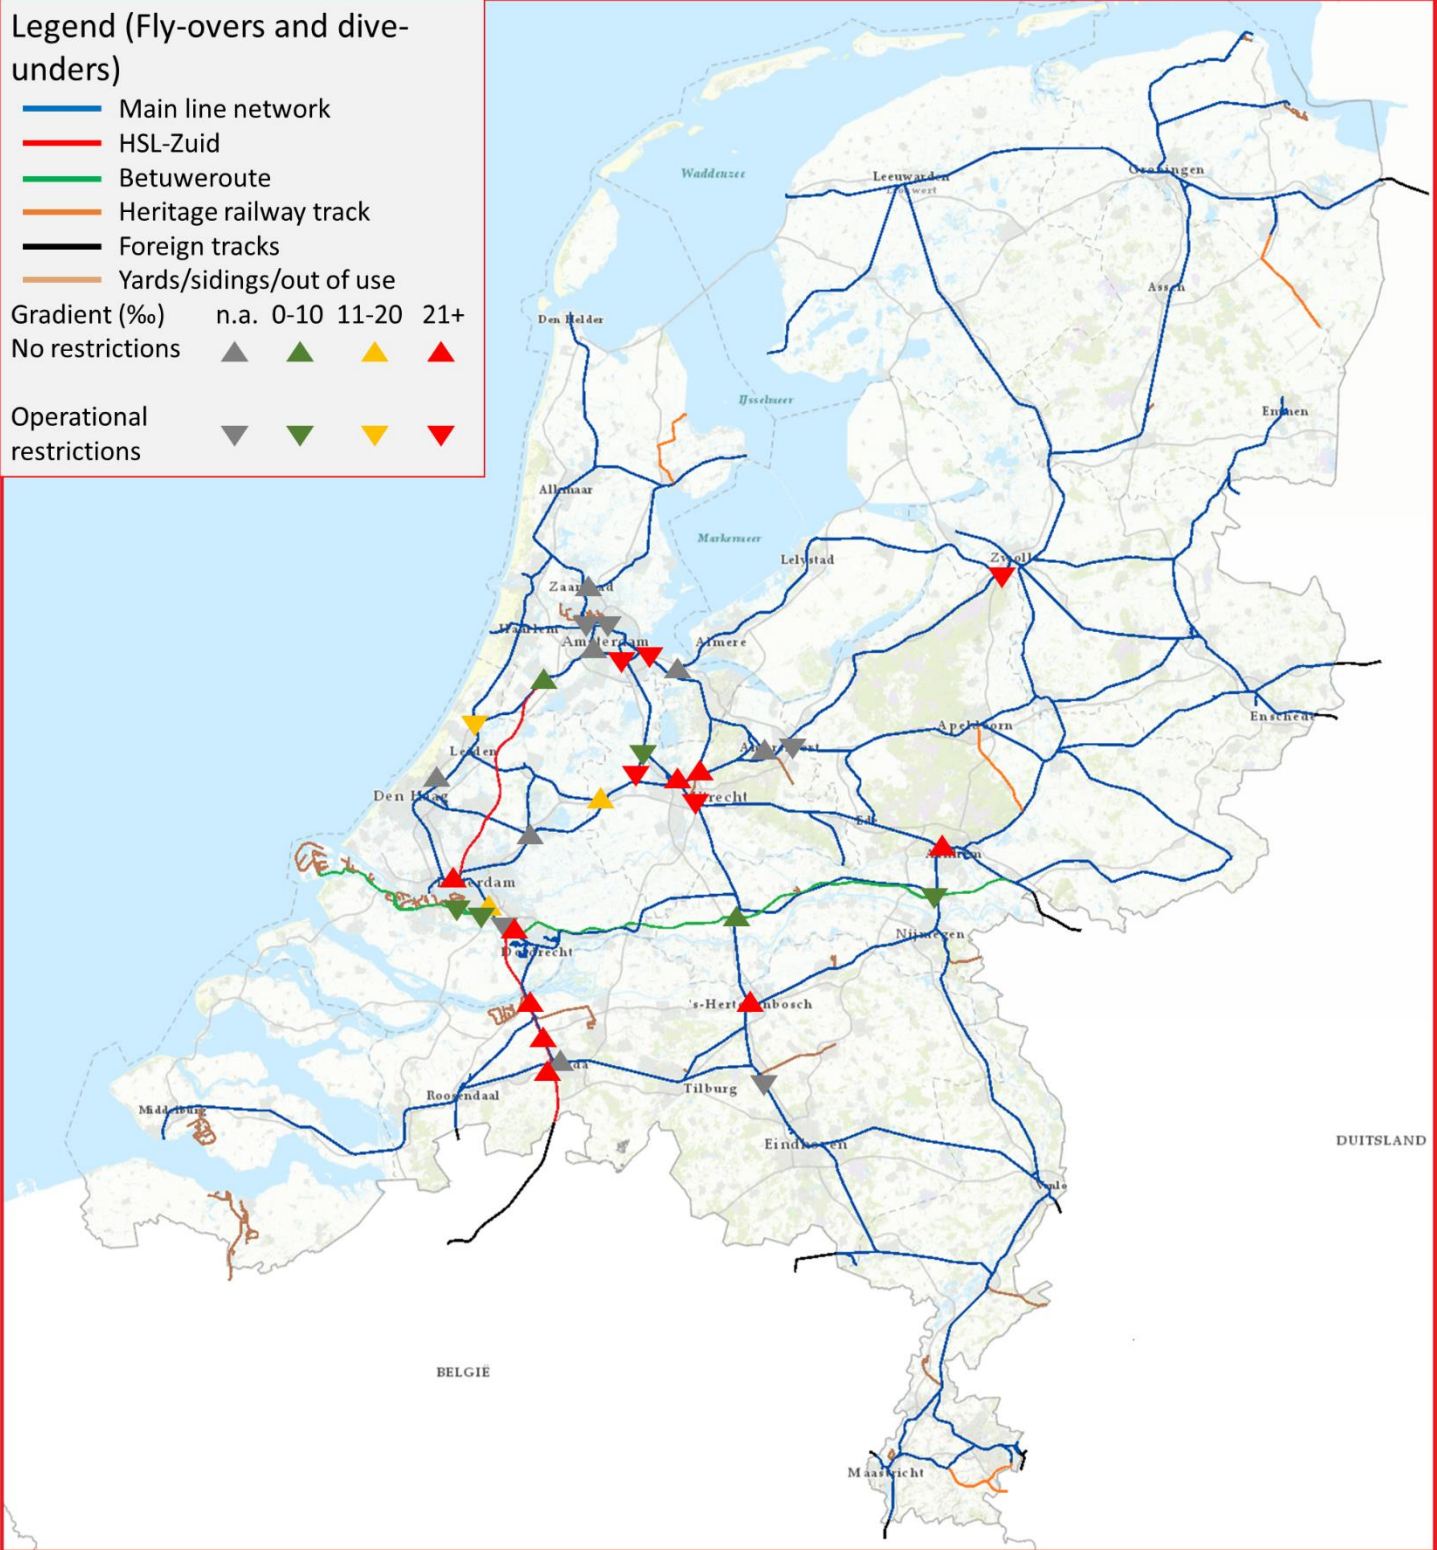
Figure 15, Gradients at fly-over and dive-unders

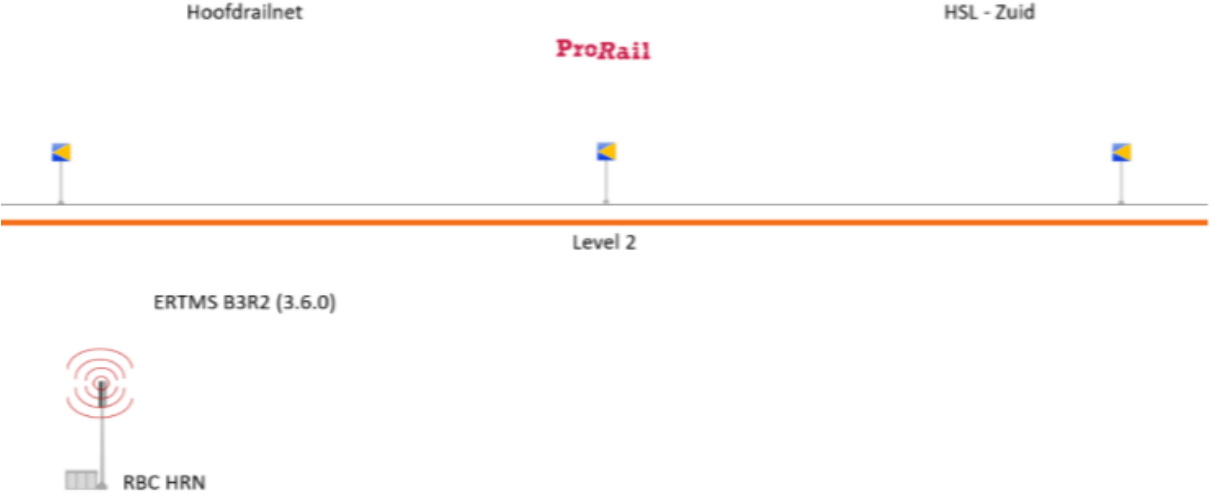
Figure 22, solution 3: RBC integration of HSL

Solution 3: HSL and main line network use the same RBC

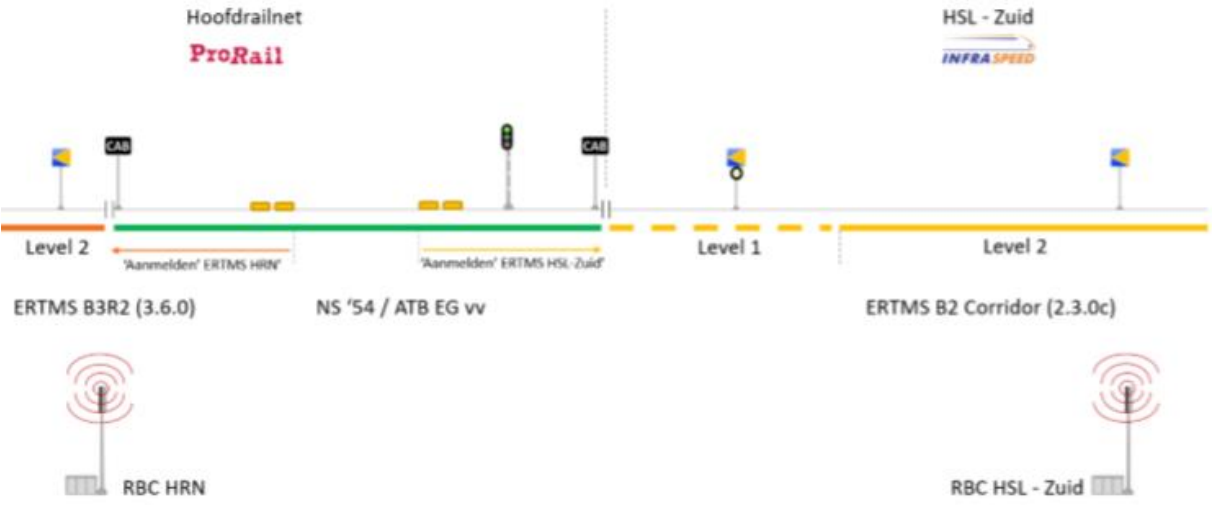
Figure 23, solution 4: ATB-island

Solution 4: ATB-island

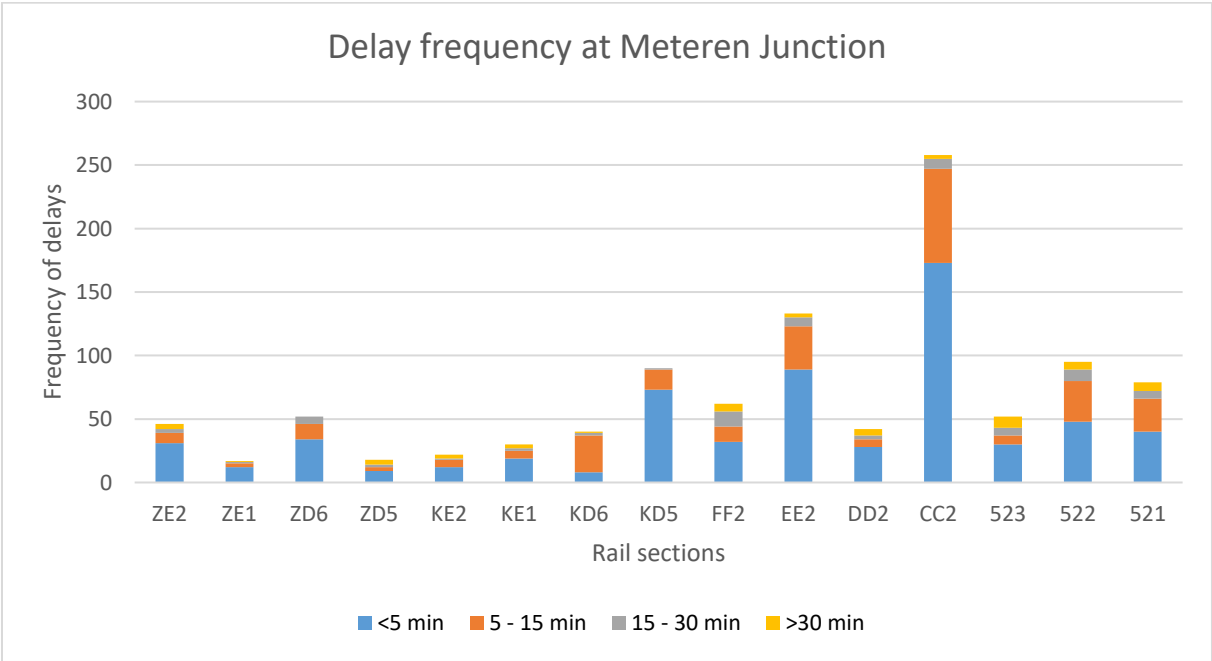
Figure 32 Disruption frequency at TROTS rail section at Meteren junction

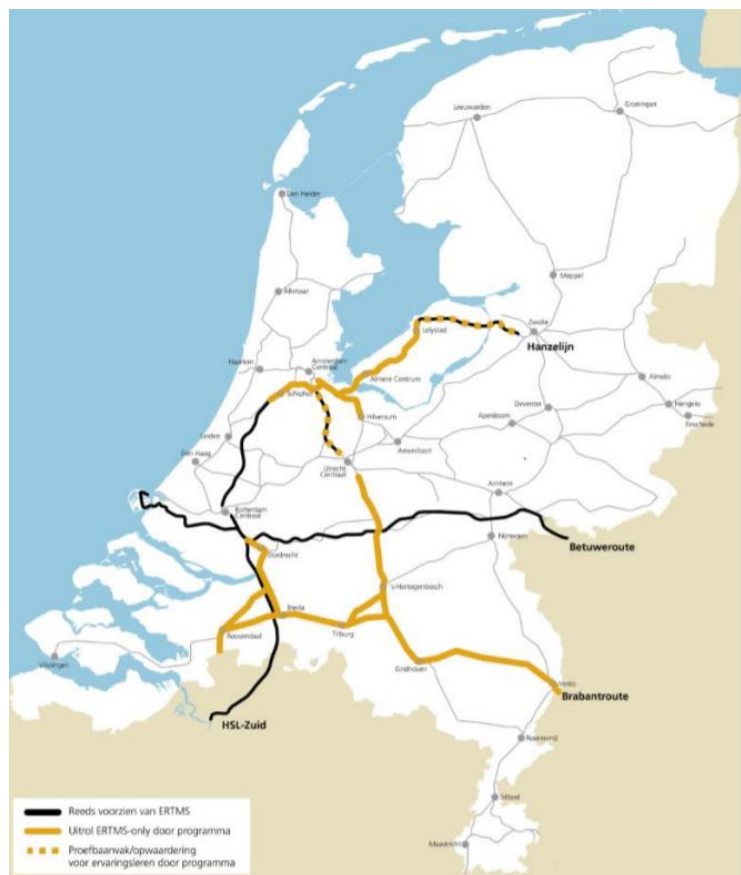
Figure 56 ERTMS transition strategy until 2030 (Ministry of I&W, 2018)

The number of ATB-EG – ERTMS transitions is currently limited to connections between the HSL-Zuid or Betuweroute and the main line network. However, as ERTMS is being applied on more railway lines, the number of operational transitions is expected to increase. Six main lines will be equipped with ERTMS between 2026 and 2030 (see Figure 56). Large stations on those railway lines, like Amsterdam, Rotterdam and Utrecht, will not be equipped with ERTMS yet, as experience is lacking with converting large station areas to ERTMS. In daily operations, the number of ATP transitions will therefore grow considerably from 2026 onwards.
