Report No. 93

HYDRAULIC CHARACTERISTICS OF LOW COST SURFACES FOR FARM DAM BYWASH SPILLWAYS.

B. A. Cornish, K. C. Yong and D. M. Stone

Feb. 1967.

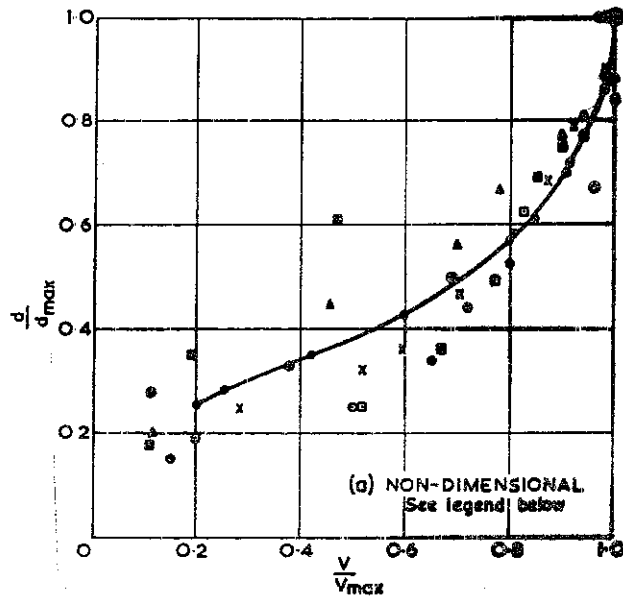
CE-D-6919

**FIGURE 2: VELOCITY DISTRIBUTION IN THE APPROACH CHANNEL
AND THE GRASSED CHANNELS AT DIFFERENT FLOW RATES
AND DEPTHS**

To provide a velocity distribution within the approach flow similar to that which occurs over a grassed channel or channel with surface treatments, the bed of the approach flume was lined with six layers of bird wire. The velocity distributions measured at the centre line of the flume immediately upstream of the test section are shown in Figure 2 for a specific rate of flow. Also shown in this figure for comparison are typical velocity distributions for four different grassed channels. No attempt was made to measure the velocity distribution of flow over the channel with soil additives or surface treatments, for it was considered that the velocity distributions would be of the usual type encountered with such surfaces.

Each surface was tested at a chosen mean velocity for a period of 1 hour. At the end of this time the flow was turned off and any surface scour noted. The tests were commenced at a mean velocity of 2 f. p. s. and then this was increased to 4 f. p. s. Further adjustments to mean velocities were in steps of 1 f. p. s. until failure of the surface occurred. The vertical velocity distributions were measured on several of the surfaces by a standard pitot tube.

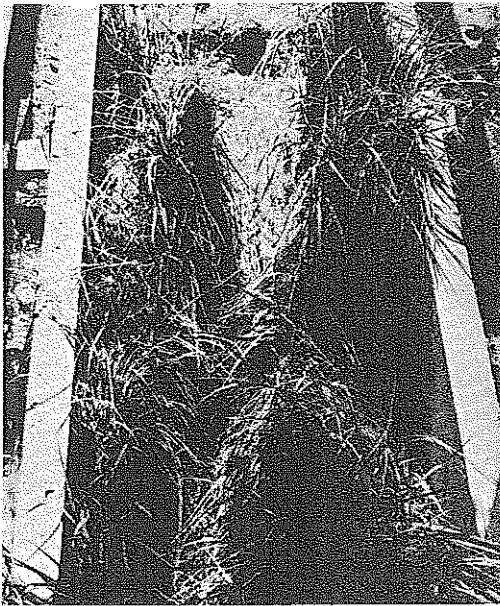
Figure 7: Couch grass at 15 weeks.

(a) Tested at 2 f. p. s.

(b) Tested at 4 f. p. s.

(c) Tested at 10 f. p. s.

Germination commenced 14 days after sowing. By the start of test the test bed had been well covered by grass up to 12 inches in height.

No scour occurred for mean velocities from 2 to 5 f. p. s. At 6 f. p. s. slight scour commenced at the upstream edge of the box but this soon became stable. At 8 f. p. s. bad scour was evident at the upstream edge. The scour extended downstream for about 6 inches. Scour elsewhere was negligible. At 10 f. p. s. the surface was deemed to have failed. Photographs of test bed are shown in Fig. 7.

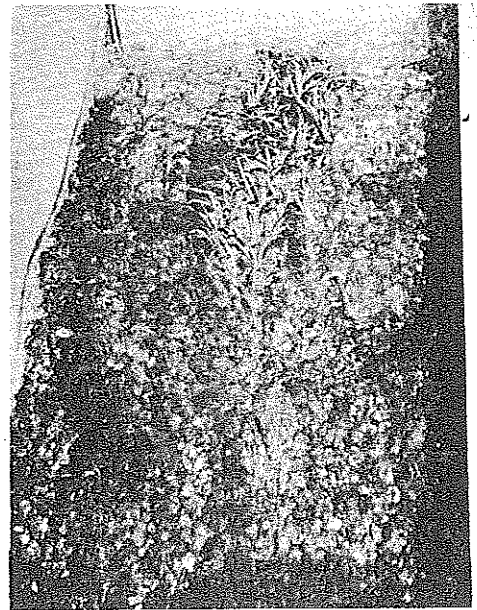
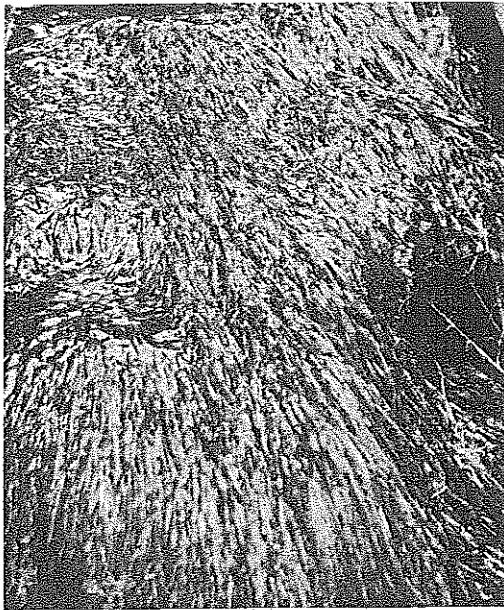
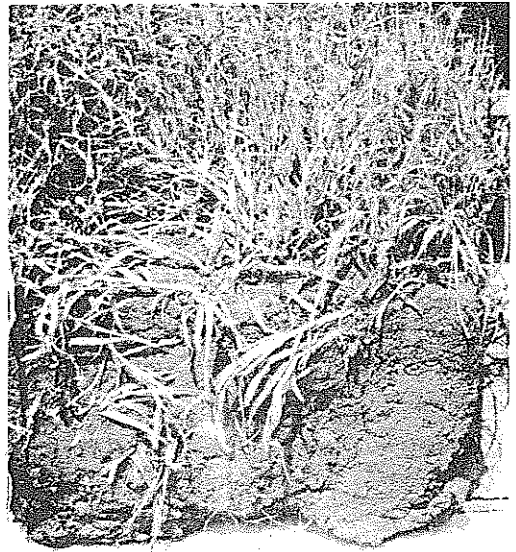
Figure 10: Rhodes grass at 5 weeks.

(a) Before testing

(b) Tested at 4 f. p. s.

(c) Tested at 7 f. p. s.

(d) Section removed after testing

Germination commenced 12 days after sowing. At the time of the test the grass was up to 6 inches long but the cover was rather patchy.

There was no significant scour at velocities up to and including 6 f. p. s. When the velocity was increased to 7 f. p. s. the scour developed rapidly and the bed failed 20 min. after the flow was commenced. After failure it was noticed that the blades of grass which had not been washed away had become ravelled. Photographs of the test bed are shown in Figure 10.

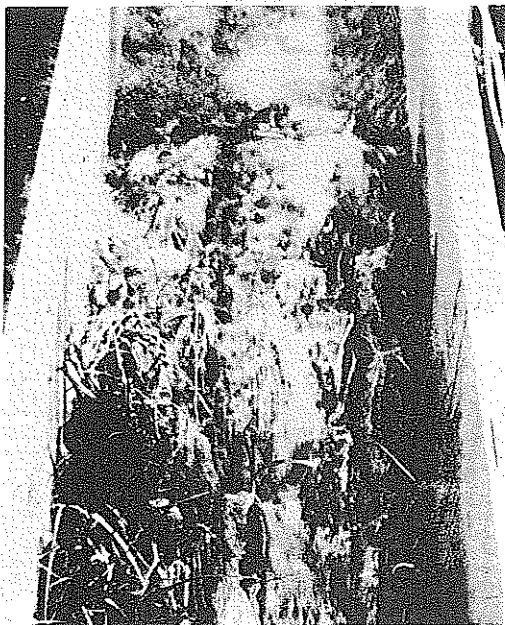
Figure 11: Kikuyu grass grown from runners at 28 weeks.

(a) Tested at 2 f. p. s.

(b) Tested at 4 f. p. s.

(c) Tested at 10 f. p. s.

The kikuyu spread rapidly and at the time of the test a good cover had been obtained with the grass varying in height between 6 and 12 inches.

Scour did not occur at velocities between 2 and 8 f. p. s. At a velocity of 9 f. p. s. general scour over most of the surface of the box occurred. When the velocity was increased to 10 f. p. s. scour developed at the upstream and downstream end of the box. Failure occurred when the velocity was increased to 11 f. p. s. Photographs of test beds are shown in Figure 11.

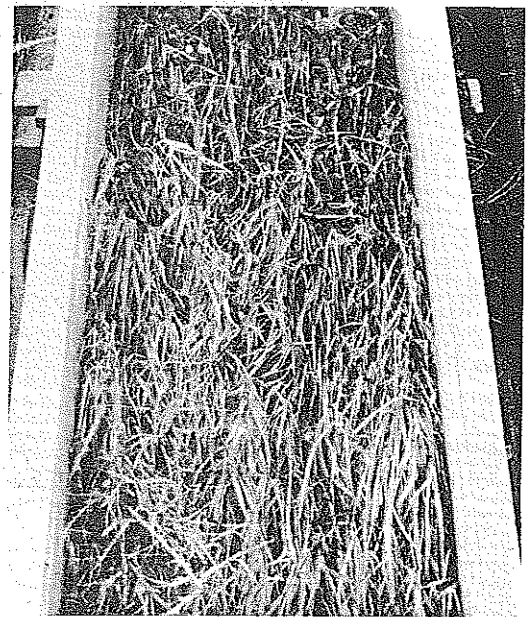
Figure 12: Kikuyu grass grown from sod at 28 weeks.

(a) Tested at 10 f. p. s.

(b) Tested at 15 f. p. s.

(c) Tested at 18 f. p. s.

After transplanting, the grass died off slightly and did not begin to grow for several weeks, but at the time of the test the grass was about 12 inches long and had established a good thick cover.

Scour did not begin until the velocity had been increased to 15 f. p. s. at which velocity the soil began to be washed away from around the roots. This scour continued as the velocity was increased. When the velocity reached 18 f. p. s. the scour at the upstream edge of the box had developed to such a stage that the surface was considered to have failed. Photographs of test bed are shown in Figure 12.

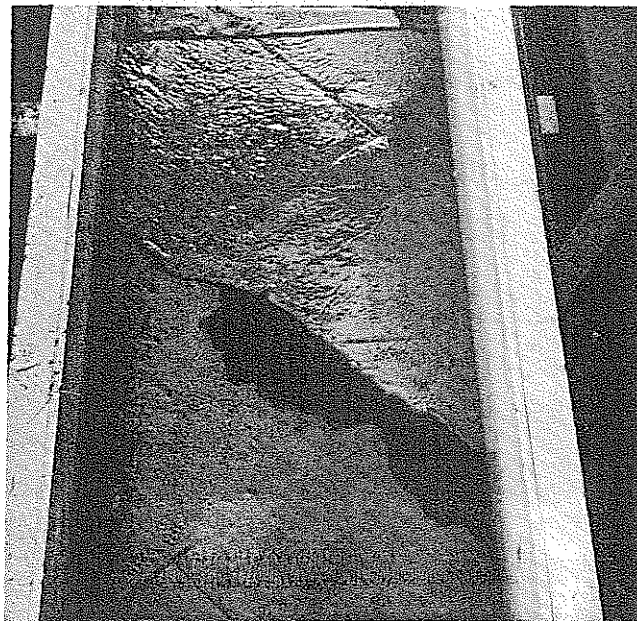
Figure 13: Test bed with soil-cement mixture tested at 8 weeks.

(a) Before testing.

(b) Tested at 15 f. p. s.

At a velocity of 8 f. p. s. portion of the top half of the upstream end of the surface broke away. This could have been due to the action of the rain earlier or the impact of water on it, because the top of the soil in the box was half an inch above the bottom of the flume upstream. At velocities of 14 f. p. s. and 15 f. p. s. the existing cracks in the surface were increased and portion of the surface along the sides was eroded and a quantity of soil was washed away from underneath the prepared surface. It was considered that the surface failed at 15 f. p. s.

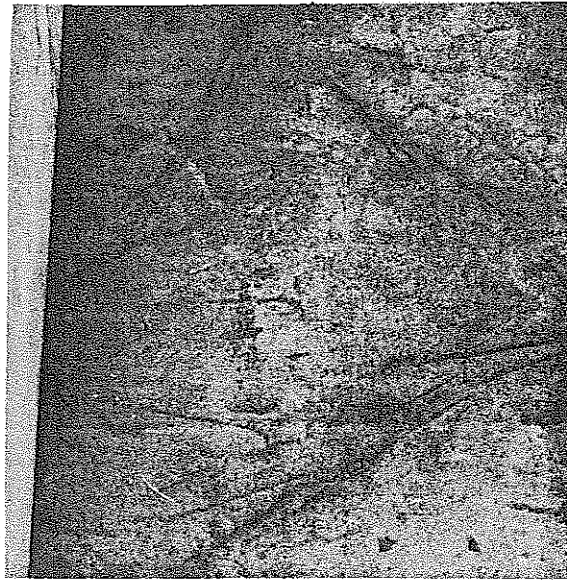
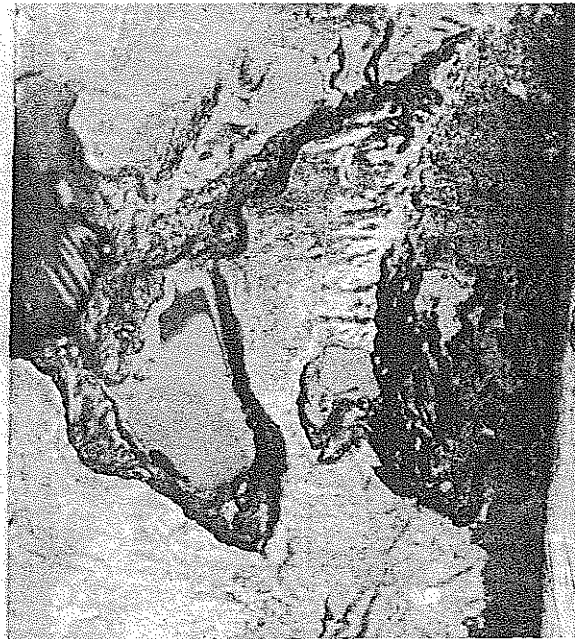
Figure 14: Test bed with lime-flyash mixture.

(a) Before testing

(b) After testing

Cracks on the surface of the test bed were observed at three places before testing. This surface failed at a velocity of 4 f. p. s. at the cracked region and the mixture was washed away and the subsoil eroded locally. At a velocity of 6 f. p. s. the subsoil was further washed away and the lime fly-ash surface was undermined and also washed away. After half an hour the greater part of the surface and subsoil was completely washed away. It was considered the surface failed at 4 f. p. s. Photographs of this surface before and after the tests are shown in Figure 14.

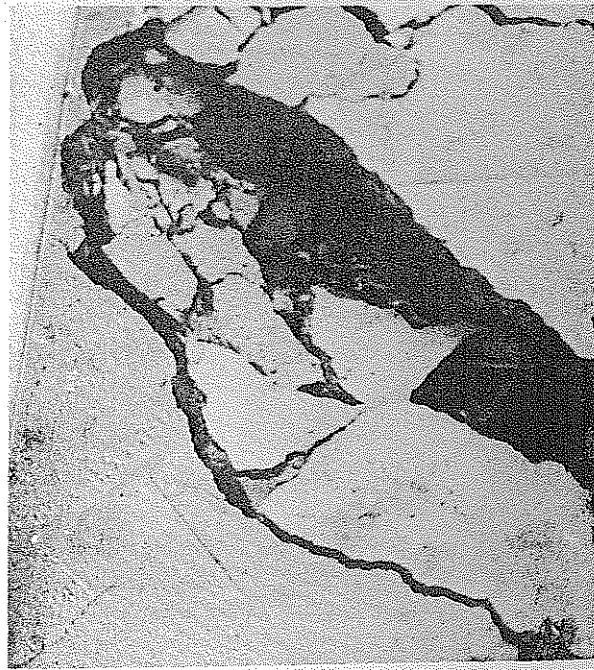
Figure 15: Test bed with a mixture of soil, wood-shavings and cement.

(a) 3 weeks after mixing - before testing.

(b) Tested at 16 f. p. s.

At the time of test a portion of the topping had been washed away by rainfall. At velocities of 2 f. p. s. and 4 f. p. s., the existing small scour holes were not enlarged and the test bed on the whole was not affected. At a velocity of 10 f. p. s. half of the downstream section of the prepared surface was washed away but the remainder stayed quite stable. Velocities up to 14 f. p. s. produced no marked change in the surface structure. At a velocity of 16 f. p. s. the surface failed sufficiently to warrant discontinuing testing, though not completely. Photographs of this surface before and after the tests are shown in Figure 15.
