Delft University of Technology
Faculty of Civil Engineering and Geosciences
Department of Design and Construction
Section of Structural and Building Engineering
Concrete Structures

Report	25.5-22-03
Project	CS3B13
Date	April 2022
Status	Final
Version	1.00

Experiment report on steel-concrete- composite bridge deck without mechanical connectors (Verbundträger)

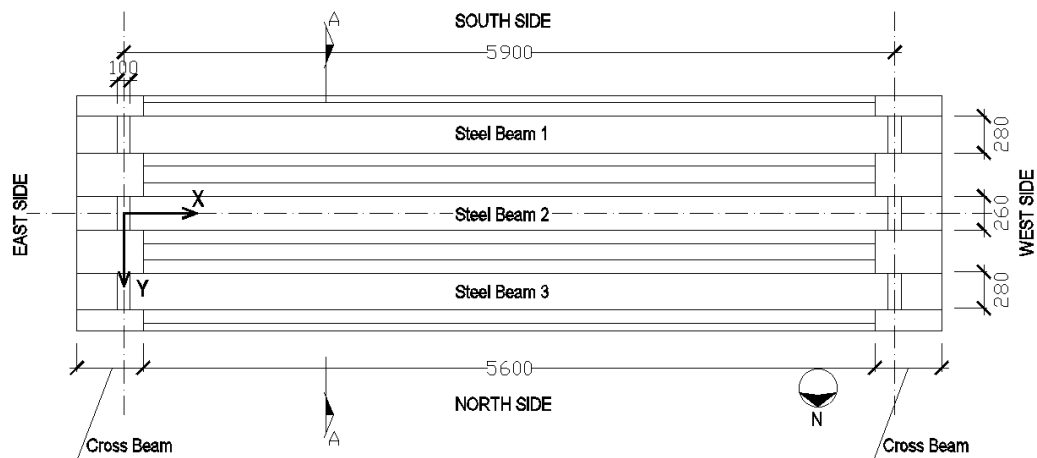
Fig. 1.1. LB1 - Bottom view. Dimensions of LB1 and position of beam 1, beam 2 and beam 3.

Dimensions of LB1 are shown on Fig. 1.1 and Fig.1.2. LB1 has a length between supports of 5900 mm. Furthermore, the tested cross-section consists of three I-beams, the two outer beams (beams 1 and 3) have a height and flange width at 280 mm and flange thickness at 18 mm. The middle beam, beam 2, has a height and flange width at 260 mm and flange thickness at 17.5 mm. At the end of the specimen its cross section is squared, whereas for the cross section between supports there's a trapezoid shaped gap between the beams with height 130 mm and width 125 mm at the top and 330 mm at the bottom. The gap continues at the outside of the outer beams as shown on Fig.1.2. In the following the steel beams are referred to as beam 1, beam 2 and beam 3, as shown on Fig. 1.1 and Fig.1.3.

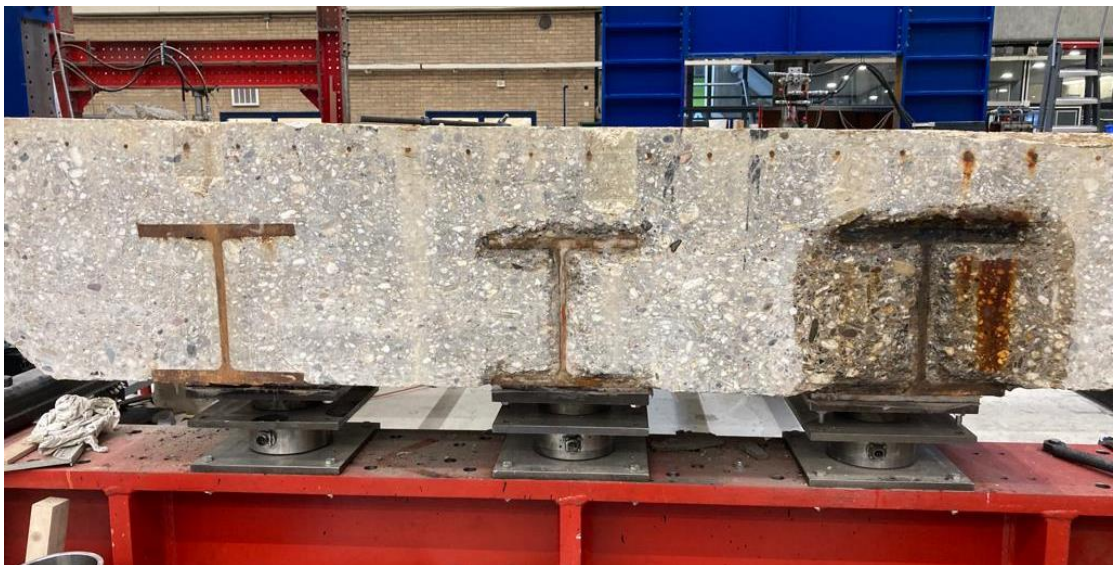
Fig.1.5. LB1. East side view.

In the lab, the specimens were simply supported to reproduce the real conditions of the structure. The supports at both sides were placed underneath the steel beams, as can be seen from Fig.1.5. Both supports were built assuring rotational freedom. A detail of the support for the specimens is shown at Fig.1.5, Fig.1.6 and Fig.1.7.

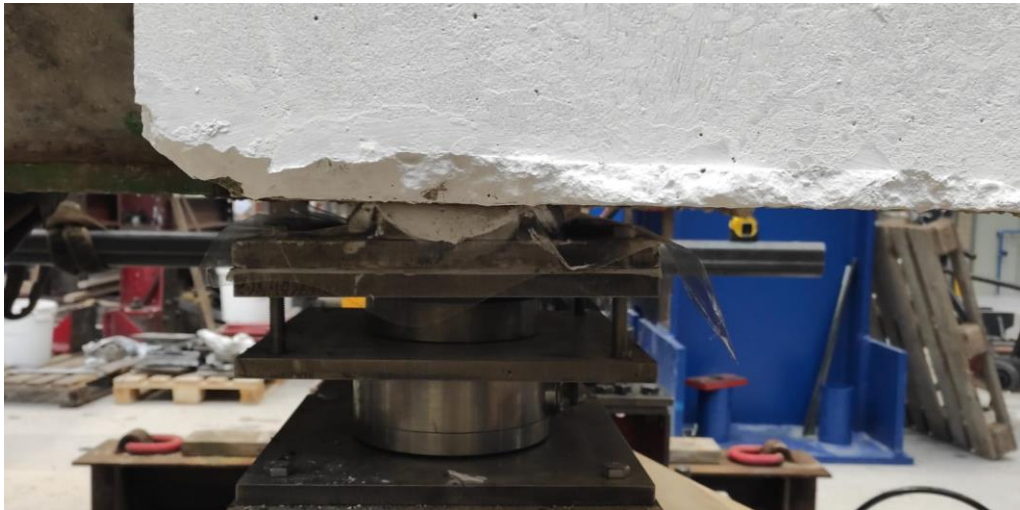
Fig.1.6. LB1. West side support below beam 3.

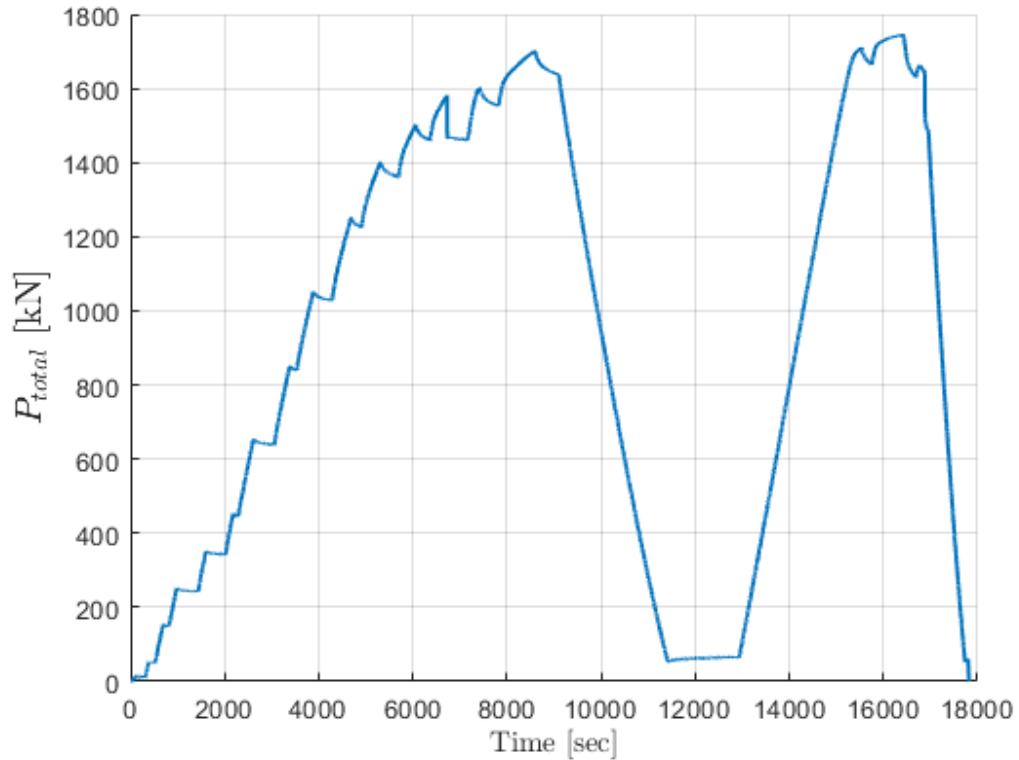
Displacement rate 0.01 mm/sec	
1 jack load [kN]	Total load [kN]
25	50
75	150
125	250
175	350
225	450
325	650
425	850
525	1050
625	1250
700	1400
750	1500
790	1580
800	1600
850	1700
25	50
850	1700
872	1744

Fig.2.5. LB1. Load history

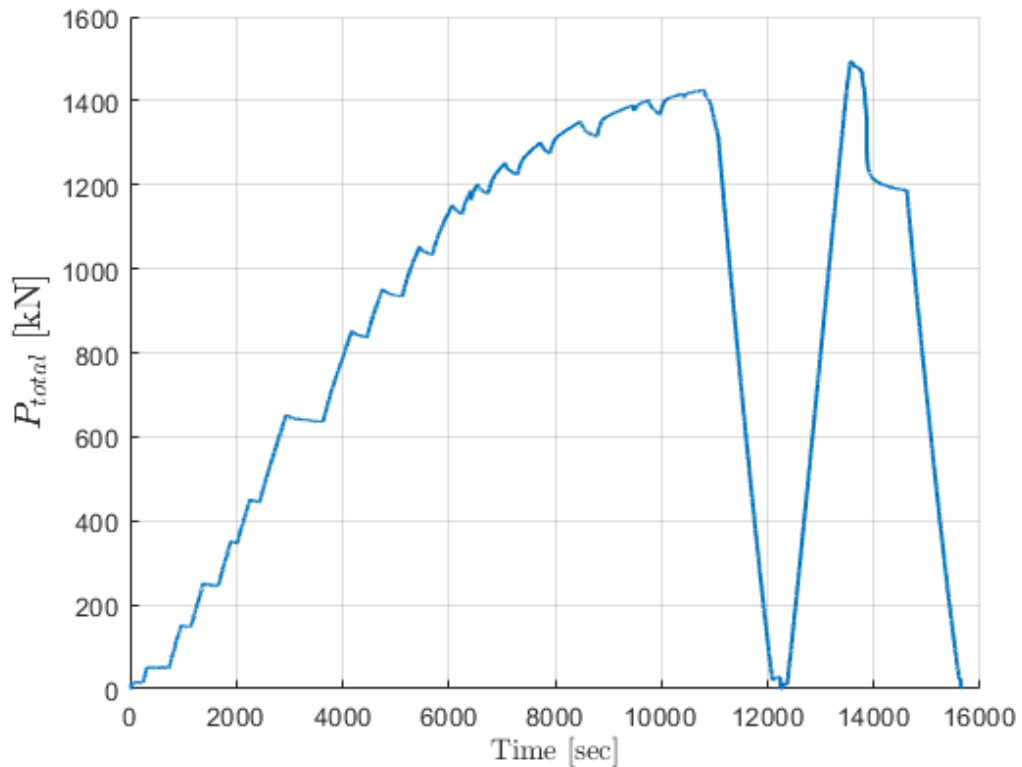
Displacement rate 0.01 mm/sec	
1 jack load [kN]	Total load [kN]
25	50
75	150
125	250
175	350
225	450
325	650
425	850
475	950
525	1050
575	1150
600	1200
625	1250
650	1300
675	1350
700	1400
725	1450

Fig.2.6. LB3. Load history. After 11000 seconds the test was stopped because the maximum displacement range was achieved. The specimen was unloaded to 0 kN and reloaded again.

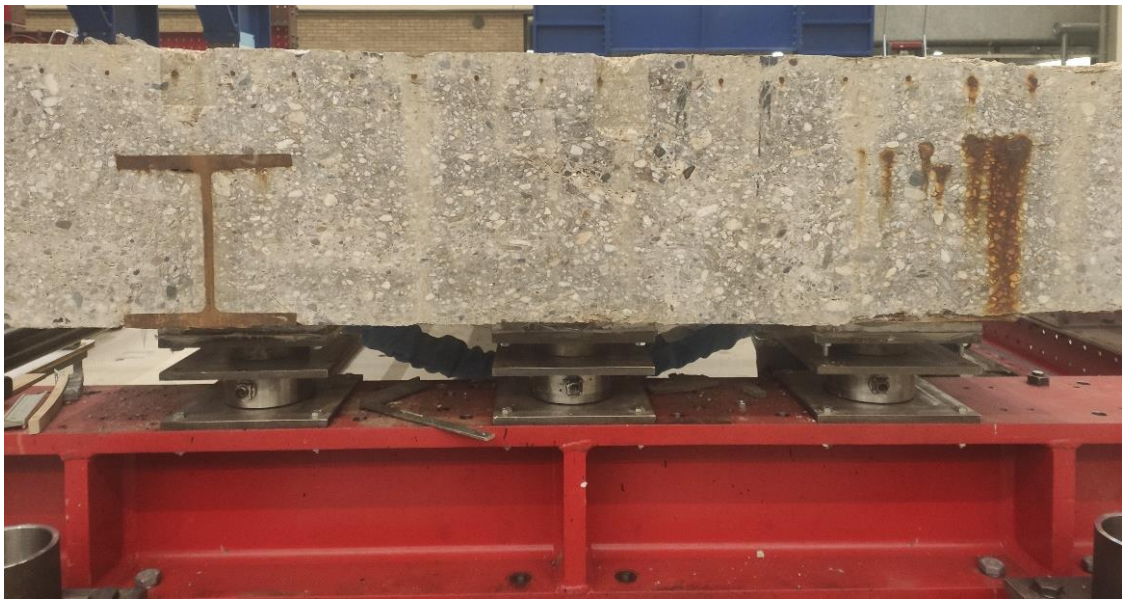
Fig.2.8. LB1 – Load Cells East view of the specimen.

At both ends of the bridge deck three load cells were installed to monitor the reaction forces. Each load cell has a range of 1000 kN. The position of the load cells is shown on Fig.2.7 and a picture of LB1 with the load cells can be seen from Fig.2.8. In addition, one load cell was used for each hydraulic jack, to monitor the applied loads.

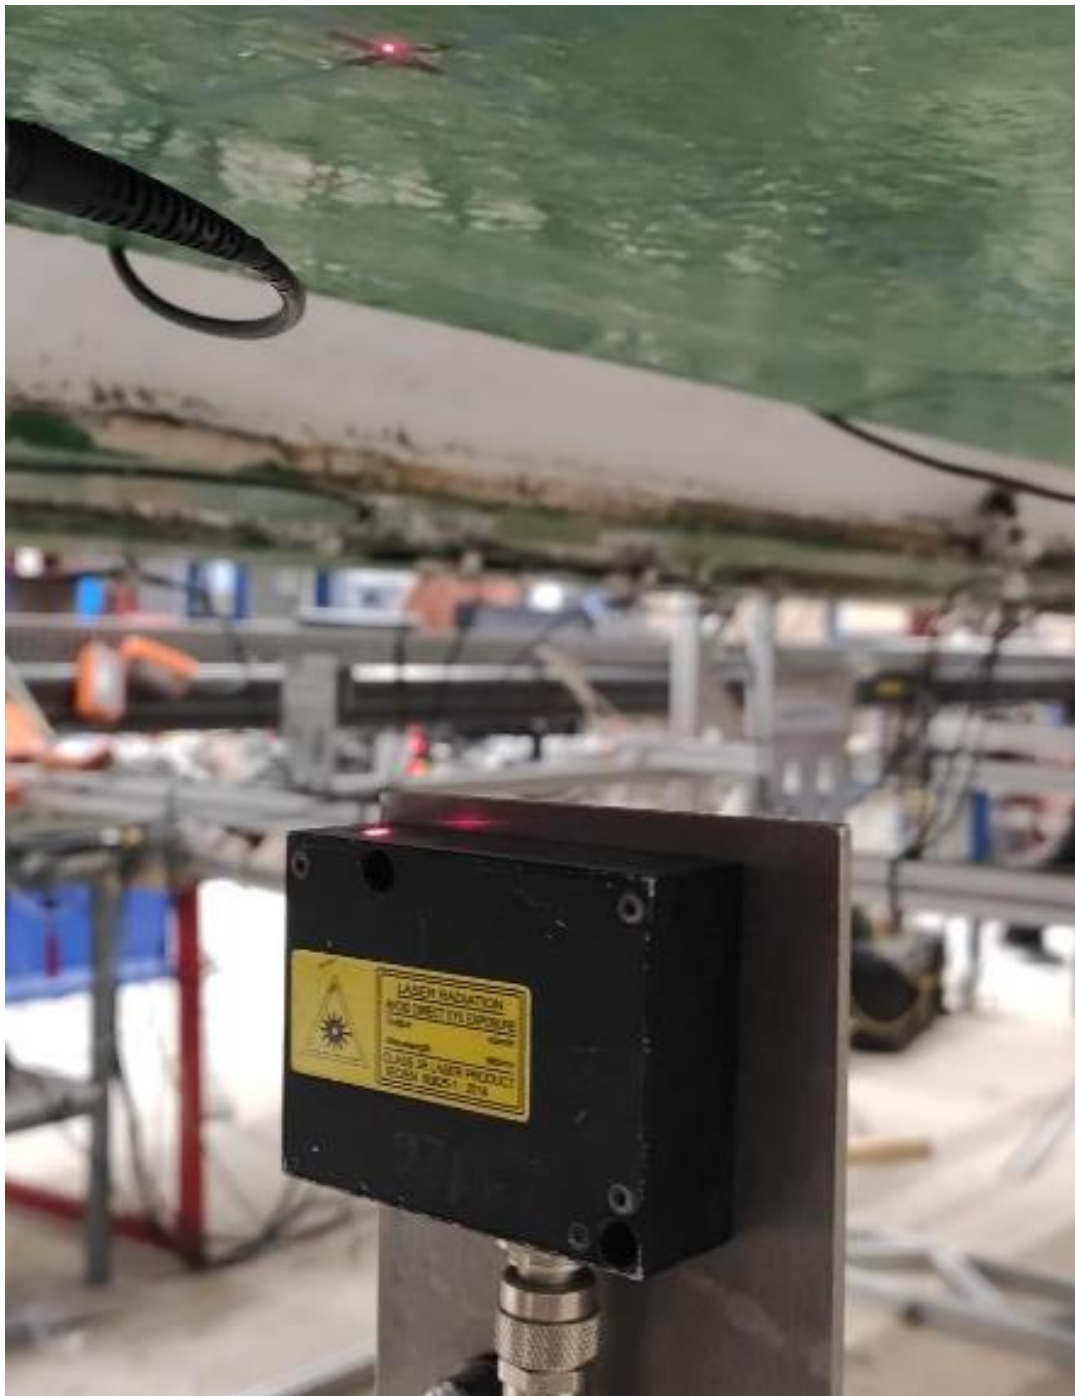
Fig.2.11. Laser measuring vertical displacement from bottom of a steel beam.

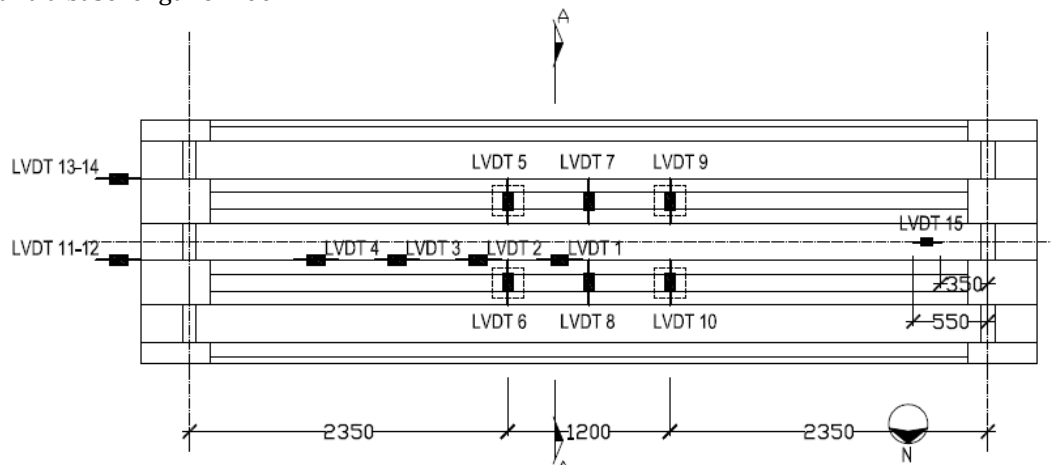
Fig.2.12. LB1 - Bottom view. Position of LVDT 1-15. LVDT 15 position at the west end of beam 2 to replace FO-S2-7.

LVDTs 1 to 10 have a range of 10 mm and a sensitivity of 0.001 mm. LVDT 11-14 have a range of 2 mm and a sensitivity of 0.0005 mm. LVDT 15, was used for replacing a damaged optic fiber sensor, FO-S2-7 for LB1 and FO-C1-7 for LB3. LVDT 15 has a range of 2 mm, a sensitivity of 0.0005 mm and a base length of 200 mm.

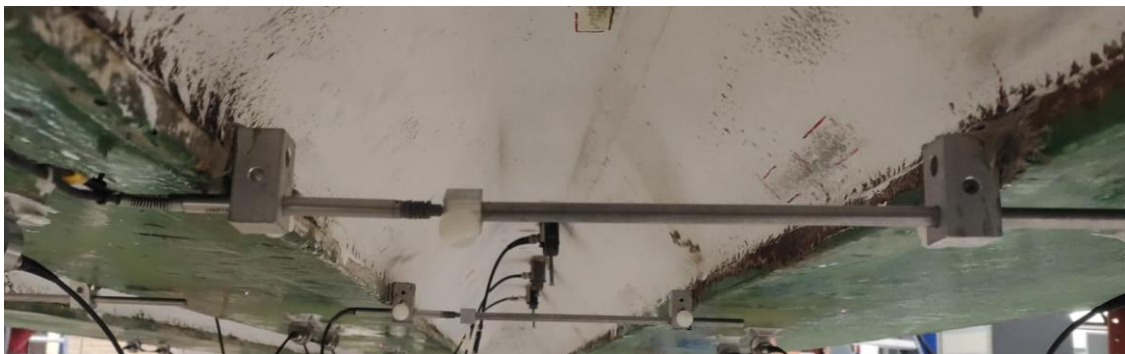
Fig.2.17. LVDT 5-10 measuring relative transverse displacement between the beams.

The LVDTs measuring the relative transverse displacements between the central and outer steel beams were glued on the bottom flange of the steel beams. The setup of the LVDTs measuring relative transverse displacements is shown at Fig.2.17 and Fig.2.18.

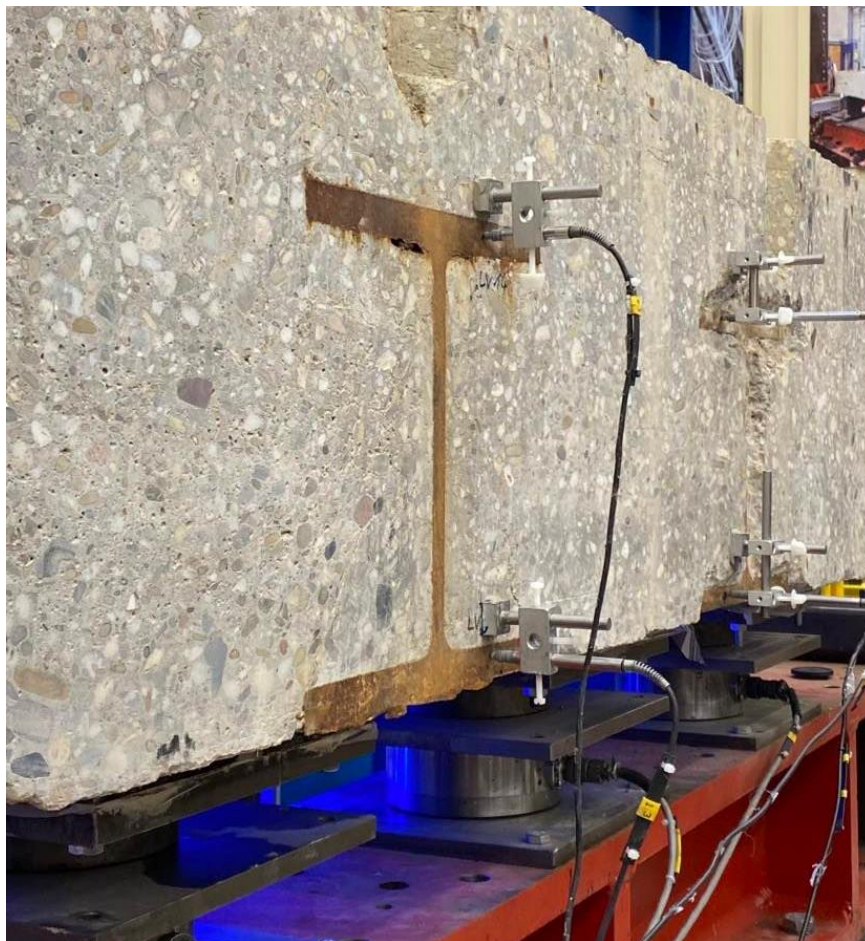
Fig.2.20. LVDTs 11-14 measuring relative longitudinal displacement at the end of LB1.

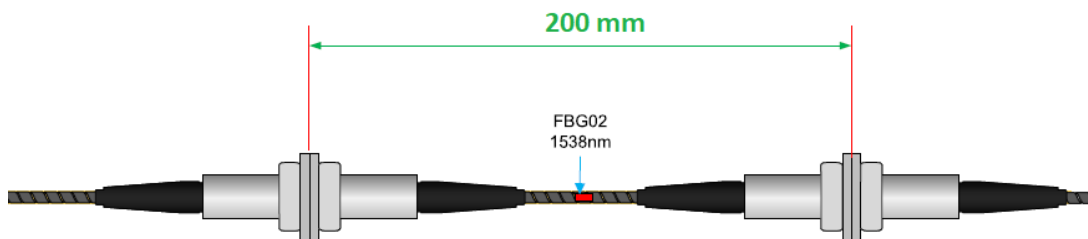
Fig.2.23. Detail of an optic fiber and an FBG sensor. (Faassen, 2021)

Optic fibers were used to measure strains both in concrete and steel. The optic fibers used are quasi distributed strain sensors that measure deformations over a base length distance of 200mm which is used to convert deformations into strains, see **Error! Reference source not found.** The optic fibers have a range of $\pm 2500\mu\epsilon$ and a sensitivity of $1.2\mu\epsilon$.

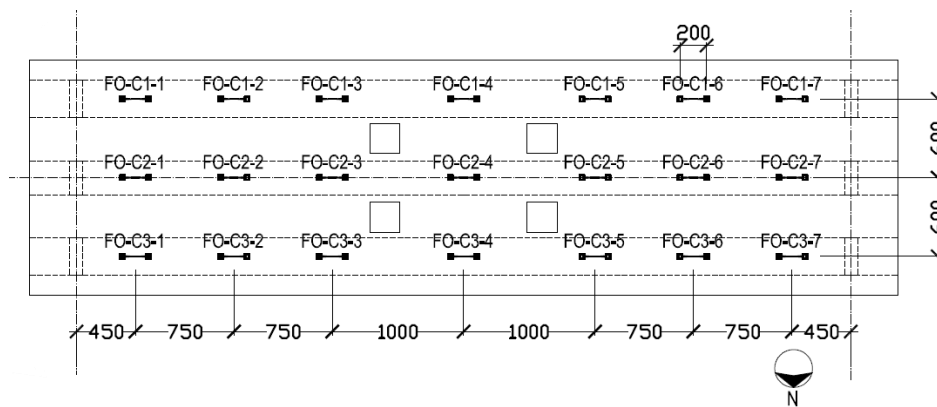
Fig.2.24. LB1 - Top view fiber optic position.

During installation of the optic fibers for LB1 sensor FO-S2-7 was damaged. In replacement LVDT 15 was installed with the same base length as for the optic fibers sensor. For LB3 the damaged sensor was placed as FO-C1-7, hence LVDT 15 replaced FO-C1-7 for LB3.

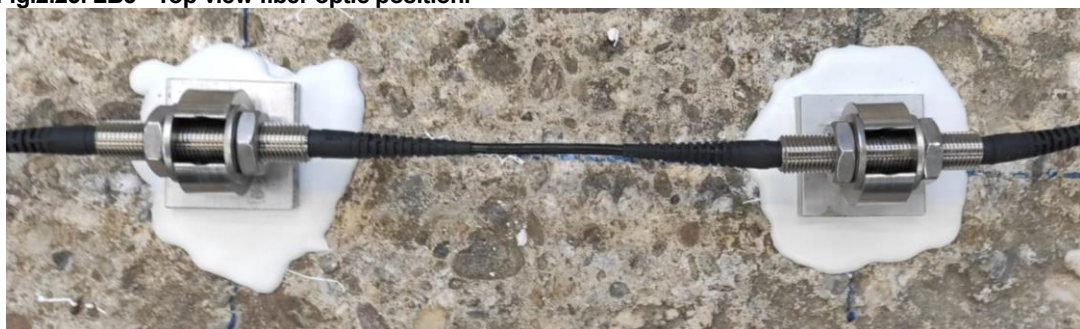
Fig.2.26. Fiber optic glued to the top of the specimen.

The optic fibers were attached to holders, that were screwed onto steel plates, that were glued to the specimens as shown at Fig.2.26 and Fig.2.27. To avoid failure of the glue during testing, the steel plates that were glued to the specimens had been sanded to make the surface rough.

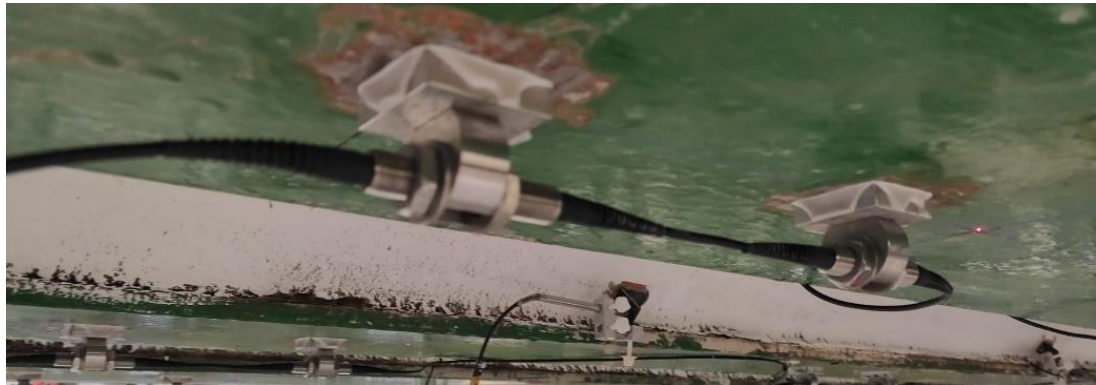
Fig.2.27. Fiber optic glued to the bottom of a steel beam.

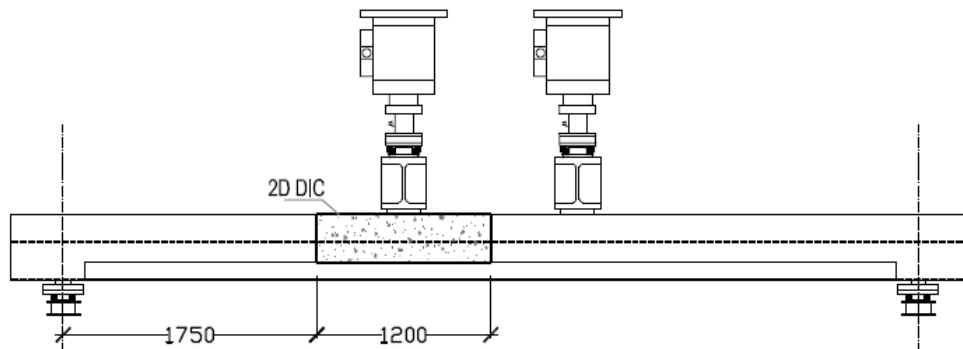
Fig.2.31. LB1 - North view 2D DIC position.

For measuring the displacement field, principal strain distribution and cracks both 2D DIC and 3D DIC were applied. 2D DIC is composed by only one camera, and therefore able to measure the displacements field in a plane. Where out of plane deformations are expected or the measured surface is not contained in a plane, a system with two cameras is used to perform a 3D DIC.

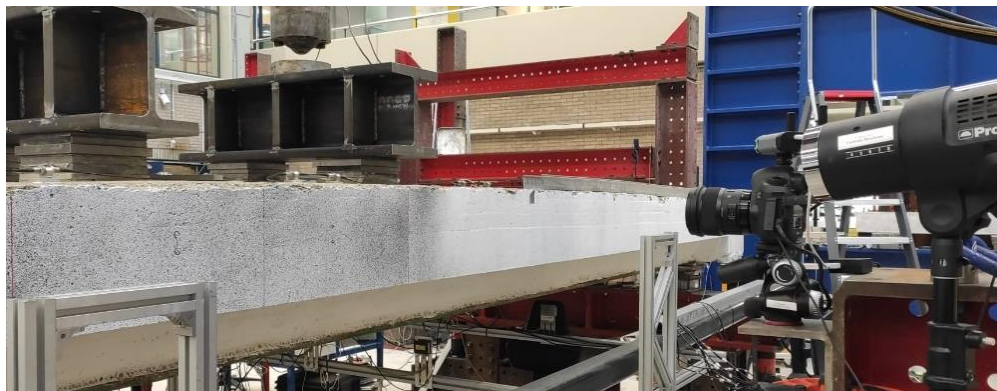
Fig.2.33. LB1 - Camera and flash setup for 2D DIC.

The 2D DIC was positioned on the side of the specimens, as shown on Fig.2.31 and Fig.2.32, respectively for LB1 and LB3. Fig.2.33 showing the setup with camera and flashlight of the 2D DIC. 3D DIC was placed underneath the specimens because the bottom surface was 3-dimensional and out-of-plane deformations are expected. Fig.2.34 and Fig.2.35 shows the position of the 3D DIC for LB1 and LB3. Fig.2.36 showing the camera setup for the 3D DIC.

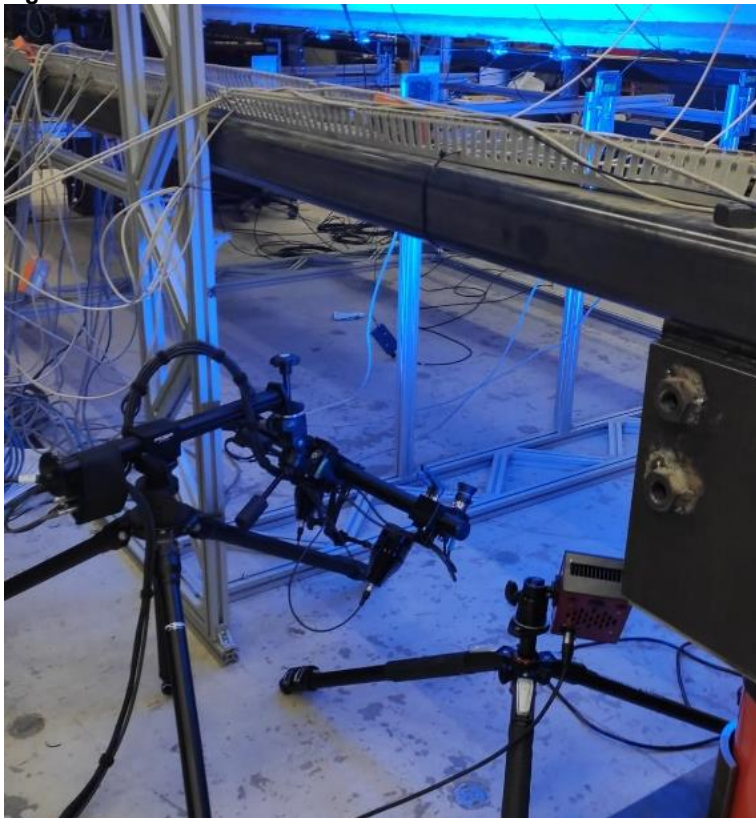
Fig.2.36. Camera and light setup 3D DIC.

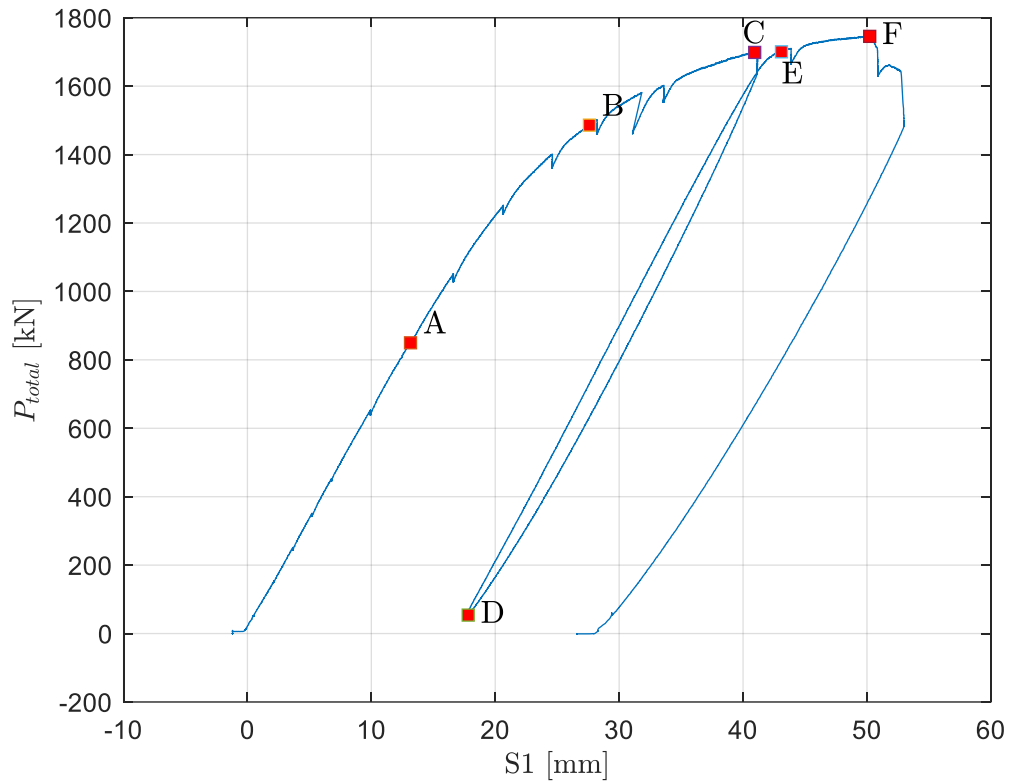
Fig.3.1. Displacement S1 on jack F1 versus total load Ptotal (sum of the forces of both jacks).

Cracking first occurred at 850 kN, point A from Fig.3.1, and the first cracks appeared as flexural cracks. The flexural cracks were first observed from the north side using the 2D DIC, but soon appeared at the 3D DIC measuring from underneath the specimen. For the 2D DIC where cracking starts see Fig.3.2.

After the load reached 1700 kN, point C from Fig.3.1, the specimen was unloaded to 50 kN to preserve the measuring devices, point D from Fig.3.1. From the unloading an irreversible vertical deformation of the specimen was observed, which shows the plastic behaviour of the specimen. The maximum displacement measured from lasers during unloading was 16 mm, measured from laser 5 that is underneath beam 2. Furthermore, the vertical displacement was not symmetrically perfect, due to small variations of the cross section over the length of the specimen. The vertical deformation measured from beam 2 is shown at Fig.3.9 at different load points.

The specimen failed after reloading at 1746 kN, point F from Fig.3.1,. Following the failure, a sudden load drop occurred, and the beam was unloaded. At this load level, delamination between steel and concrete occurred at beam 1. The delamination crack propagated through the hole beam reaching also the support. See Fig. 3.10, Fig.3.11, Fig.3.12.

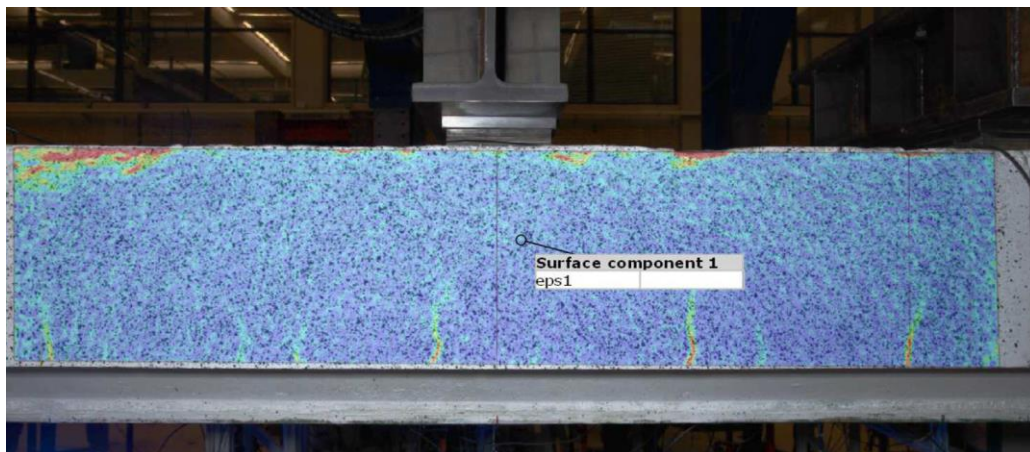
Fig.3.2. LB1. Point A – Principal strain field ϵ_1 - Cracking starts ($P_{total}=850$ kN). 2D DIC from the north side.

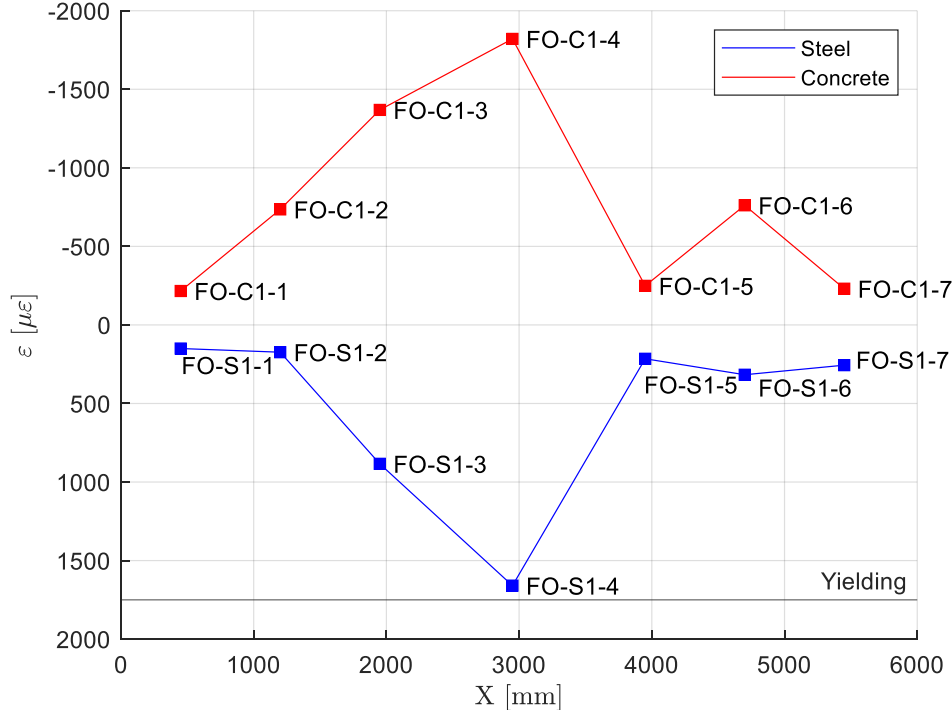
Fig.3.3. LB1. Point B – Beam 1 – Strains - Yielding starts at beam 2 (Ptotal=1447 kN). X, the position of the optic fibers from the support, versus the strain measured for optic fibers above and below beam 1.

Following cracking, yielding was first measured at mid-span from optic fiber FO-S2-4 at the bottom flange of beam 2. The yielding was observed assuming that yielding begins at 1,75‰. When yielding began, the load was 1447 kN and the adjacent beams had a strain close to yielding but only an elastic strain. The strains at 1447 kN at beams 1, 2 and 3 can be seen from Fig.3.3 and Fig.3.5.

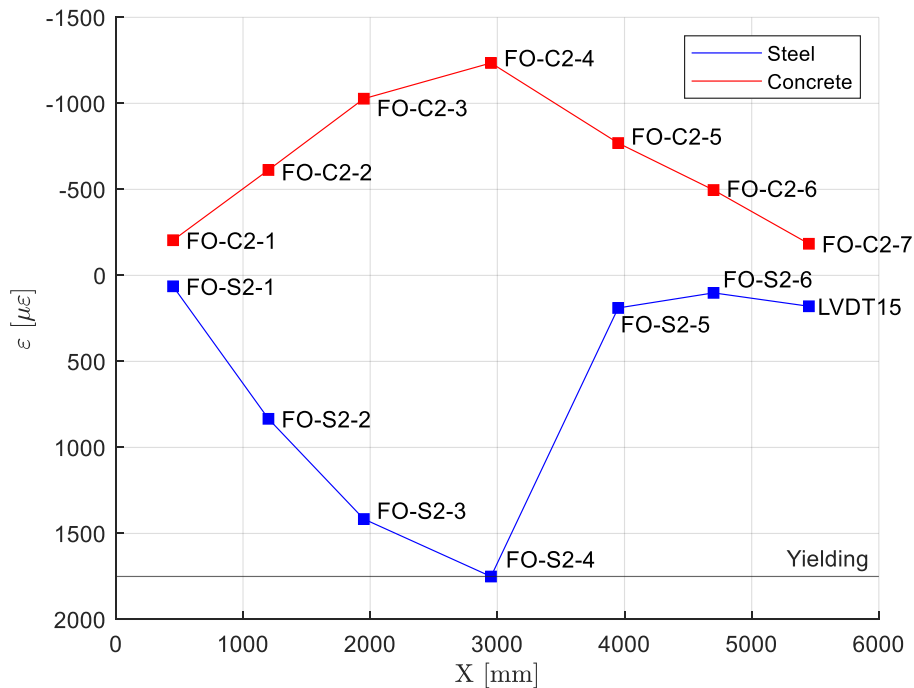
Fig.3.4. LB1. Point B – Beam 2 – Strains - Yielding starts at beam 2 (Ptotal=1447 kN). X, the position of the optic fibers from the support, versus the strain. FO-S2-7 broke during preparation of LB1 and is replaced by LVDT 15. FO-S2-5 and FO-S2-6 show smaller strains which can be considered outliers.

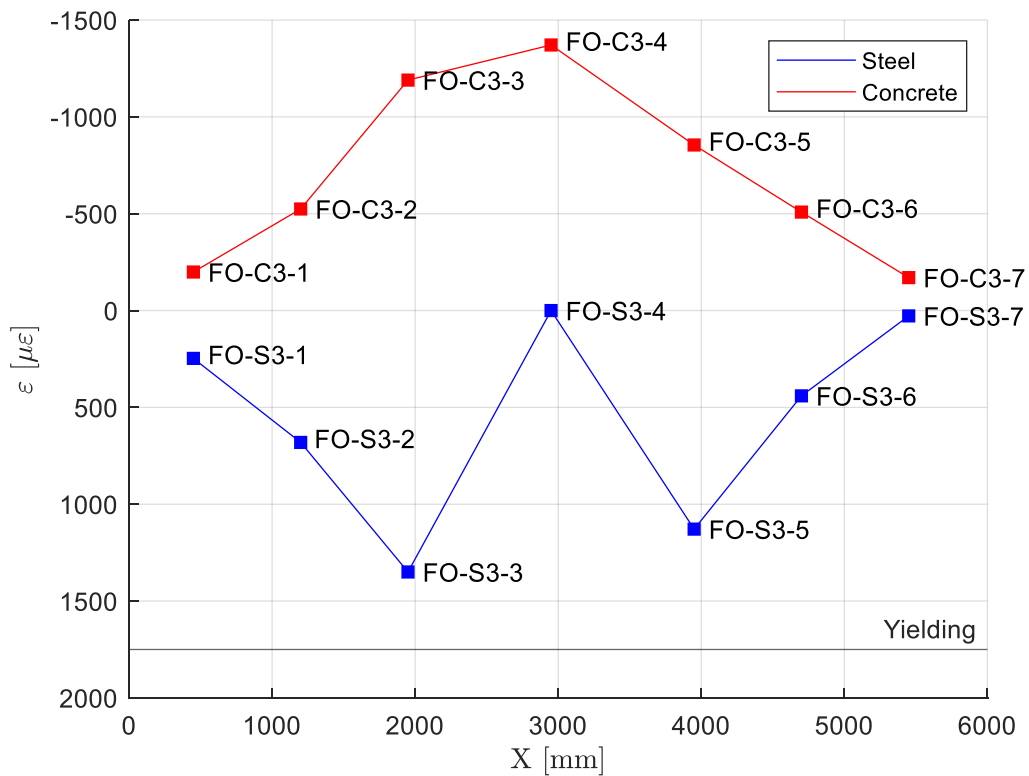
Fig.3.5. LB1. Point B – Beam 3- Strains - Yielding starts at beam 2 (Ptotal=1447 kN). X, the position of the optic fibers from the support, versus the strains. FO-S3-4 is not out of range despite the strain measured being smaller than expected therefore can be considered an outlier.

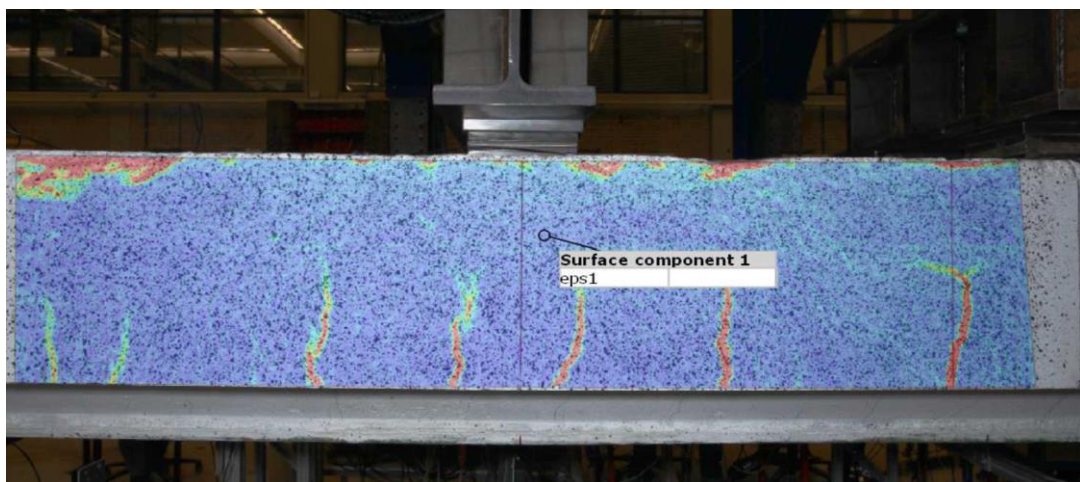
Fig.3.6. LB1. Point C -- Principal strain field ϵ_1 - max load before first unloading (Ptotal=1700 kN). 2D DIC from the north side.

When the load reached 1700 kN, point C from Fig.3.1, the flexural cracks at the side started to propagate in longitudinal direction at a height approximately corresponding to the top flange of the beams. Moreover, the cracks underneath the specimen started to propagate in longitudinal direction when yielding began, this was observed from the 3D DIC. Underneath the specimen, the cracks closest to the supports were propagating into one continuous crack. The 2D and 3D DIC at 1700 kN can be seen from Fig.3.6 and Fig.3.7.

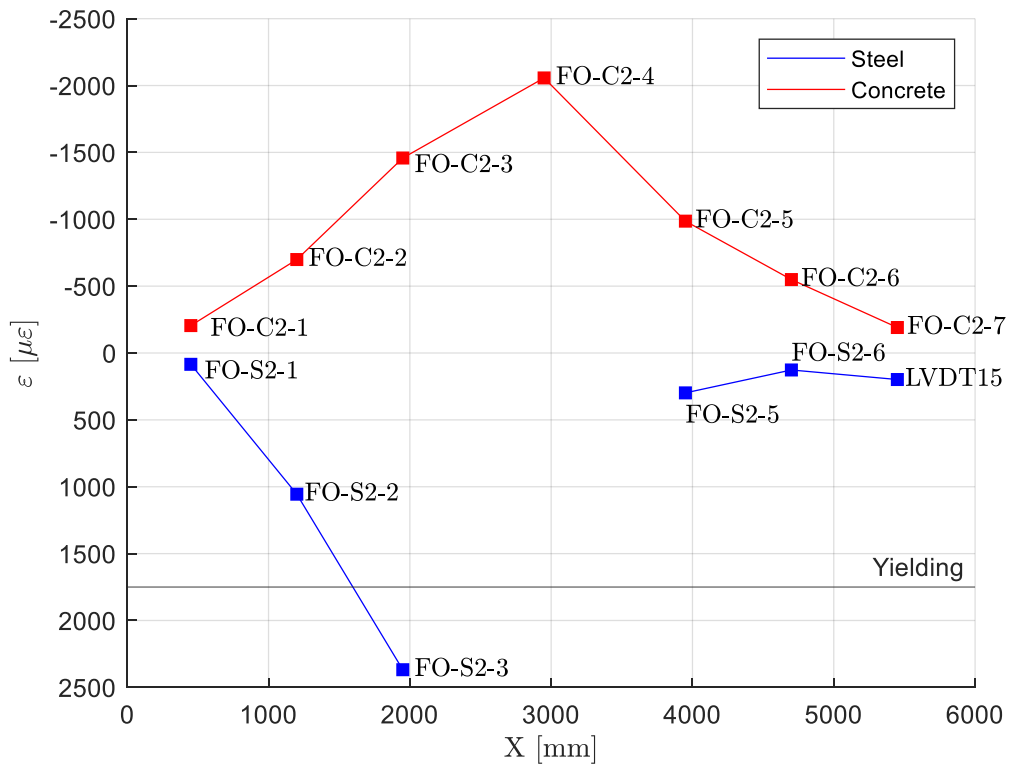
Fig.3.8. LB1. Point C - Max load of first loading ($P_{total}=1700$ kN). X, the position of the optic fibers from the support, versus the strain measured for optic fibers above and below beam 2. FO-S2-4 fell out of range. FO-S2-7 broke during preparation of LB1 and was replaced by LVDT 15.

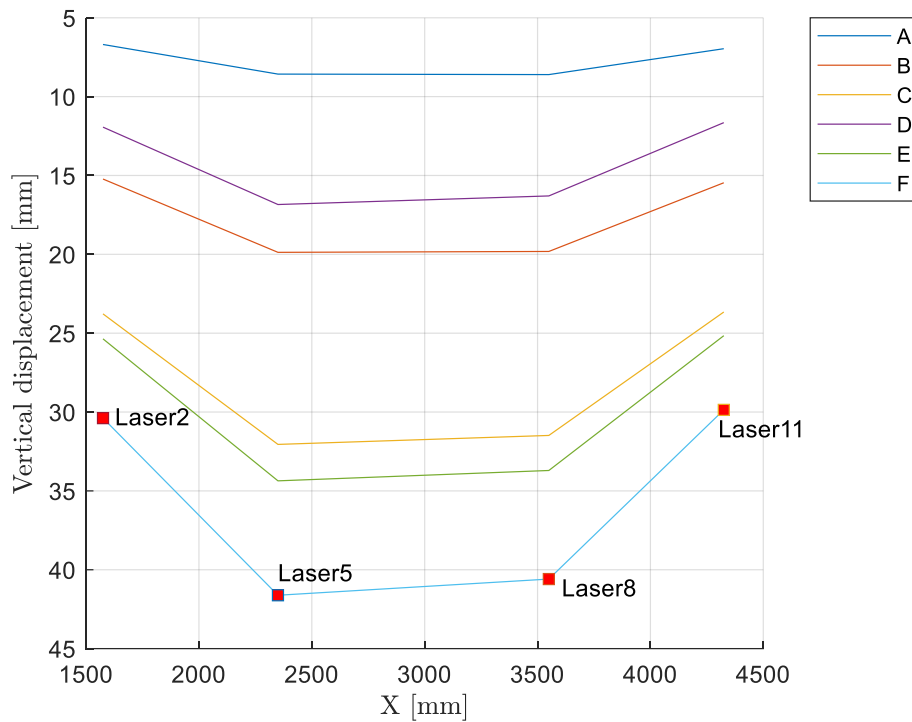
Fig.3.9. LB1. Displacement profile at beam 2 for different load levels (A-F from Fig.3.1). Laser 2, 5, 8 and 11 positioned at beam 2. X, distance to the support, versus the total vertical displacement.

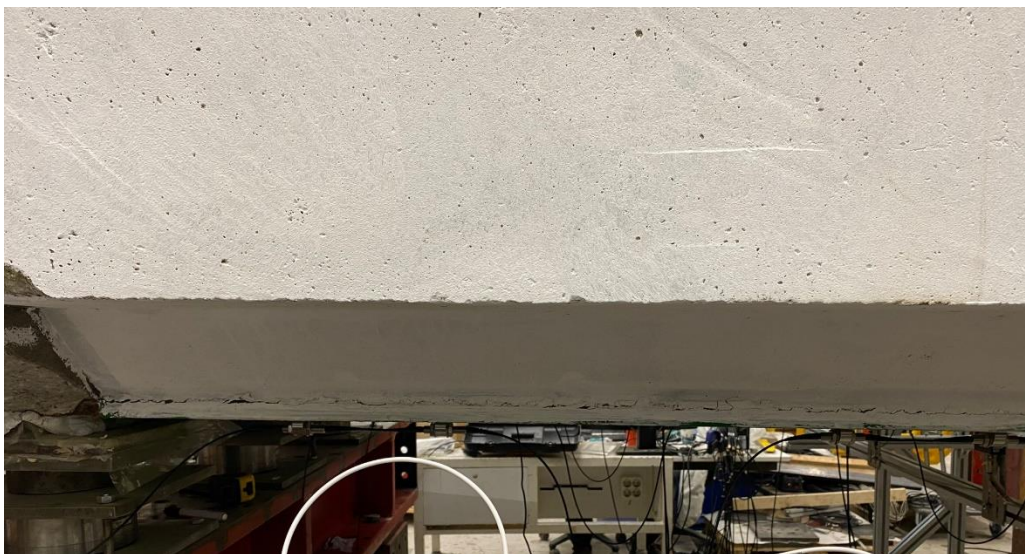
Fig. 3.10 - LB1 - Delamination crack observed at Ptotal = 1746 kN. Steel beam 1. Picture from south view.

From the south side delamination cracks were observed at beam 1 that propagated to the support at load cell 4, which can be seen from, Fig. 3.10 and Fig.3.17. At the west end of the specimen there was a gap between beam 1 and the concrete, which can be seen from Fig.3.12. At the east side there were cracks in the concrete between the top and bottom flanges of beam 1, which can be seen from Fig.3.11. Underneath the specimen there was a longitudinal crack between beams 1 and 2 going from support to support which can be seen from Fig.3.18.

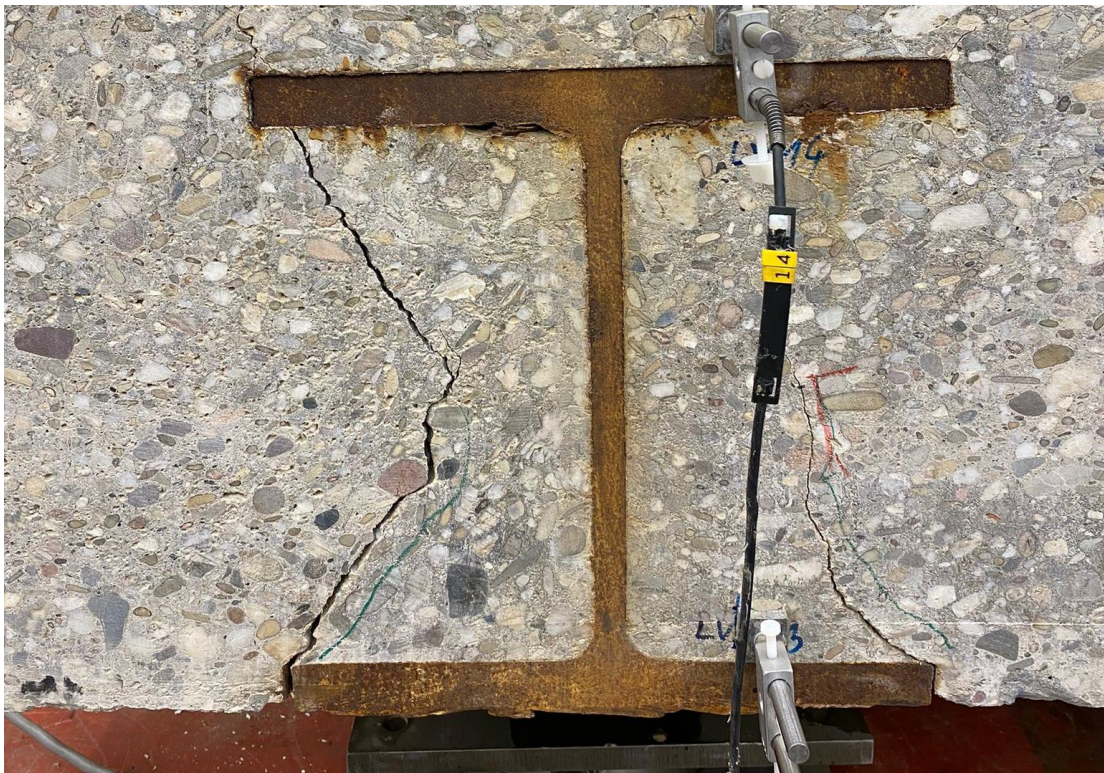
Fig.3.11. LB1. Cracks between flanges of beam 1 at the east end after testing.

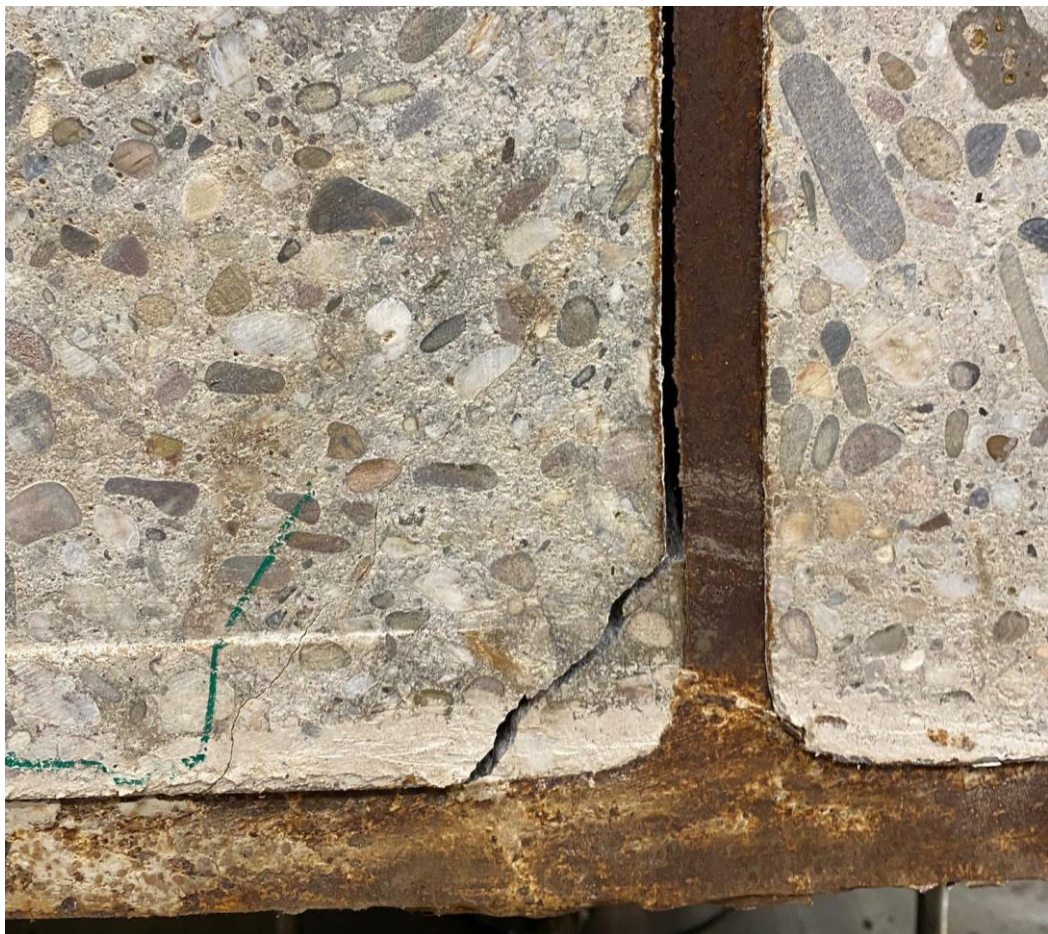
Fig.3.12. LB1. Crack at the west end of beam 1 after testing.

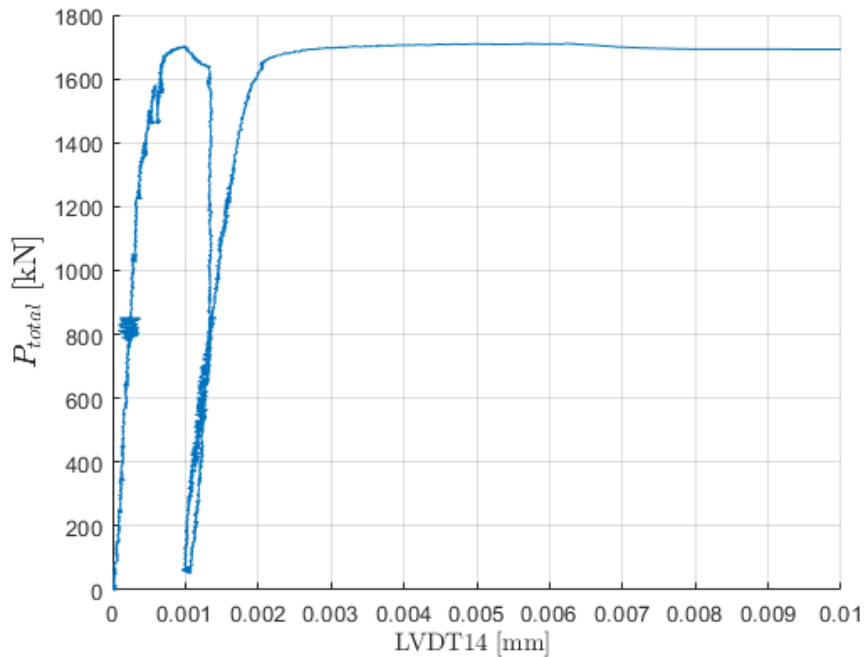
Fig. 3.13 - LB1 - Relative displacement between steel top flange and adjacent concrete at Beam 1 end. The maximum relative displacement measured was 1mm, the graph is limited to keep scale.

The delamination was also measured at LVDT14 which during most of the experiment had values close to zero until the delamination crack propagated until the support and the displacement increased significantly. See Fig. 3.13.

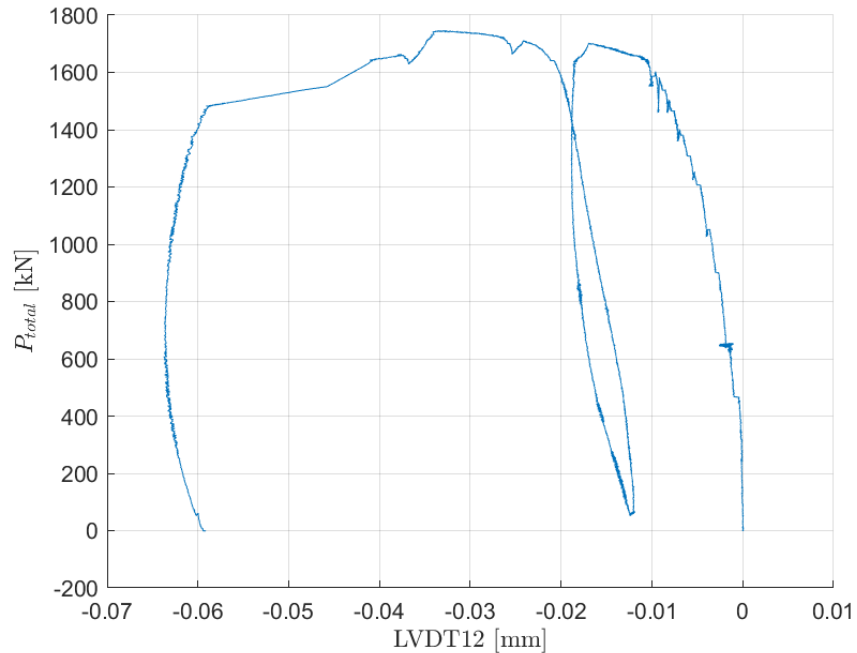
Fig.3.14. LB1. Longitudinal displacement at top flange of beam 2 versus total load.

A similar behaviour was observed at LVDT 12 which activated showing slip of the beams at the top flange. LVDT 12 measuring slip at beam 1 showed a trend like the vertical displacement, whereas LVDT 14 measuring slip at beam 2 only showed slip at failure. LVDT 12 can be seen on Fig.3.14. LVDT 11 and 13, showed small values of relative displacement.

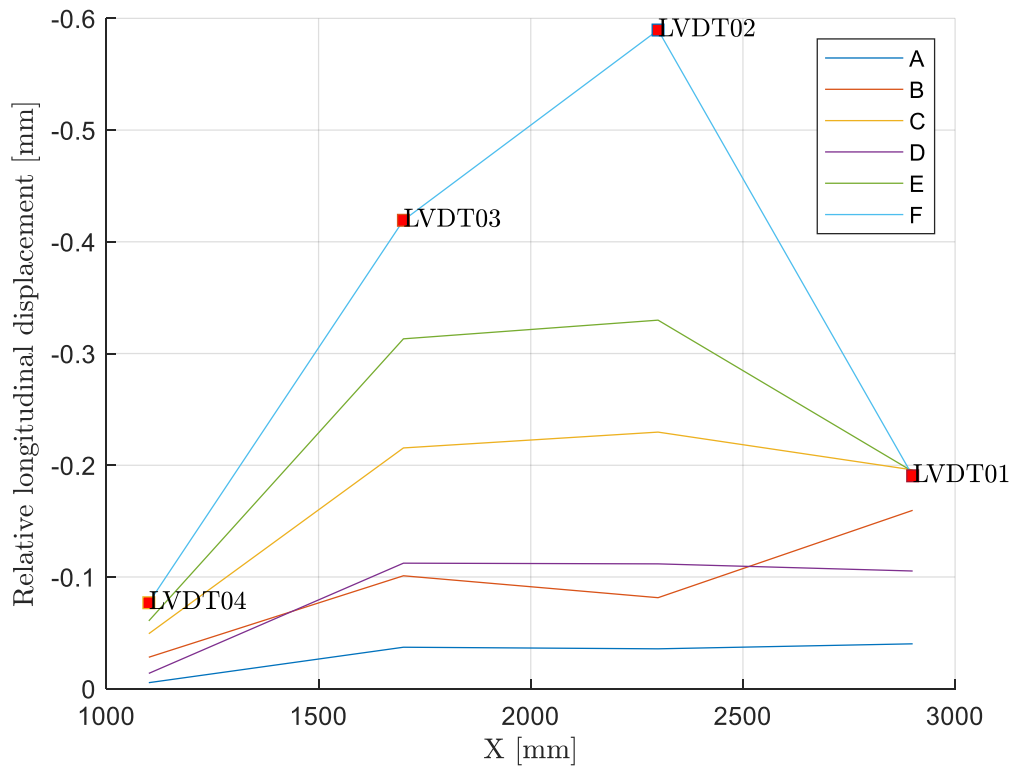
Fig.3.15. Point A-F for LVDT 1-4. Relative longitudinal displacement between steel and concrete versus X, the distance to the support.
