Delft University of Technology
Faculty of Civil Engineering and Geosciences
Department of Design and Construction
Section of Structural and Building Engineering
Concrete Structures

Report	25.5-22-03
Project	CS3B13
Date	April 2022
Status	Final
Version	1.00

Experiment report on steel-concrete- composite bridge deck without mechanical connectors (Verbundträger)

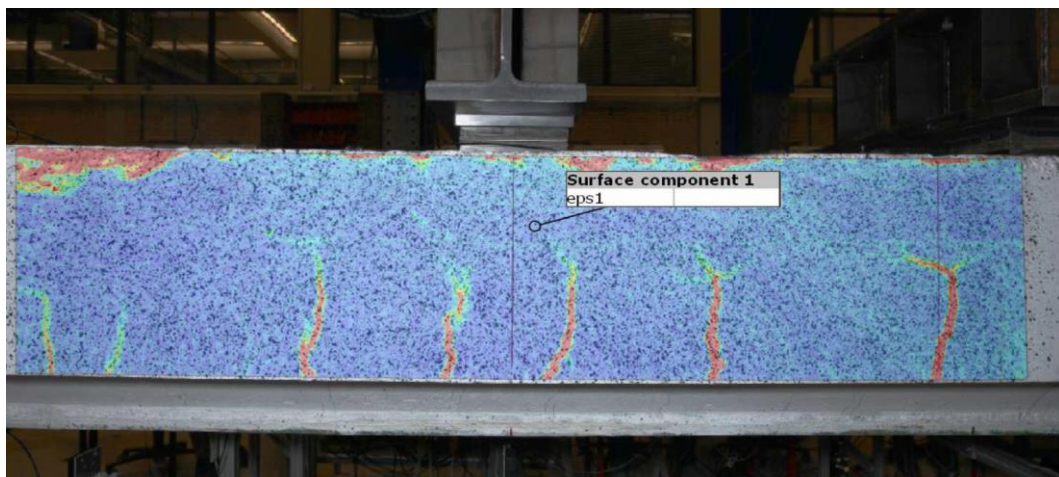
Fig.3.16. LB1. Point F - the max load is achieved (Ptotal=1746). 2D DIC from the north side.

Flexural cracks propagated in longitudinal direction at a height around the position of the top flange, especially on the region where the load was applied. The 2D DIC at failure can be seen from Fig.3.16.

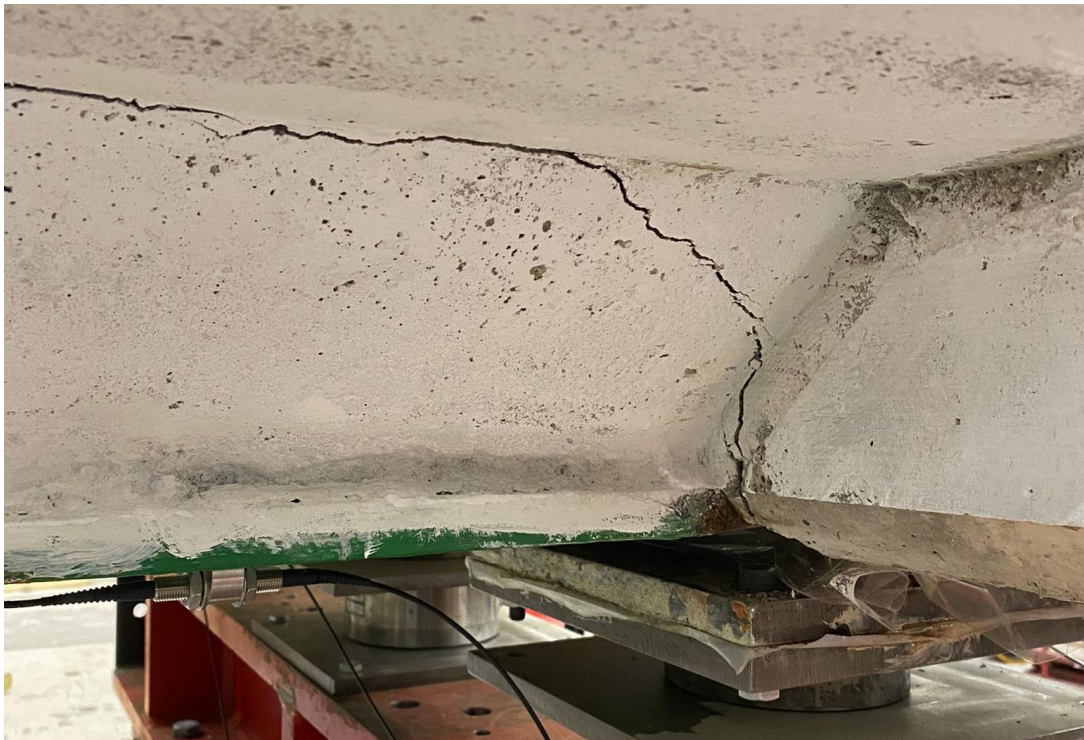
Fig.3.17. LB1. Crack from the east support along beam 1.

From the south side delamination cracks were observed at beam 1 that propagated to the support at load cell 4, which can be seen from, Fig. 3.10 and Fig.3.17. At the west end of the specimen there was a gap between beam 1 and the concrete, which can be seen from Fig.3.12. At the east side there were cracks in the concrete between the top and bottom flanges of beam 1, which can be seen from Fig.3.11. Underneath the specimen there was a longitudinal crack between beams 1 and 2 going from support to support which can be seen from Fig.3.18.

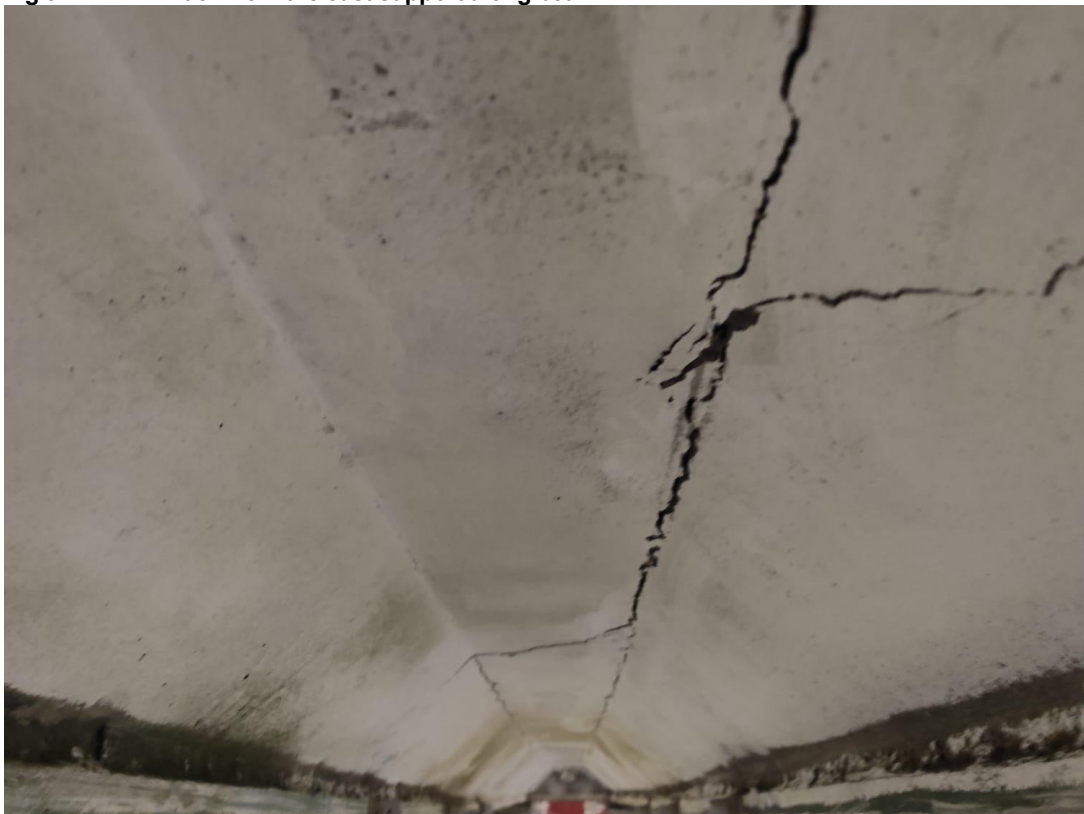
Fig.3.18. LB1. Crack between beam 1 and 2 underneath the specimen. The crack was observed after the test.

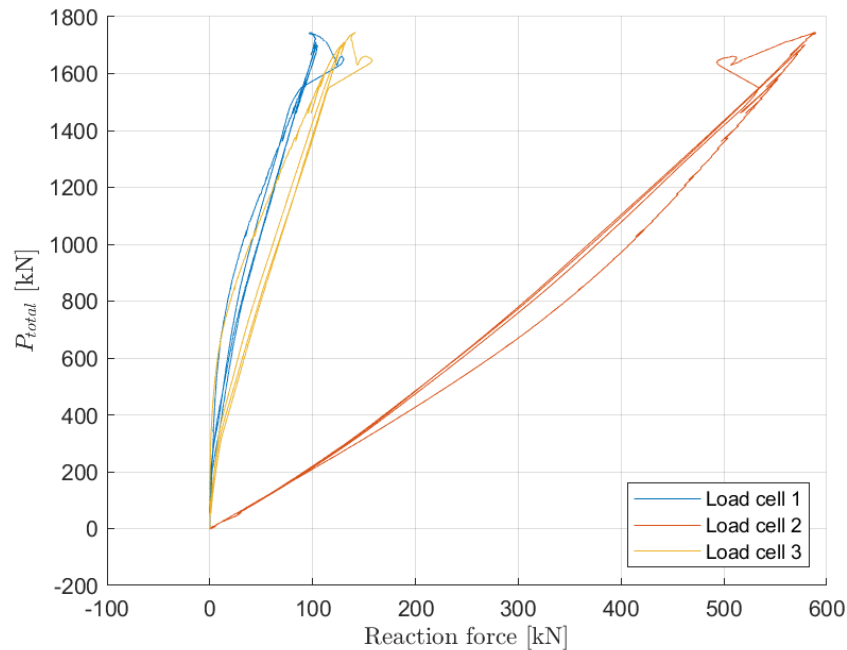
Fig. 3.19 – LB1 - Reaction force from load cells versus total load for load cell 1-3, west side.

The load distribution among the three beams can be obtained by analyzing the load cells measurements. It was observed that the middle beam carried a higher portion of the loads. See Fig. 3.19 and Fig. 3.20. Moreover the response is not completely symmetric.

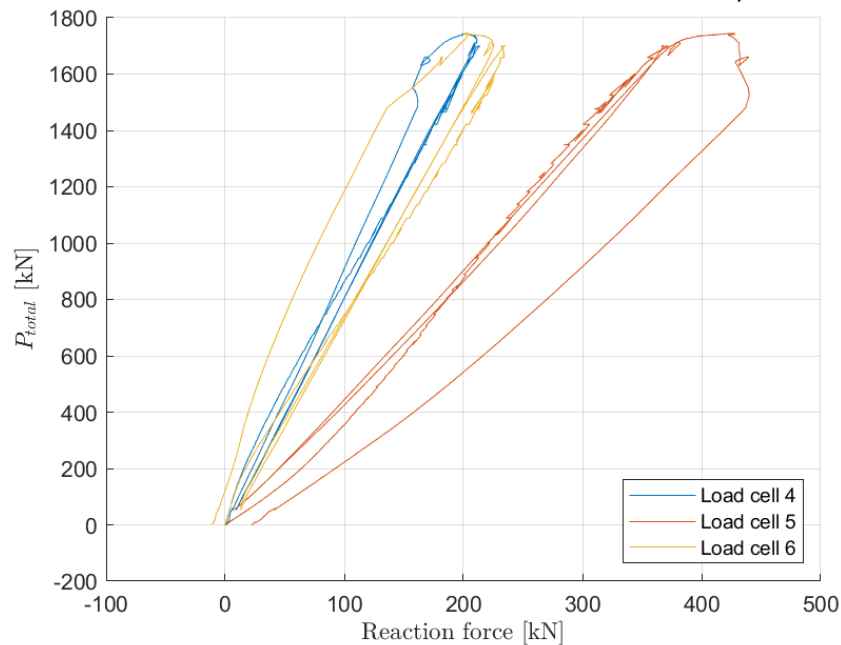
Fig. 3.20 – LB1 - Reaction force from load cells versus total load for load cell 4-6, east side.

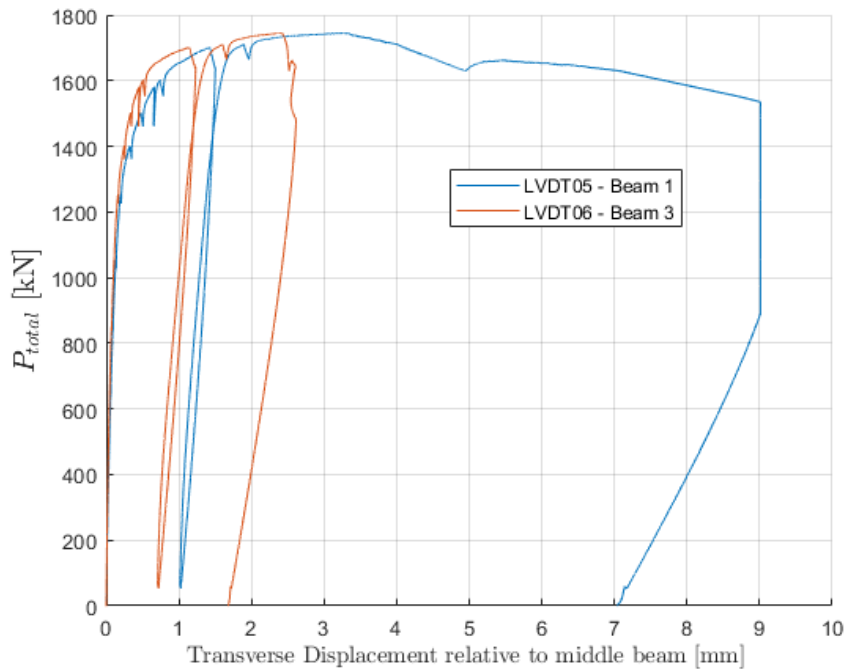
Fig. 3.21- LB1 - Relative transverse displacements from the outer beams measured from the bottom flange.

On the transverse displacements of the beams, it was observed that Beam 1 (southern beam) experienced a bigger transverse displacement from the middle than Beam 3 (northern beam). This can be seen on the measurements of LVDTs 5 and 6 (LVDTs 7-10 showed a similar behavior), see Fig. 3.21.

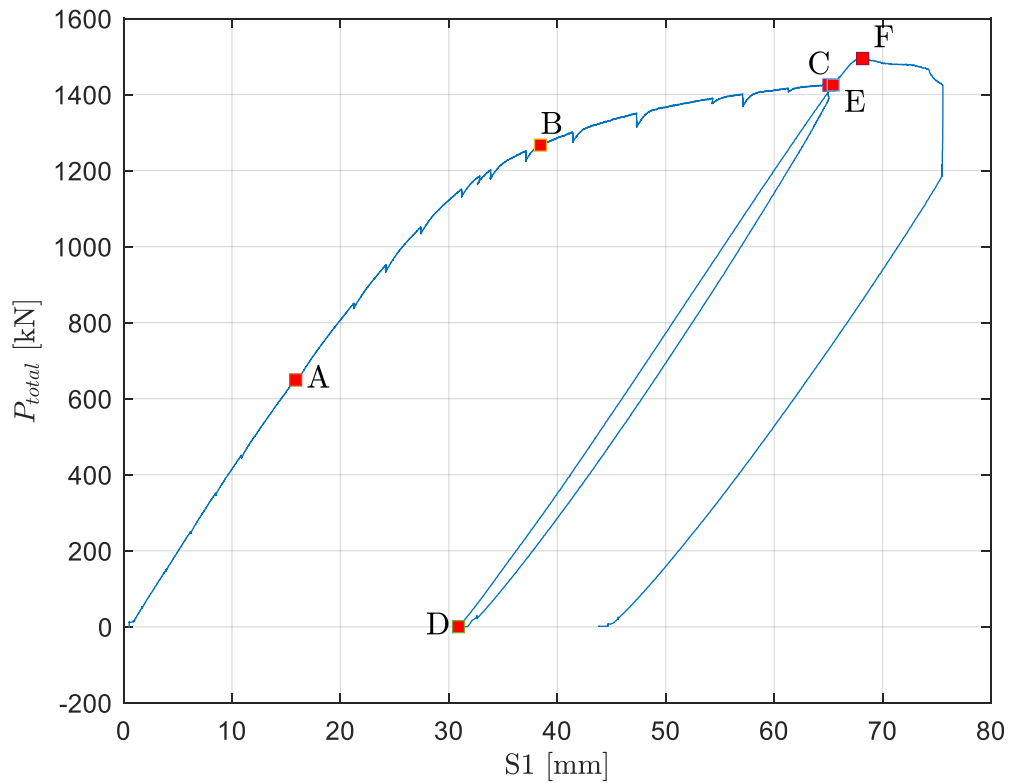
Fig.3.23. Displacement S1 at jack F1 versus total load (sum of both jacks). Characteristic load points shown with capital letters.

Cracking first occurred at 650 kN, point A from Fig.3.23. The first cracks appeared as flexural cracks, these were first observed from the north side of the specimen, using 2D DIC, at this point cracking was also visible from the 3D DIC positioned underneath the specimen. The 2D and 3D DIC at 650 kN can be seen from Fig.3.24 and Fig.3.25.

When the maximum displacement range was achieved at 1426 kN, point C from Fig.3.23, the 2D DIC showed that the flexural cracks had propagated to approximately the position at the top flange of the steel beams, which is shown at Fig.3.31.

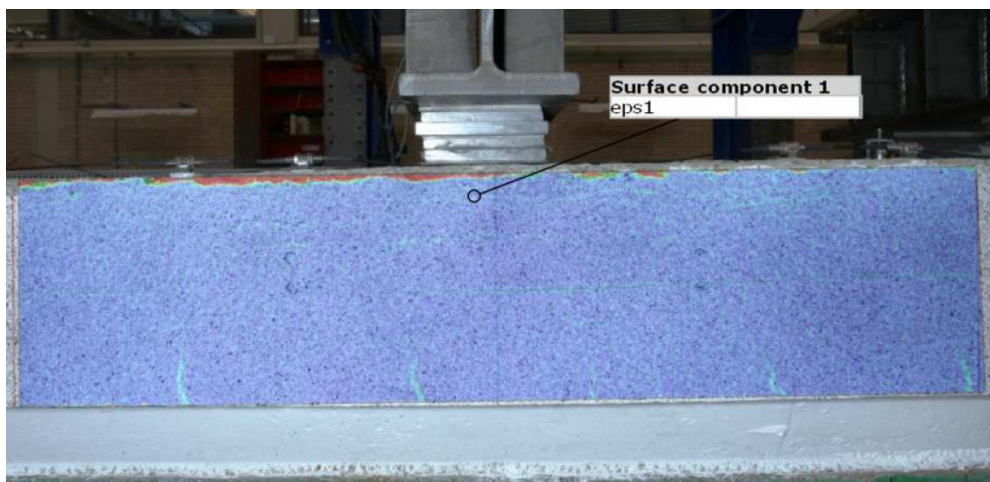
Fig.3.24. LB3. Point A – Principal strain field ϵ_1 - Cracking starts ($P_{total}=650$ kN). 2D DIC from the north side.

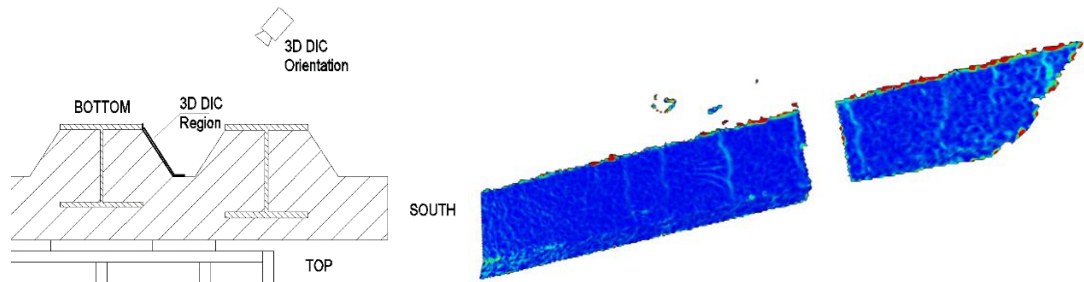
Fig.3.25. LB3. Point A – Principal strain field ϵ_1 - Bottom surface of the concrete - Cracking starts ($P_{total}=650$ kN). 3D DIC from underneath the specimen.

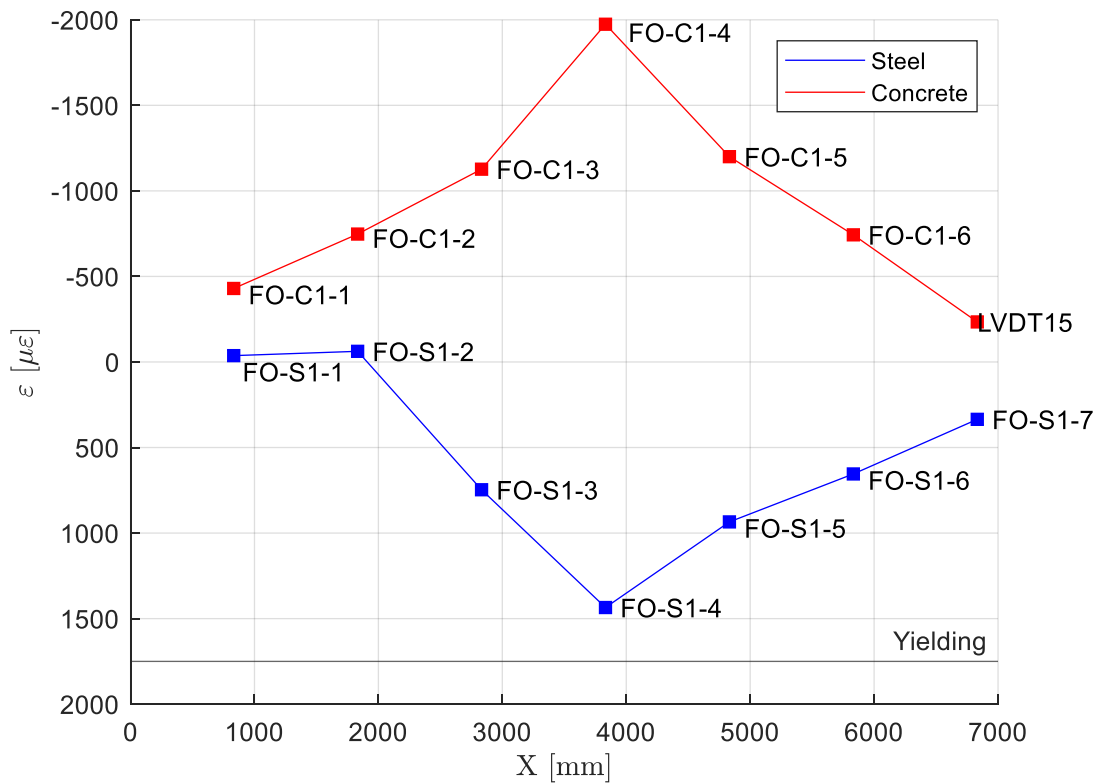
Fig.3.26. LB3. Point B – Beam 1 – Strains - Yielding starts at beam 3 ($P_{total}=1267$ kN). X, the position of the optic fibers from the support, versus the strain. FO-C1-7 broke during preparation of LB1 and was replaced by LVDT 15.

Following cracking, yielding was first measured at 1267 kN close to mid-span at beam 3 from optic fiber FO-S3-5. At this point FO-S3-4 measured relatively low values, although it was expected that this would measure the highest strains at beam 3, later FO-S3-4 obtained values that seemed reasonable. The maximum strain of the top concrete layer was in the range 2,0‰, measured at midspan from optic fiber FO-C1-4. The strain for beams 1, 2 and 3 are shown at Fig.3.26 to Fig.3.28.

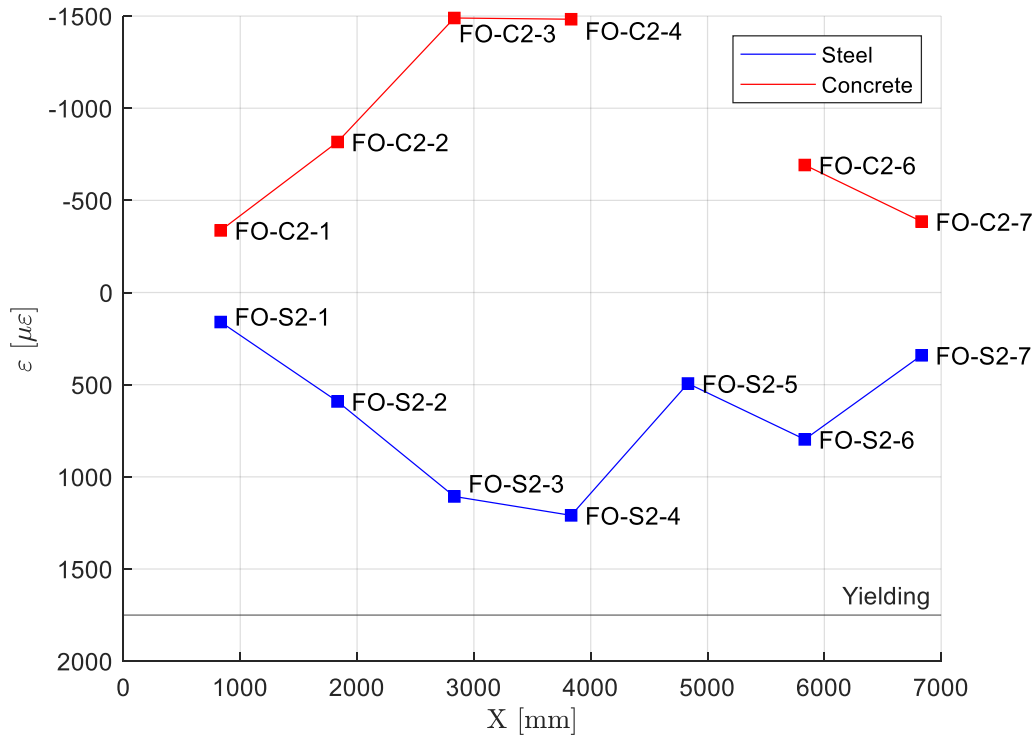
Fig.3.27. LB3. Point B- Beam 2 – Strains - Yielding starts at beam 3 (Ptotal=1267 kN). X, the position of the optic fibers from the support, versus the strain. FO-C2-5 fell out of range.

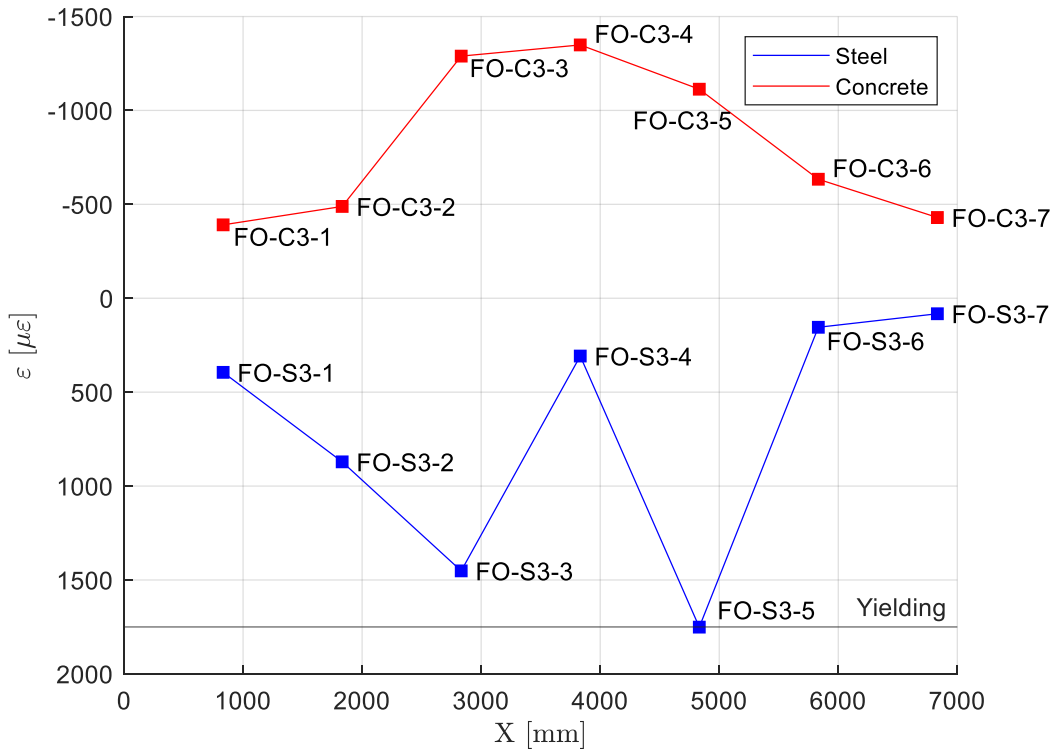
Fig.3.28. LB3. Point B - Yielding starts at beam 3 (Ptotal=1267 kN). X, the position of the optic fibers from the support, versus the strain 3. FO-C2-5 fell out of range. FO-S3-4 shows inconsistent values and can be seen as an outlier.

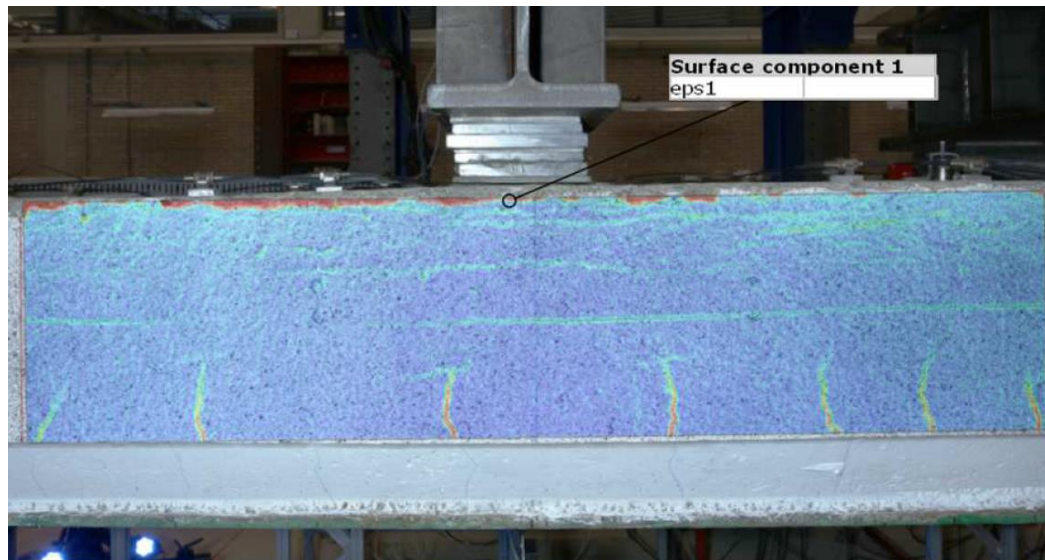
Fig.3.29. LB3. Point B – Principal strain field ϵ_1 - Yielding starts at beam 3 ($P_{total}=1267$ kN). 2D DIC from the north side.

At 1267 the 2D DIC showed horizontal cracks at the top half of the concrete layer which can be seen as initiation of concrete crushing. At this level concrete compressive strains were $2000\mu\epsilon$ at mid span as it was measured it can be seen in Fig.3.26. In addition, the flexural cracks started to propagate in longitudinal direction, without reaching the position of the top flange of the steel beams. Moreover, the cracks underneath the specimen had grown and became more visible. The 2D and 3D DIC at 1267 kN is shown at Fig.3.29 and Fig.3.30.

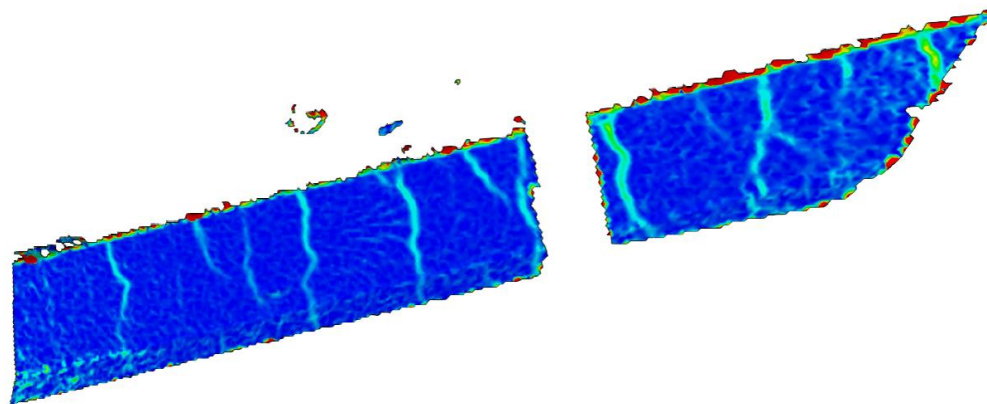
Fig.3.30. LB3. Point B – Principal strain field ϵ_1 - Bottom surface of the concrete -Yielding starts ($P_{total}=1267$ kN). 3D DIC from underneath the specimen.

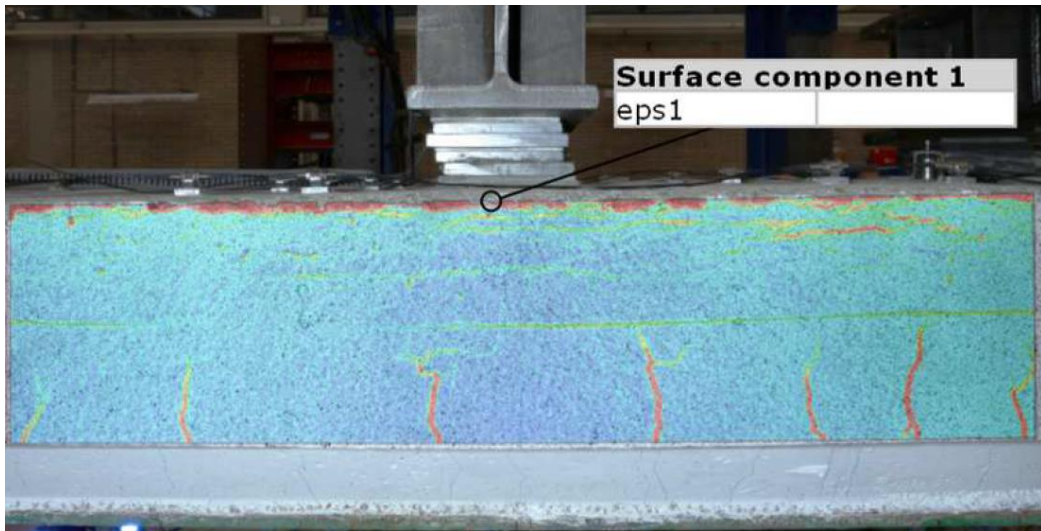
Fig.3.31. LB3. Point C –Princpal strain field ϵ_1 - max load before first unloading ($P_{total}=1426$ kN). 2D DIC from the north side.

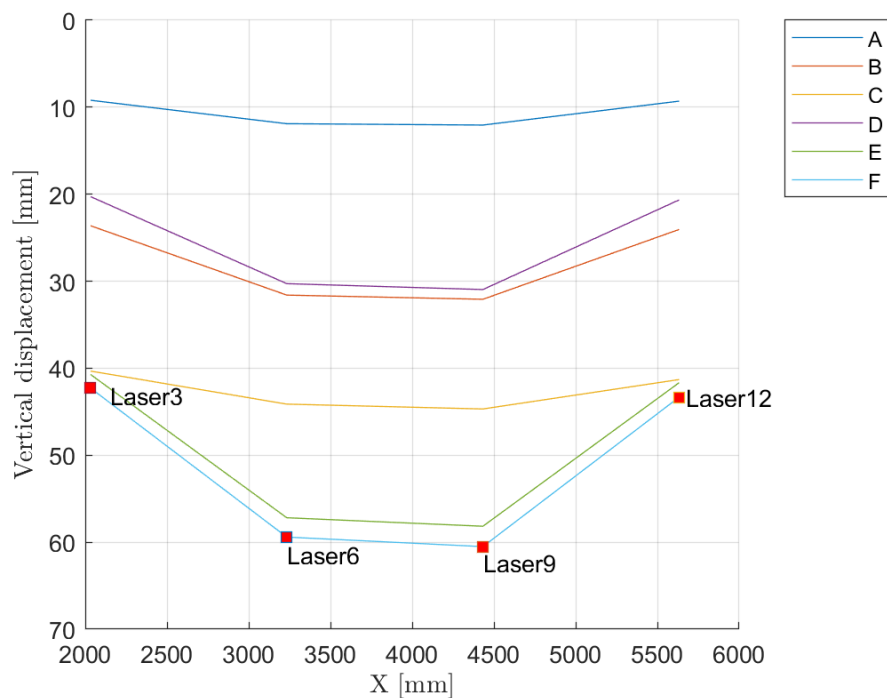
Fig.3.32. LB3. Vertical displacements under beam 3 at different load levels (Point A-F) for laser 3, 6, 9 and 12. X, distance to the support, versus the total vertical displacement.

Between 1426 kN and 1494 kN, point F from Fig.3.23, the vertical displacement merely increased with 3 mm measured from laser 6 and 9. The vertical displacement increased linearly with increasing load during the reloading, till the specimen failed at 1494 kN,

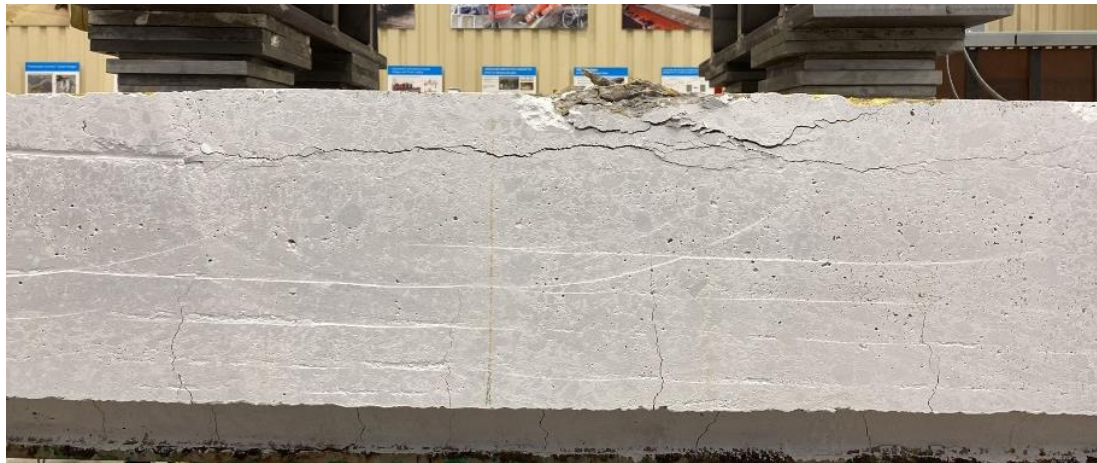
Fig.3.33. LB3. Mid-span from south side after testing showing cracks and crushing.

Following the failure, crushing occurred at the top layer of the concrete, see Fig.3.33.

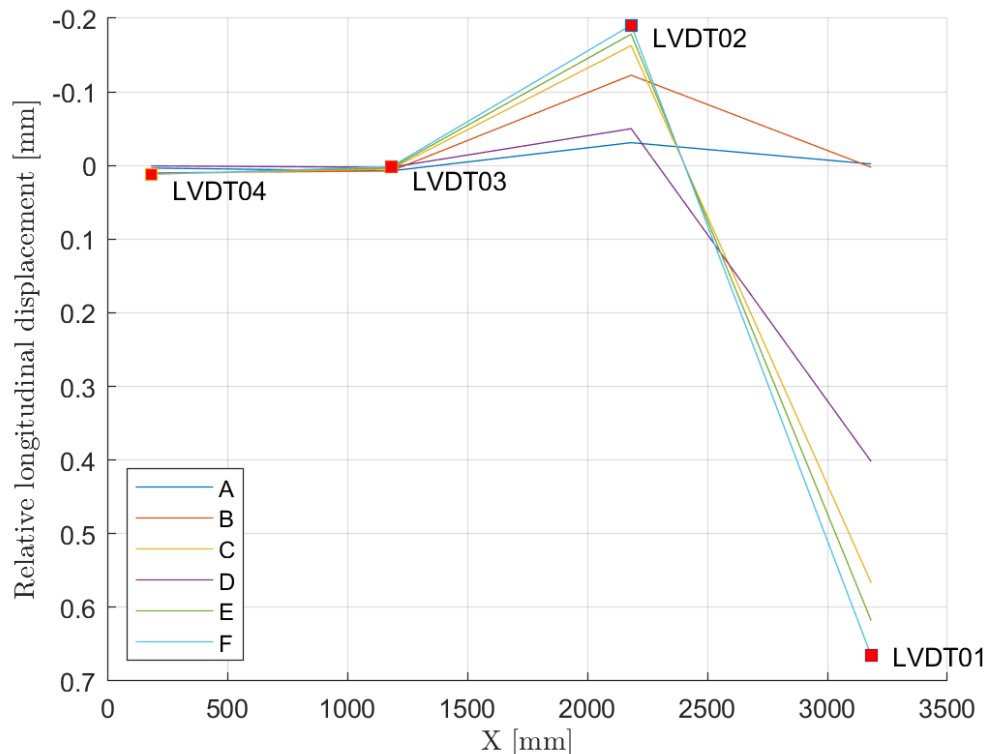
Fig.3.34. LB3. Point A-F for LVDT 1-4. Relative longitudinal displacement between steel and concrete versus X, the distance to the support.

At failure LVDT 1 and 2 were activated, whereas LVDT 3 and 4 were almost constant throughout the entire testing, see Fig.3.34. In addition, LVDT 11-14 measuring relative longitudinal displacement at the end of the specimen, were not activated, indicating that no slip occurred.

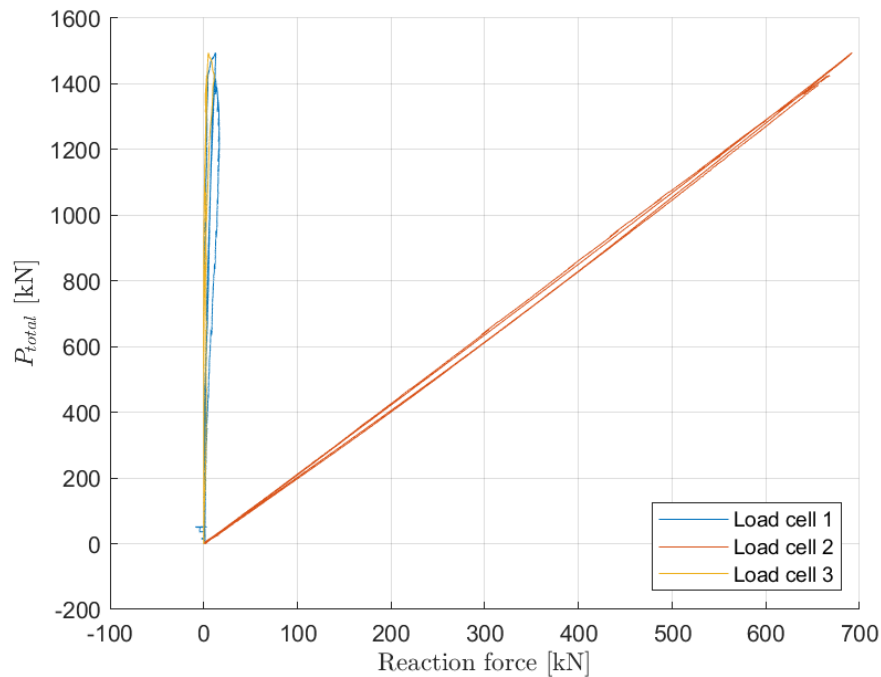
Fig. 3.35 - LB3 - Reaction force from load cells versus total load for load cell 1-3, west side

The load distribution among the three beams can be obtained by analyzing the load cells measurements. It was observed that the middle beam carried a much higher portion of the loads. See Fig. 3.35 and Fig. 3.36. Moreover, the response is not symmetric on the longitudinal direction.

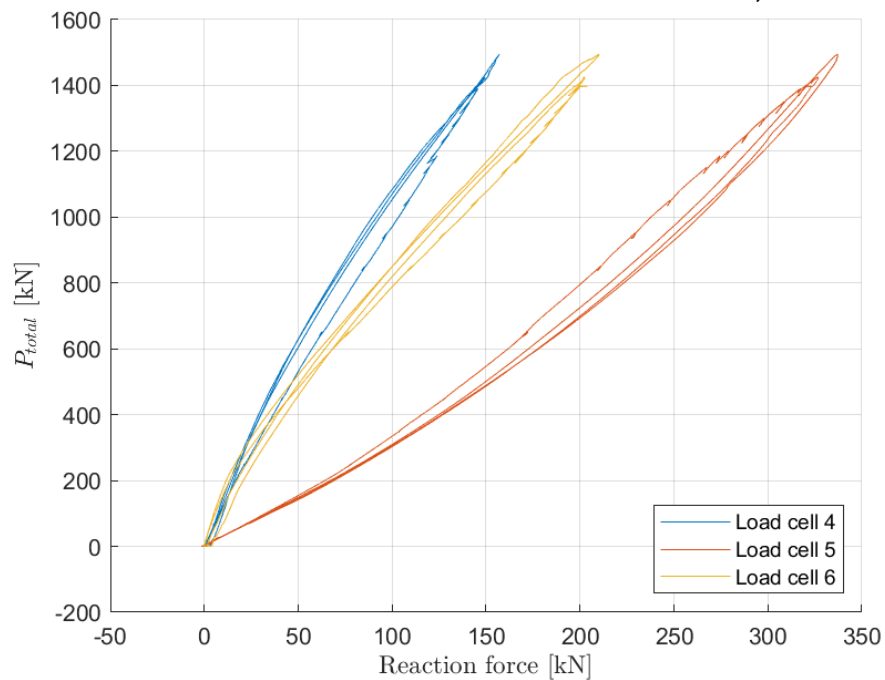
Fig. 3.36 - LB3 - Reaction force from load cells versus total load for load cell 4-6, east side

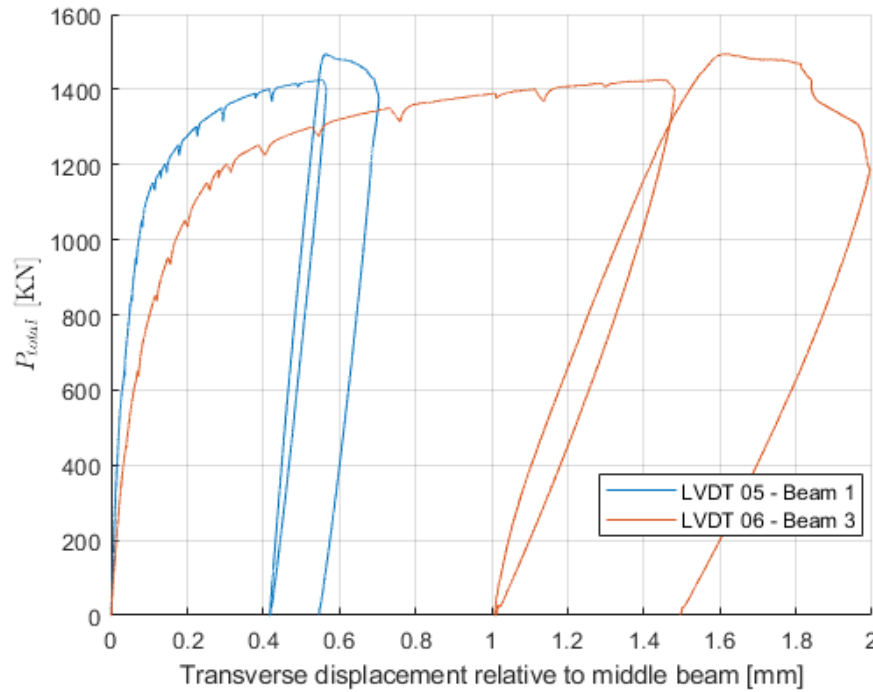
Fig. 3.37 - LB3 - Relative transverse displacements from the outer beams measured from the bottom flange.

On the transverse displacements of the beams, it was observed that Beam 3 (northern beam) experienced a bigger transverse displacement relative to the middle than Beam 1 (southern beam). This can be seen on the measurements of LVDTs 5 and 6 (LVDTs 7-10 showed a similar behavior), see Fig. 3.37.

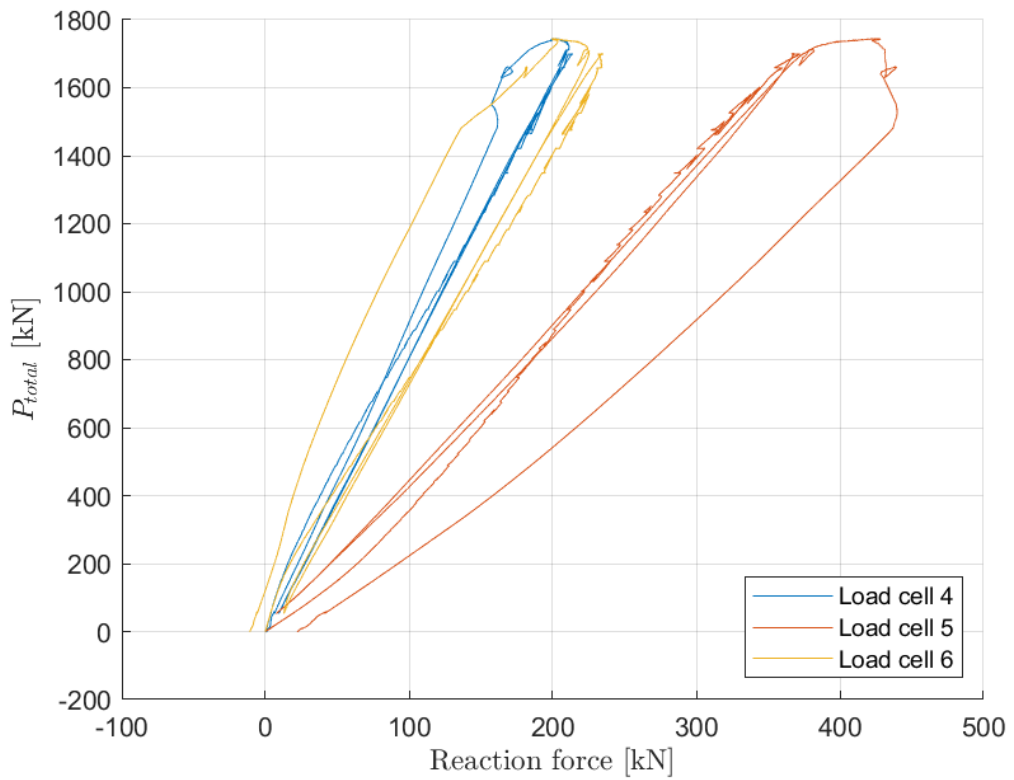
Fig A.2. LB1. Reaction force from load cells versus total load for load cell 1-3.

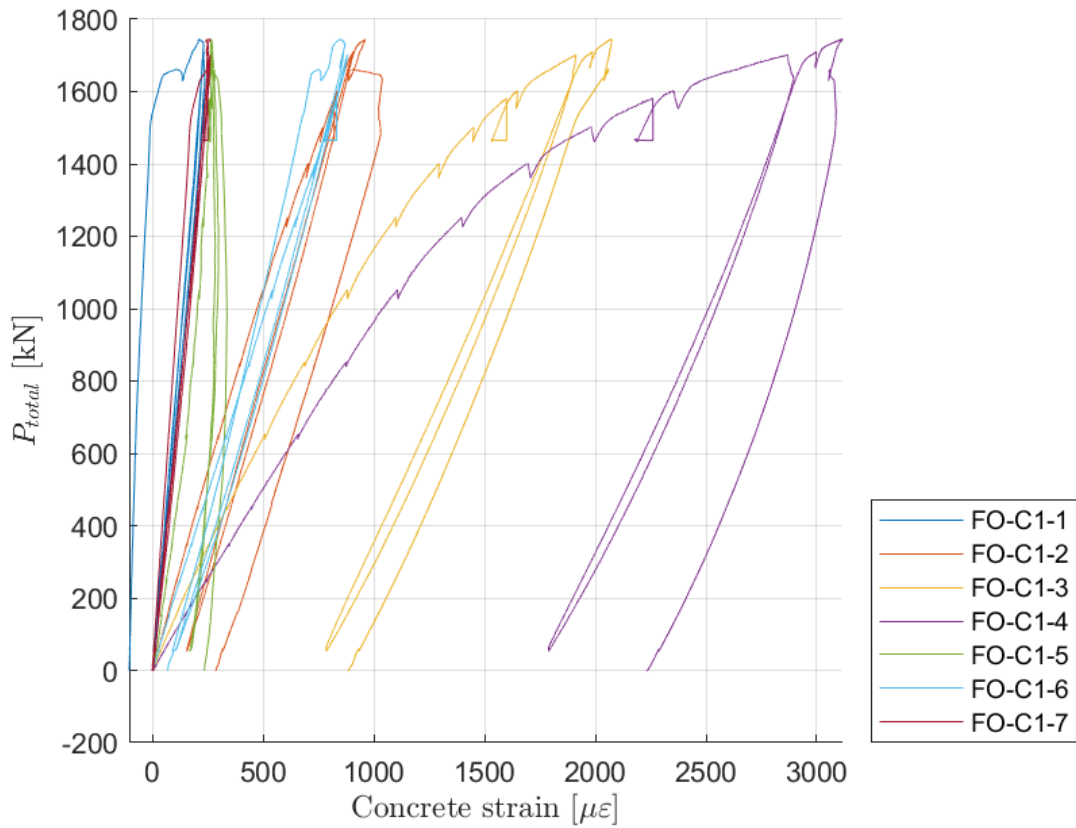
Fig B.1. LB1. Concrete strain versus total load for FO-C1-1 to FO-C1-7 at beam 1.

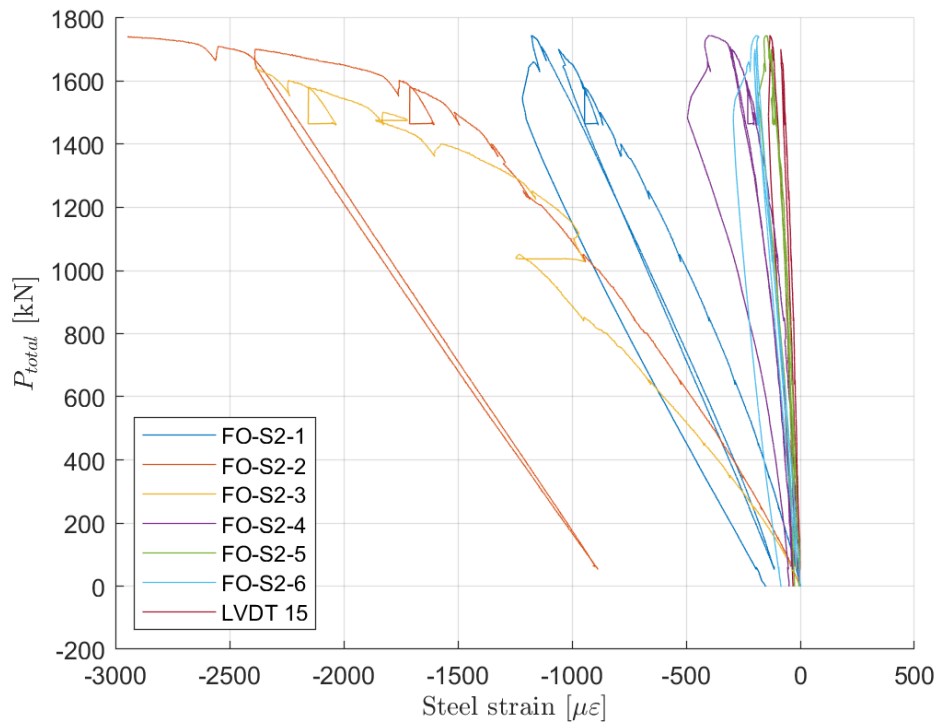
Fig B.5. LB1. Steel strain versus total load for FO-S2-1 to FO-S2-6 and LVDT 15 at beam 2. FO-S2-7 broke during preparation of LB1 and was replaced by LVDT 15. FO-S2-3 and FO-S2-4 fell out of range during testing, so the measurement stopped when they reached their maximum strain.

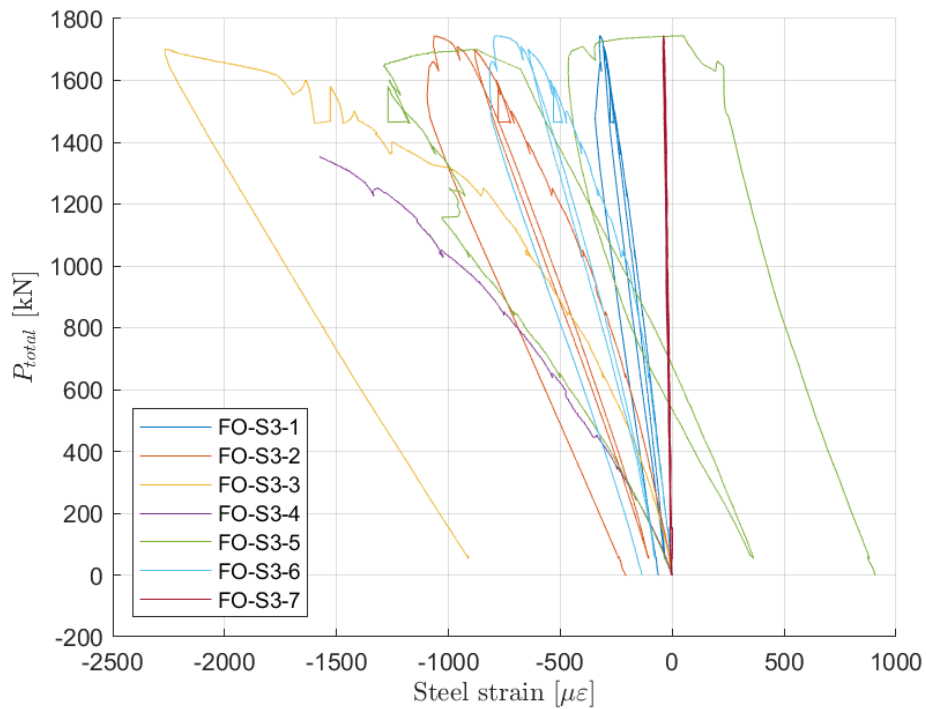
Fig B.6. LB1. Steel strain versus total load for FO-S3-1 to FO-S3-7. FO-S3-3 has been linearized and stopped where it reaches its maximum strain. FO-S3-4 fell out of range for a long time and the results from where it fell out of range have been removed.

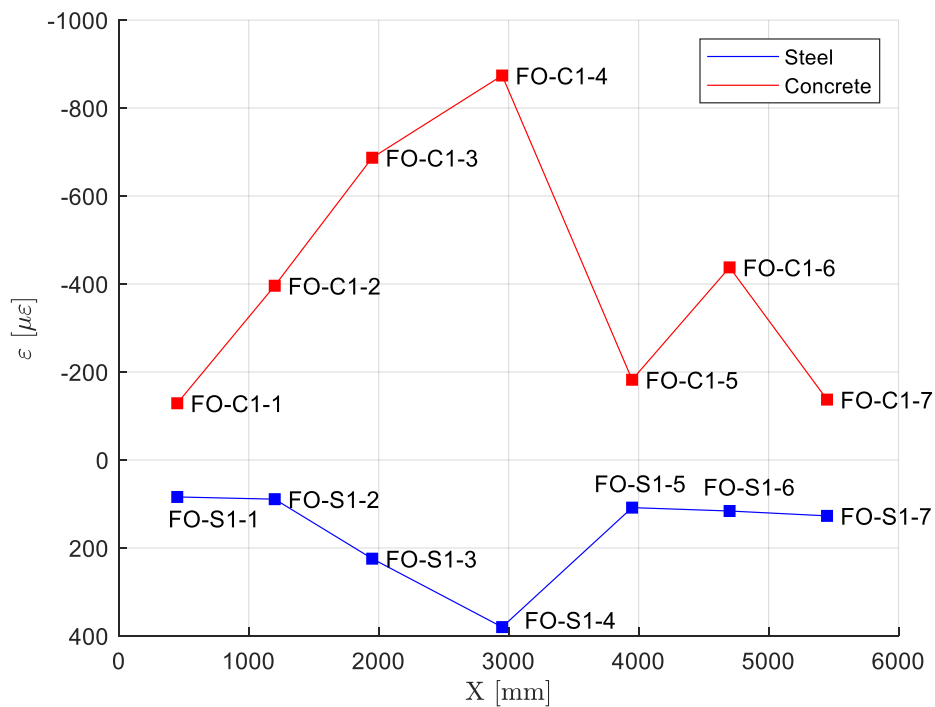
Fig B.8. LB1. Point A - Cracking starts (Ptotal=850 kN). X, the position of the optic fibers from the support, versus the strain measured for optic fibers above and below beam 1.

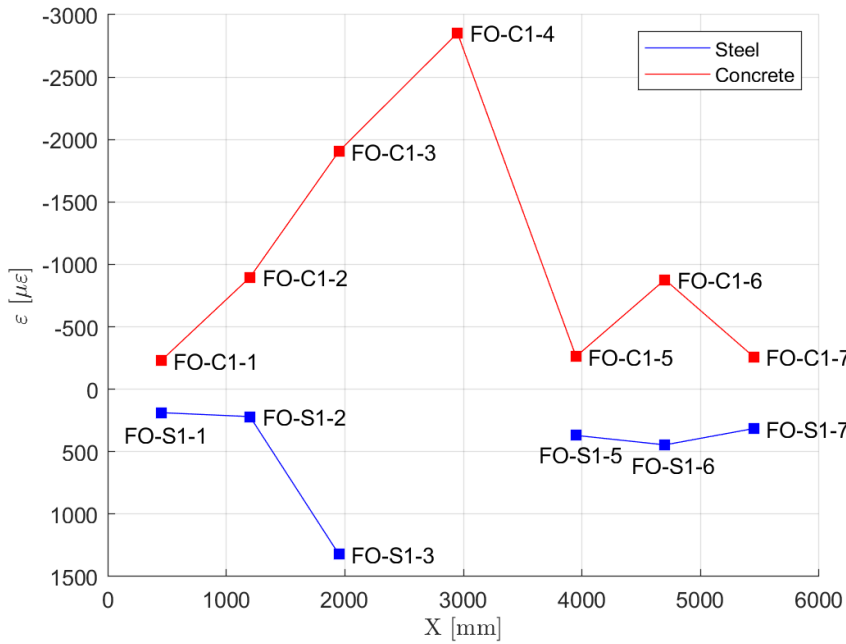
Fig B.9. LB1. Point C - Maximum load before the specimen was unloaded to relax the optic fibers (Ptotal=1700 kN). X, the position of the optic fibers from the support, versus the strain measured for optic fibers above and below beam 1. FO-S1-4 fell out of range.

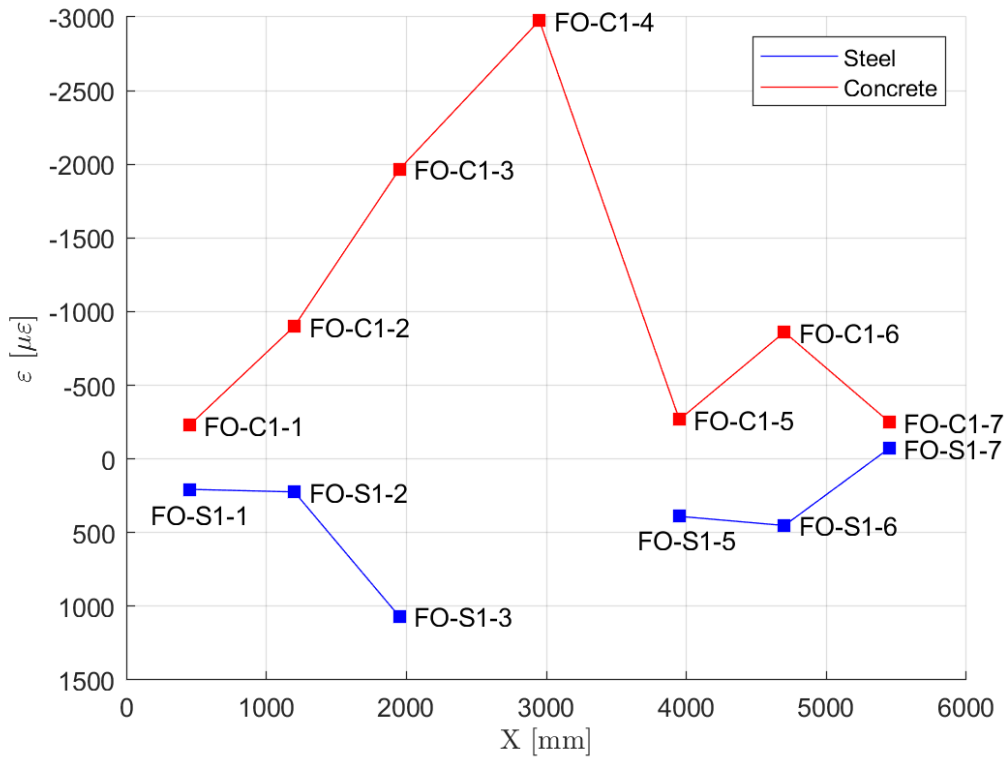
Fig B.11. LB1. Point E - Second loading reaches same load as the max load of first loading (Ptotal=1700 kN). X, the position of the optic fibers from the support, versus the strain measured for optic fibers above and below beam 1. FO-S1-4 fell out of range.

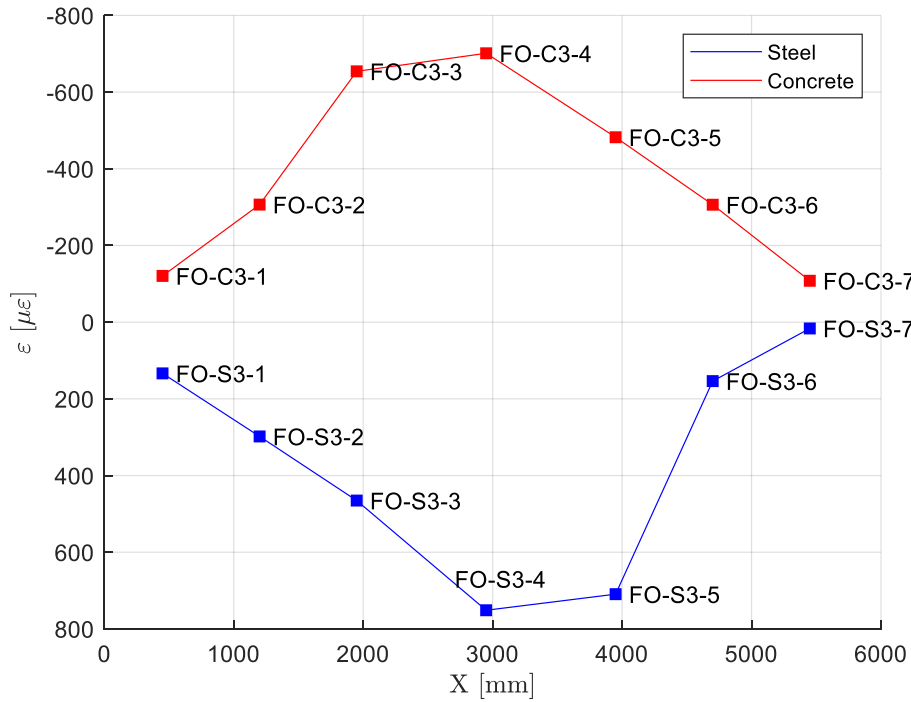
Fig B.13. LB1. Point A - cracking starts ($P_{total}=850$ kN). X, the position of the optic fibers from the support, versus the strain measured for optic fibers above and below beam 1.

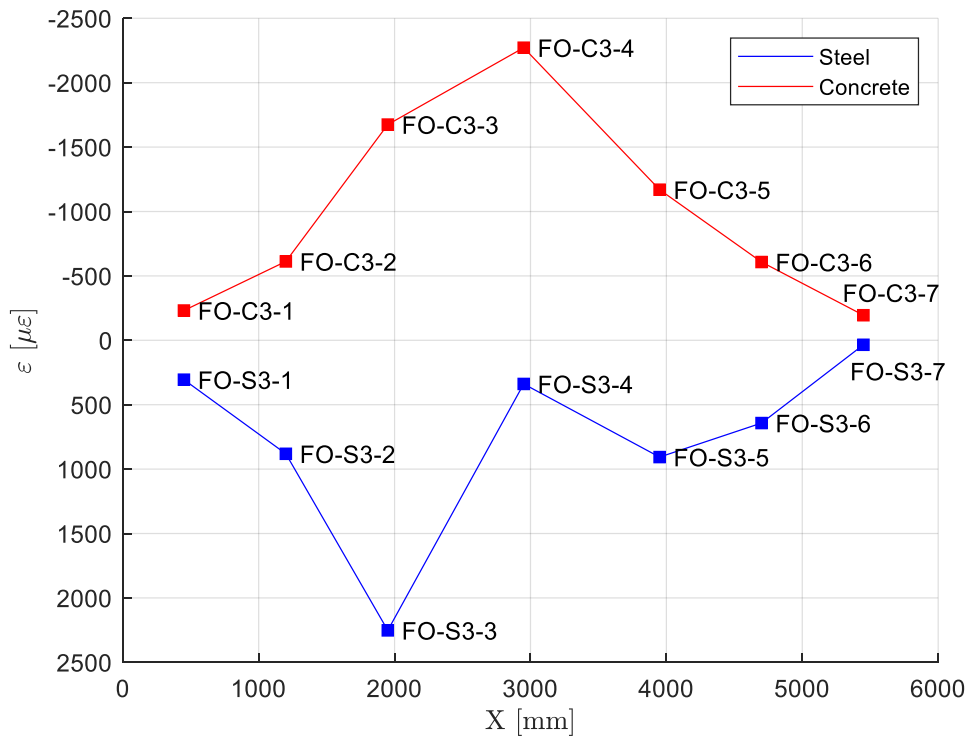
Fig B.14. LB1. Point C - Maximum load before the specimen was unloaded to relax the optic fibers ($P_{total}=1700$ kN). X, the position of the optic fibers from the support, versus the strain measured for optic fibers above and below beam 3. Results from FO-S3-4 may not be valid at this loading point.

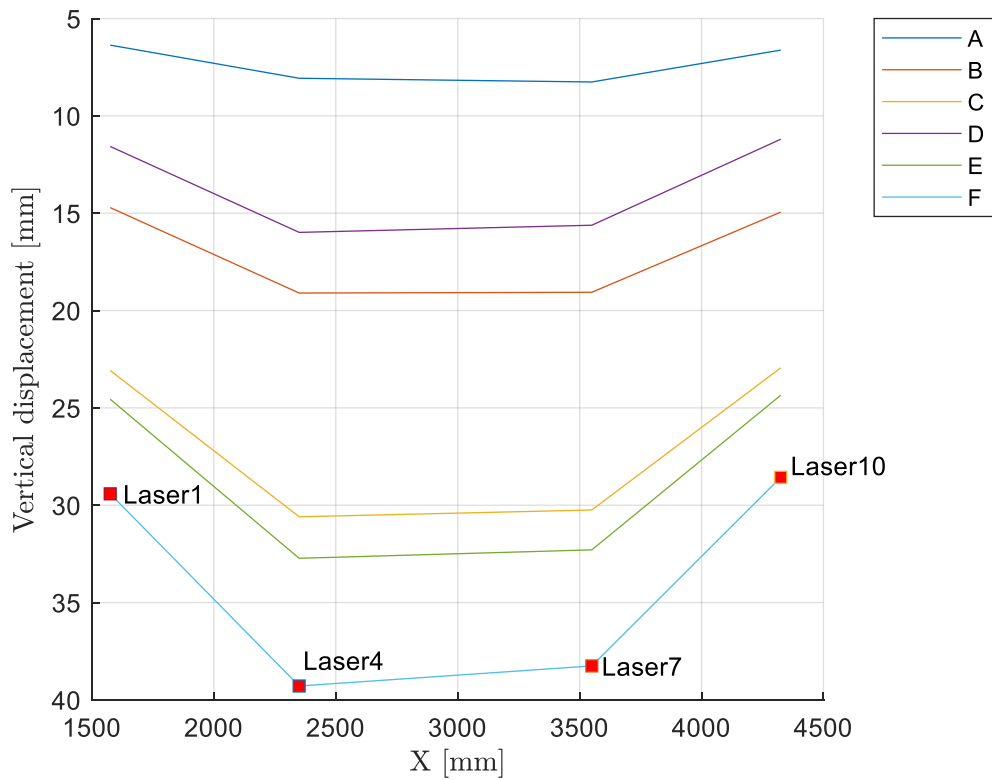
Fig C.1. LB1. Laser 1, 4, 7 and 10 positioned at beam 1. X, distance to support, versus vertical displacement for point A-F.
