Delft University of Technology
Faculty of Civil Engineering and Geosciences
Department of Design and Construction
Section of Structural and Building Engineering
Concrete Structures

Report	25.5-22-03
Project	CS3B13
Date	April 2022
Status	Final
Version	1.00

Experiment report on steel-concrete- composite bridge deck without mechanical connectors (Verbundträger)

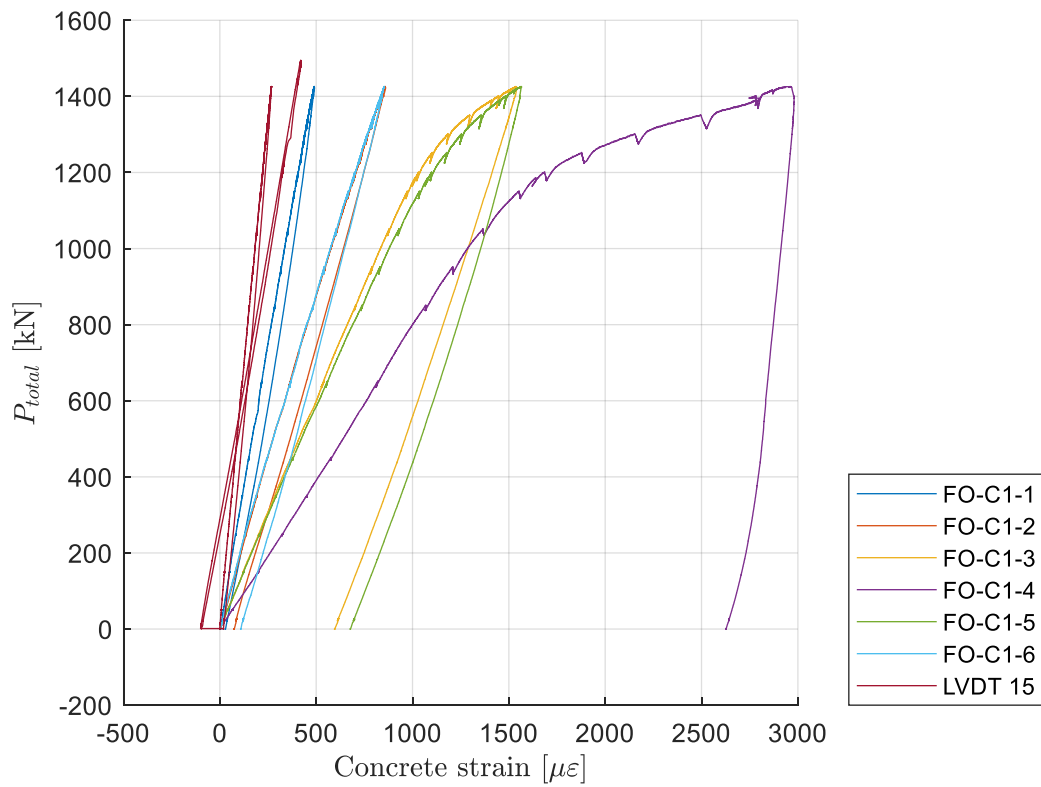
Fig H.1. LB3. Concrete strain versus total load for FO-C1-1 to FO-C1-6 and LVDT 15 at beam 1. FO-C1-7 was damaged during preparation of LB1 and was replaced by LVDT 15.

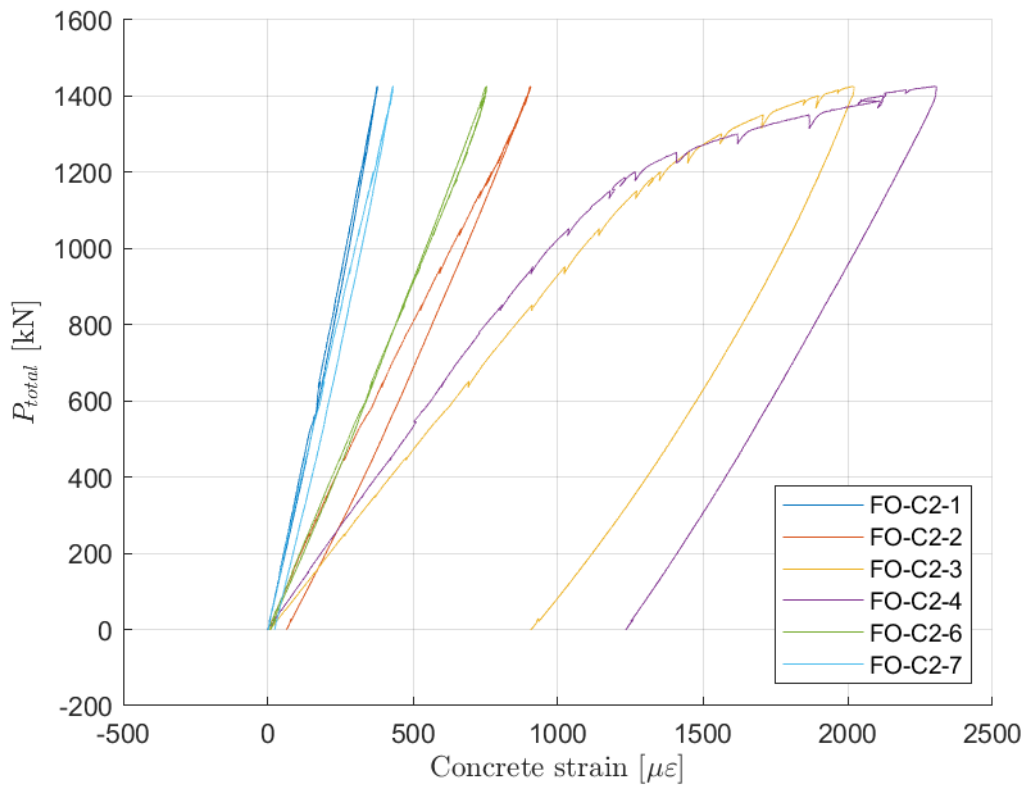
Fig H.2. LB3. Concrete strain versus total load for FO-C2-1 to FO-C2-7 at beam 2. FO-C2-5 fell out of range from the start of the testing.

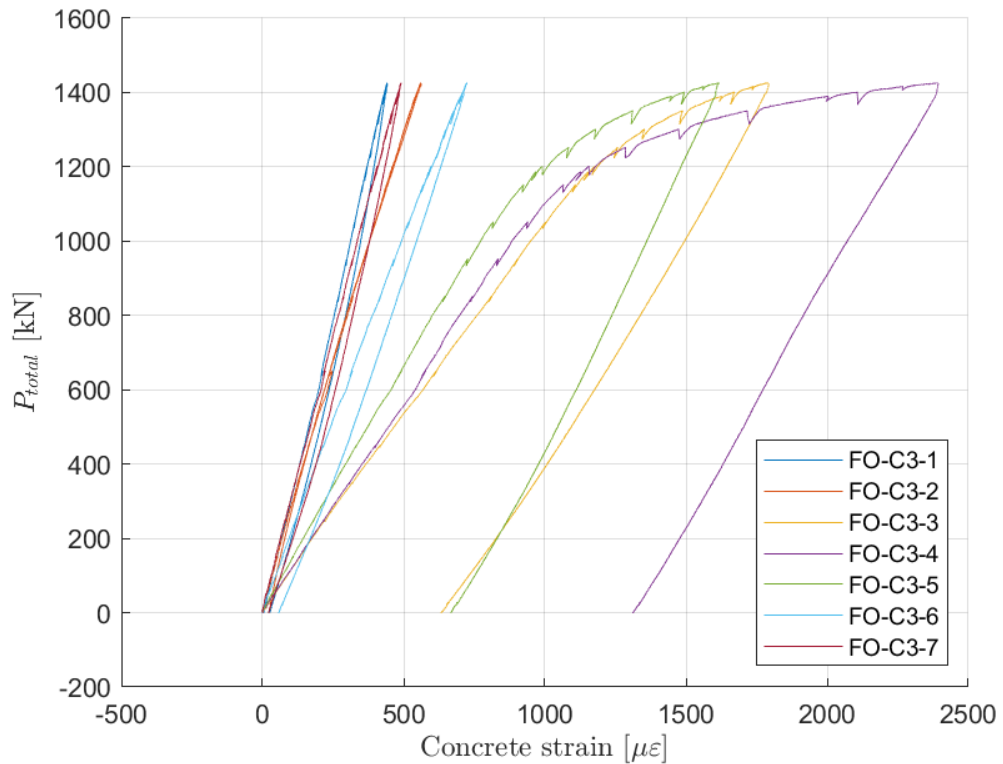
Fig H.3. LB3. Concrete strain versus total load for FO-C3-1 to FO-C3-7 at beam 3.

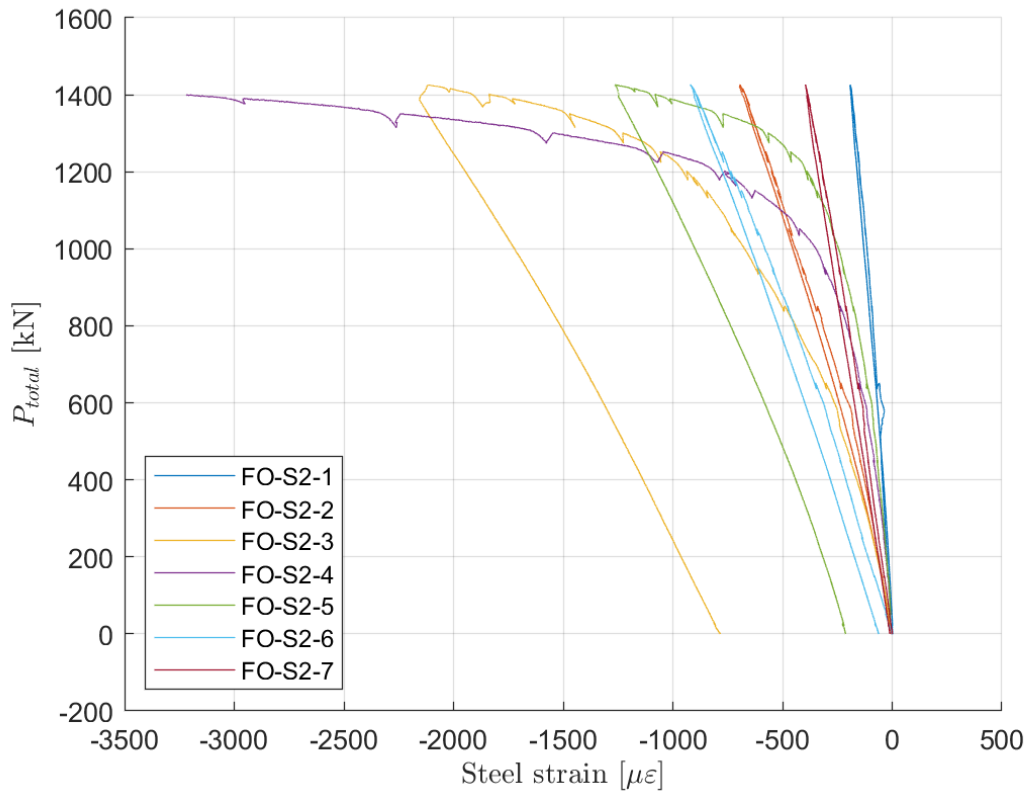
Fig H.5. LB3. Steel strain versus total load for FO-S2-1 to FO-S2-7 at beam 2. Around 1400 kN FO-S2-4 fell out of range. FO-S2-1 also fell out of range, the measurements following this have been left out.

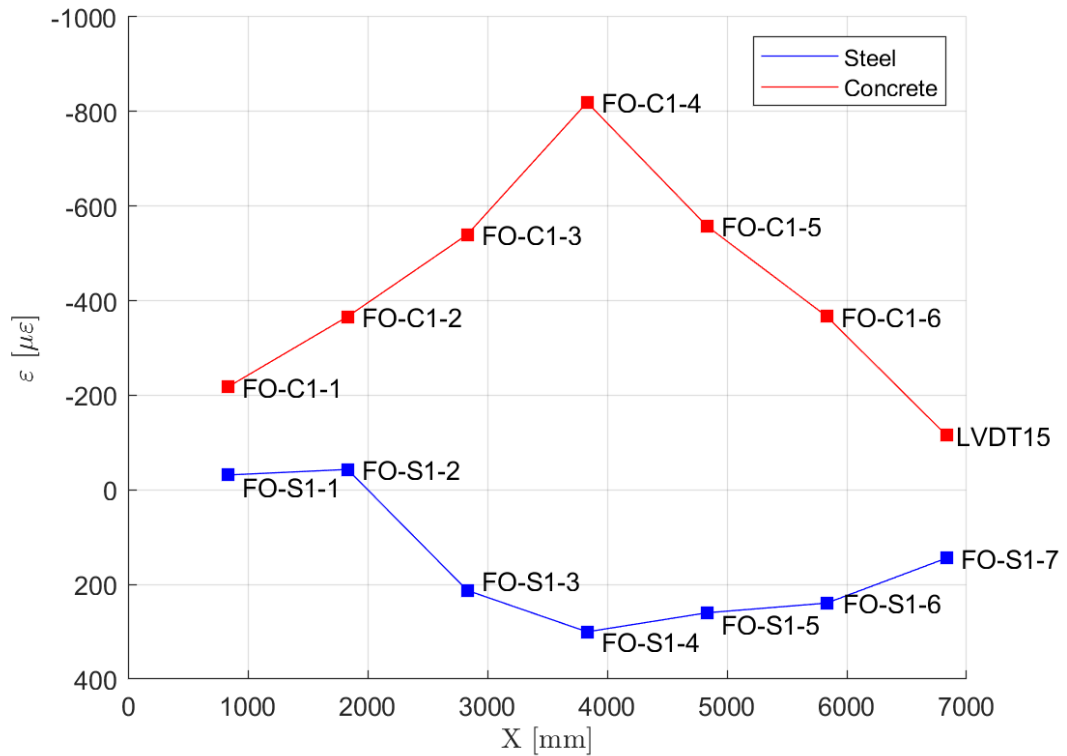
Fig H.7. LB3. Point A - Cracking starts (Ptotal=650 kN). X, the position of the optic fibers from the support, versus the strain measured for optic fibers above and below beam 1. FO-C1-7 broke during preparation of LB1 and was replaced by LVDT 15.

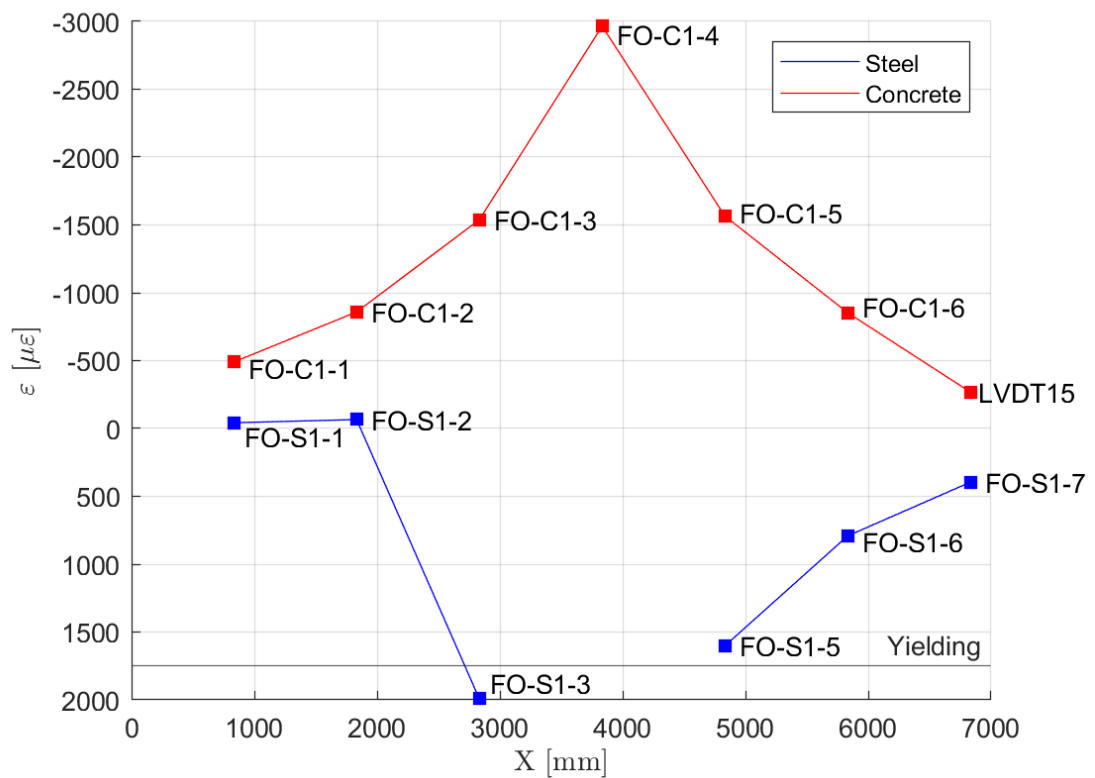
Fig H.8. LB3. Point C - Max load of first loading (Ptotal=1426 kN). X, the position of the optic fibers from the support, versus the strain measured for optic fibers above and below beam 1. FO-S1-4 fell out of range. FO-C1-7 broke during preparation of LB1 and was replaced by LVDT 15.

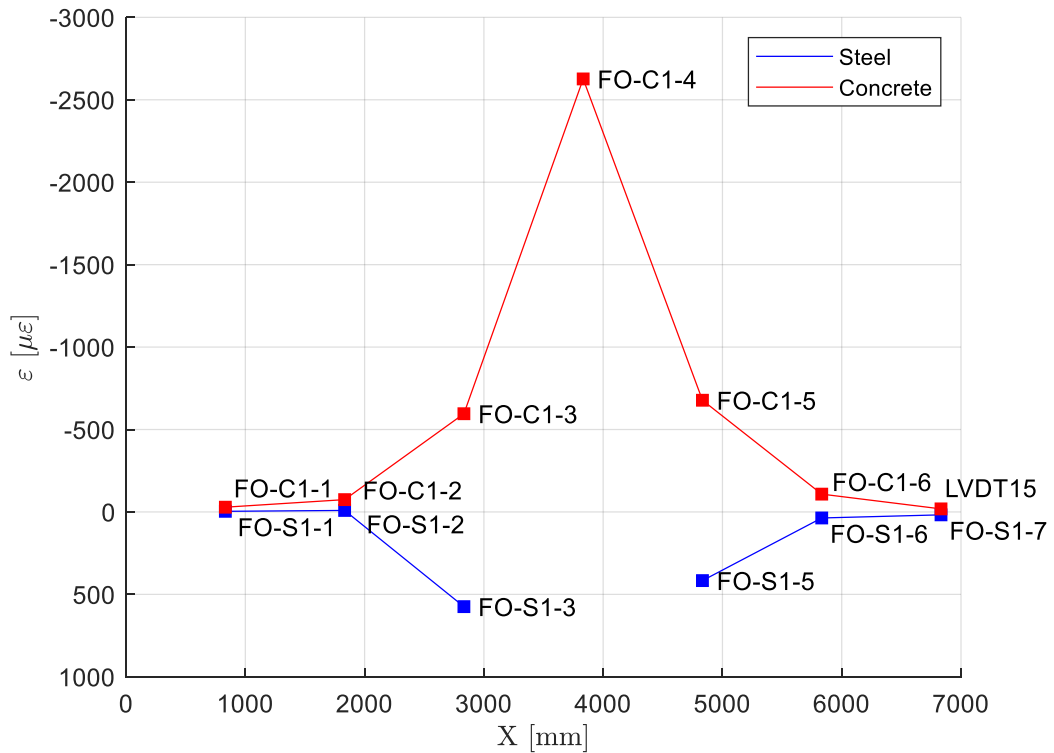
Fig H.9. LB3. Point D - Unloading to increase the displacement range of the hydraulic jacks ($P_{total}=0$ kN). X, the position of the optic fibers from the support, versus the strain measured for optic fibers above and below beam 1. FO-S1-4 fell out of range. FO-C1-7 broke during preparation of LB1 and was replaced by LVDT 15.

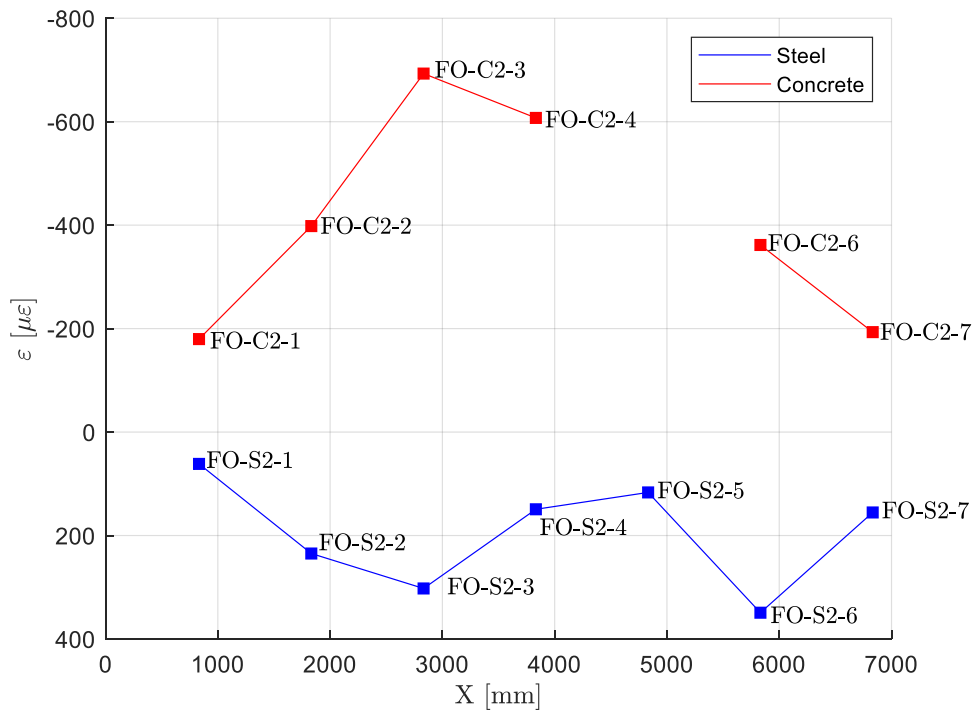
Fig H.10. LB3. Point A - Cracking starts ($P_{total}=650$ kN). X, the position of the optic fibers from the support, versus the strain measured for optic fibers above and below beam 2. FO-C2-5 fell out of range.

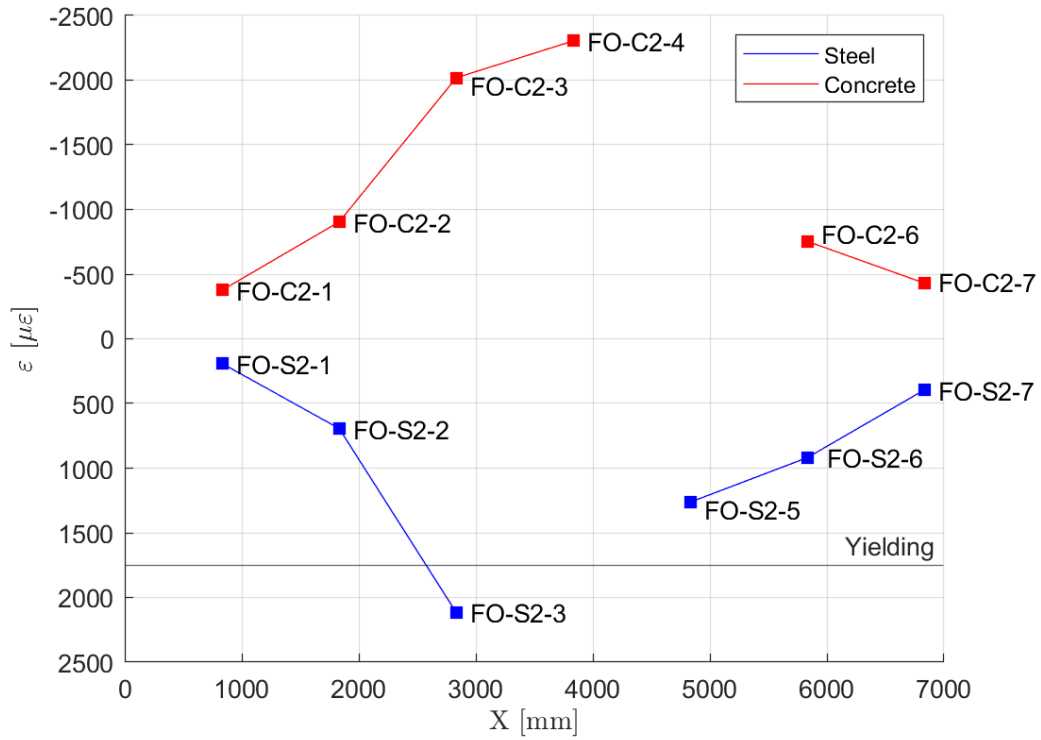
Fig H.11. LB3. Point C - Max load of first loading ($P_{total}=1426$ kN). X, the position of the optic fibers from the support, versus the strain measured for optic fibers above and below beam 2. FO-C2-5 and FO-S2-4 fell out of range.

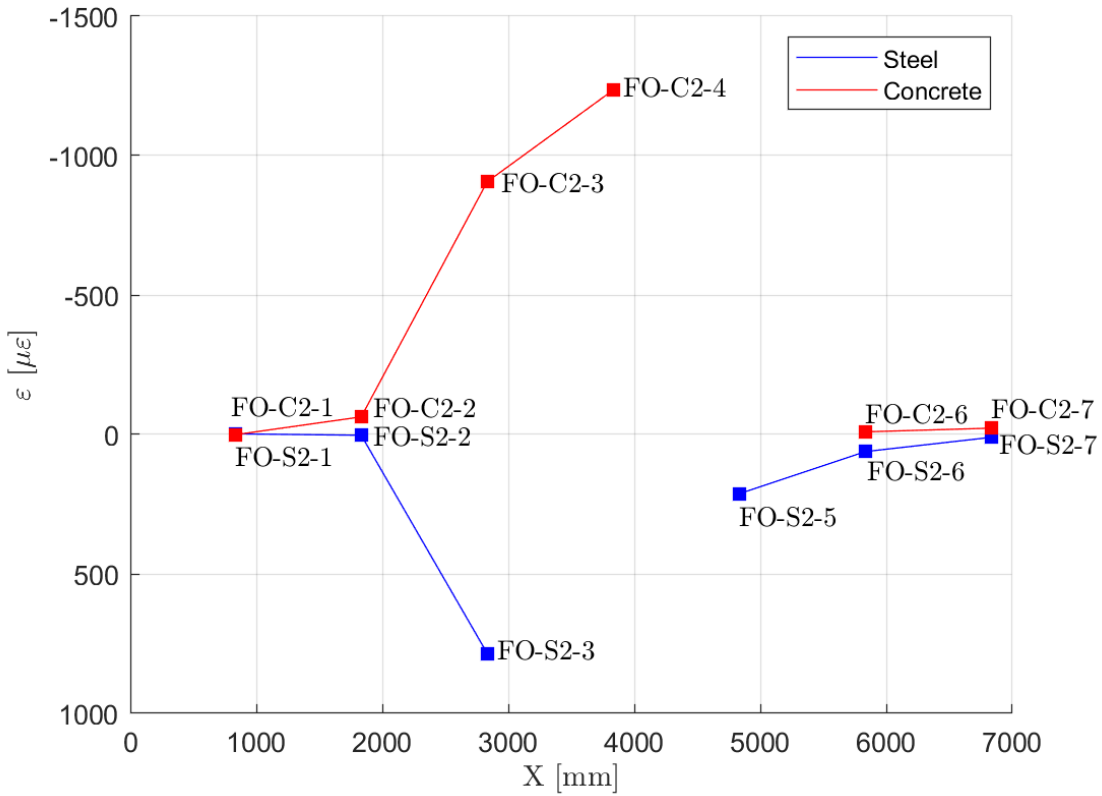
Fig H.12. LB3. Point D - Unloading to increase the displacement range of the hydraulic jacks ($P_{total}=0$ kN). X, the position of the optic fibers from the support, versus the strain measured for optic fibers above and below beam 2. FO-C2-5 and FO-S2-4 fell out of range.

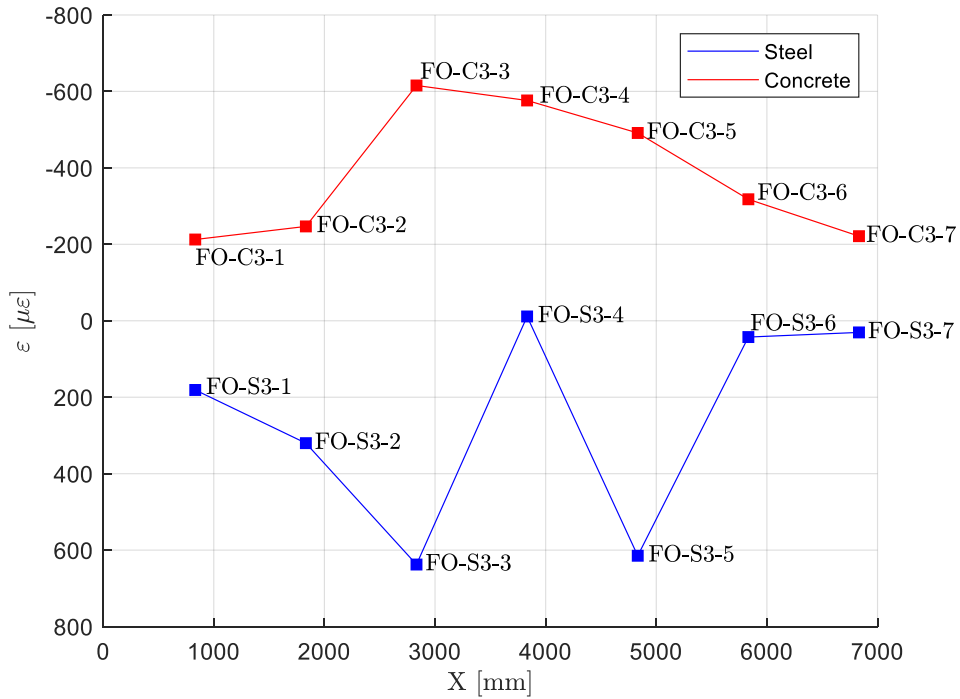
Fig H.13. LB3. Point A - Cracking starts (Ptotal=650 kN). X, the position of the optic fibers from the support, versus the strain measured for optic fibers above and below beam 3. The strain at FO-S3-4 first started to increase after yielding.

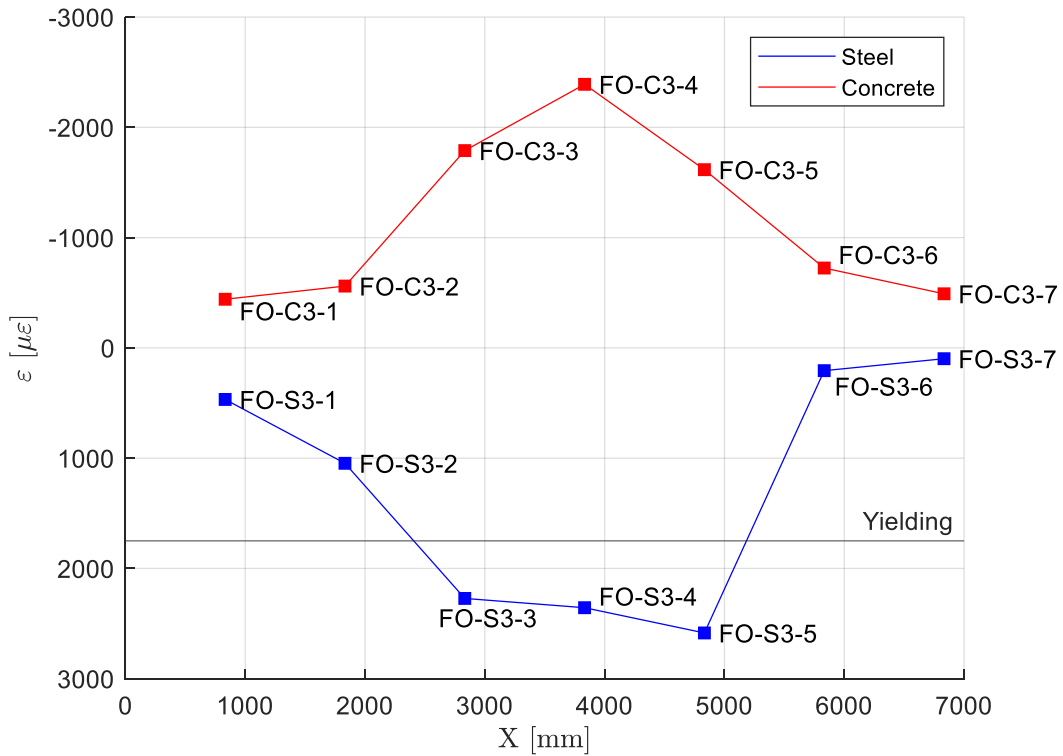
Fig H.14. LB3. Point C - Max load of first loading (Ptotal=1426 kN). X, the position of the optic fibers from the support, versus the strain measured for optic fibers above and below beam 3.

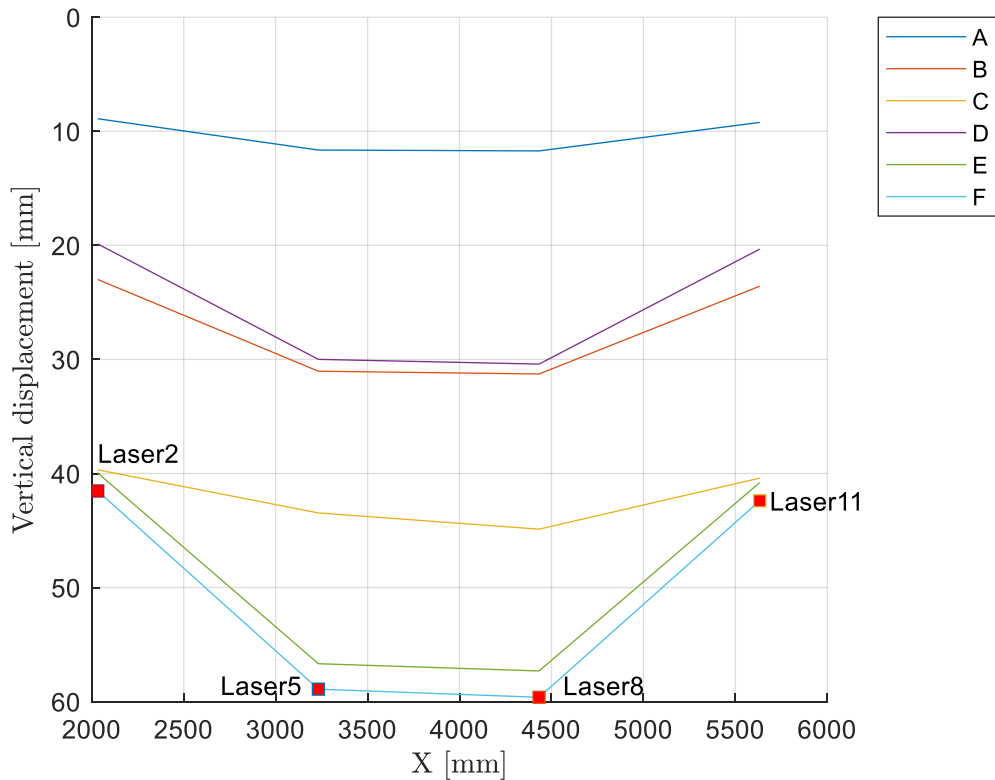
Fig 1.2. LB3. Point A-F for laser 2, 5, 8 and 11 positioned at beam 2. X, distance to the support, versus the total vertical displacement.

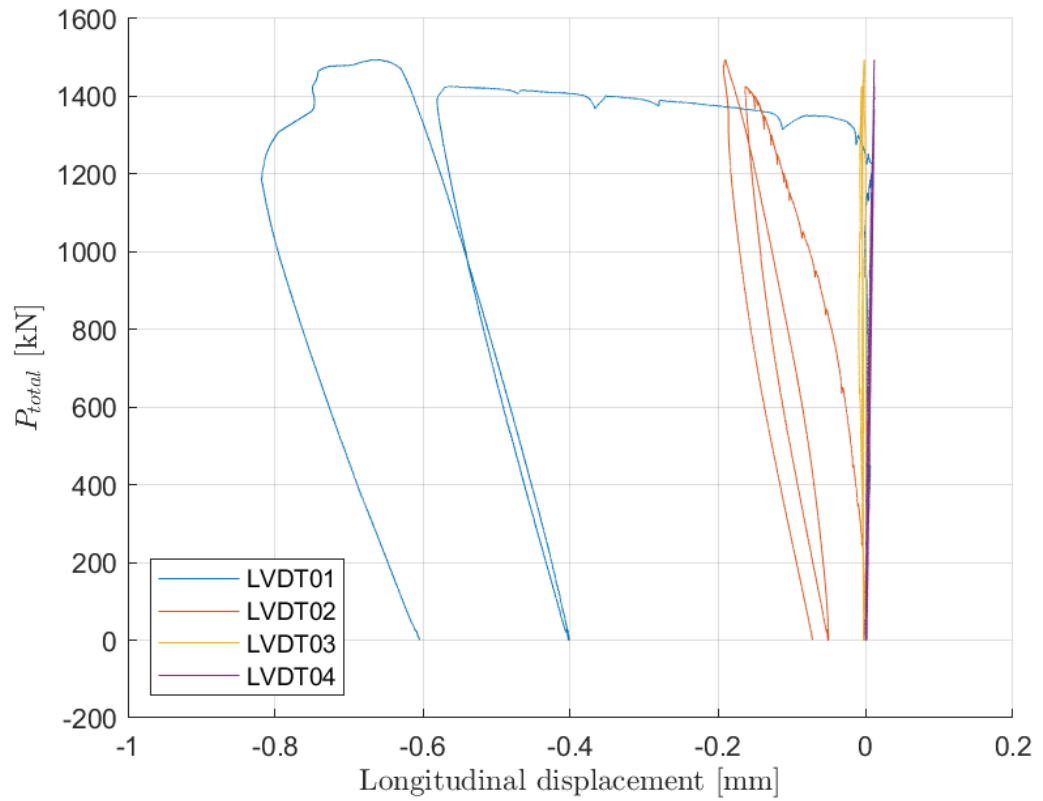
Fig J.1. LB3. Relative longitudinal displacement between bottom flange and concrete versus total load for LVDT 1-4 at beam 2.
