# Stability of rock on mild slopes

Msc Thesis

J.F.S. van Wijland  
August 2020

Master of Science program  
Hydraulic Engineering

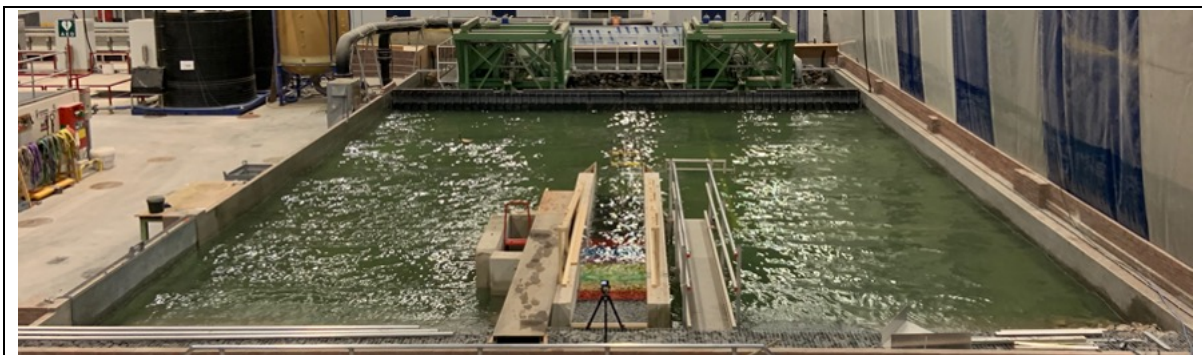
**Figure 13:** The Pacific basin facility at Deltares during a test. The flume with the mild slope can be seen in the middle.

The physical model tests (both 1:8 and 1:10 slope) have been performed in the Pacific Basin at the laboratory of Deltares in Delft. An impression of the test set-up is presented in Figure 13. The dimensions of the basin are 28 m by 14 m. The height of the basin is 1.25 m where the water height can vary between 0.25 and 1.0 m. The basin contains two wave generators each with a length of 7 m, which can generate long-crested irregular waves. The wave paddles have no reflection compensation, but to minimize re-reflections from the basin walls, wave dampening slopes are present. A flume has been built in the basin and the side walls consist of large concrete blocks. The flume contains a 1:8 slope and has a width of 1 m. The slope is made of steel plates to model an impermeable core. At the bottom part of the slope concrete has been applied to smoothen the conversion from the steel plates to the bottom of the basin. Wooden triangle shaped structures have been placed at the lower end of the flume to reduce the reflection effect of the rectangular blocks (Figure 14). The reflected waves within the flume are assumed to disperse over the full width of the basin and are eventually absorbed by the wave dampening slopes. Figure 14 shows all dimensions concerning the test set-up. Table 8 depicts the main characteristics of the model. Appendix B shows more photos to give a more detailed impression of the test set-up.
