# Bio-Based Composite Footbridge: Design, Production and *In Situ* Monitoring

This paper deals with the design, production and monitoring of a bio-composite footbridge with a span of 14 m across the river Dommel in the city of Eindhoven, the Netherlands. The specific bio-composite material that was used for this research is a Natural Fibre Reinforced Bio-Polymer (NFRBP). The goal of the research is to prove that NFRBP can be applied as a load-bearing structure in an outdoor environment. For this purpose, a multidisciplinary team of academic researchers from two universities and from the Centre of Expertise Biobased Economy, together with a manufacturer from the NFRBP industry, have developed a feasible design that could be produced in a short period of time and within a limited budget. The footbridge was designed, built and installed within less than one year. In the two years after the installation of the footbridge, the structural behaviour of the bridge was monitored by means of optical fibre glass strands, integrated within the structure, with the purpose of measuring deformations and change in elasticity that occur over time.

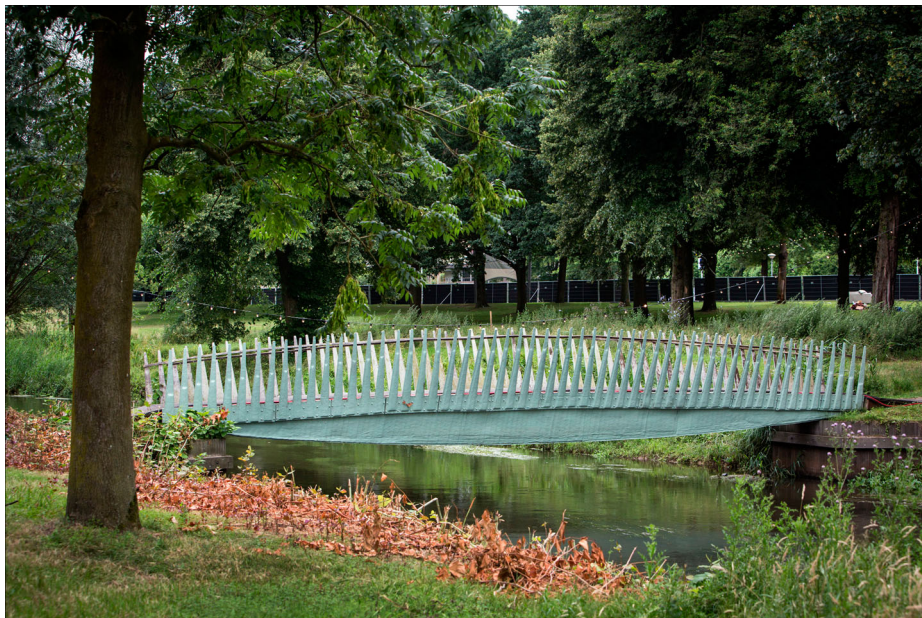
Fig. 1: The bio-composite footbridge, 18 months after the installation across the river Dommel

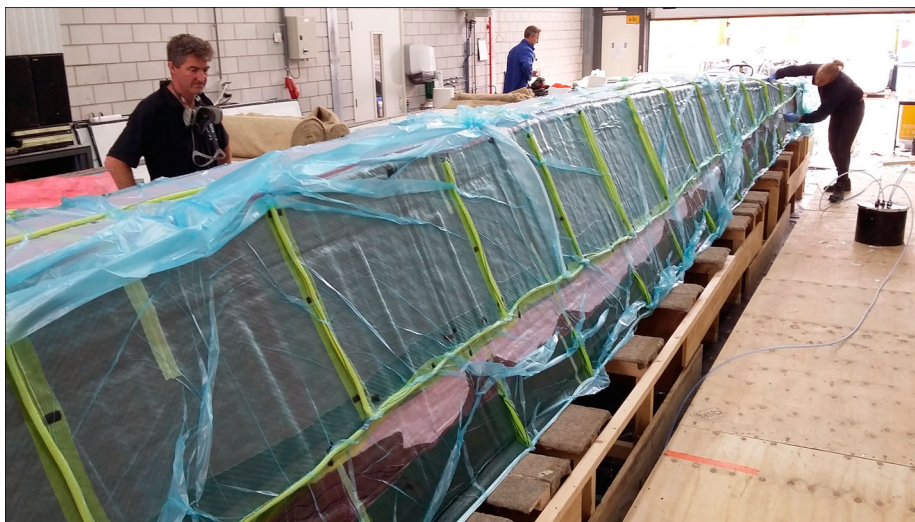
Fig. 4: Production of the 14m long bridge

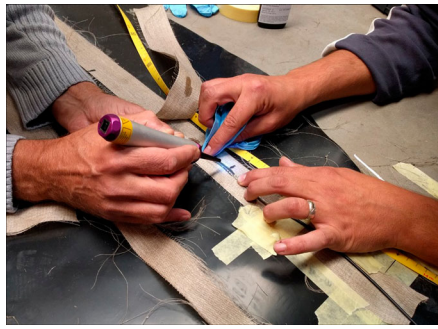
Fig. 9: Preparation of optical (glass) fibre bragg grating sensors

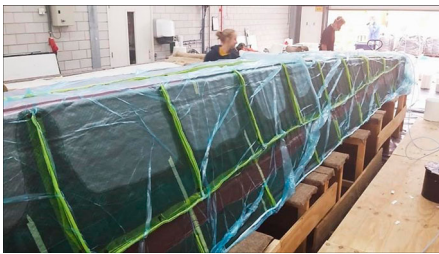
Fig. 14: Bridge beam during vacuum injection

*Figure 14* shows the injection of the bridge beam (in top down position). In the dark green coloured areas, between the yellow injection canals, the resin has already penetrated the fibres. After the vacuum injection and the hardening, the bridge beam was turned 180 degrees and then cured at a temperature of approximate 50°C for a 36 h period using electrical air heaters. The bridge rail elements were then mounted and lastly, to prevent moisture accessing the structure over time, a coating system was applied.

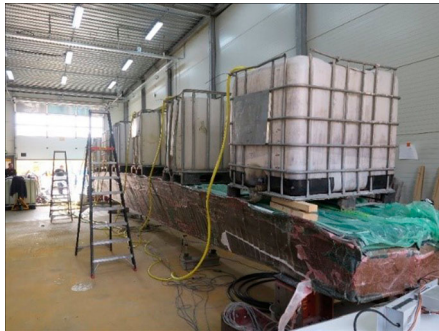
Fig. 15: Impression of the load test using seven water tanks

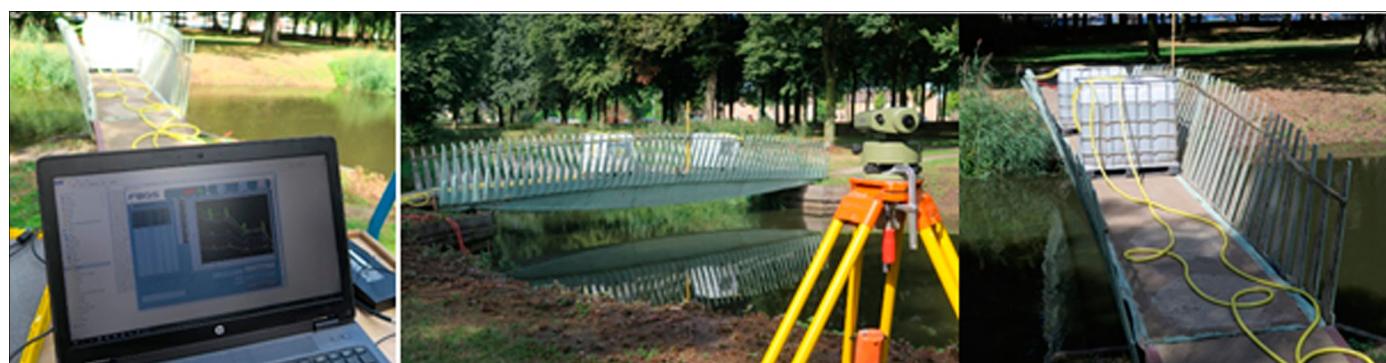
Fig. 21: Cyclic loading test performed one year and ten months after installation
