Fieldwork Hydraulic Engineering

Asparuhovo Beach

TU Delft Bulgarian Fieldwork 2021

Final Report
Varna, Bulgaria
CIE5318

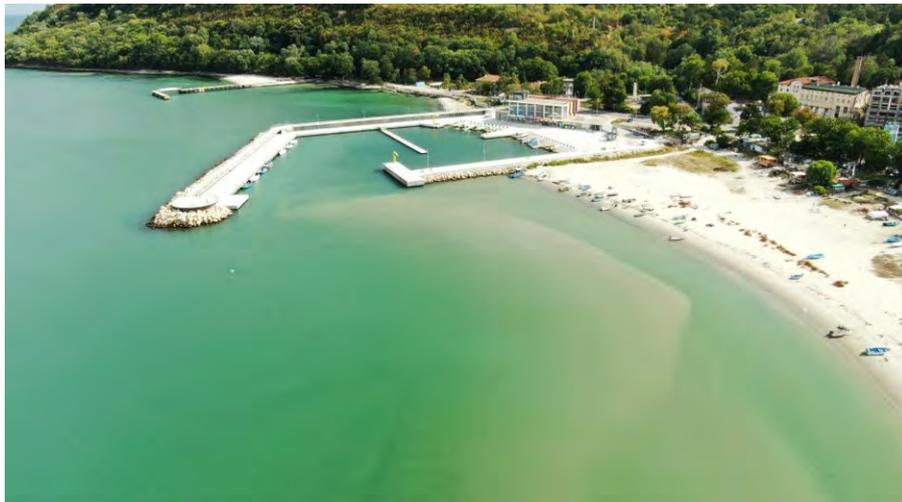
Since the construction of Karantinata port in 2019, a strong trend of sedimentation occurred near the port (entrance). In the beginning this did not form a problem, since Asparuhovo beach became just slightly longer and wider at the port side. However, in 2021 the sedimentation process already leads to a partial blocking of the port entrance of Karantinata port, which disturbs port operations. In the current situation, the Karantinata port loses its functionality and the hydraulic processes behind this sedimentation trend are unknown.

Figure 1.3: Aerial picture of the sedimentation in front of the port (24/09/2021)

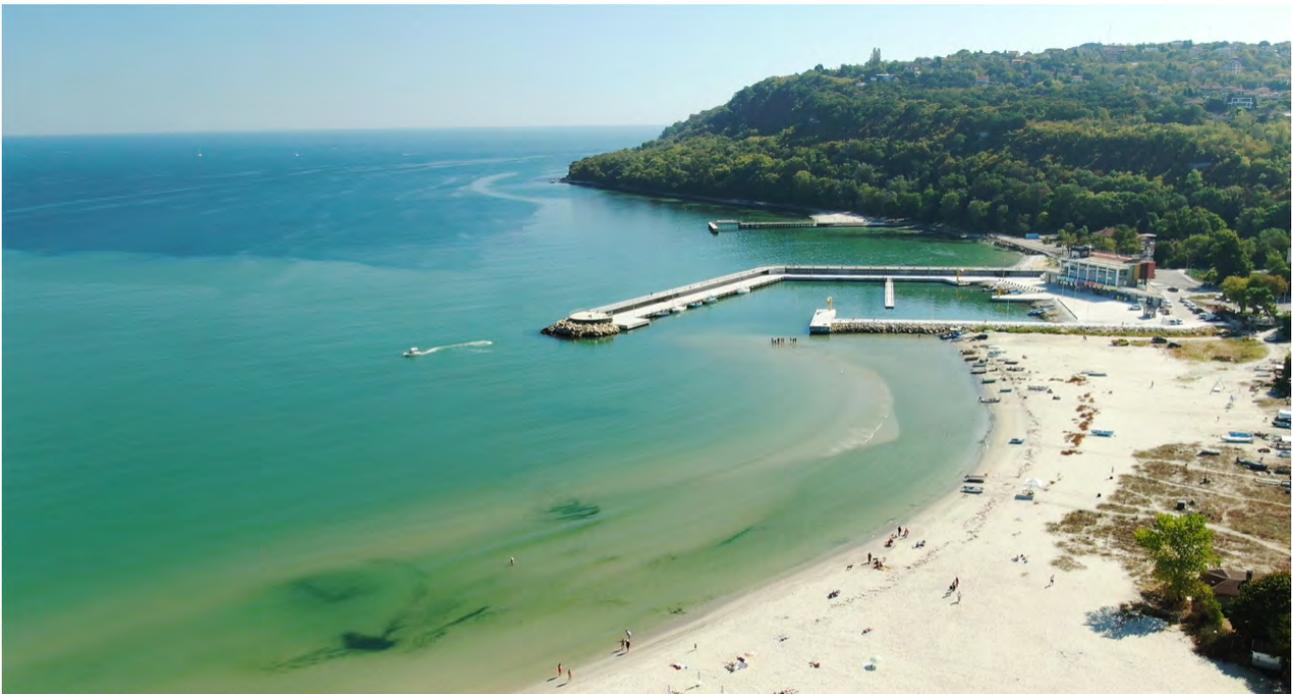
Figure 2.1: Sandbank at the Asparuhovo foreshore

This bathymetry is an estimation retrieved by interpolation and the bathymetry shows some flaws. For example, there is a sand bank present close to the waterline, which does not show up properly on the estimated bathymetry. A drone picture that clearly shows the sandbank is presented in Figure 2.1.

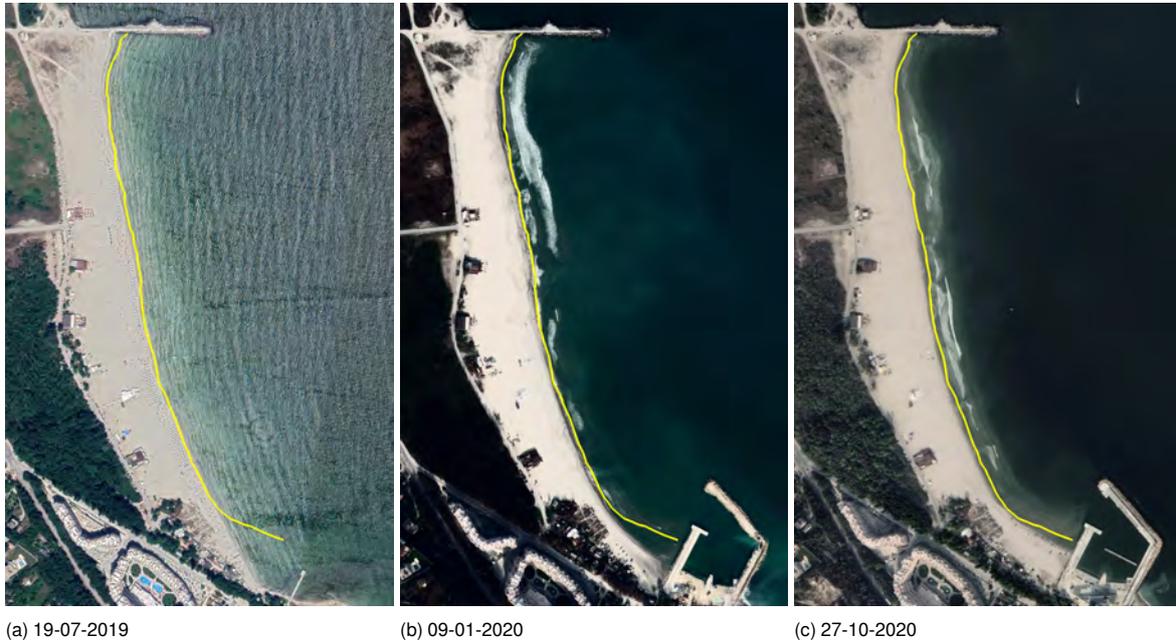
By using GPS measurements and satellite images, the position of the waterline can be evaluated and compared to previous years. The average waterline is determined using 2 devices, which both measured 2 tracks (from South to North and vice versa). The average waterline is then compared to 3 satellite images, shown at Figure 2.3. The measured waterline length is almost 1 km. The first image (19-07-2019) shows the old waterline position before port Karantinata was built. The second image (09-01-2020) was taken just after the port was finished. The third image (27-10-2020) is the most recent satellite image available and represents the current situation.

Figure 2.3: Waterline measurements average compared to satellite images taken on specified dates

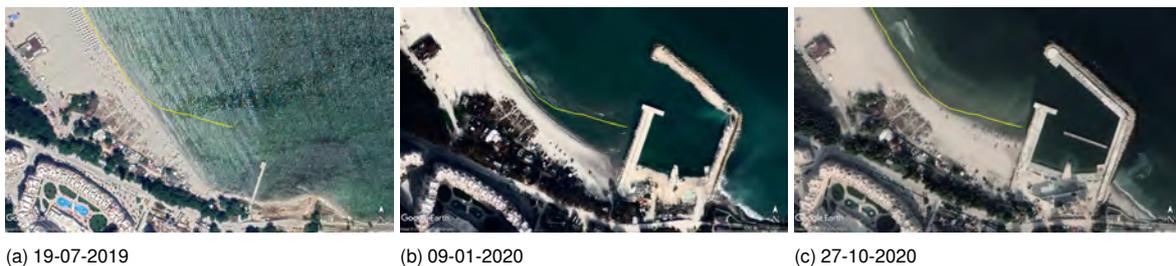
Figure 2.4: Zoom of average waterline measurements around port entrance compared to satellite images taken on specified dates

The sedimentation at the Western side of the port can clearly be seen, by looking at the waterline advance during the years. This can also be seen at Figure 2.4, where the same shoreline and satellite images can be seen, zoomed in on the port.

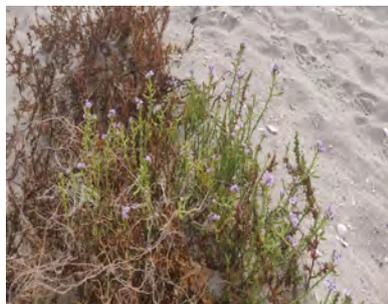
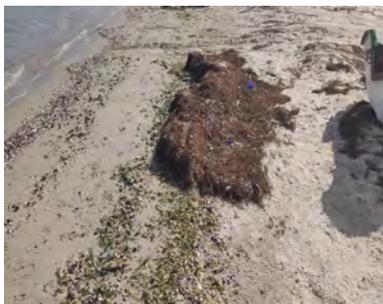
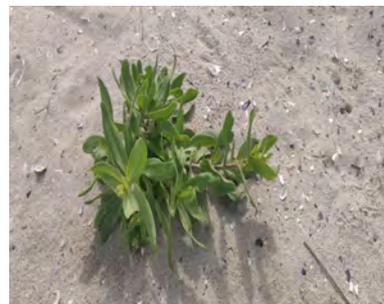
(a) Grass species

(b) Remains seagrass

(c) Another plant species

Figure 2.8: Examples vegetation on Asparuhovo beach

On the beach and near the dune foot some vegetation is present. Different species of grass and plants cover the beach near the dune foot. An advantage of the present vegetation on the beach is that it can reduce erosion of the beach during storms. Near the dunefoot (edge of the beach), the vegetation consists of somewhat rougher and bigger plants and grasses, like buses and trees.

Along the waterline, remains of seagrass and seaweed are found that are washed ashore. This indicates that probably patches of seagrass and seaweed grow on the foreshore. These were not visible from the beach and nearshore, so these grow probably more offshore.

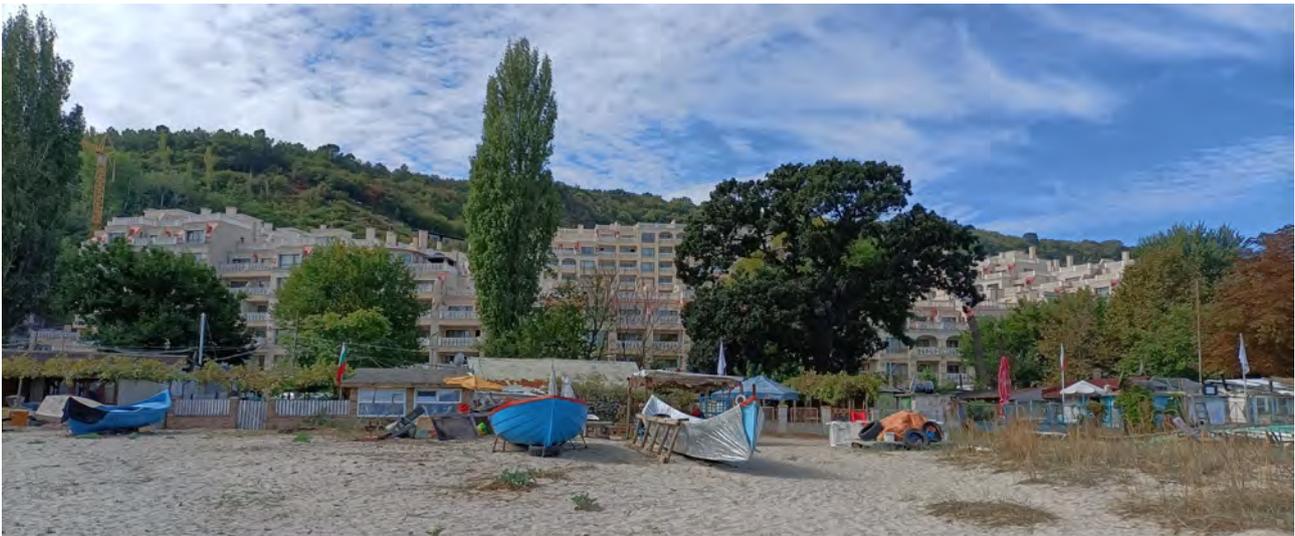
Figure 2.10: Small cabins and litter on Asparuhovo beach

The influence of anthropogenic activities was clearly noticeable on the beach. Near the Karantinata port fishermen place their boats on the beach and collect and process their catch. This causes that there remains a lot of waste on the beach, like old fishnets and fishing equipment. Once, even a seagull was spotted with a fishing hook hooked in his body (see Figure 2.9). Also, the fishermen drive their cars to the waterline to collect their catch and to transport equipment.

Some locals have houses on the beach and the state of houses differed, with some newer than others. Also smaller cabins with different purposes were present. These could also be shelter for the fishermen. Around the structures waste was collected, which affects the ecology and aesthetics in a negative way.

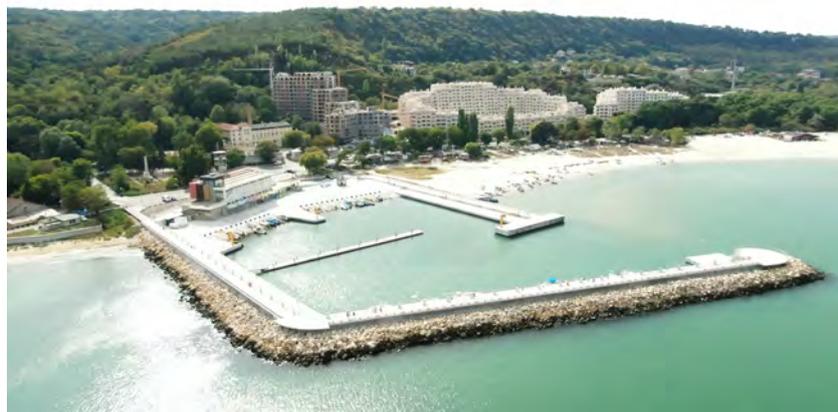
Karantinata port is protected from the waves by a breakwater. This breakwater consists of a wide concrete path that divides the open part of the breakwater where everyone can enter and the closed part of the port where you have to enter through a secured entrance. This path leads to a round viewpoint of concrete at the head of the breakwater. At the seaside rocks are present to break the incoming waves from hitting the concrete structure behind. In the concrete, a wave recurve return wall is made that returns the incoming water in heavier conditions, which should prevent large overflowing.

Figure 2.14: Breakwater at Karantinata Port

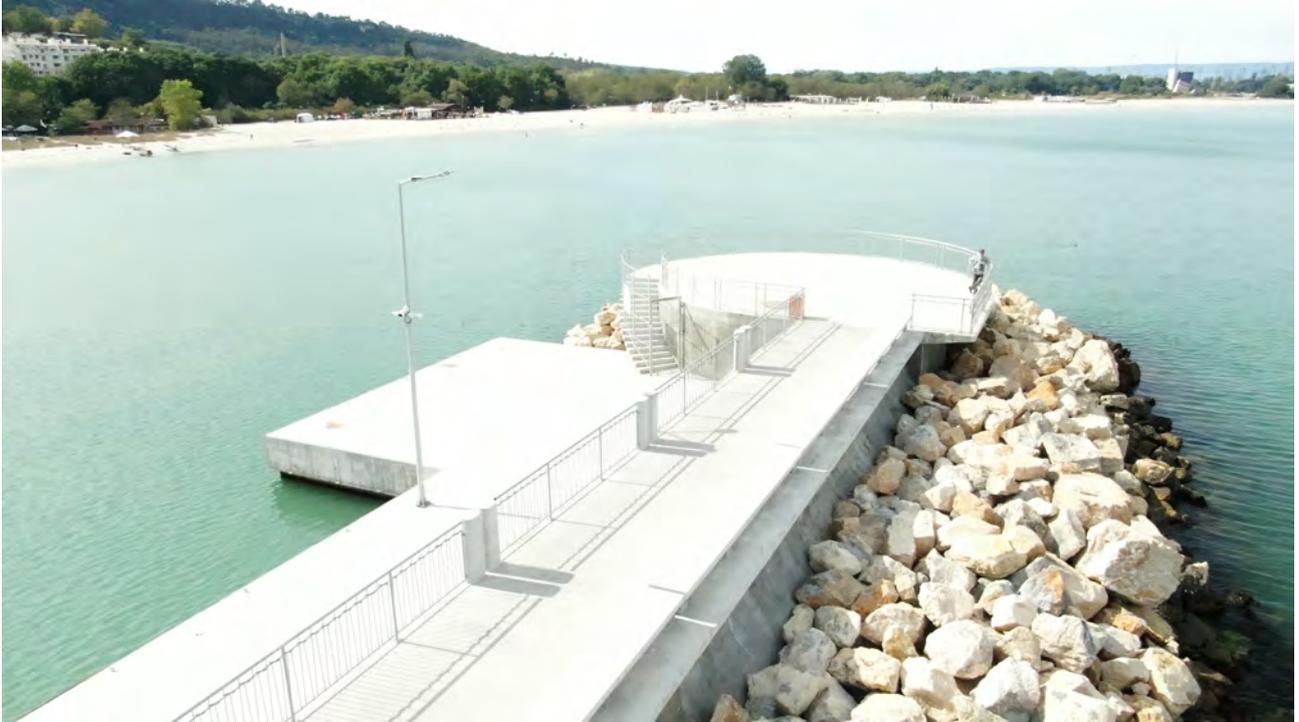
The rocks around the entire breakwater have the same structure. The layout has a 2-3 meter wide horizontal plateau. After that the rocks descend with a steep slope towards the bottom. The rocks are placed not very elegantly and show that they have not seen a larger storm before as some seem not very stable in their placement. The rock sizes differ quite a bit which would indicate that a larger spread of the rock is used around the entire breakwater.

Figure 2.15: Head of the breakwater

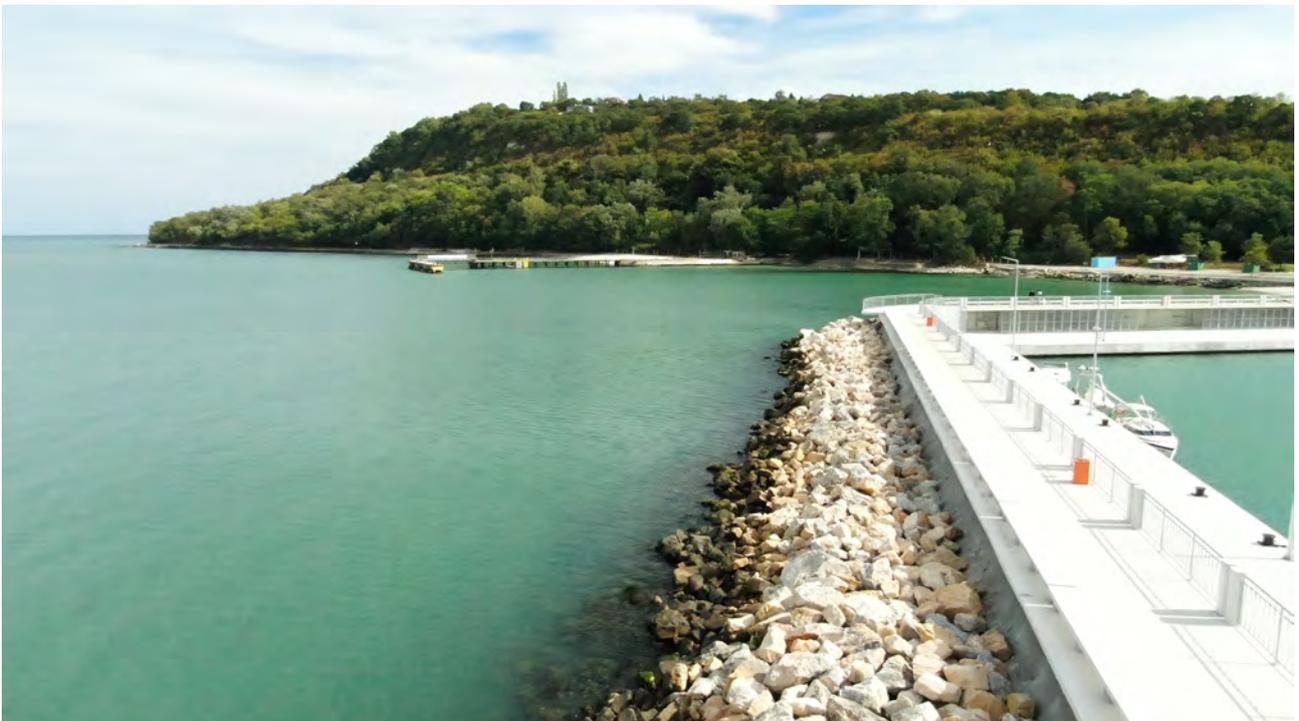
Figure 2.16: Seaside of the breakwater with plateau and steep slope

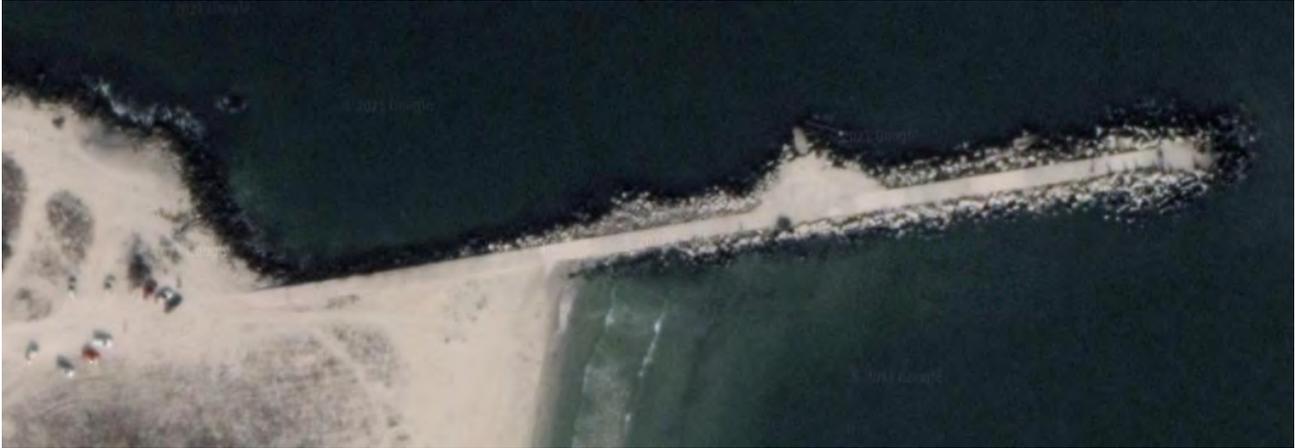
Figure 2.17: Aerial view breakwater Asparuhovo beach (Google, 2021)

At the Northern side of Asparuhovo beach a breakwater is situated. The breakwater separates Asparuhovo beach from the main channel between the Black Sea, the port of Varna and Lake Varna, laying more inland. The breakwater is approximately 220 meters long and the main protection layers differs in material over the length of the breakwater. The breakwater has two main function: preventing sedimentation in the navigation channel and preventing erosion of Asparuhovo beach.

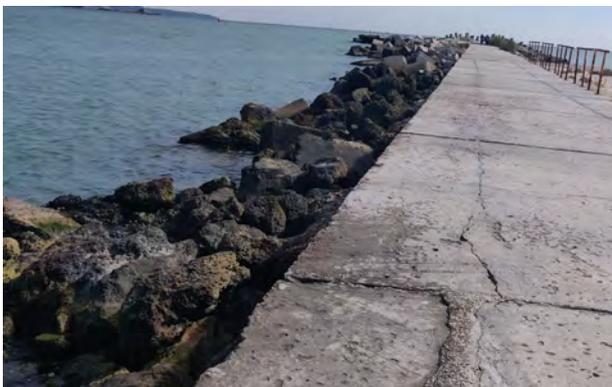
The most onshore part of the breakwater is made out of concrete plates that make a path on top of the breakwater with on one side the sand of Asparuhovo beach and on one side natural blackish rock. The size and distribution along the breakwater was irregular. Only a few randomly placed concrete blocks were there. In the concrete along most of this part there was a crack of about 1 cm wide that was located at the channel side and between 30 or 40 cm from the side of the concrete plates, this is also visible in Figure 2.18. It was clearly visible that reparations had taken place in this section of the breakwater. A comparison with earlier assessments showed that the cracks at the beginning had been filled. At the beach side 5 times 4 connected steel poles were located, these were rusty. Also at the start of the concrete plates 3 heavily rusted steel poles were present. The breakwater continued along the channel, but this part was out of the scope of this assessment.

(a) Towards sea

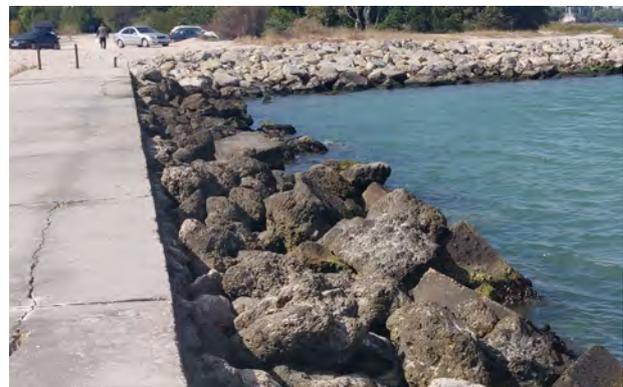
(b) Towards channel

Figure 2.18: Landside of breakwater

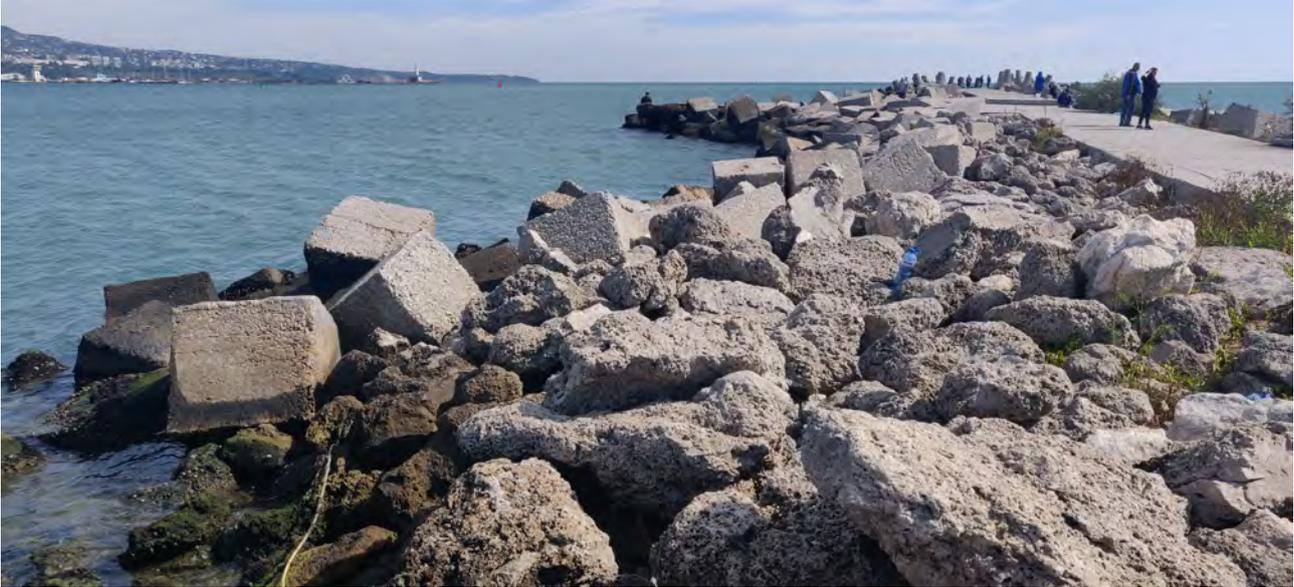
The middle part was along the breakwater irregular in profile at the side of the access channel. Two parts were sticking out and were used by local fisherman to catch fish. In these parts there was a larger concrete plate that created a widening of the path from the concrete plates. The part consisted mostly of different sizes concrete blocks with the larger blocks more towards the seaside of the breakwater. However, it was filled up with natural rock as well reaching towards under the concrete plates. For reinforcement different parts of concrete originating from other spots were placed on top of the concrete blocks. Also in this part, the crack at 30-40 cm from the channel side was present.

Figure 2.19: Rock and blocks sticking out at two places in the middle part of the breakwater

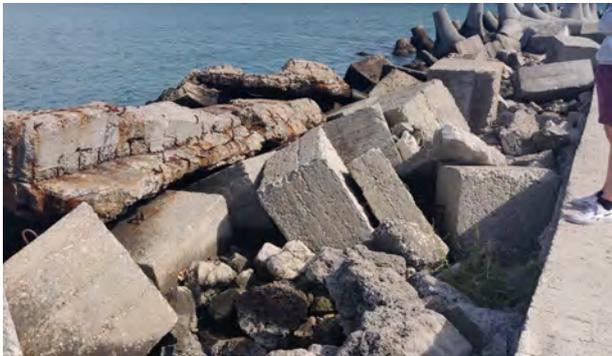
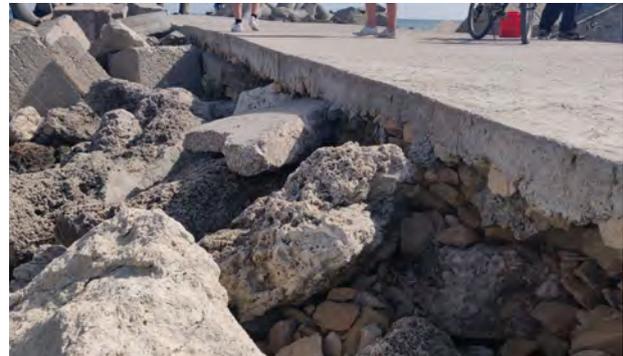
(a) Concrete reinforcement

(b) Smaller rocks underneath concrete plates

Figure 2.20: Middle part of the breakwater

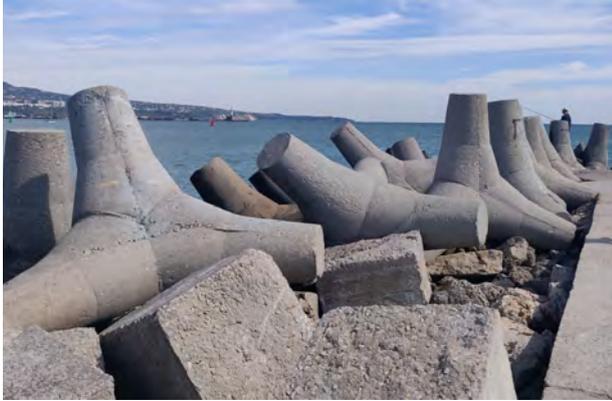
The head of the breakwater consisted of mostly Tetrapods and some concrete blocks. The Tetrapods were not regularly placed and had some distance between them. At the end of the concrete plates there was one larger more round concrete plate where some pieces had broken off at the side of the channel. Also in the concrete that was used for the Tetrapods, cracks were visible that could indicate a decrease in strength of the concrete, shown in Figure 2.22.

(a) Tetrapods and cubes at end of the breakwater

To improve the quality of the breakwater there are multiple options. The cracks can be filled up to reinstate the quality of the concrete plates. Some erosion at the channel side might have lead to cracking of the concrete plates. Reinforcing under this side of the breakwater with extra rock might help to prevent this. On further notice, it is good to check on the concrete of the Tetrapods at the end of the breakwater. More severe cracks can cause breaking of the Tetrapods in which they will (partly) lose its function. In this case new Tetrapods / extra cubes need to be placed at the head.

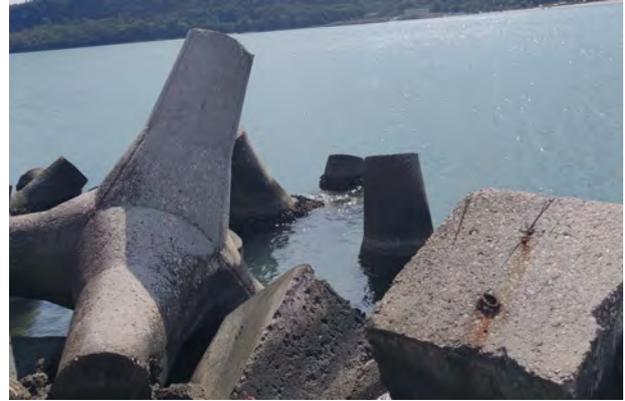
(b) Placement of Tetrapods

Figure 2.21: Tetrapod picture 1 and 2

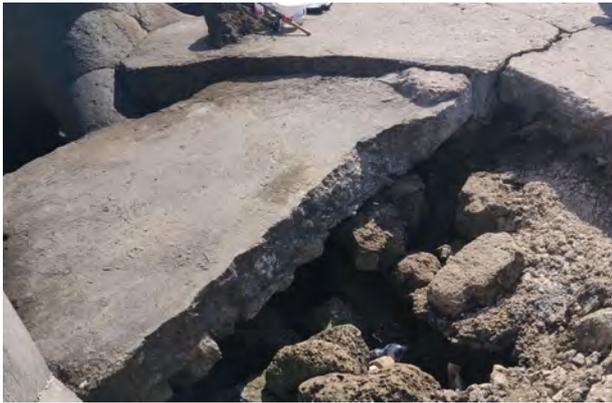
(a) Pieces broke off at the head of the concrete plates

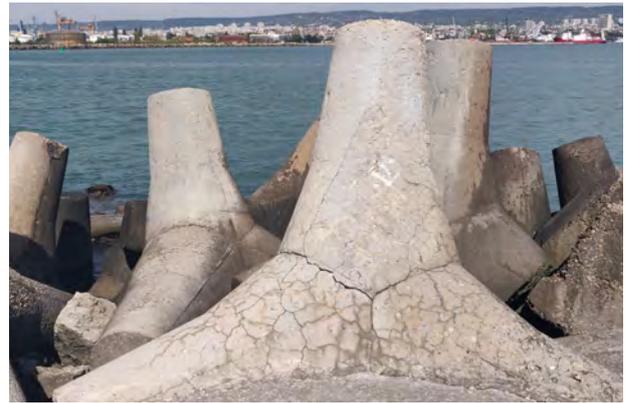
(b) Cracks in Tetrapods at head of breakwater

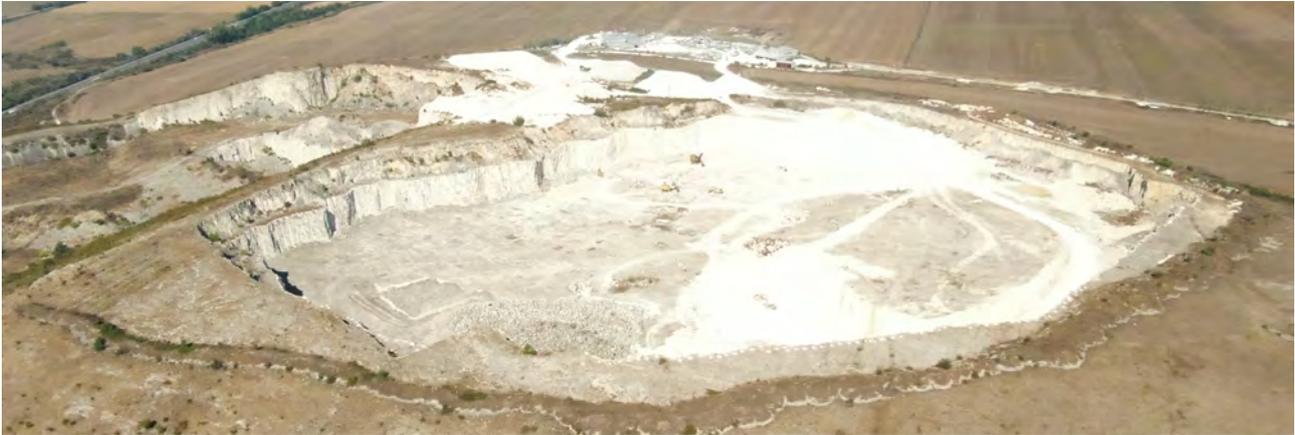
Figure 2.25: The Martsiana quarry

The Martsiana quarry is located 40 km away from Asparuhovo beach. In this quarry, limestone for coastal application is obtained by using a drilling and blasting technique. Then it is transported and separated in a crushing and sorting plant.

At the quarry different stone sizes were available, from which two different piles were examined and samples were measured. The quality, blockiness, length to thickness ratio and the amount of material available was measured. The goal is to examine how suitable the material from this quarry is for building a breakwater. This could be important for the potential solutions, because it is convenient to know if good material is available close to the Karantinata fishing port.

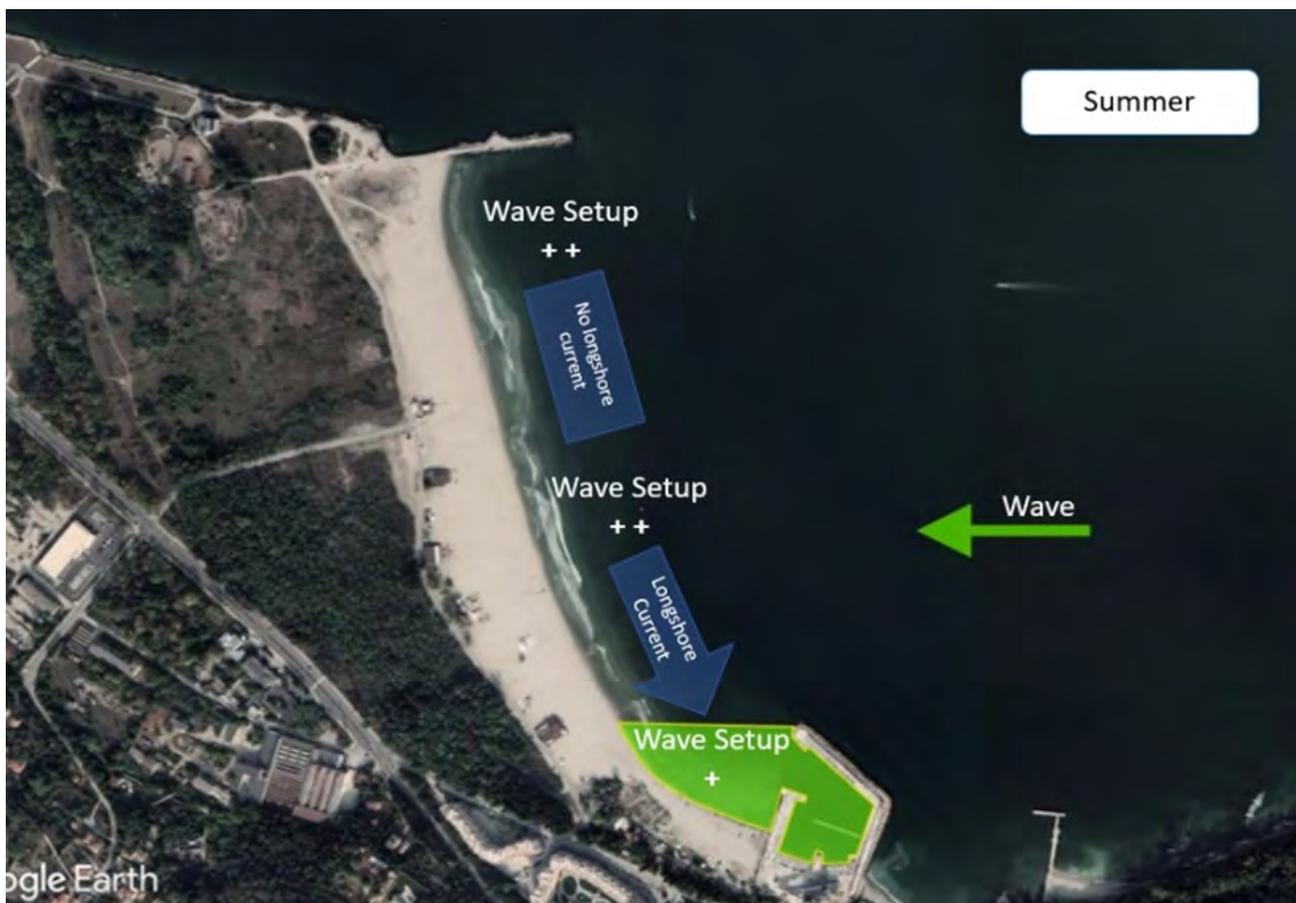
Regarding the case of Asparuhovo beach, in summer conditions, the waves come from an East-Northeast and Easterly direction. The breakwater of Karantinata port creates a sheltered area behind it, where the wave height is smaller. As a result, the wave set-up in the sheltered area will be lower than at the exposed areas at the middle and North of the beach. This leads to an alongshore difference in water surface elevation. The water surface elevation difference creates a longshore current in the direction of Karantinata port. The different levels of wave set-up and the direction of the longshore current during summer conditions are displayed in Figure 3.2. The longshore current takes place at the depth where the rip current disappears and transports sediment from the middle of the beach towards Karantinata port. At the sheltered area, in front of the port, the hydrodynamic forces are less severe, allowing the sediments to settle and result in sedimentation. This sedimentation results in the formation of a shoal at the port entrance. This shoal is very steep and therefore has an unstable slope. Sand is sliding down the shoal and blocking the port entrance. As there are no natural forces to get the sand out of this sheltered area, this sedimentation will keep continuing.

Figure 3.2: Wave Set-up and Longshore Current on Asparuhovo beach

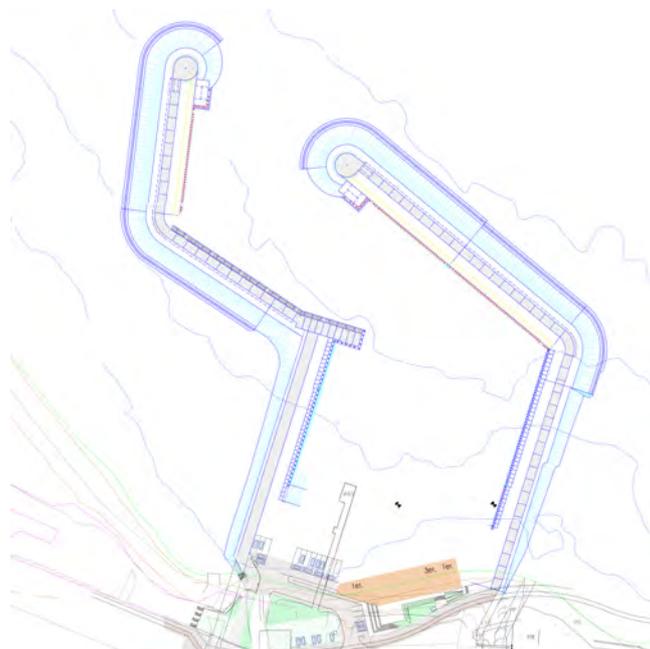
The first idea for a redesign of the port layout is to relocate the port entrance, so sedimentation does not affect the port operation as much anymore (see Figure 5.1). The new location of the port entrance is put more seaward and in deeper water. What used to be the shortest breakwater is elongated and curved around the most seaward breakwater.

Figure 5.1: Relocation of the port entrance

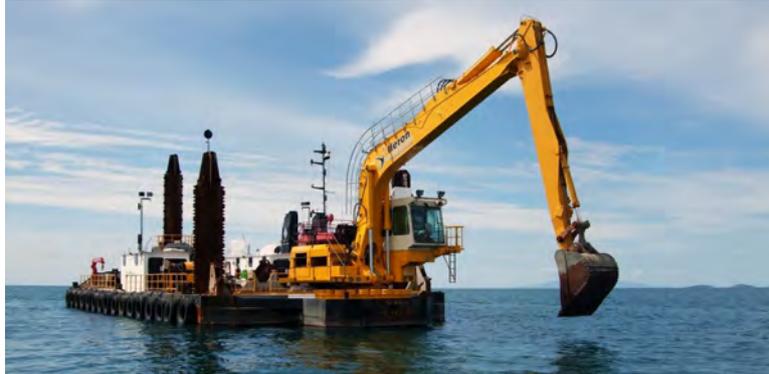
Another solution for the sediment problem at Karantinata port could be to introduce a long term dredging plan. Dredging should deepen the port clearance and free the port entrance. Dredging works can be performed by a high variety of dredging vessels, but for the size of Karantinata port a Backhoe Dredger (BHD) vessels is most suitable (see Figure 5.4). The BHD picks up the sediment using a bucket and fills up another barge that sails to a dumping location.

Figure 5.4: Back Hoe Dredger (Seatools, sd)

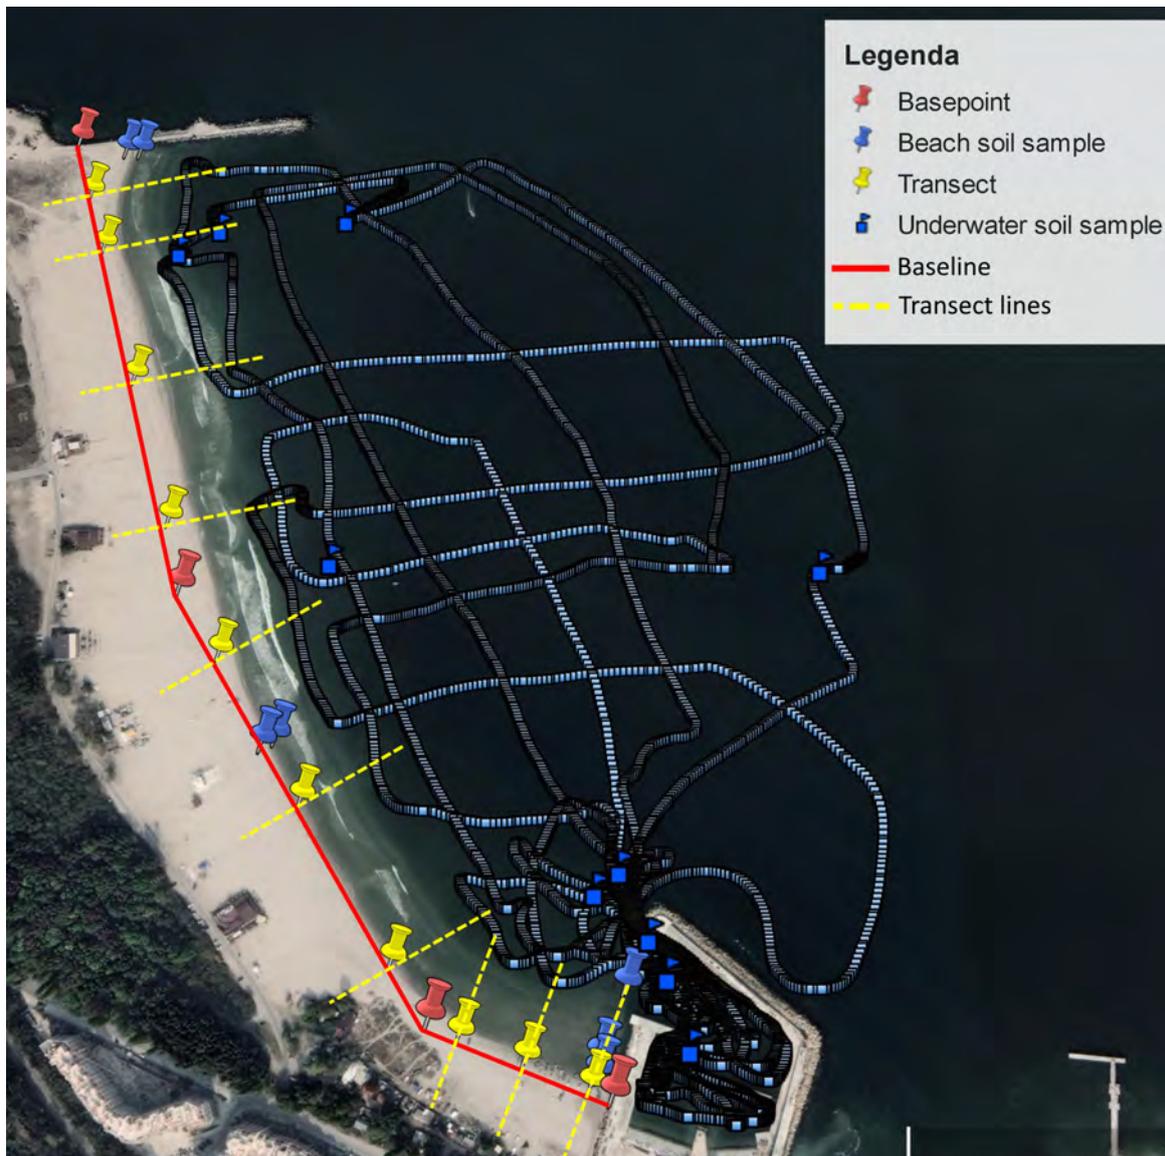
Figure D.1: Full overview of all measurement locations

In this Appendix the method for every measurement is extensively discussed. Also, the equipment that was used for the measurements is shown. This includes the measurements of the beach profile, waterline, bathymetry, waves and soil samples. The locations of all measurements are shown in Figure D.1.

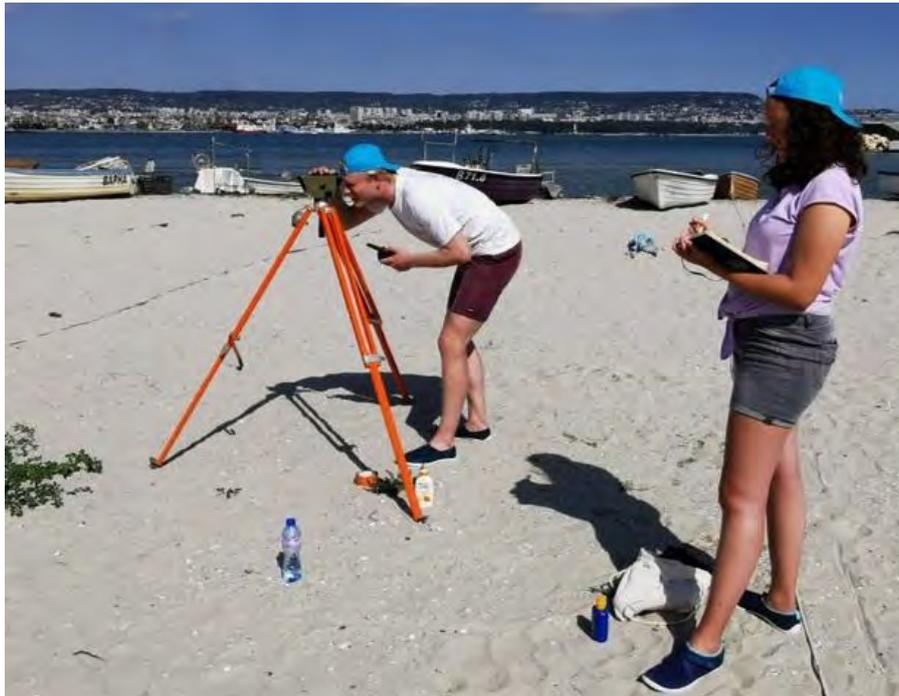
Figure D.5: Reading heights on levelling device standing on tripod

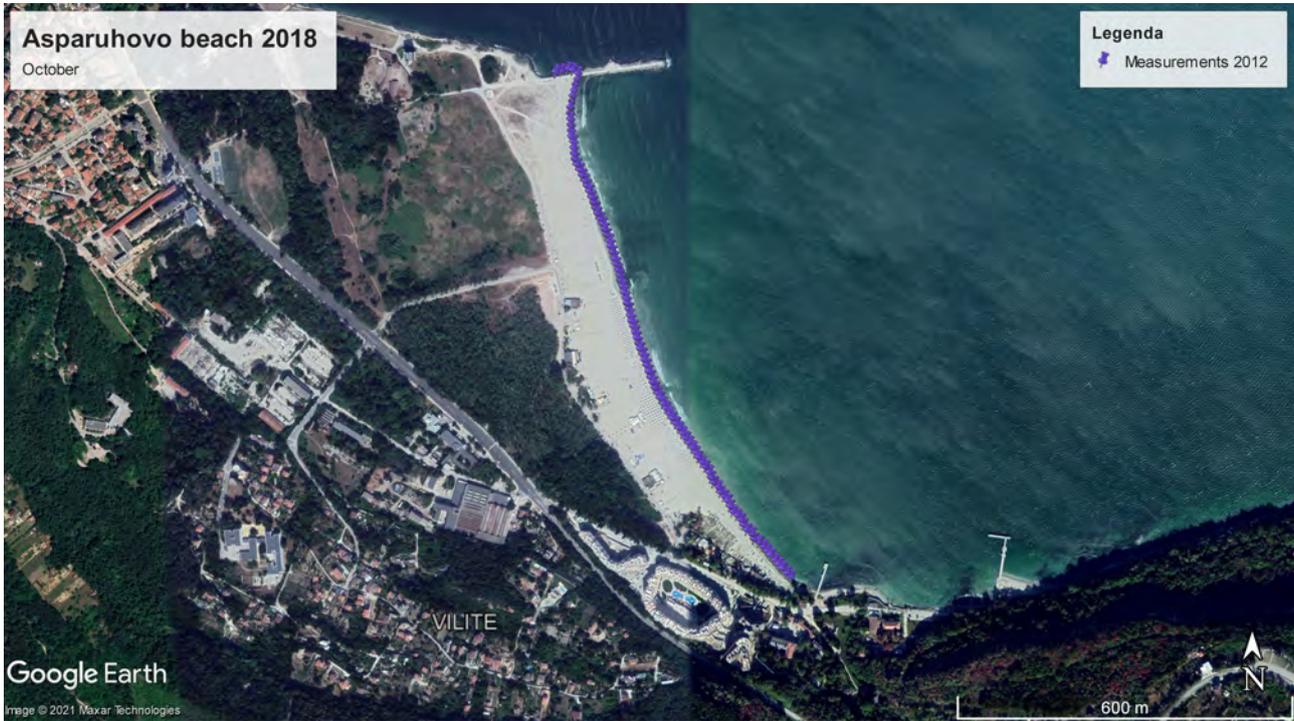
Figure D.6: Waterline 2018 measurement (Google, 2021)

The GPS files from earlier years were plotted in Google Earth and compared to the newest one. Also the evolution of the beach line could be researched through older satellite images of Google Earth. Beach line measurements from previous years plotted in Google Earth are displayed in Figures D.6 and D.7.

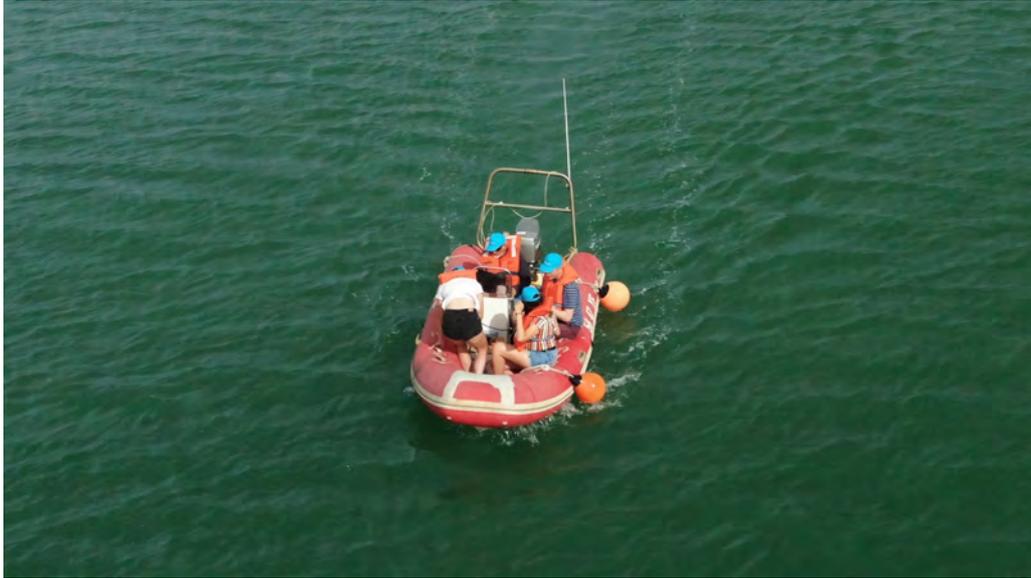
Figure D.8: Bathymetry measuring

The bathymetry of the bay at Asparuhovo beach was investigated to finalize the profile measurement of the entire area. This bathymetry is of interest to the project, because it shows the underwater morphology that is key to understand how waves will react to entering the bay. Also differences in depth can lead to conclusions about sediment transport. All measurements were done in calm waters at constant speed to avoid any measurement errors in vertical motion of the measuring device.

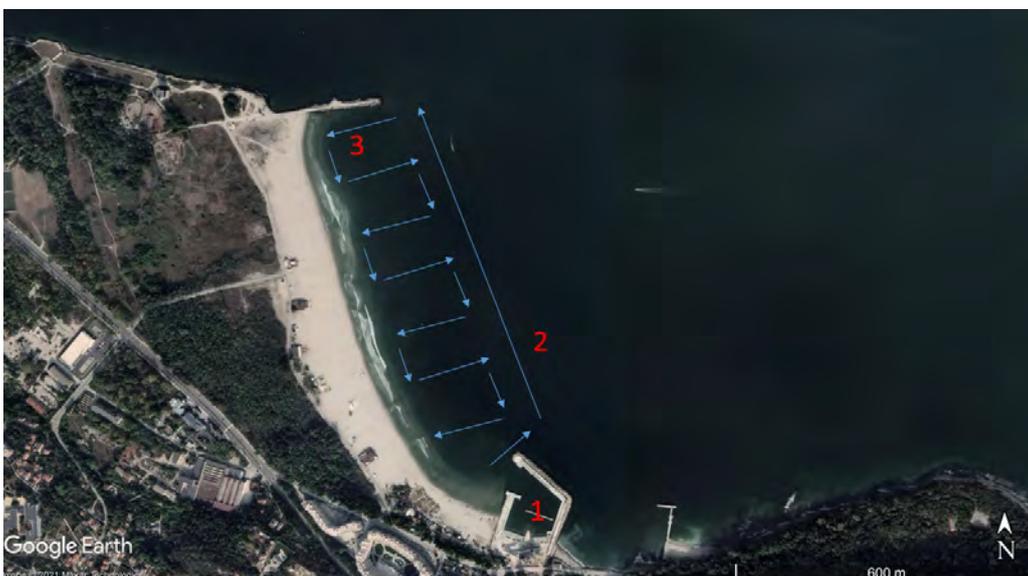
Figure D.9: Plan bathymetry

For the data gathering a boat was used with a FishFinder. This was used at the time function, which meant that the slower the boat was sailing the more dense the points would be. First the port was sailed around very slowly to have a good view of the bathymetry inside the port. After that the boat sailed out towards the sea and the Northern breakwater at the access channel to create a boundary for the racks to the sea and back to the beach. The plan for data gathering and the retrieved data points are shown in Figures D.9 and D.10. The retrieved data points differ somewhat from the original plan as at the same time also the sand samples from the bottom were retrieved.

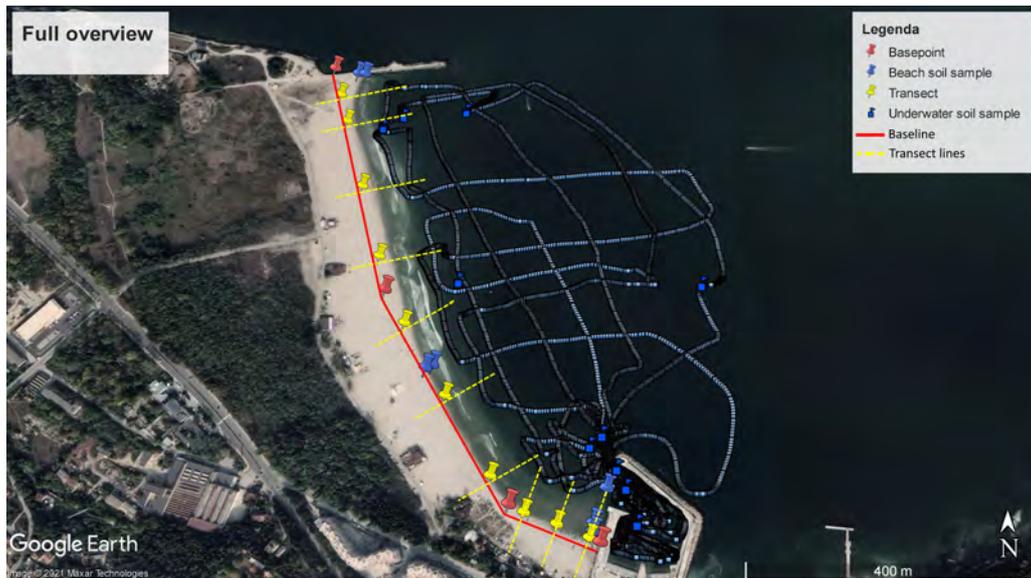
Figure D.10: Retrieved bathymetry depth samples

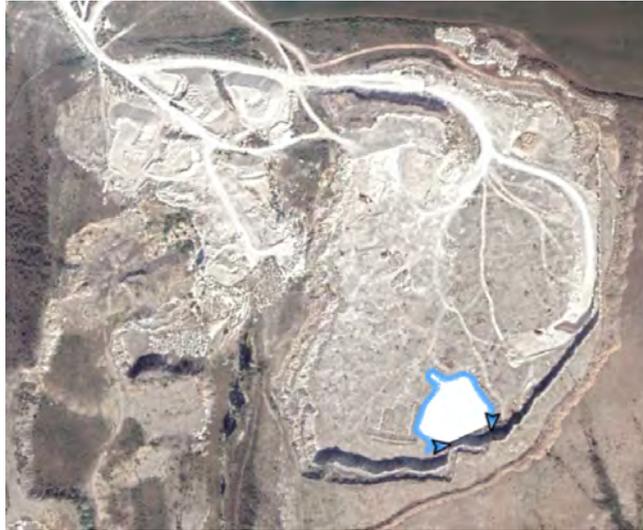
Figure D.13: GPS area measurement of big rock pile at Martsiana quarry

The total volume of rock in the pile was also measured. This was done by measuring the circumference with a GPS device on a phone (see Figure D.13). The average height of the pile and the porosity of the pile were determined visually. The total volume of rock in the pile was determined with Equation (D.4).

$$V_{total} = A_{pile} \cdot h_{average} \cdot (1 - porosity) \quad (D.4)$$

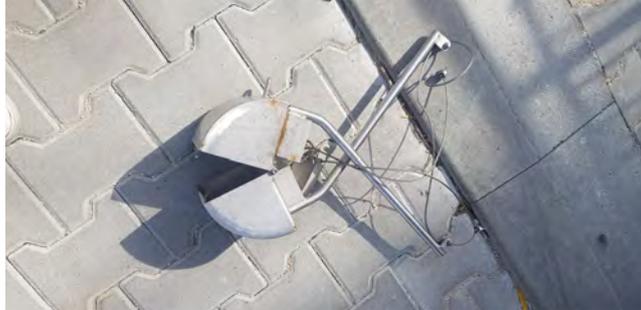
Figure D.16: Van Veen Grab

As it is not possible to use the piston sampler at larger water depths the 'Van der Veen grab' was used to retrieve sediment from deeper water. It was used while sailing the boat. When the boat was at a location of interest the grab was prepared and used. The grab was attached to a cable of which the end remained at the boat to retrieve the grab. The grab was opened and sunk into the water. Once the opened grab hit the ground the string that held the grab open was released so that the grab enclosed the sediment at the bottom. This sediment was then retrieved by the cable and stored in designated storage bags.

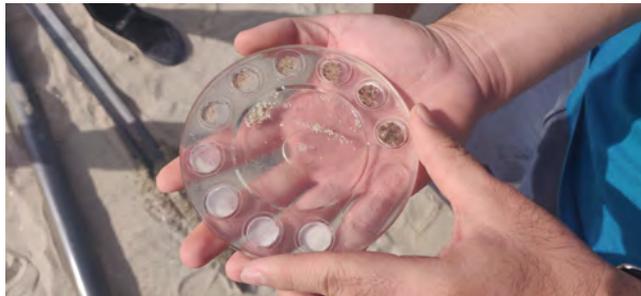
Figure D.17: Sand ruler

To get a first indication of the size of the sand samples a sand ruler was used. With this the retrieved sediment samples can be compared to standard distributed grain sizes that are on the sand ruler. This is for a first indication only. To get a clear estimation the sediment is first rubbed dry in the hand and then placed in the middle of the sand ruler. By comparing the sand to different grain sizes along the sand ruler, the size of the retrieved sand can be estimated.

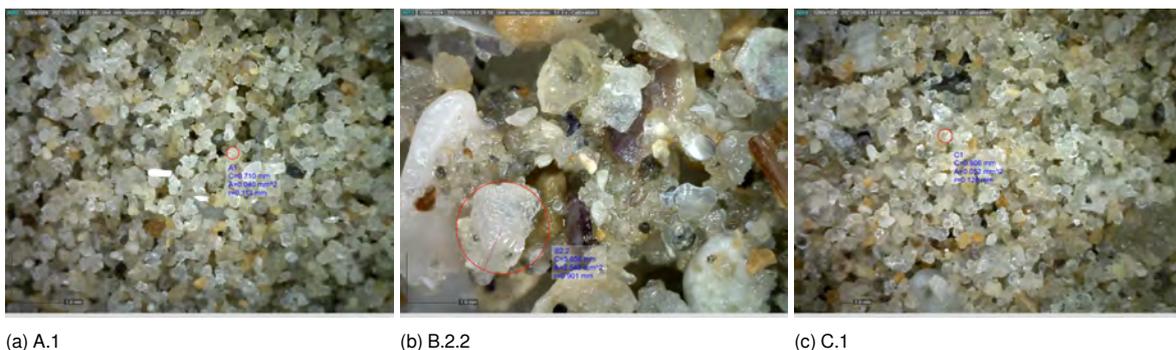
Figure D.18: Snapshots of some d_{50} measurements done for different samples with the Dino-Lite microscope

Once all the samples were taken and secured, they were analysed by using the Dino-Lite microscope as shown in Figure D.20a. The DinoCapture 2.0 software was then used to calibrate the microscope and measure the d_{50} of every soil sample. Of every measurement a screenshot was taken and stored, such as shown in Figure D.18. The corresponding measurements of the d_{50} can be found in Appendix E.2.

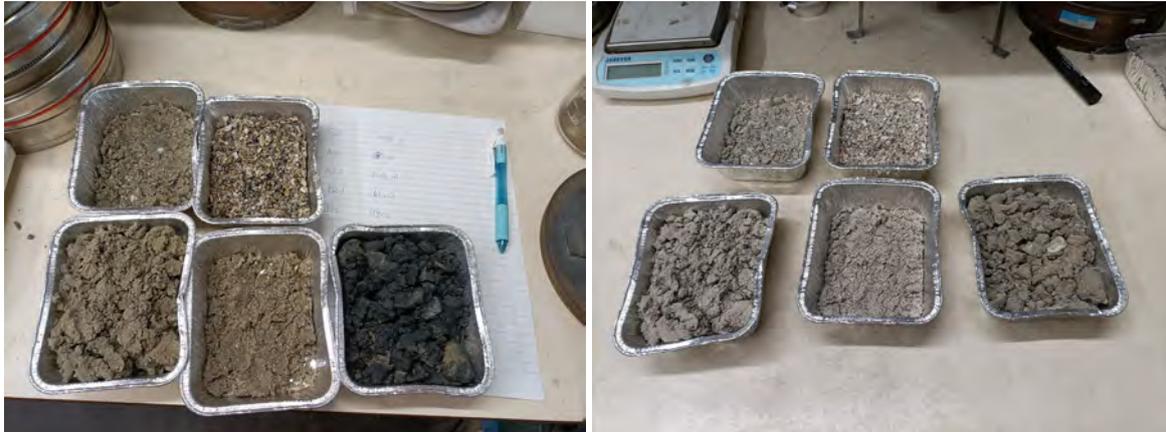
(a) Before

(b) After

An oven was used to remove organic materials and any water from the soil samples. All samples were placed in allocated aluminium trays and then the trays were put inside the oven. All the samples were heated on 150°C for 24 hours. See Figure D.19 for the trays with samples before and after 24 hours in the oven.
