Fieldwork Hydraulic Engineering

Asparuhovo Beach

TU Delft Bulgarian Fieldwork 2021

Final Report
Varna, Bulgaria
CIE5318

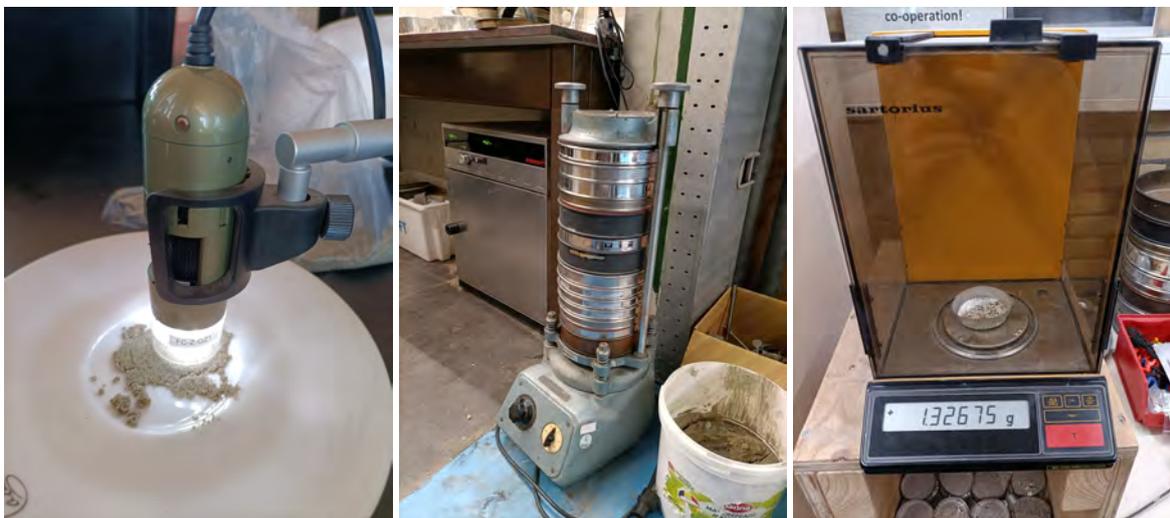
(a) Dino-Lite AM4115T - EDGE universal micro-
scope

(b) Sieving machine with sieves

Once all the samples were taken and secured, they were analysed by using the Dino-Lite microscope as shown in Figure D.20a. The DinoCapture 2.0 software was then used to calibrate the microscope and measure the d_{50} of every soil sample. Of every measurement a screenshot was taken and stored, such as shown in Figure D.18. The corresponding measurements of the d_{50} can be found in Appendix E.2.

The dried samples were then subjected to a sieve analysis to determine the grain size distribution of each soil sample. The sieves were stacked into a column with the sieve with the biggest opening diameter on top. The opening diameter of each sieve was chosen such that the maximum amount of available sieves was used, in the realistic range that could be expected from the d_{50} measurements with the microscope. This range was decided to be between a maximum sieve opening of 2360mm, and a minimum of 90mm. The sieve sizes that were used are shown in Table D.2. The sieving took place on full power for 10 minutes per sample.

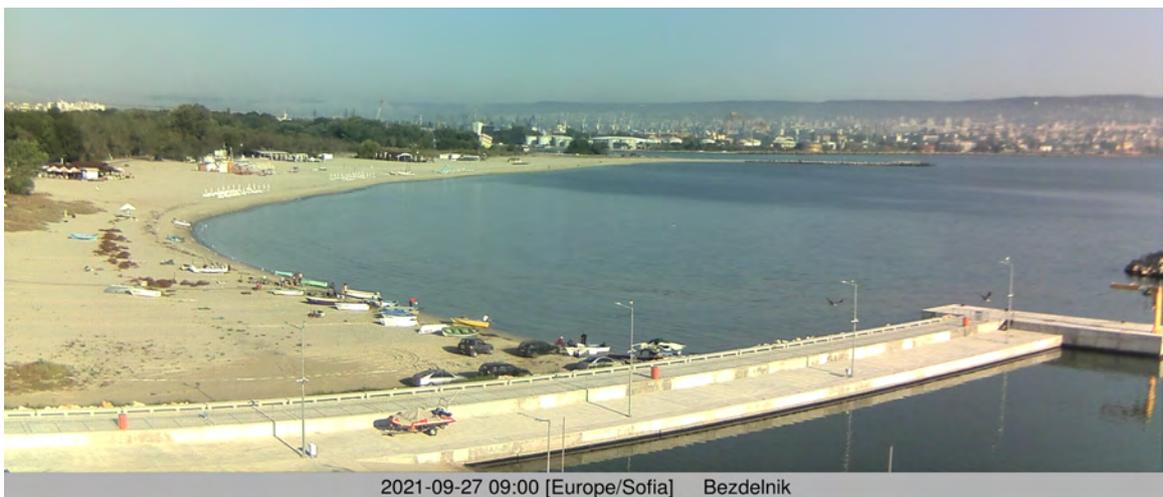
Figure E.10: Picture of wave conditions 27/09/2021 9:00

In order to get a better understanding of the consequences of certain offshore wave conditions, a comparison was made between three situations; a situation with mild wave heights, a situation with medium wave heights and one with large wave heights. On the 27th of September 2021, at 9:00 in the morning, the conditions were relatively mild. The significant wave height at that moment was equal to 0.22 meters and the waves were predominantly coming from South-eastern direction. The picture made at that moment is displayed in Figure E.10. On October 5th at 10:00 a wave height of 0.82m was recorded by the wave buoy. A picture of the conditions at the beach is displayed in Figure E.11. On the 6th of October 2021, at 17:00 the wave heights were relatively high (1.37m) the waves came predominantly from an eastern direction. The picture made at that moment is displayed in Figure E.12.

Comparing the three pictures, it can clearly be seen that in the case of the harsher conditions, the waves are significantly larger and break further from the coast. When the conditions are mild, the waves are very low and the individual waves can not clearly be identified. When comparing the conditions at October 5th and 6th, the individual waves can be identified and it can be observed that the wave lengths on October 6th are larger than on October 5th. This can be explained by the longer duration of the storm.

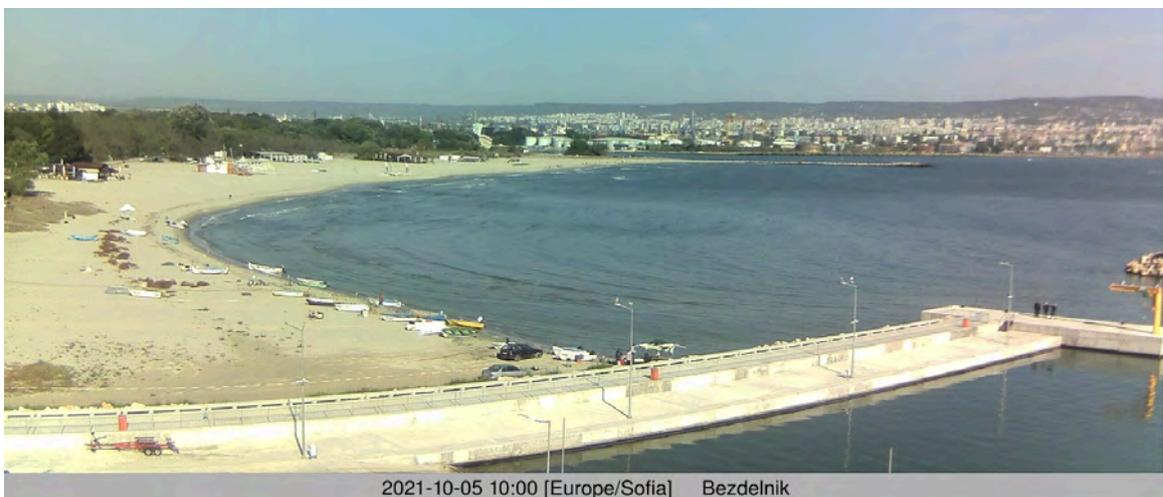
Figure E.11: Picture of wave conditions 05/10/2021 10:00

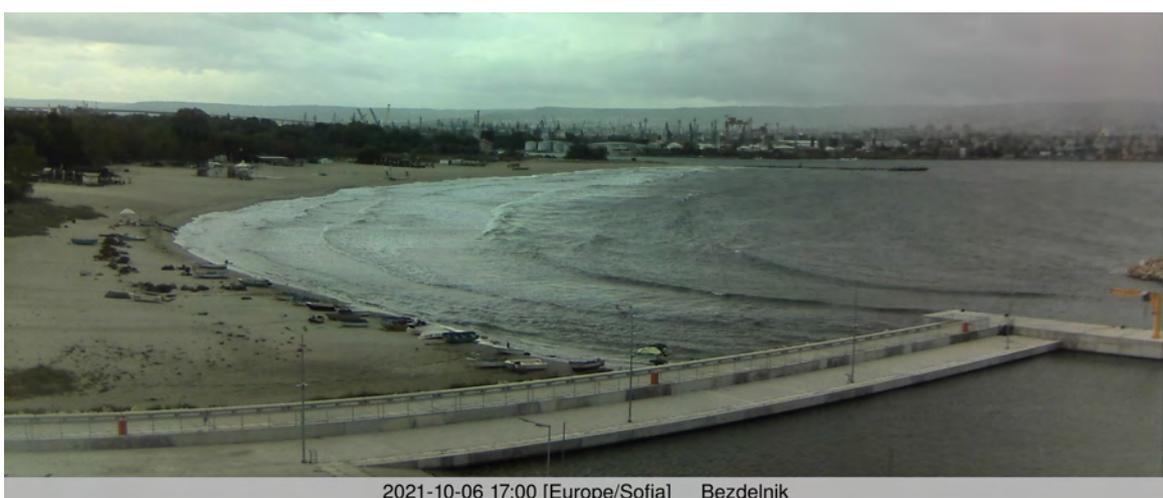
Figure E.12: Picture of wave conditions 06/10/2021 17:00

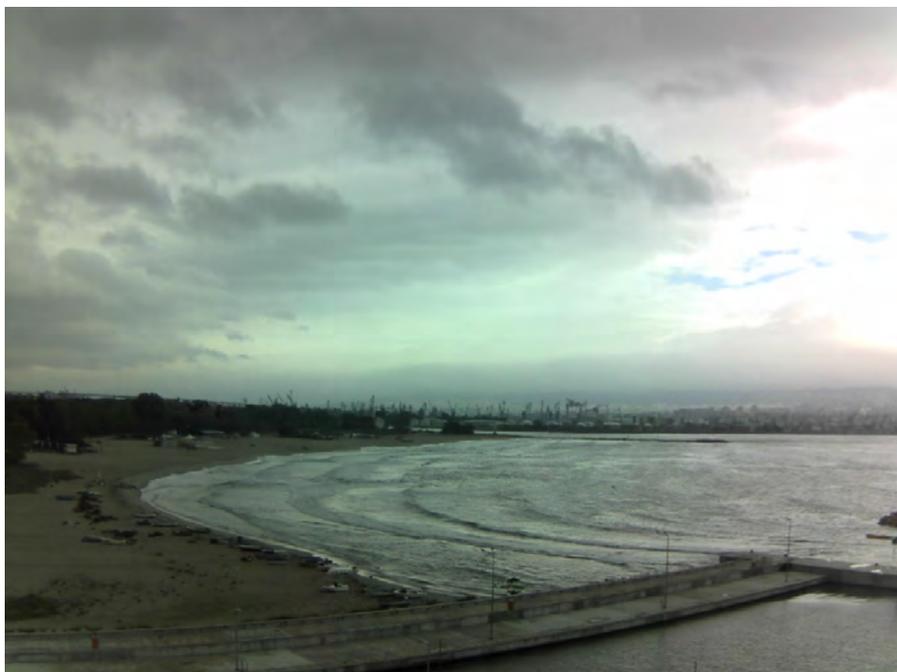
(a) Picture made by time lapse camera

Furthermore, the presence of rip currents is looked at. There are several signs with which a rip current can be identified. The most clear signs are: (1) deeper, dark colored water, (2) fewer breaking waves, (3) rippled surface, surrounded by smooth water and (4) anything that is flowing back to the sea, or colored water flowing back out to sea. Not all rip currents have to show all these signs. Some rips may only show one or two of the signs (Surf Life Saving Australia, 2016).

With the use of this knowledge and the pictures made by the time lapse camera, it can be identified that a rip current is present most of the time. A clear identification of this rip current can be done on the basis of a picture made at 13.00 on the 9th of October 2021 (see Figure E.12). At the location of the rip current, it can clearly be observed that fewer waves are breaking. Furthermore, the surface seems to be slightly more rippled than the surrounding water. Lastly, the color of the water at the location of the rip current is darker than the surrounded water. The identified rip current is indicated with the blue arrows in the picture.

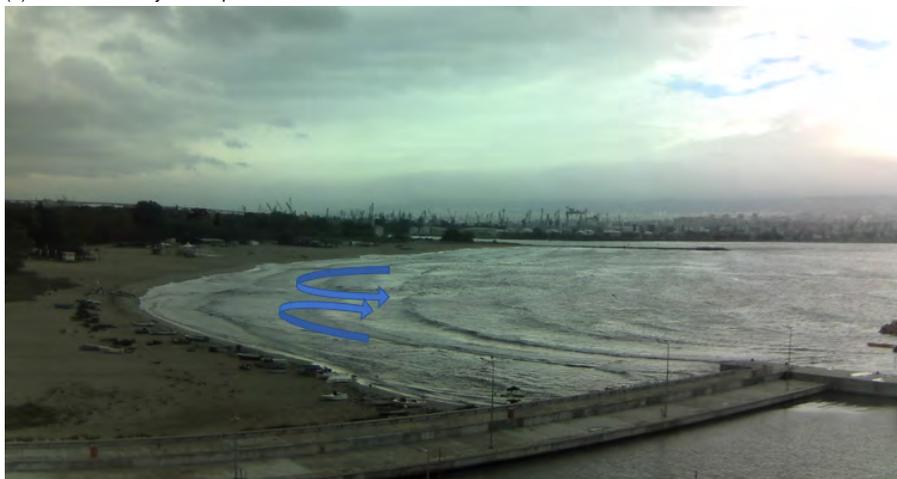
(b) Identification of the rip current

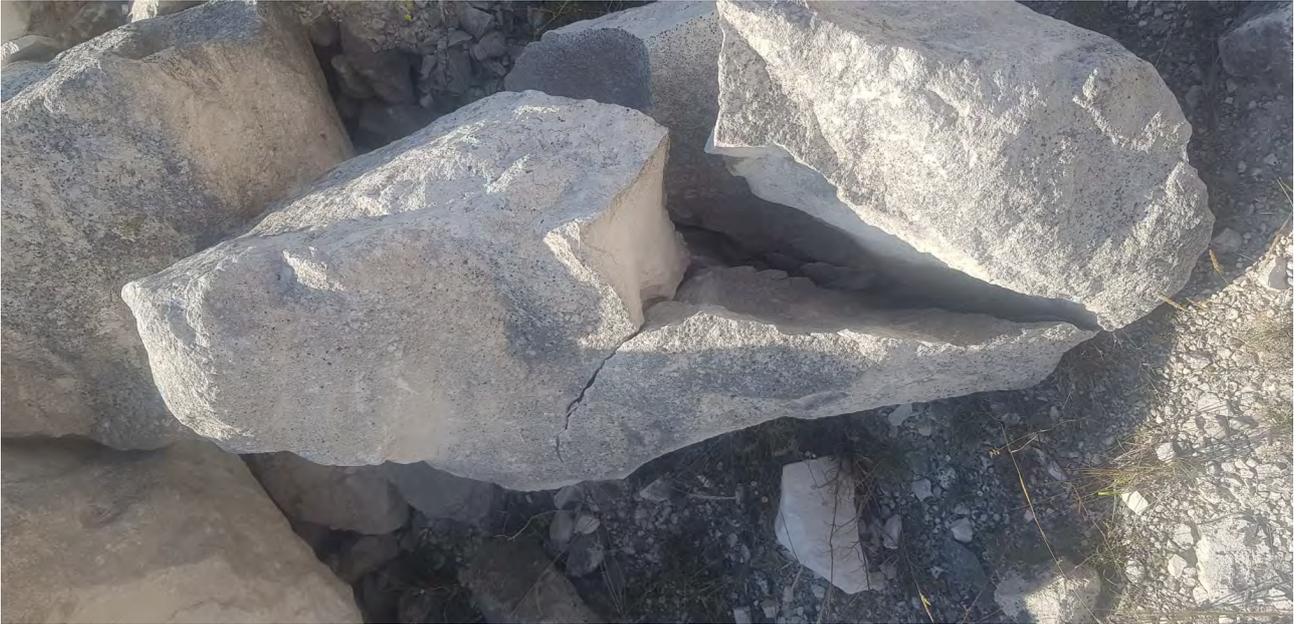
However, also a visual assessment was made. These observations showed that a lot of rocks were damaged badly (see Figure E.17 and Figure E.18). The current pile of rocks would therefore not be suitable for construction a breakwater, except if high quality control is applied. The rocks need to be inspected individually to look for any cracks or other weak spots. If a breakwater has to be build, it is therefore recommended to first look at other quarries and see if their rocks are of higher quality.

Figure E.17: Examples of damages of the large rocks in the pile

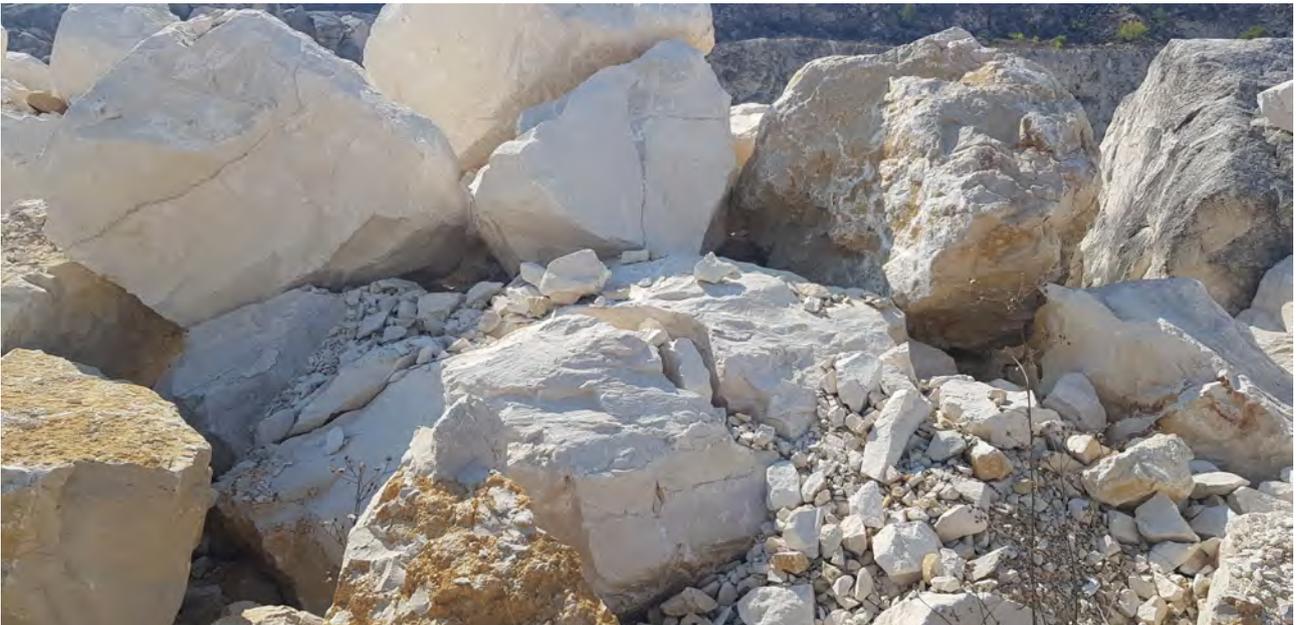
Figure E.18: Examples of damages of the large rocks in the pile
