## Appendix: supplementary data (SD)

Section 1 provides information on the average sedimentological and geochemical analysis of the aquifer material conducted by TNO in 2018. Section 2 provides supplementary figures on the monitored infiltration period one, section 3 likewise for period two. Section 4 lists the analytical results on recharge water quality. Section 5 provides photographs taken at the ASTR site in Breezand. Section 6 presents additional micrographs on sampled points discussed in section 2.5. Section 7 provides the analytical results on the well rehabilitation samples including the sedimentological analysis and XRD analysis results. Lastly, section 8 provides additional submersible camera shots of the injection wells.

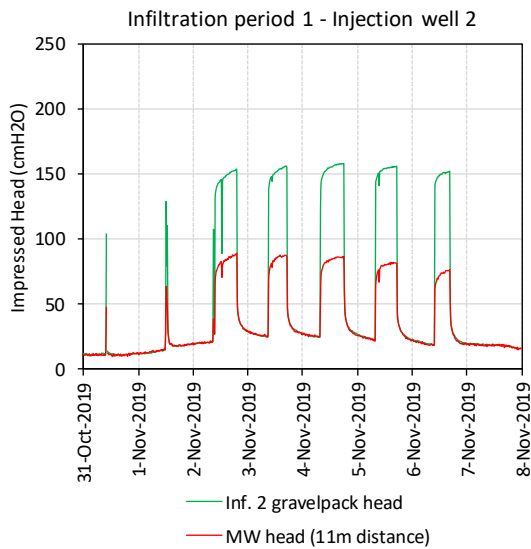
Figure 2.2a: The head in the injection well two gravelpack piezometer and the abstraction well gravelpack piezometer (dedicated monitoring well) for infiltration period one.

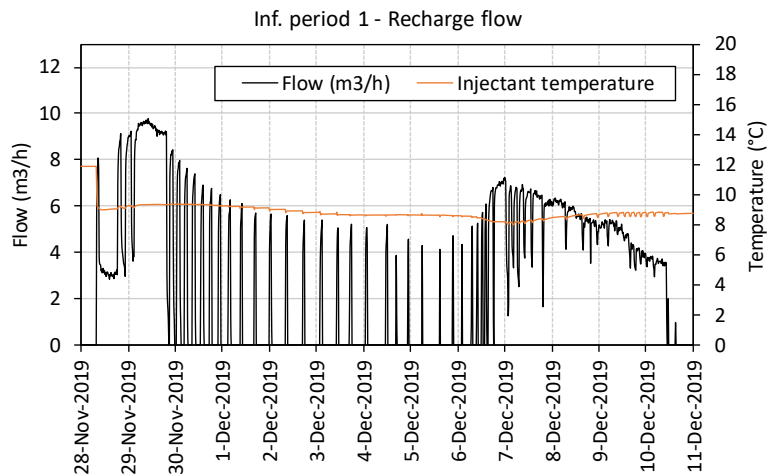
Figure 2.4b: Recharge rate (m<sup>3</sup>/h) for infiltration period one

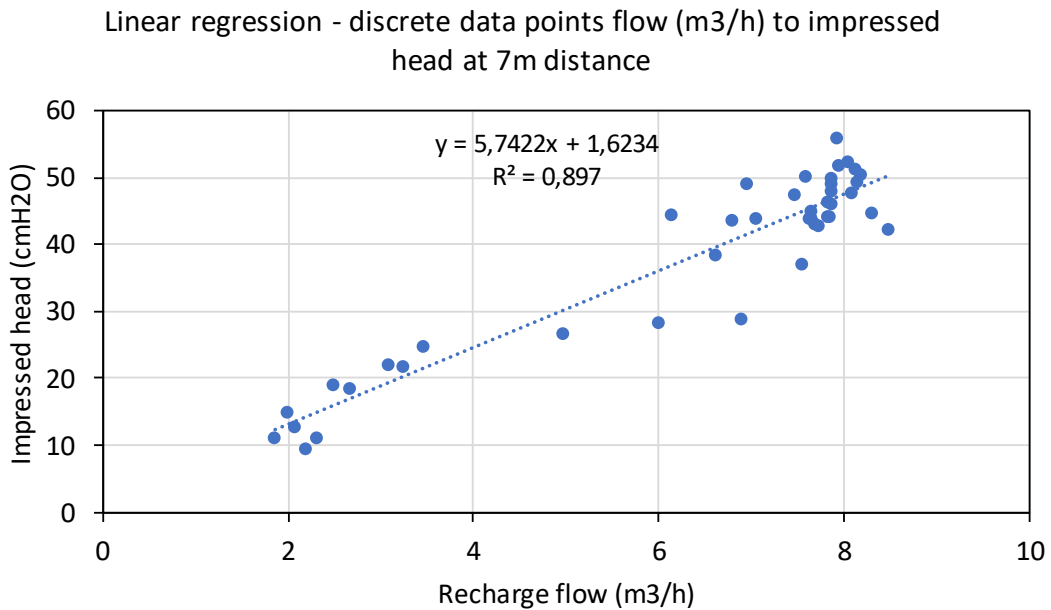
Figure 2.6: Linear regression of head rise to recharge flow during infiltration. The regression constant is used to derive the recharge flow during infiltration period one. N = 46.

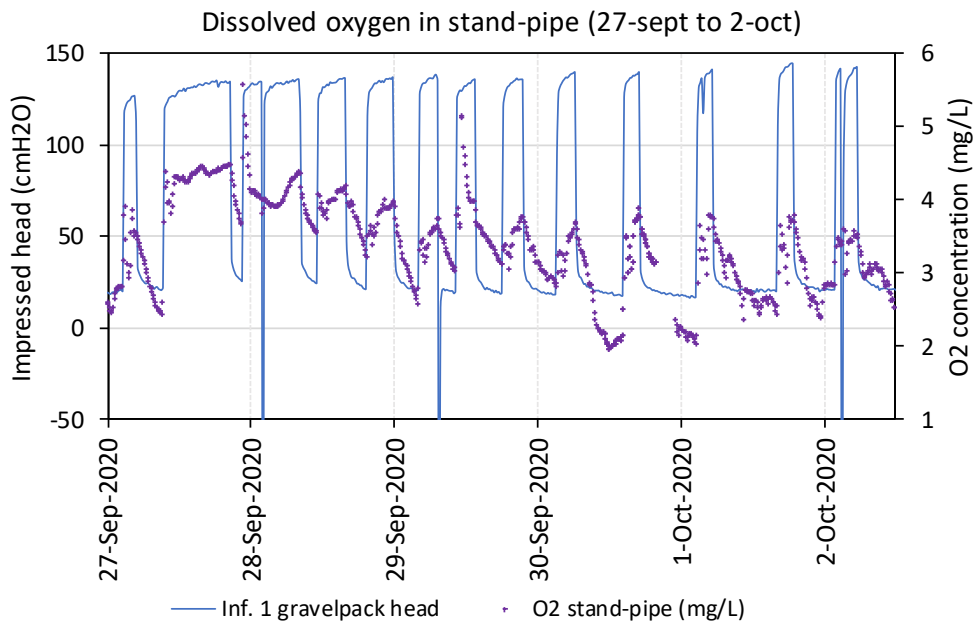
Figure 3.6: Typical trend of dissolved oxygen in the standpipe during short injection runs.

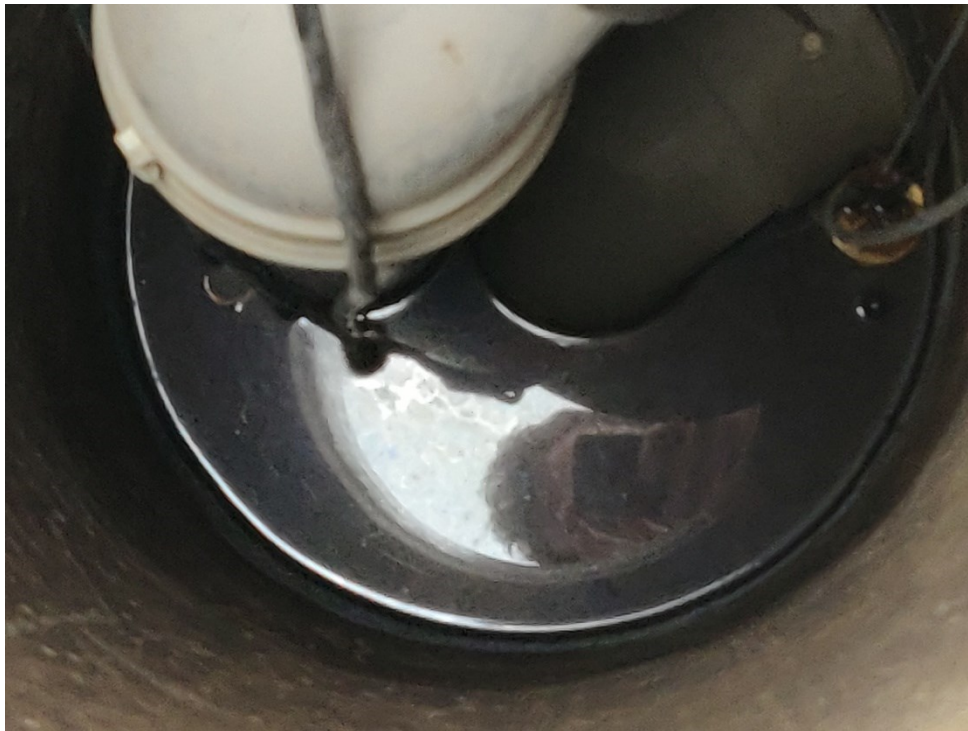
Figure 5.1: Metallic sheen on stagnant water within the standpipe taken November 25<sup>th</sup>, 2020 after a 41-day standstill.

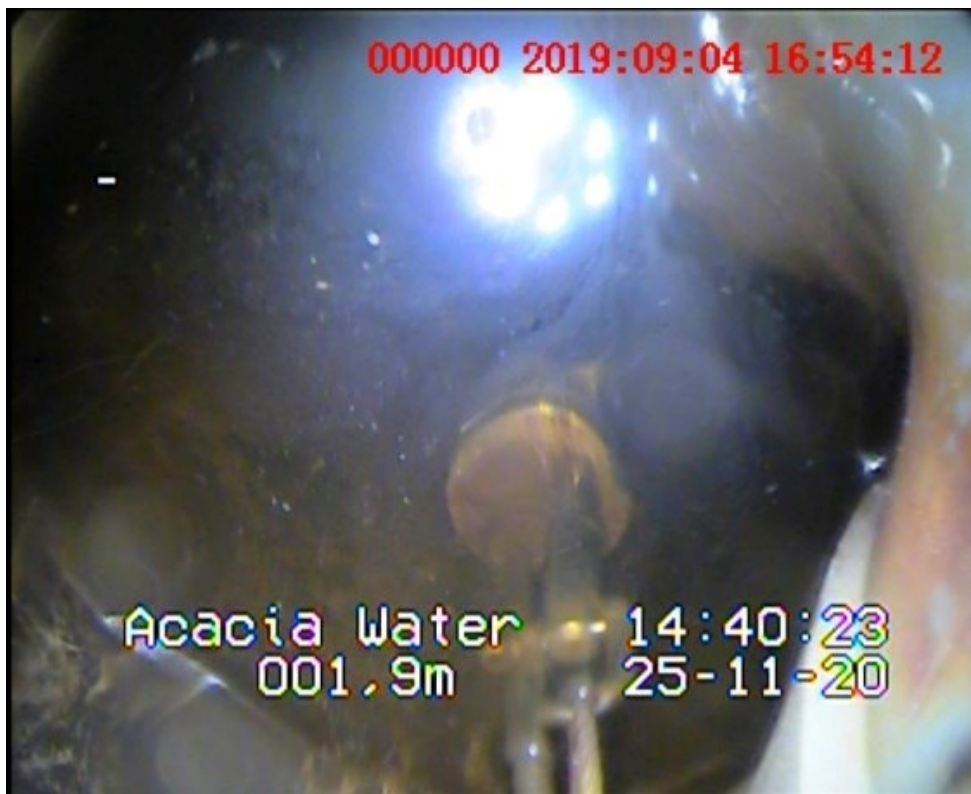
Figure 5.2: Metallic sheen on stagnant water within the standpipe taken November 25<sup>th</sup>, 2020 after a 41-day standstill.

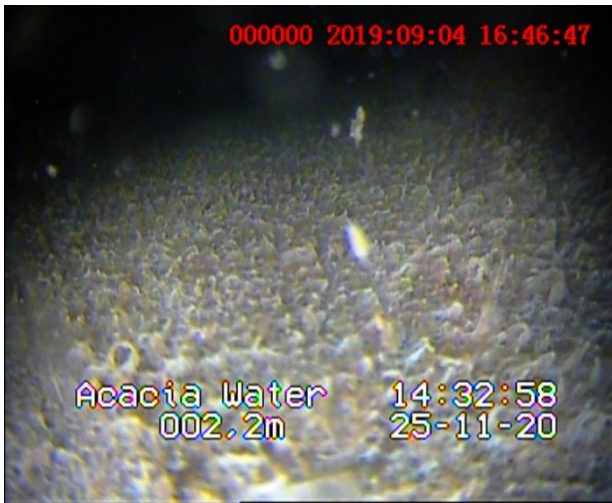
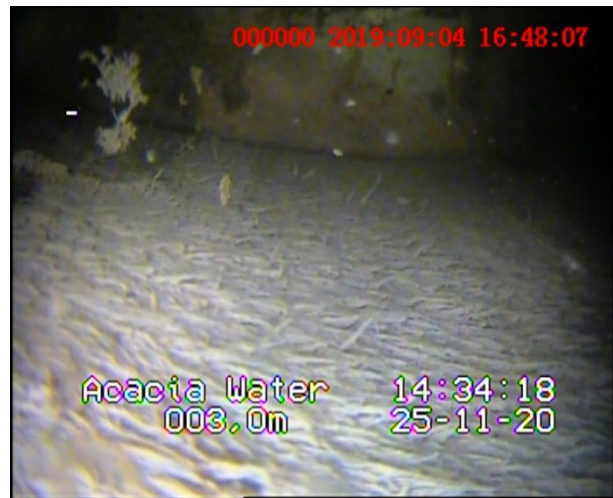
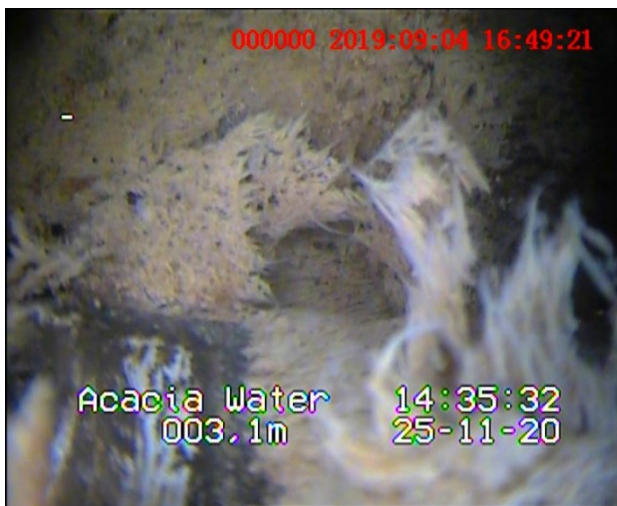
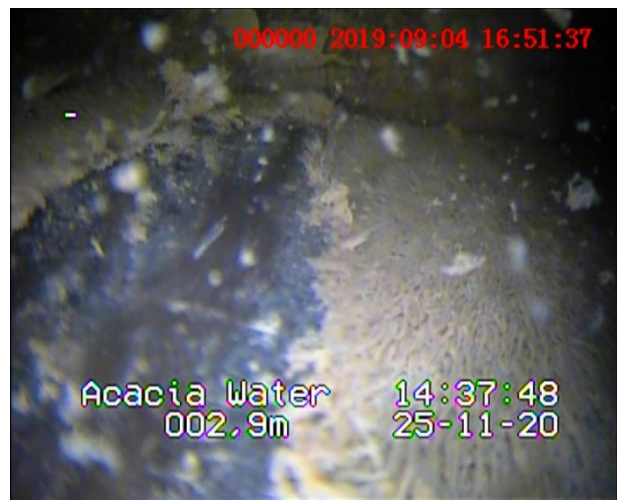
Figure 5.3: Several shots of the conditions within the standpipe taken November 25<sup>th</sup>, 2020 after a 41-day standstill. A thick mat of microbial deposits covered the pipe interior and seemed to thicken with depth. The image below shows the standpipe material colour.

Figure 5.5: Camera shot of the conditions within the main tile outlet discharging tile drainage water to the drain reservoir. A mat of microbial deposits similar to that in the standpipe (fig. 5.3) is seen.

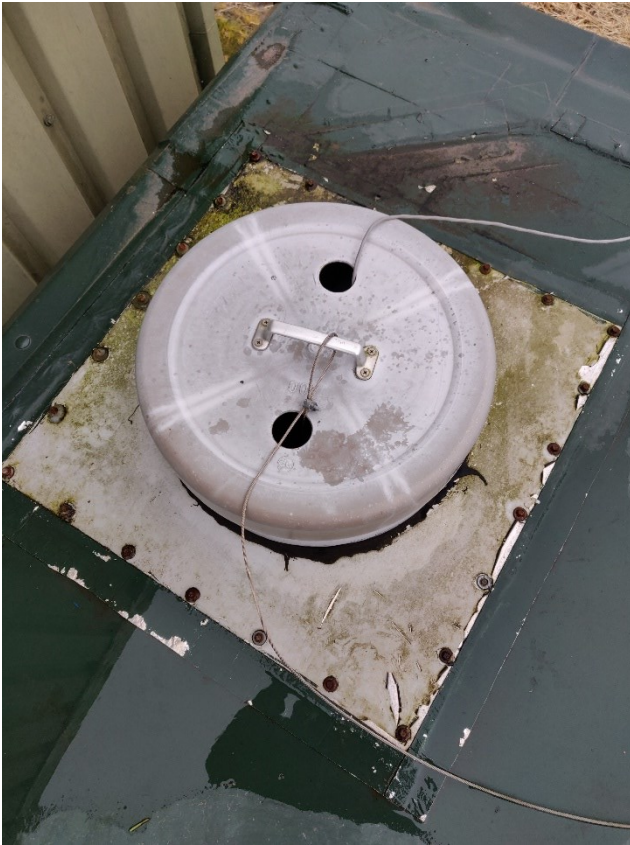
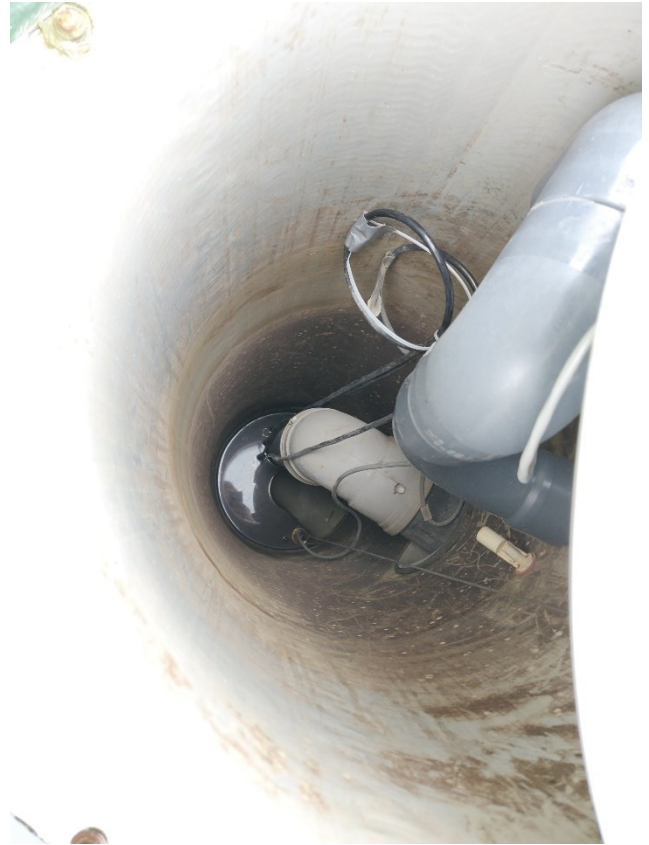
Figure 5.4: Images taken on top of the container, showing the top of the standpipe in contact with atmospheric oxygen and the interior (right).

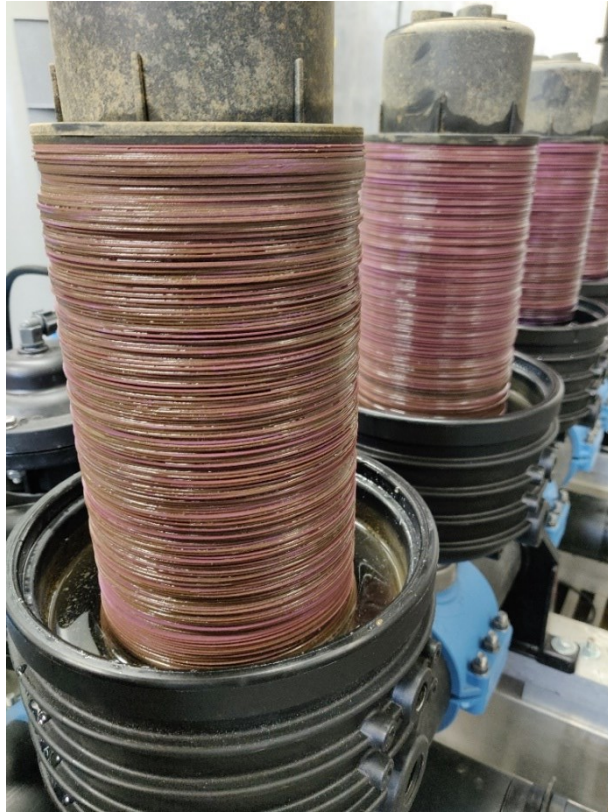
*Figure 5.6: Image taken of the disc-filters after the head is removed. The filter is covered in brown slimy material. Shot taken November 25<sup>th</sup>, 2020 after a 41-day standstill.*

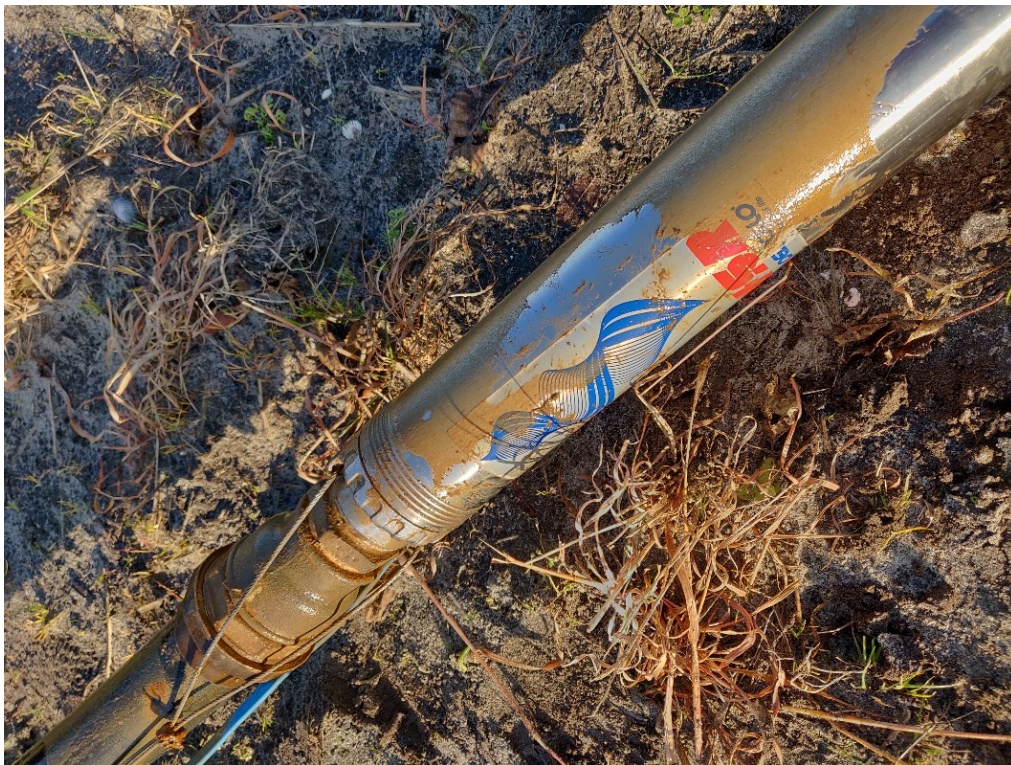
*Figure 5.7: The automated backflush pump removed prior to the well rehabilitation on November 25<sup>th</sup>, 2020. A thin layer of brown glutinous material is discerned suggesting iron oxides.*

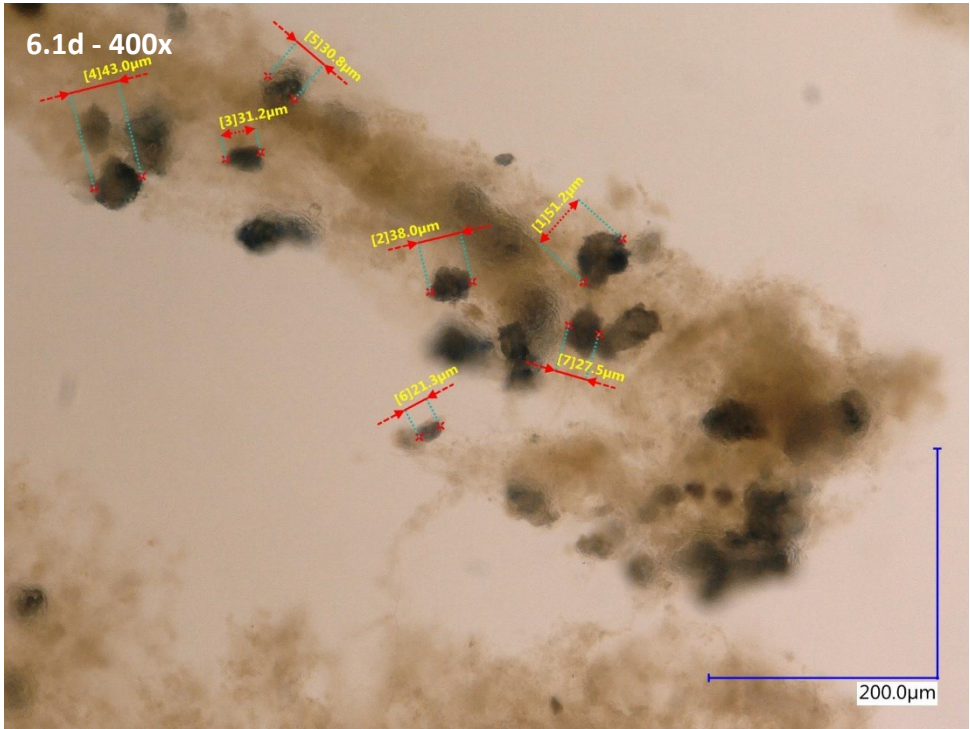
Figures 6.1 correspond to micrographs taken of disc-filtrate material (S2). Figures 6.2 correspond to micrographs taken of material removed from the standpipe (S3). Figures 6.3 correspond to the material removed during the well rehabilitation on November 25<sup>th</sup>, 2020 (S1.2). Figures 6.4 correspond to material removed during the well rehabilitation between 2<sup>nd</sup> and 4<sup>th</sup> February 2020 (S1.1).

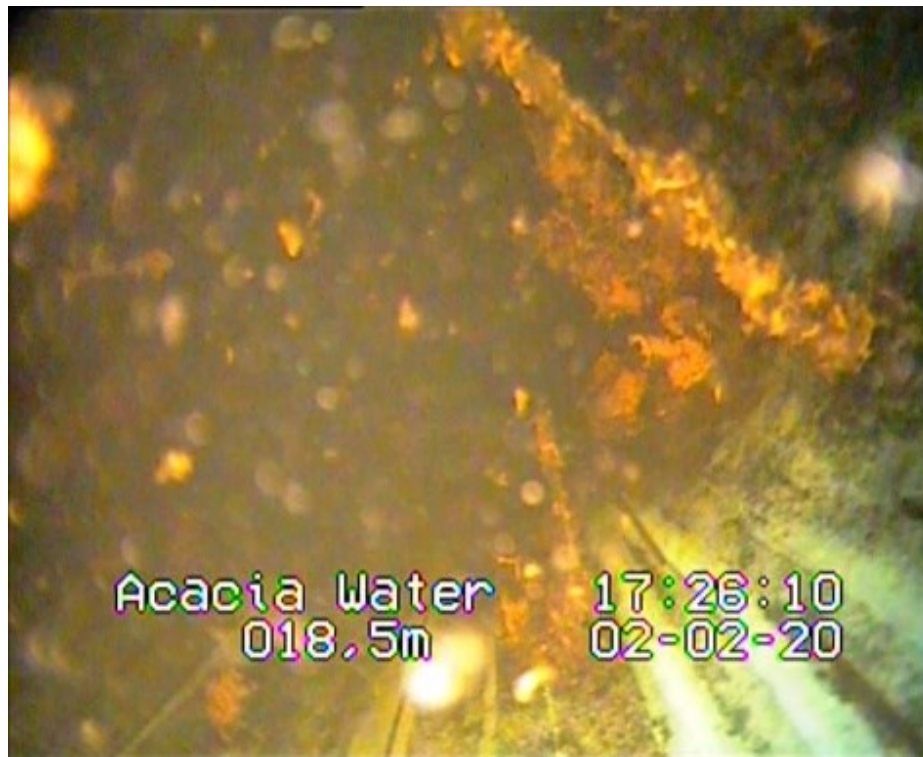
Figure 8.1: Large biofilm depicted near the middle filter screen shot after the first clogging event from infiltration period one.

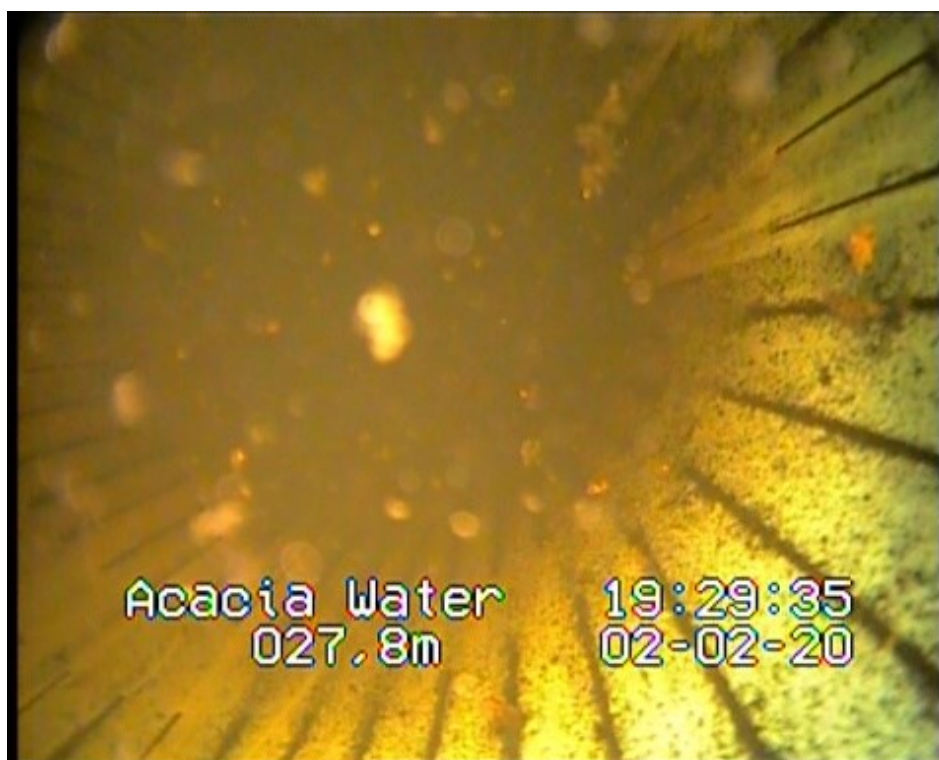
Figure 8.2: Dark material (organic) within filter slots with staining on the well interior.

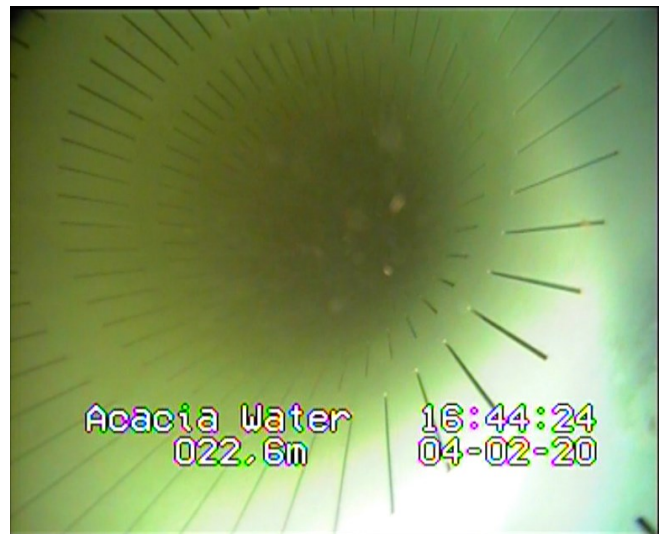
Figure 8.3: Very clean filter slots and well interior after the well rehabilitation between February 2<sup>nd</sup> and 4<sup>th</sup>, 2020.
