An Application of New Pedestrian Tracking Sensors for Evaluating Platform Safety Risks at Swiss and Dutch Train Stations

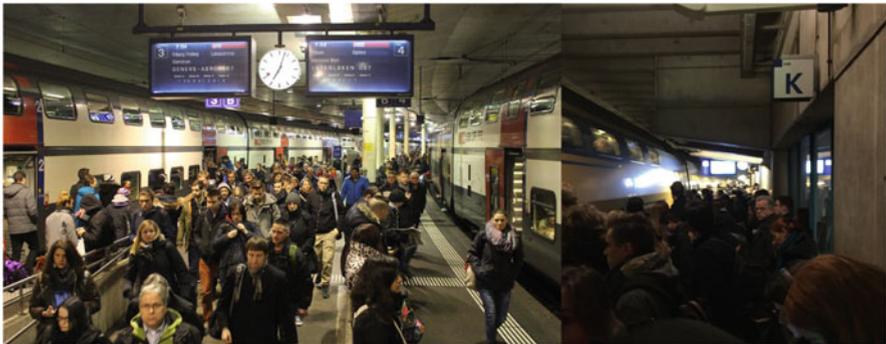
Fig. 1 Crowding at train station platforms. Left: Bern SBB, track 3/4, 8 March 2016, 7.03 h; Right: Utrecht Centraal, track 5, 7 December 2015, 8.01 h. These pictures are representative for peak hours at regular work days

Until recently, pedestrian measuring systems at Swiss and Dutch train stations have been used only for counting the number of pedestrians at a predefined area (occupancy) or passing a counting line (flow rate). Advanced systems have not been sufficiently accurate as well due to challenging semi-outdoor environment with high flow rates at a train station (see Fig. 1).

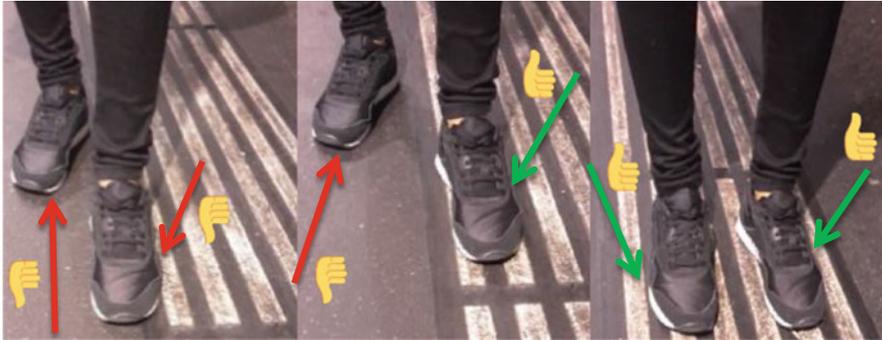
Fig. 2 Safety line at platform of Bern (CH); red arrow is “in danger zone”—indicator

The experiments have been performed in the context of our research on the use of the danger zone at train platforms (see [5]). The validation of the correct position of pedestrians at the platform before train arrival(s) in the sensor data has been the main objective of this experiment. As indicated in Fig. 2, a pedestrian is in the danger zone when standing or walking with at least one foot at the track side of the safety line at the platform. Both feet at the safety line or at the non-track side of the safety line are considered as safe. The objective is to assess if measurements are according to reality, with a small margin of measurement error. For this experiment, we have chosen to set the margin of error at ± 10 cm or approximately a foot width. In practice, there is no need for a higher accuracy.
