FEASIBILITY STUDY

Coastal erosion study Hoi An

A feasibility study on coastal erosion problems in Hoi An, Viet Nam. Finding a solution for the erosion problem the city of Hoi An is affected by in the recent decades.

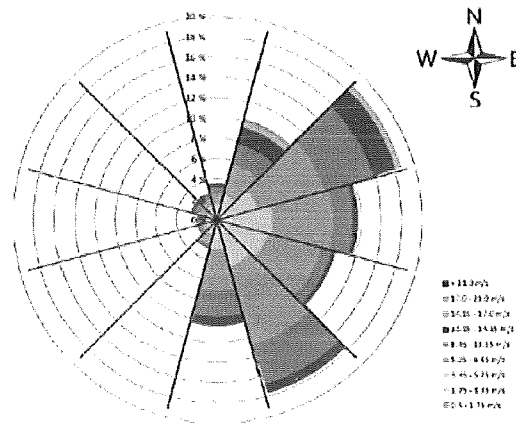
season. During the dry season the wind direction is mostly from the SE direction. A wind rose is also given in the Hyder report, the wind rose is shown in figure 2.6. The similar pattern for the wind- and wave conditions indicates that the waves are mainly caused by wind (sea-state waves), swell waves occur less.

FIGURE 2.6: Wind rose of the yearly average wind speed and direction

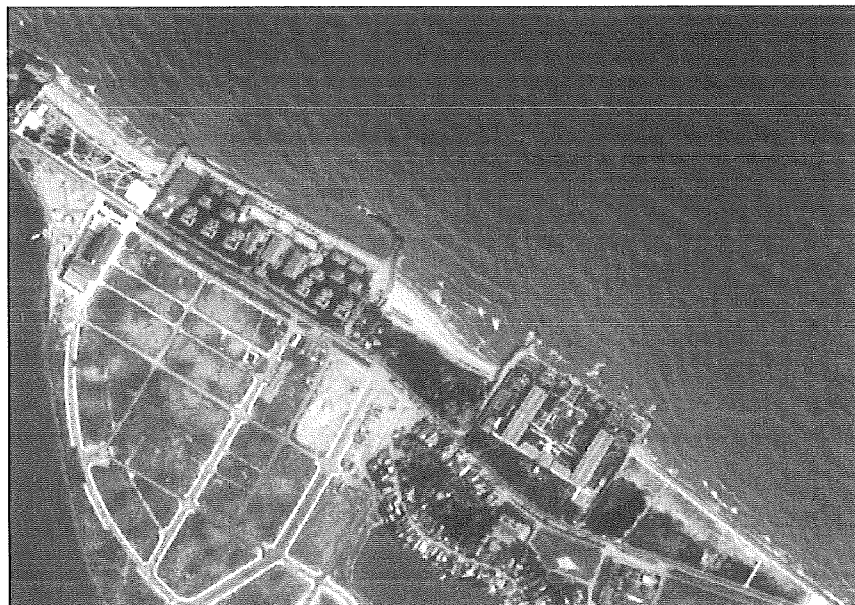
Especially at the north side of the mouth of the Thu Bon River, significant coastal erosion can be observed in the last decade(s). Several coastal protection works were executed in order to combat the erosion at the beach resorts. The coastal erosion has proceeded along the coastal sections without any protection (the sandy beach lies further landward than the protection works) and secondly, the protection works are damaged heavily at certain locations, which indicates that the erosion of the seabed in front of the coastal protection works has proceeded as well. These are clear signs of a significant sand deficit. From these observations it is also clear that coastal erosion is more severe on the north side than it is along the coastal stretch at the south side of the river mouth. This does however not guarantee that the severe coastline retreat that has been observed at the north side of the river mouth will not occur on the south side as well in due time.

FIGURE 2.7: Severe beach erosion has occurred at the north side of the river mouth

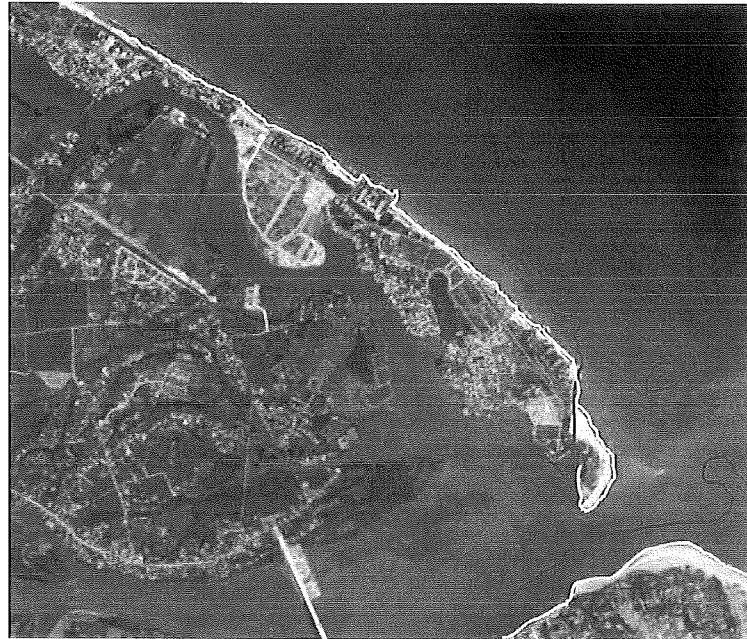
FIGURE 4.2: Coastline in 1995 (the red line) compared with the present situation (the white line)

The coastline at Cua Dai, close to the old city of Hoi An, shows structural retreat in the last 20 years. In 1995 the coastline stretched several hundreds of meters further into the sea compared to the current situation. The 1995 situation is indicated with the red line in figure 4.2. The current situation is indicated with the white line. An interesting development during the years is the movement of the river mouth. The width of the mouth hasn't changed much but the location has. The river mouth is now more southwards and more landwards. Figure 4.3 indicates the same line but now with the situation as it was in 1995. One can clearly see that there used to be a nice wide beach but there is not much left of it.

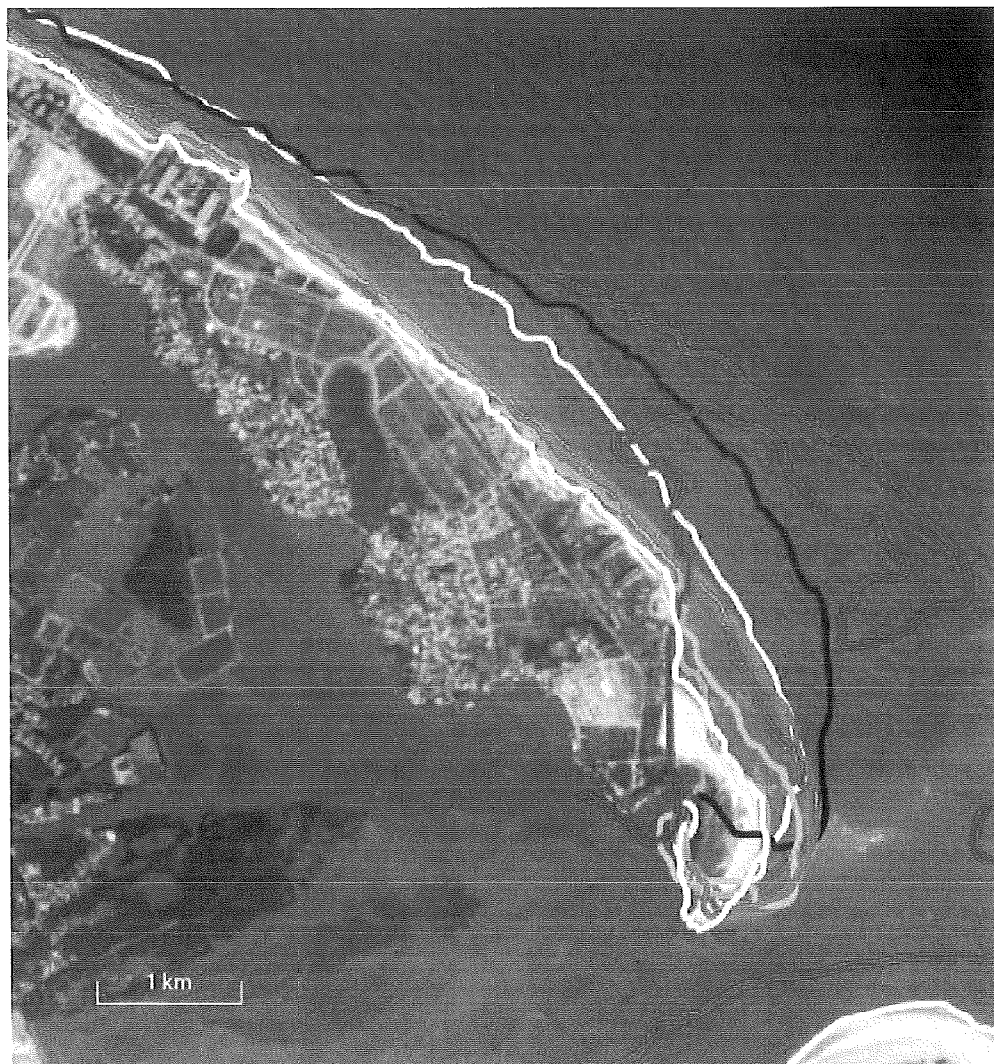
Figure 4.4 shows the development of the coastal retreat. The spit that is present in the 1995 line is already completely gone in the 2000 line. This is most likely due to the storm of 1999. This gigantic storm, combined with huge rainfalls caused a major flood in central Vietnam. The large discharge of the river and big waves spread the sediment in the spit over the rest of the coast creating a very wide beach. The yellow and the blue line show this nicely. However, in the period between 2000 and 2015 severe erosion occurred and the beaches almost completely flushed away. Most erosion took place in the area up until about 2 km north of the river mouth. A bit further north some accretion is visible between 2000 and 2004 but this was only temporary, after 2004 also the more northern parts suffered from erosion.

FIGURE 4.4: Coastline development between 1995 and 2015

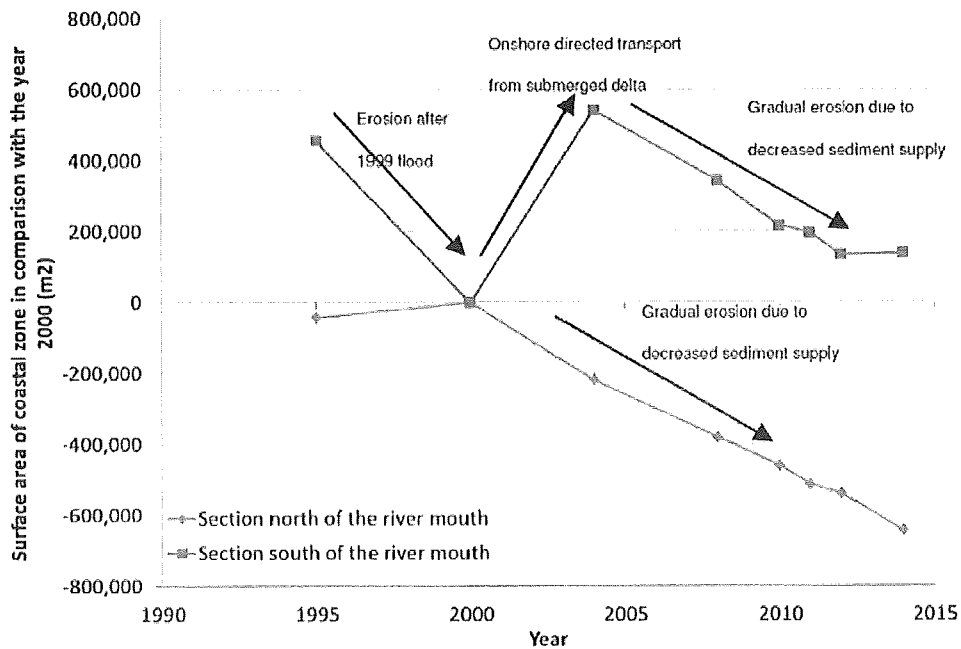
Prof.Dr. Stive states that the southern shore has an overall pattern of sedimentation due to the by-pass system. This is confirmed by calculations on the southern shore by Arcadis and Hyder [?]. The results of these calculations are shown in figure 4.9. The coastline as it was in 2000 was used as a reference line, the y-axis shows the increase or decrease of surface area. Notable is the sudden increase in surface on the southern side after 2000. This is probably caused by the 1999 flood that caused a huge sediment discharge in the river. Lots of this sediment settled on the tip of the southern shore after which natural processes flattened out the coastline again. The interesting part of this figure however is the 2010 to 2014 area. After 2010 the surface of the southern shore seems to remain more or less on its position while the northern shore surface keeps decreasing. Somehow about 100.000 m^3 of sediment seems to disappear within 4 years. Strikingly this is more or less the same as the reclaimed land area.

FIGURE 4.9: The development of the coastal areas north and south of the river mouth. Calculations done by Arcadis and Hyder [?]

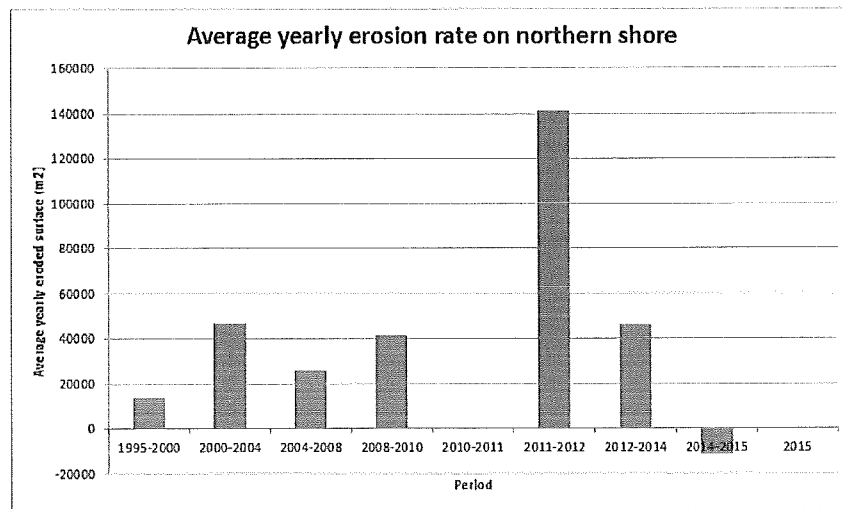
An interesting discovery is made when the gradient of the blue line in figure 4.10 is plotted. This gradient indicates the average yearly surface loss over a certain period. These values are indicated in figure 4.11. A sudden peak is present around 2011. This sudden peak can be explained when the northern shore area is observed better. One can see that there has been a large land reclamation which started in 2010 and was finished in 2012.

FIGURE 4.11: Average yearly erosion rates [m^2] at the norther coast.

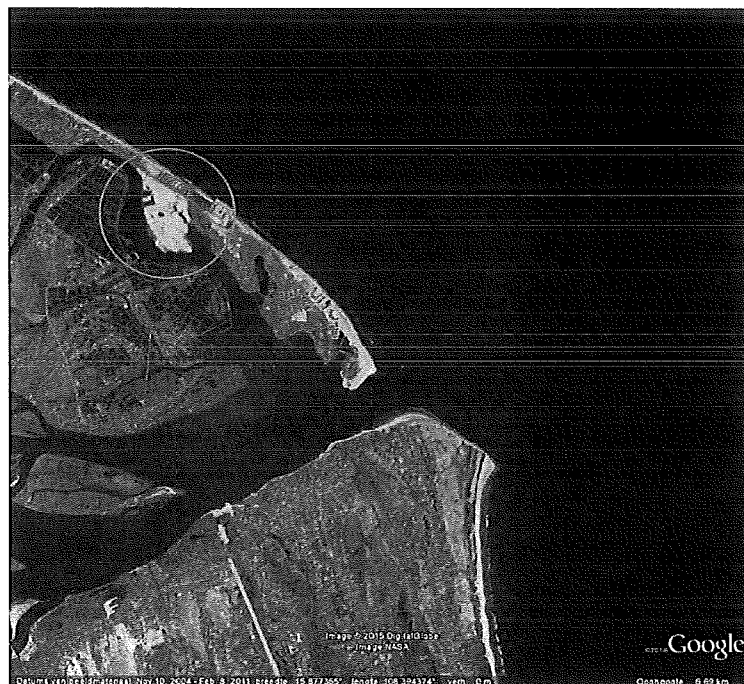
Satellite pictures of the coastal area show that severe land reclamation has taken place between 2010 and 2011. This is visible in figure 4.12 and 4.13. An area of about 35.000 m^2 worth of rice paddies and shrimp farms has been turned into land. The required sediment for this land reclamation is maybe taken from the Cua Dai beaches. In this case, this sped up the erosion process even more. The first signs of reclamation are visible in a picture of the situation in 2010. When a picture of 2011 is observed the total area has already been reclaimed.

FIGURE 4.13: The land reclamations is almost finished in 2011. The red circled area is the reclaimed area.

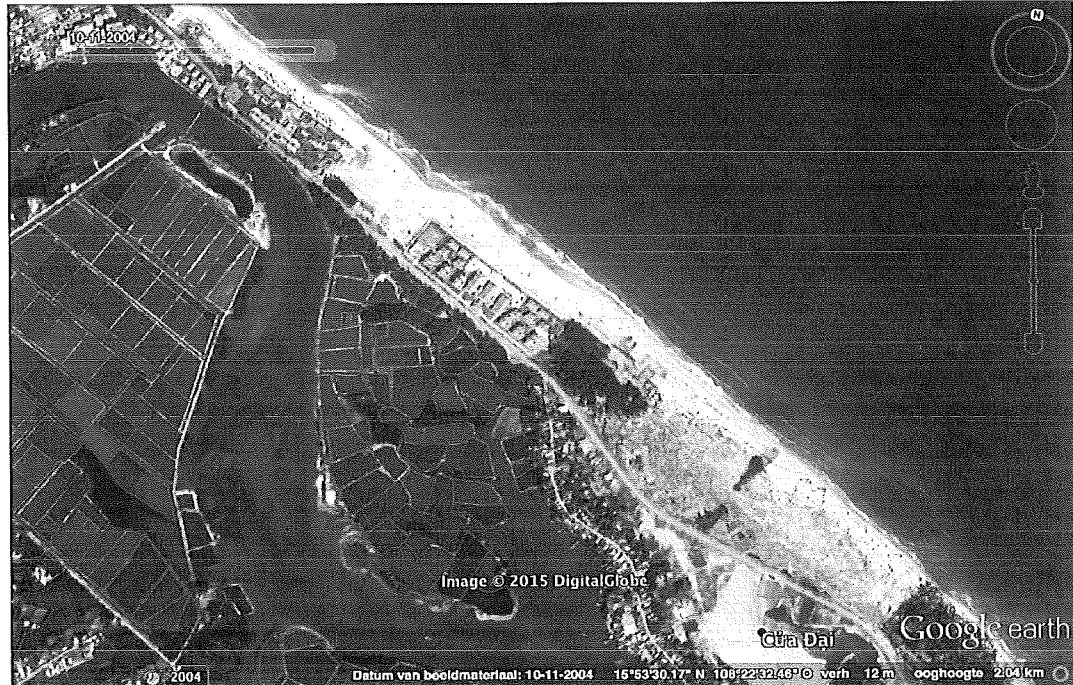
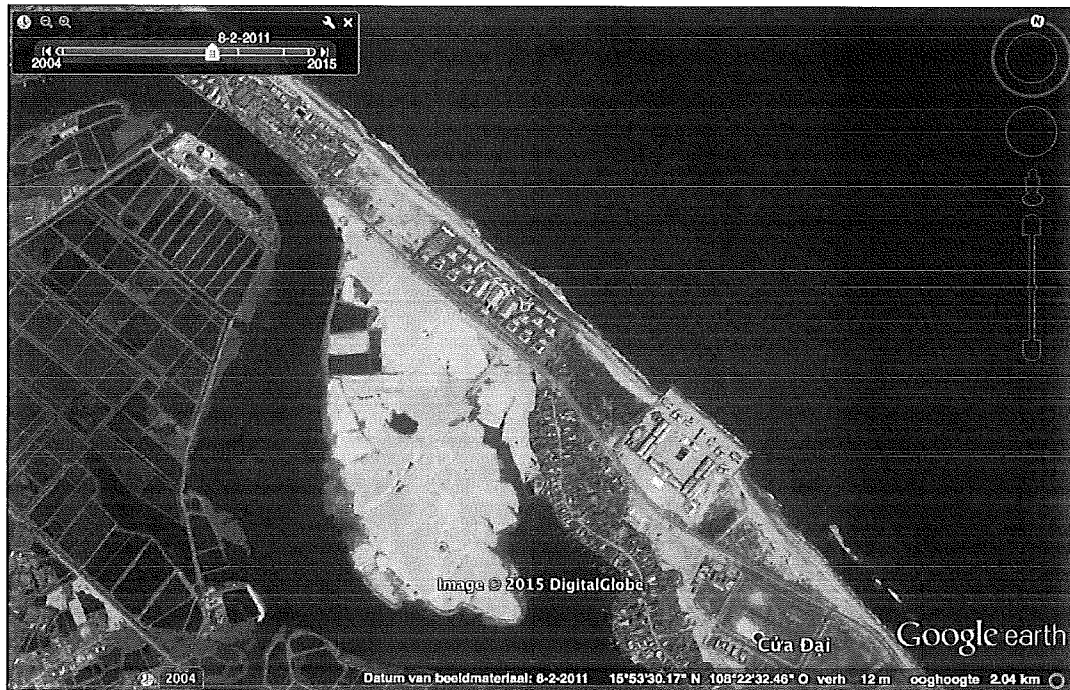
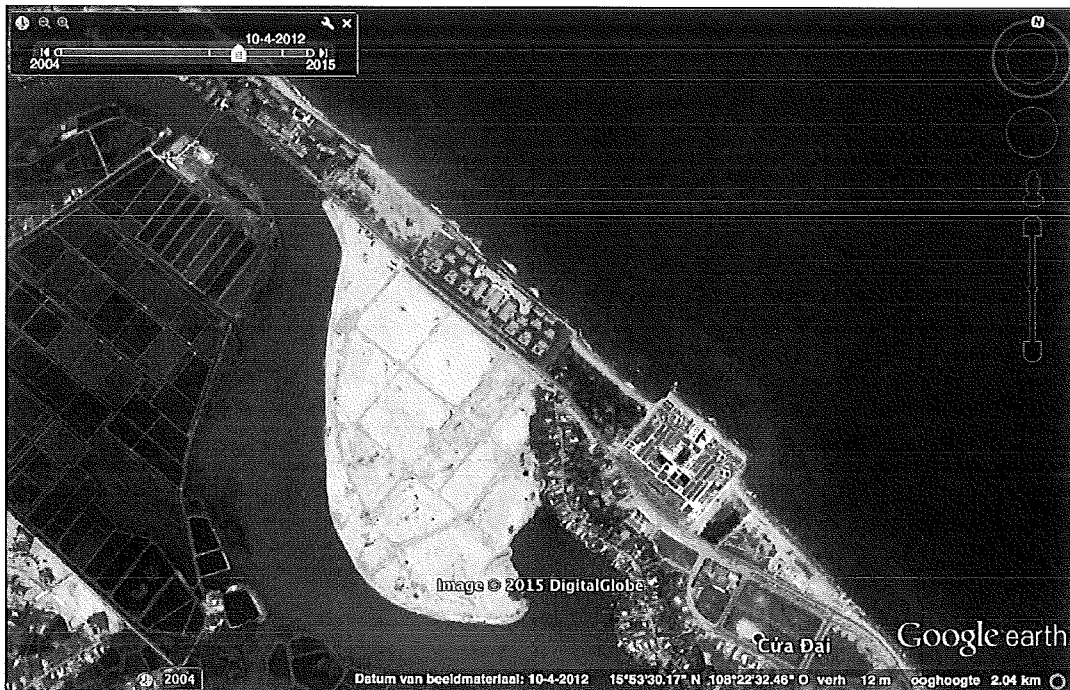
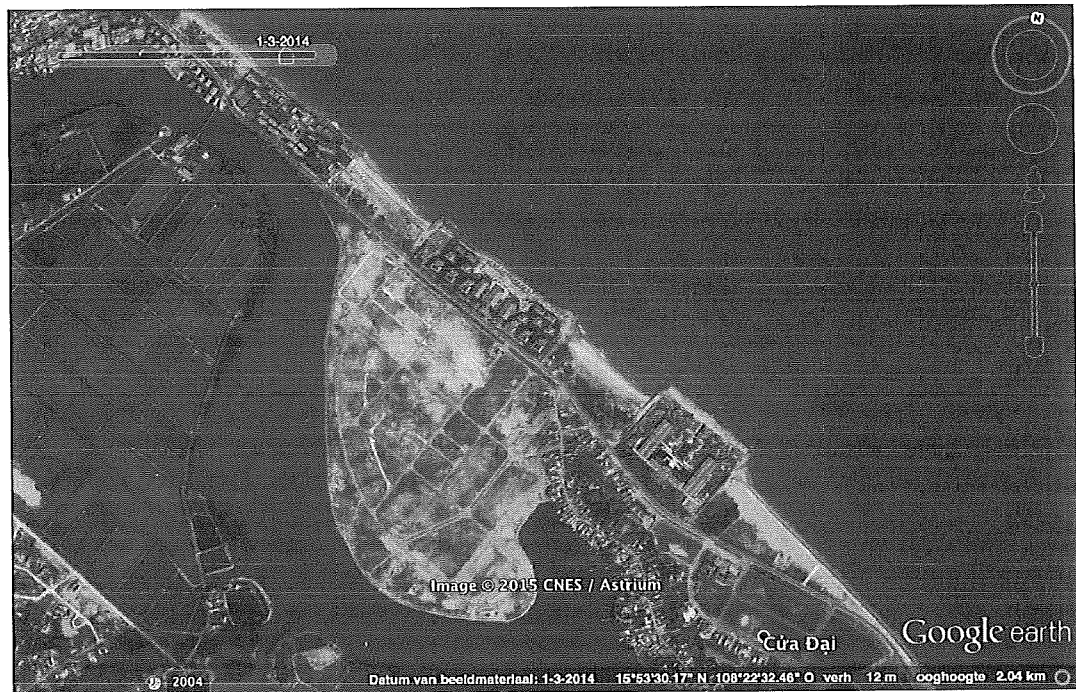
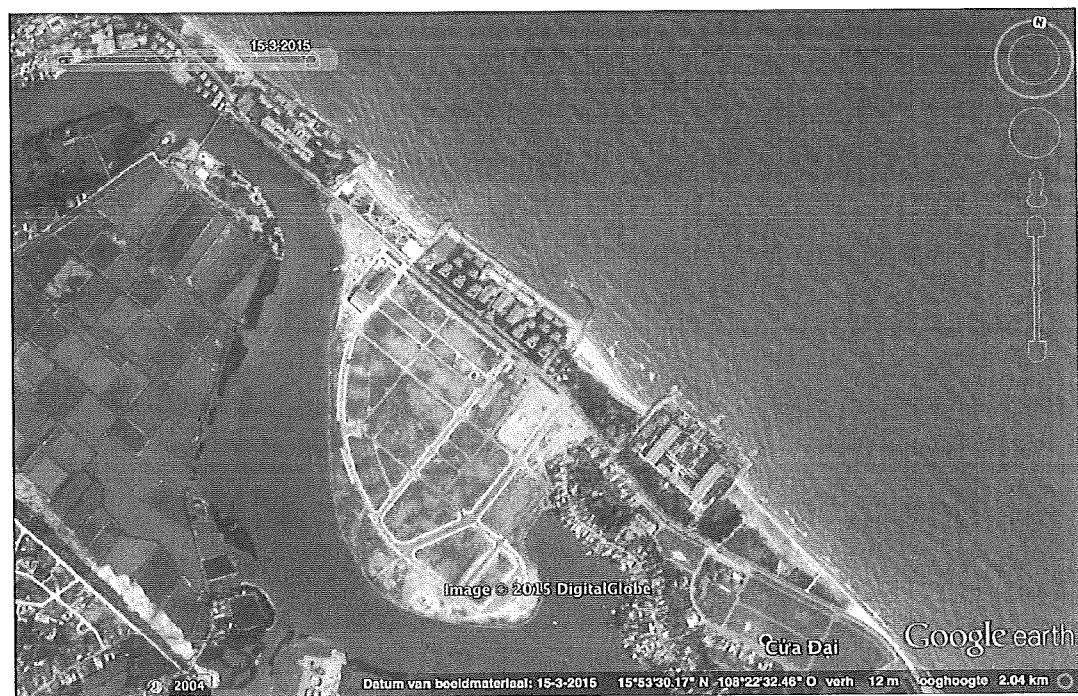
FIGURE A.10: A Hoi An beach resort, situation 10-11-2004

FIGURE A.11: A Hoi An beach resort, situation 8-4-2011

FIGURE A.12: A Hoi An beach resort, situation 10-4-2012

FIGURE A.13: A Hoi An beach resort, situation 1-3-2014

FIGURE A.14: A Hoi An beach resort, situation 15-3-2015

In pictures A.10 until A.14 it is clearly visible that the beach has eroded massively. About 100 to 120 meters of beach has flushed in just 11 years. At some spots the beach had retreated so far that the beach resorts are already located behind the waterline. Pictures A.15 until A.19 demonstrates that the coastline has already retreated to the road and starts to threaten this as well. This is clearly visible when putting the situation of 10-11-2004 and 15-3-2015 next to each other, as demonstrated in figure ???. Although the pictures look quite different, they are taken at exactly the same location. This indicates the huge amount of erosion that has taken place and also the enormous urban development in the past 11 years.
