Flood Fragility of a Cavity Wall

experimental results on the deformations of a
window-featured cavity wall due to hydrostatic flood actions
and failure of the window-wall interface

Report

Master of Science
in Hydraulic Engineering

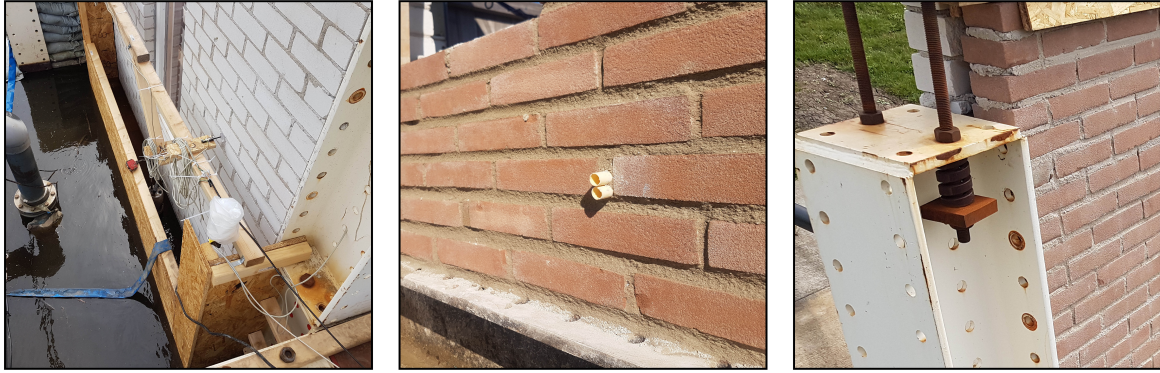
Figure 3.8: Left: The catchment box during testing. A small pump located inside the box is used to empty the box when needed. Centre: The small pipes used to mimic the weep holes. Right: location of the springs.

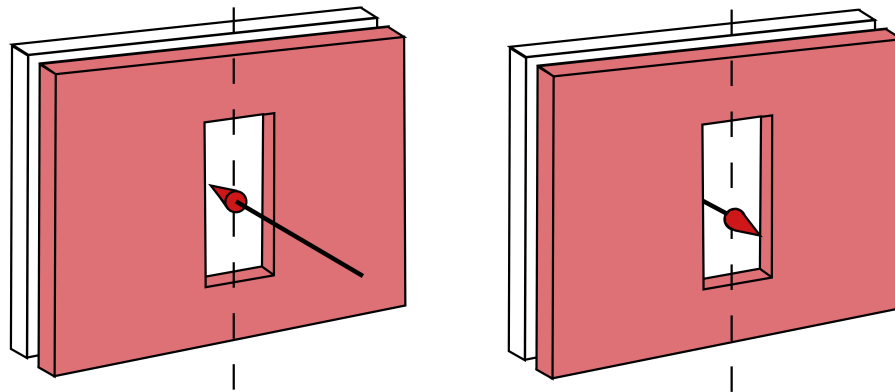
Figure 4.1: Left: illustration of inward movement of the wall. The sensors are pressed and measure positive deflections. Right: illustration of outward movement of the wall. The sensors are released and measure negative deflections.

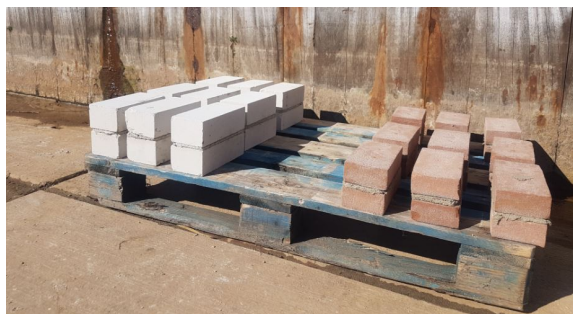
Figure 4.6: The couplets were left to harden next to the wall for the same duration.

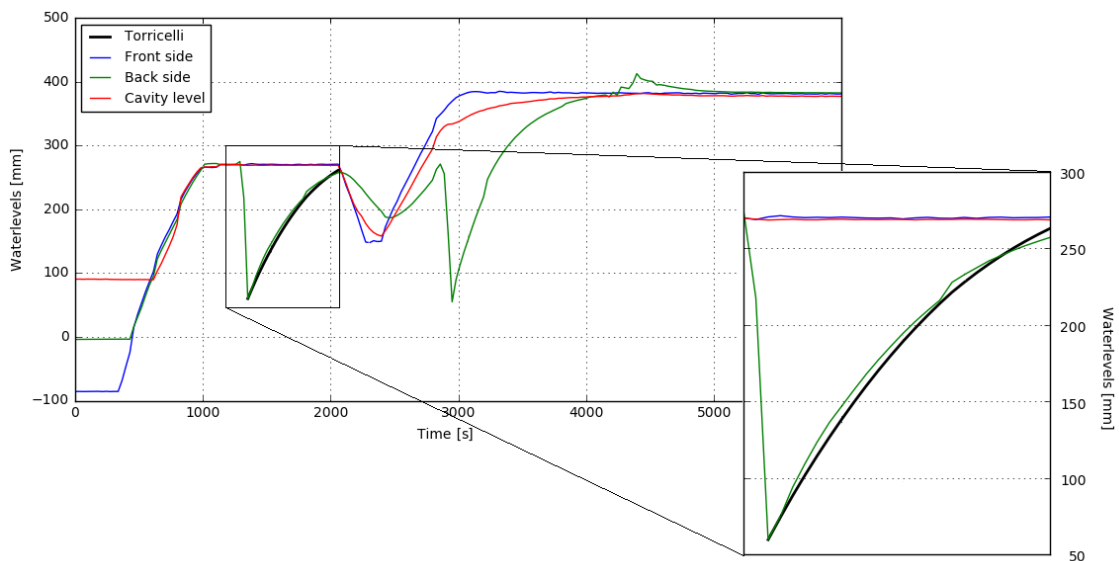
Figure 4.7: Graphical representation and detail of the observed water level and the water level described by the Torricelli theory.

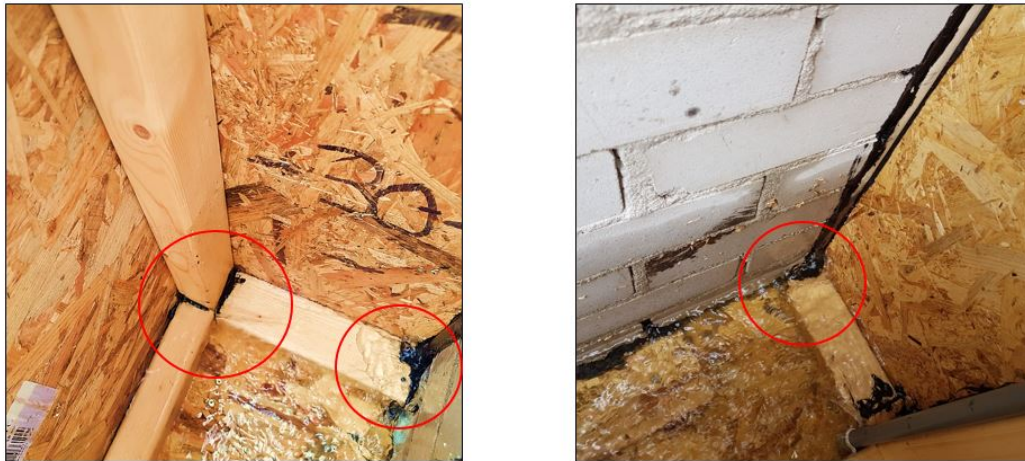
Figure 4.8: Photographs of the box leakages at the bottom of the box. In the corner three beams connect insufficiently; forming a pathway for the water to enter the box. At the locations where the box meets the steel rig also water was observed. It was tried to seal these points, but the water came through anyway.

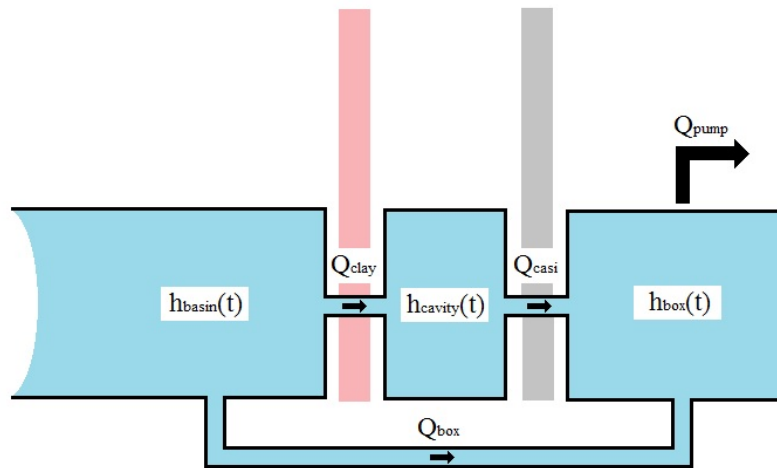
Figure 4.10: The hydraulic system that is used to obtain the discharges through the walls. The leakage pathways are presented as single canals while in fact there are multiple pathways. Note that inertia originating from the small pathways is neglected and that loss factors are not accounted for. The water level in the basin, although slightly changing, is assumed constant because of the large area.

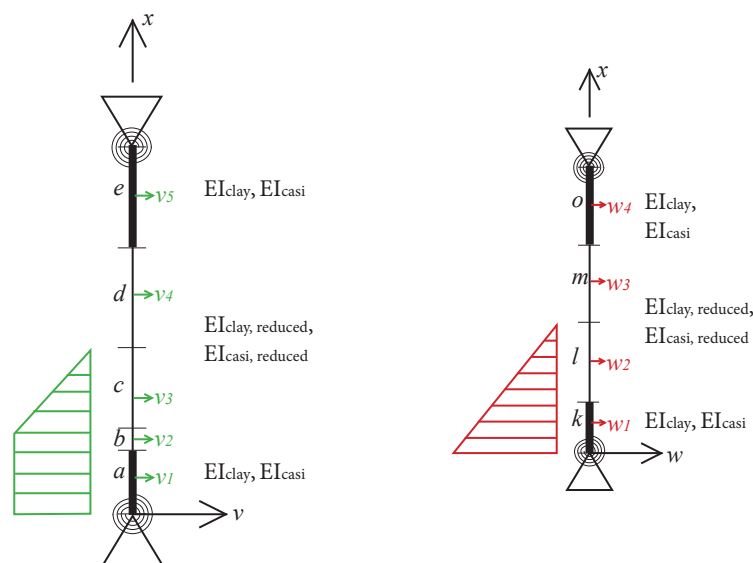
Figure 5.1: Left: analytical model for the cavity wall being subjected to pressures from both sides. The pressure inside the residence reduces the total forcing, which results in the trapezium-shaped pressure. Right: analytical model for the cavity wall subjected to hydrostatic pressure from outside only.

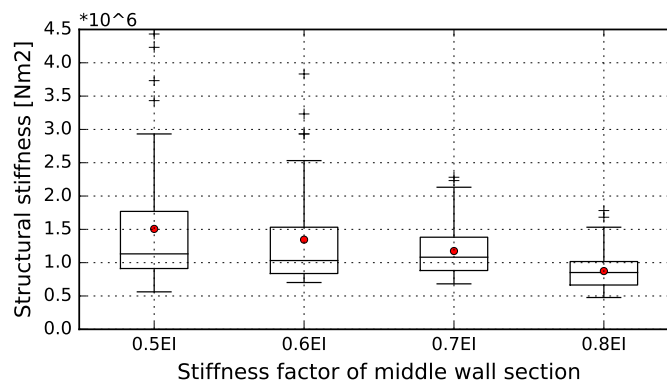
Figure 5.2: Boxplots of the overall stiffness required to describe the measured deformations compared to different $EI_{reduced}$ factors describing the middle section of the wall. For low $EI_{reduced}$ factors, the results become more trivial ranging significantly, while for high factors this trend reduces; resulting in a weaker wall.

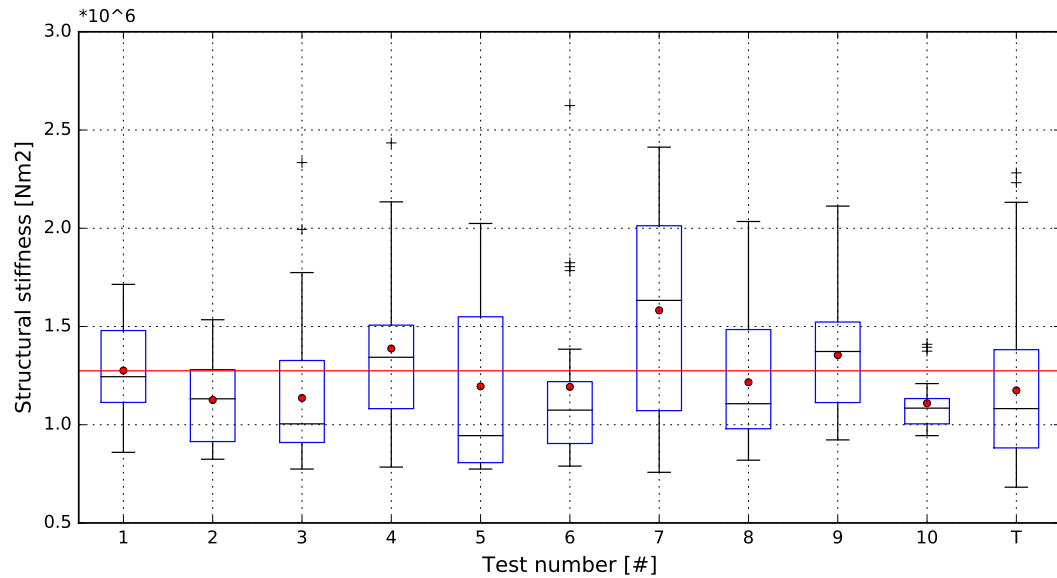
Figure 5.3: Boxplots of the found stiffness for different water level combinations per performed test. The boxplots are computed with data from the first three deflection sensors. The red dots mark the average value of the specific test, while the median (Q2) is indicated by the black line. The total average value is indicated by the red line. Test T indicates the boxplot for all tests combined and is identical to boxplot '0.7EI' in the previous figure. Note that outliers are defined with two times the standard deviation.

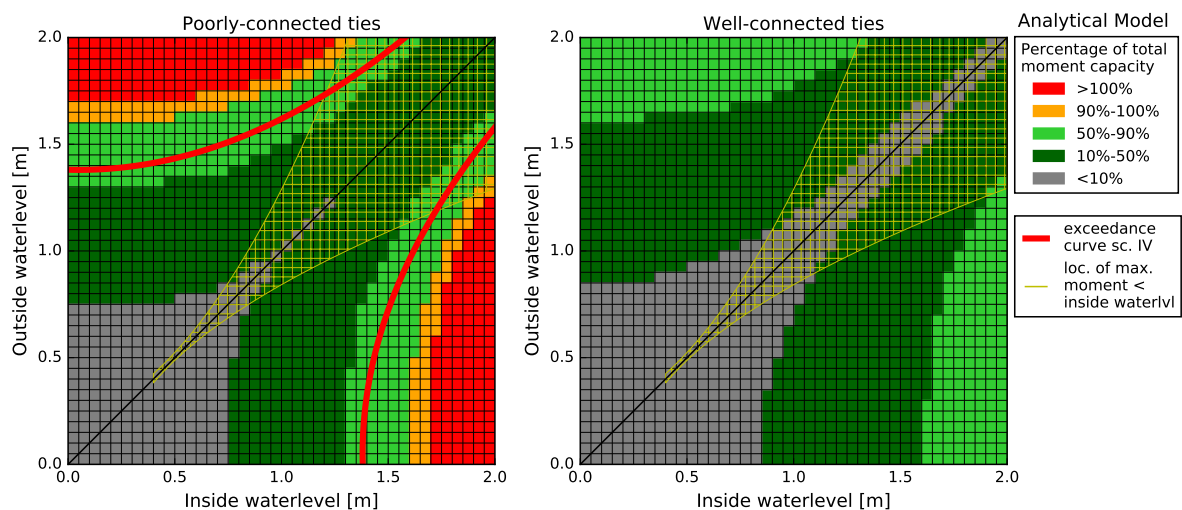
Figure 5.5: Analytically computed results on the occurring internal moments as a function of water levels at both sides of the wall. The Figure shows the results for the upper and lower boundary i.e. for poorly-connected wall ties (left) and well-connected wall ties (right). The maximum capacity is calculated by Equation 5.2 and is denoted as 100%. The colour gradient shows the occurring moments as percentage of the maximum allowable moment. For both plots, the imagery is mirrored in the $x=y$ line; assuming that the wall will behave identically in both ways. Additionally, the area in which the maximum moment is found below the inside water level is marked yellow for both plots.

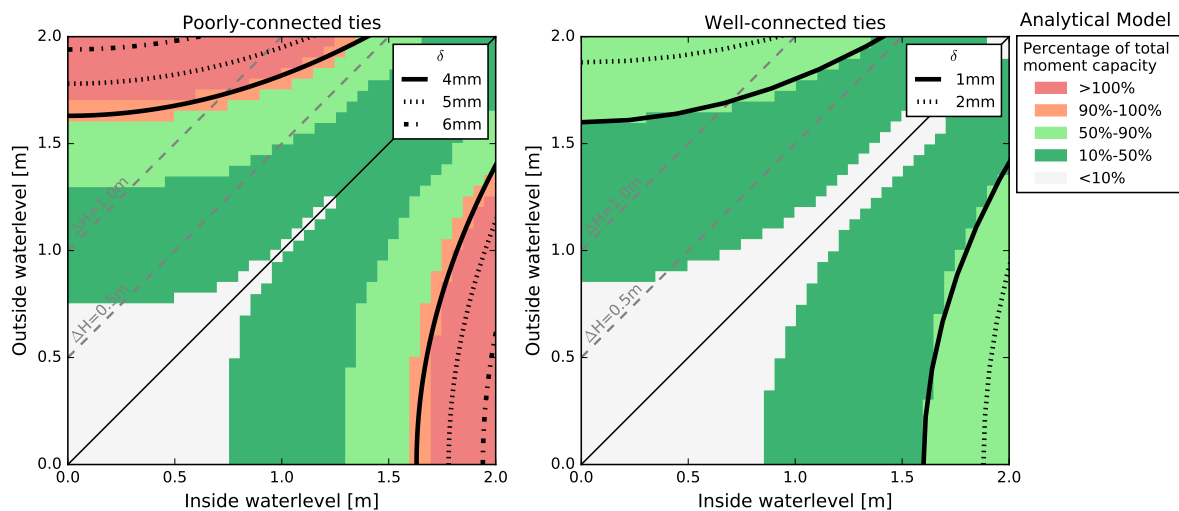
Figure 5.6: Analytically computed results on the occurring deformations as a function of water levels at both sides of the wall. Several exceedance lines for the deformations are projected on the previous obtained momentum behaviour as to have a comparison between both failure modes. Note that the results are again separated to account for the different wall tie-approach. Both plots show small deformations in the order of millimeters. In both plots (grey) diagonal lines indicate situations with equal head difference, see also Figure 5.16.

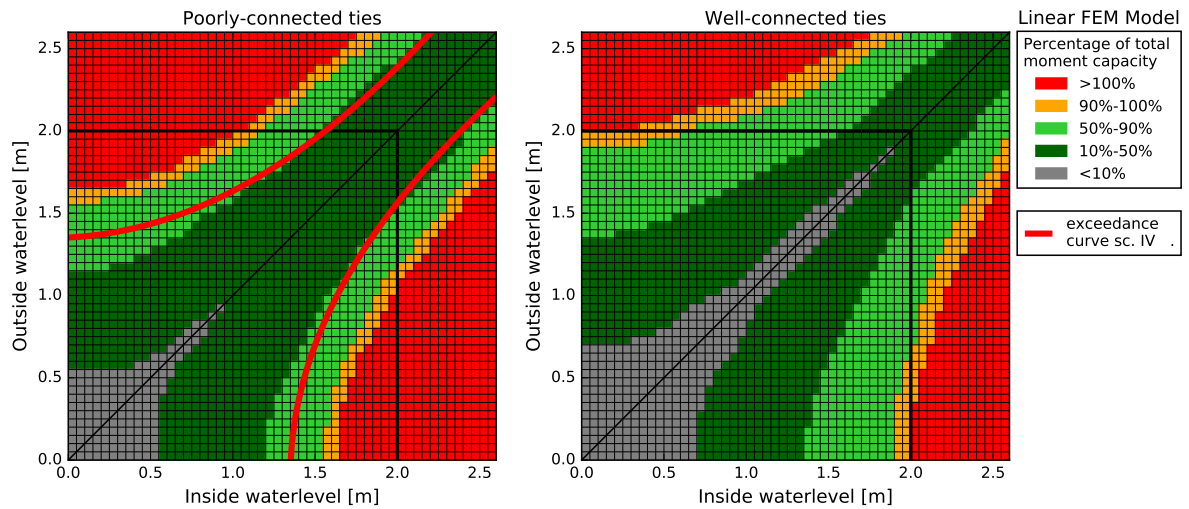
Figure 5.9: Computed results on the occurring internal moments using FEM. Left: contour plot of the behaviour of the resisting moment corresponding to poorly-connected wall ties. As with previous figures, the colours mark a certain percentage of the maximum calculated resisting moment (Eq. 5.2). Right: The contour plot corresponding to the second scenario. As to have an adequate comparison with the analytical model a square is added for both plots; marking the 2.0 m (horizontal and vertical) boundary of Figure 5.5 and Figure 5.6.

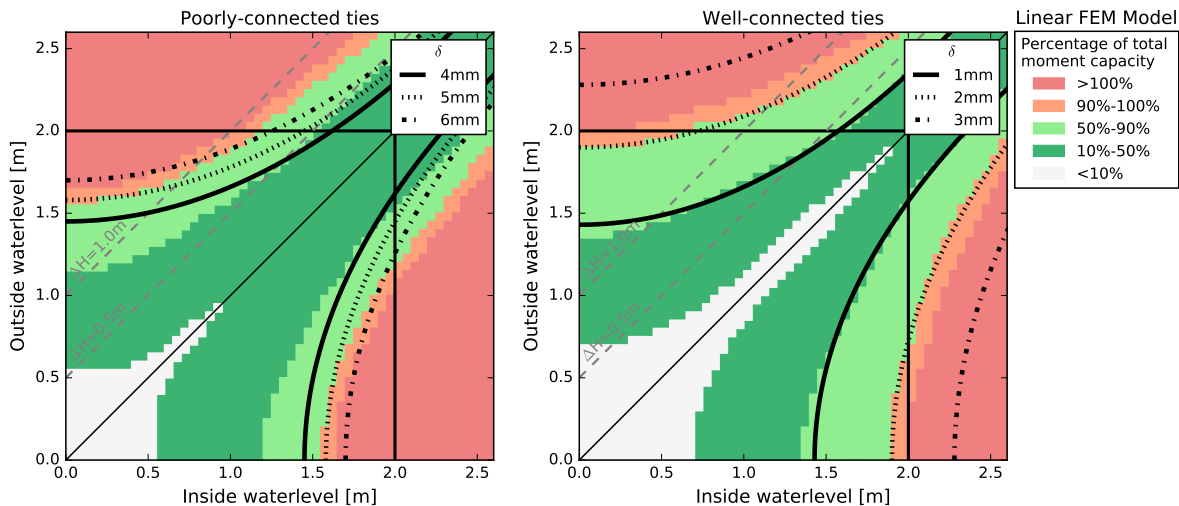
Figure 5.11: Computed results on the occurring deformations using FEM. Left: Deformations from the third scenario overlaying the earlier found momentum behaviour. Right: the deformations found by FEM for the second scenario. In both plots (grey) diagonal lines indicate situations with equal head difference, see also Figure 5.16.

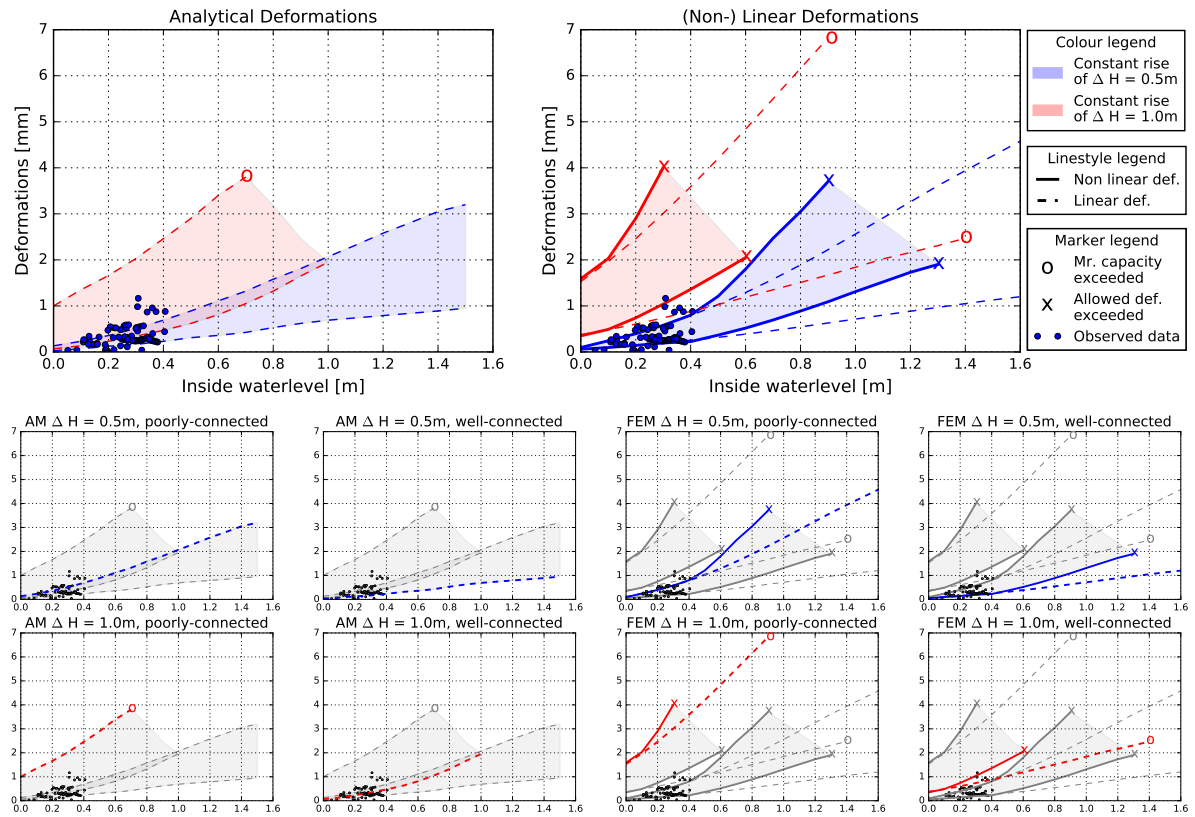
Figure 5.16: The computed deformations for both the analytical model and FEM. Left: Analytically computed upper and lower bounds regarding a constant head difference of $\Delta H=0.5\text{m}$ rising upwards along the wall (blue). In addition a similar configuration is computed regarding $\Delta H=1.0\text{m}$ (red). Right: the upper and lower bounds for $\Delta H=0.5\text{m}$ and $\Delta H=1.0\text{m}$ for the non-linear analysis. The linear FEM results are shown as dashed lines. The real observations are shown as dots. For a better overview, below the lines are shown individually depending on (I) the model, (II) the constant head difference, and (III) the behaviour of the wall ties. The single lines correspond to the diagonal slices shown in Figure 5.6 and Figure 5.11.

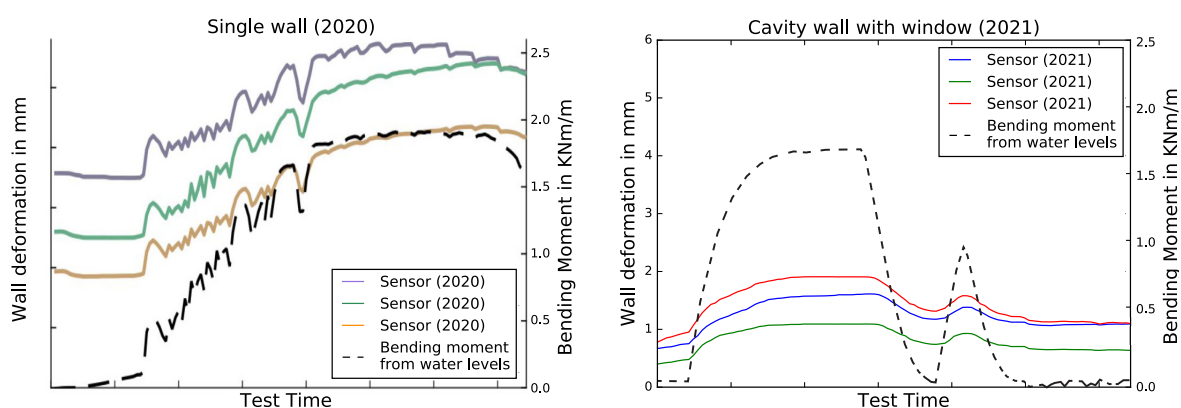
Figure 6.1: Comparison between the experiment of 2020 (left) and the current project of 2021 (right). Both (partial) results were obtained for similar conditions: 25kPa of overburden, no support from the sides, and similar bending moment values. (Left figure adapted from: Dutch Buildings Flood Fragility by Korswagen (2021)).

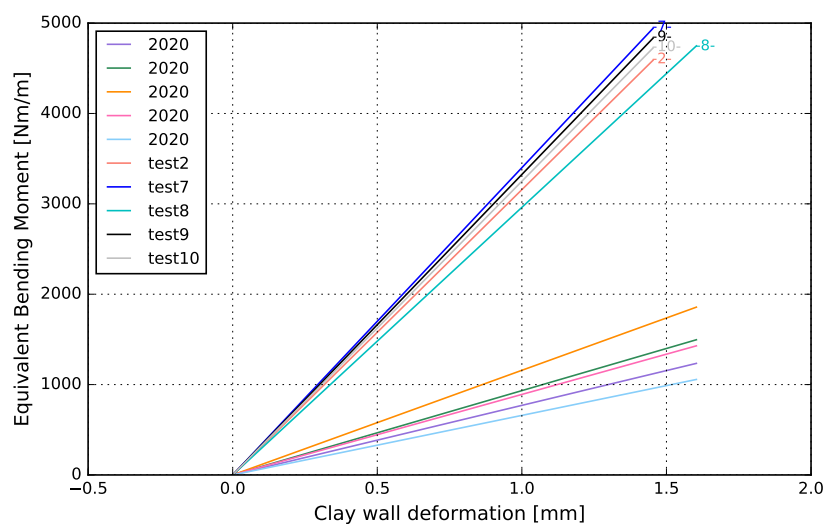
Figure 6.2: Comparison between the different slopes obtained from the force-displacement plots from both FPH experiments. (Data obtained and adapted from: Dutch Buildings Flood Fragility by Korswagen (2021)).

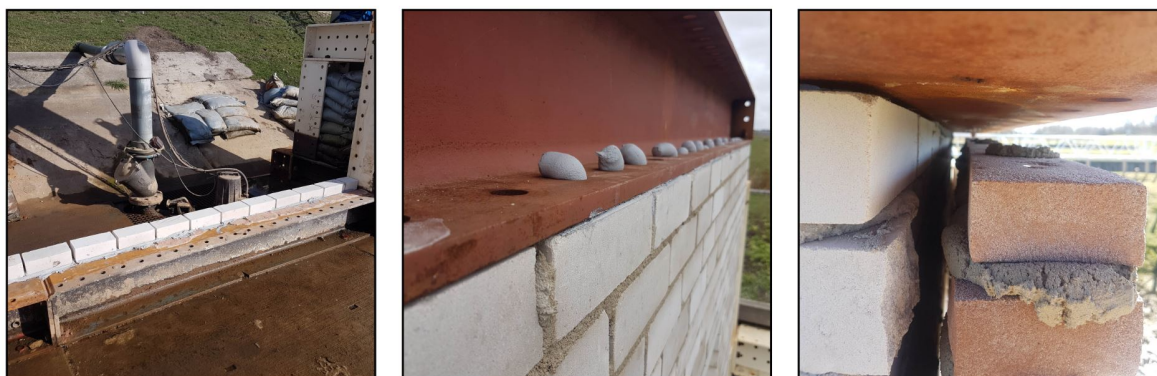
Figure C.4: Left: the first course of calcium silicate bricks. Centre: two-component epoxy glue at the top of the wall. Right: Existing gap between the steel beam and the clay wall.

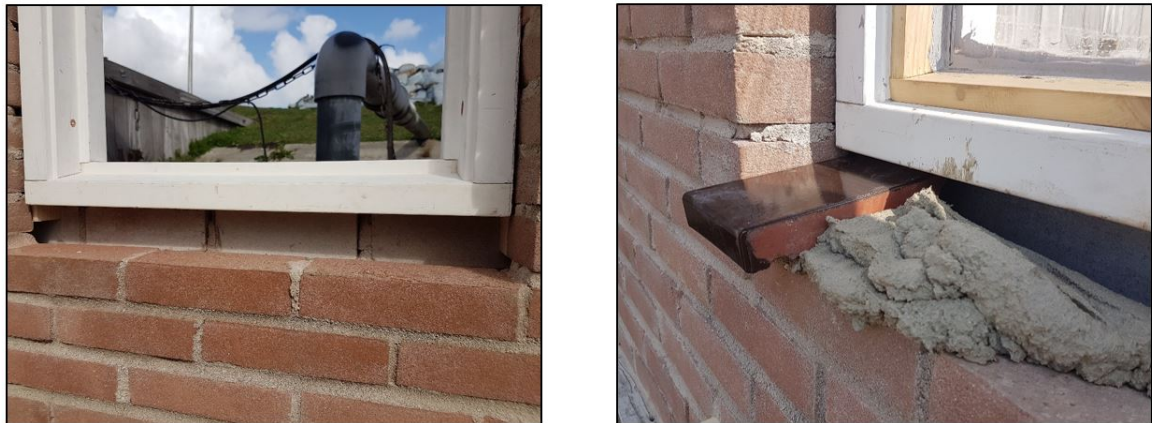
Figure C.7: Placement of the ceramic sills. Underneath the window profile a rebate is present in which the flange of the sill can be locked. Left picture: the situation before placement of the sills. Right picture: sill placement. Note also the small rebate in the sill itself, which is present to allow rainwater to drop in front of the wall instead of seeping over the wall.
