In-Plane Behaviour of Unreinforced Masonry Strengthened with a Structural Glass Window

A Proof of Concept

Article

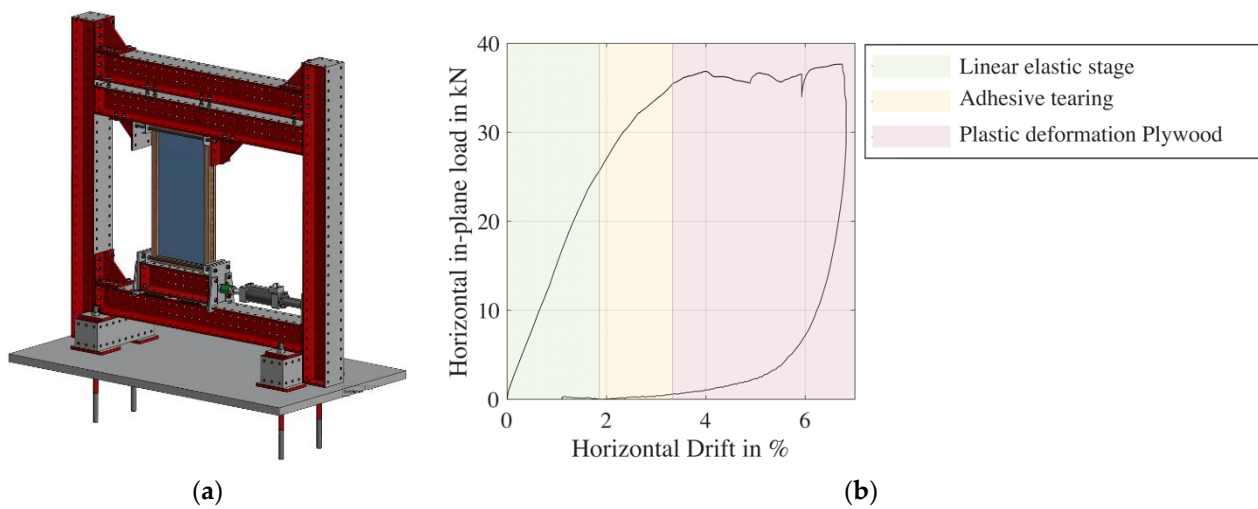
Figure 3. In-plane test on the standalone window: (a) test set-up, (b) obtained capacity curve.

To understand the behaviour of the window prototype and evaluate its capacity, a quasi-static in-plane test on the standalone prototype was performed (Figure 3a). During the test, the window was loaded in a double clamp configuration by imposing a displacement at its bottom right corner while its top part remained fixed. The resulting capacity curve

(Figure 3b), expressed as horizontal in-plane load vs. horizontal drift, showed elasto-plastic behaviour that can be divided into three subsequent phases as follows. In the first stage, the load was transferred through the adhesive without tearing, leading to a linear elastic behaviour of the window. The linear elastic stage is depicted in green and is followed by a second stage in which tearing of the adhesive occurs. Tearing of the adhesive started at a drift of 1.9% and concluded at 3.3% when direct contact between the glass panel and the wooden frame occurred after crushing of the adhesive. During the last phase, the glass panel rotated inside the wooden frame compressing and deforming the horizontal plywood elements. At the end of the test, these plywood elements showed residual plastic deformation with a glass penetration of around 10 mm.

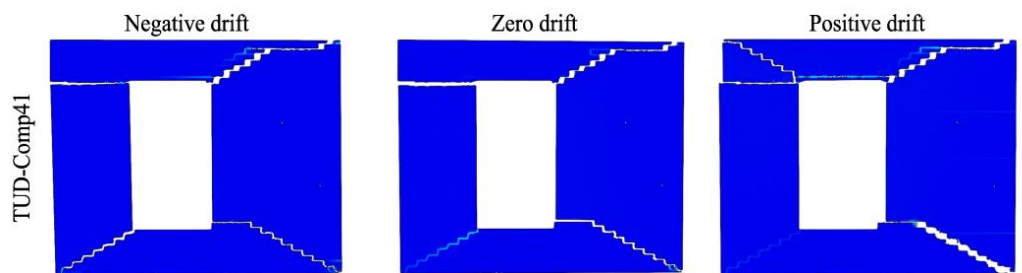
Figure 10. Failure mechanism of the unstrengthened wall (TUD-Comp41) resulting from the ULS protocol at a displacement of 40 mm (1.6/−1.5% drift).

Considering the unstrengthened case, a maximum base shear force of +22.1 kN (at 1.28 mm displacement, 0.05% drift) and −19.5 kN (at −7.0 mm displacement, 0.26% drift) was obtained, with an initial stiffness of 37.6 kN/mm, evaluated in the first repetition of the protocol at 40% of the maximum force (8.3 kN). The ultimate displacement, evaluated at a residual capacity of 80%, was 40 mm (1.6/−1.5% drift). No significant out-of-plane displacements were reached during the test as the maximum displacement was 8 mm (8% of the wall thickness). The onset of cracking occurred at the first repetition of the protocol with the horizontal crack at the bottom left side of the short pier (Crack 2 in Figure 8b) and at the top left corner of the window opening (Crack 7 in Figure 8b). The evolution of the crack pattern resulted mainly in diagonal cracks from the window corners, causing a rocking behavior of the piers and sliding of the masonry portion above the window opening and the larger pier with respect to the rest (Figure 10).
