Journal of Coastal and Riverine Flood Risk

# Rapid damage assessment caused by the flooding event 2021 in Limburg, Netherlands

## Abstract

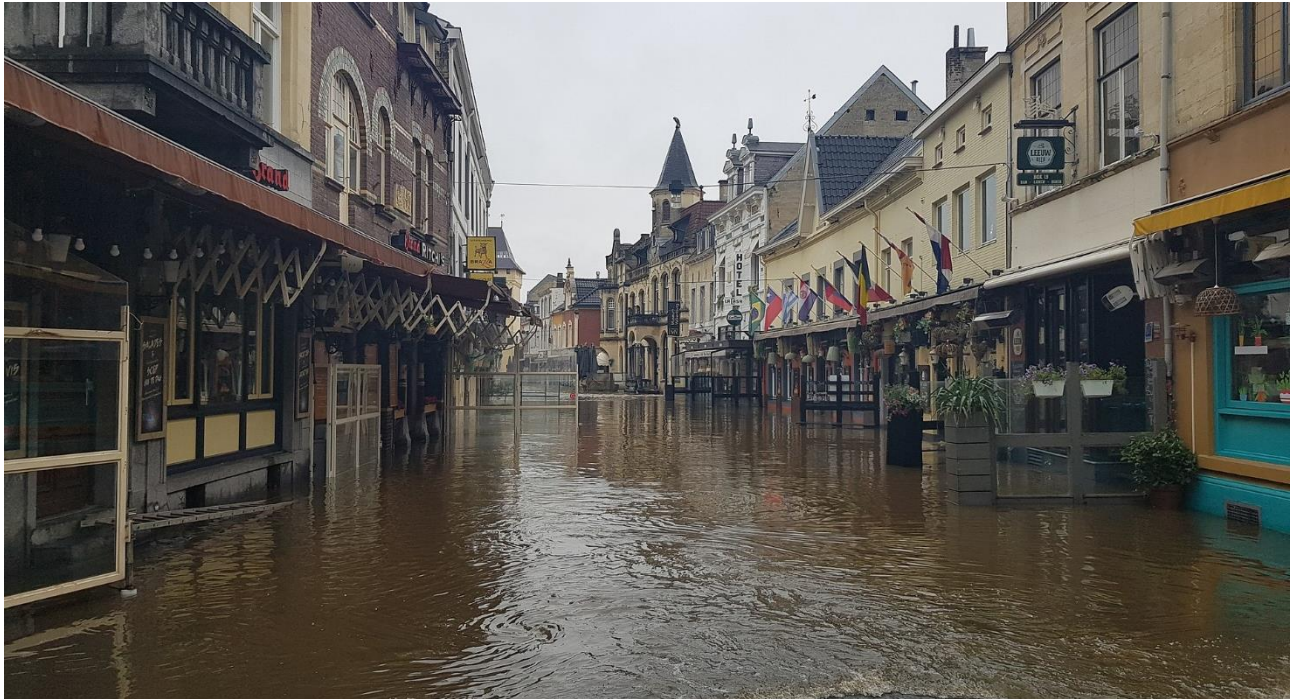
Figure 3: Impression of damage in the city of Valkenburg (source Wikimedia).
