Field performance monitoring of pervious concrete pavements

Road Materials and Pavement Design

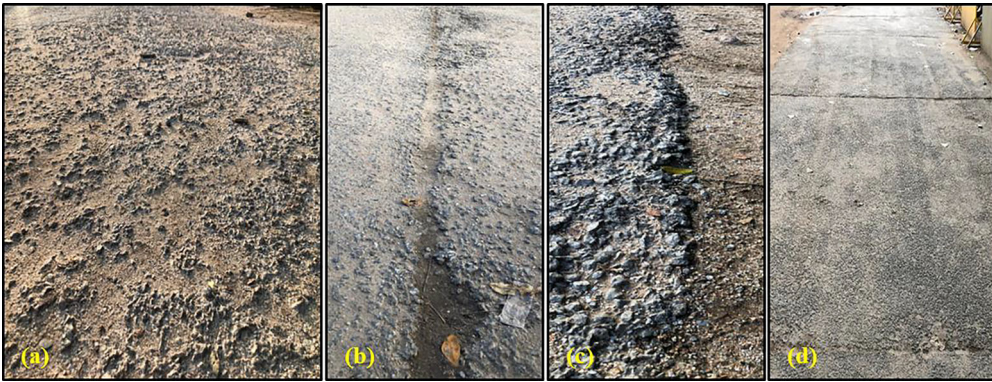
- i. *Ravelling*: was encountered across 25% of the total PCP area. Most of the pavement slabs performed satisfactorily, and there were no major signs of ravelling except for the presence of a few loose aggregate particles. However, severe ravelling was observed in three PCP slabs (Figure 3a) on which garbage dump trucks as well as construction and excavation vehicles were parked. This indicated that the aggregates in PCP slabs were either crushed or dislodged from the surface due to heavy static loads and slow moving / stopping operations of the municipal utility vehicles on

Figure 3. Structural defects: (a) severely ravelled pervious concrete pavement slab, (b) joint deterioration, (c) edge cracking and (d) skid marks.

- ii. *Joint deterioration*: was one of the major distresses that was encountered between the joints of more than 75% the slabs with high levels of severity, as shown in Figure 3b. Note that joint deterioration was prevalent after one year of construction. Essentially, the joints were filled with loose material (such as soil and other suspended matter) that might have accumulated during seepage of stormwater into PCP system.
- iii. *Edge cracking*: was not a significant distress and was observed only across those slabs (Figure 3c) that allowed vehicles to move from PCP surface to the adjacent areas.
- iv. *Skid marks*: were generally caused due to sudden braking action of vehicles over low density areas. Although skid marks may serve as the cause for initiation of raveling, the test sections did not show any signs of ravelled aggregates, as seen in Figure 3d.

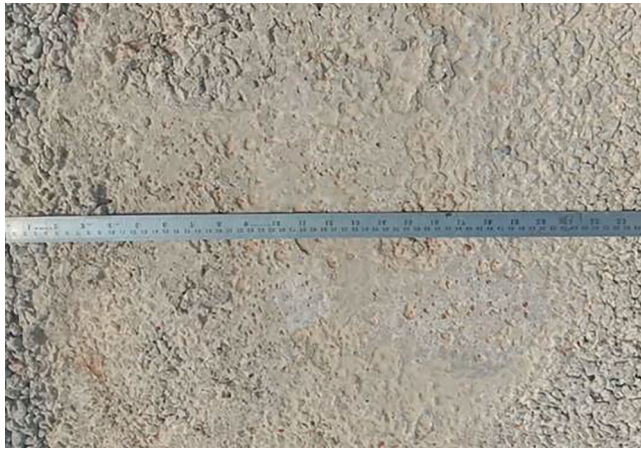
Figure 4. Severely sealed surface of pervious concrete pavement slab.

Surface sealing was another functional distress observed in PCP, and Figure 4 depicts a severely sealed PCP surface. Surface sealing was caused due to: (a) improper mix design, (b) addition of water during placement to allow free flow of stiffened PC from RMC trucks, (c) excessive spraying of water to prevent moisture loss from PC prior to compaction, and (d) over compaction. Figure 5 presents the schematic and locations of the PCP slabs that were subjected to different levels of sealing.

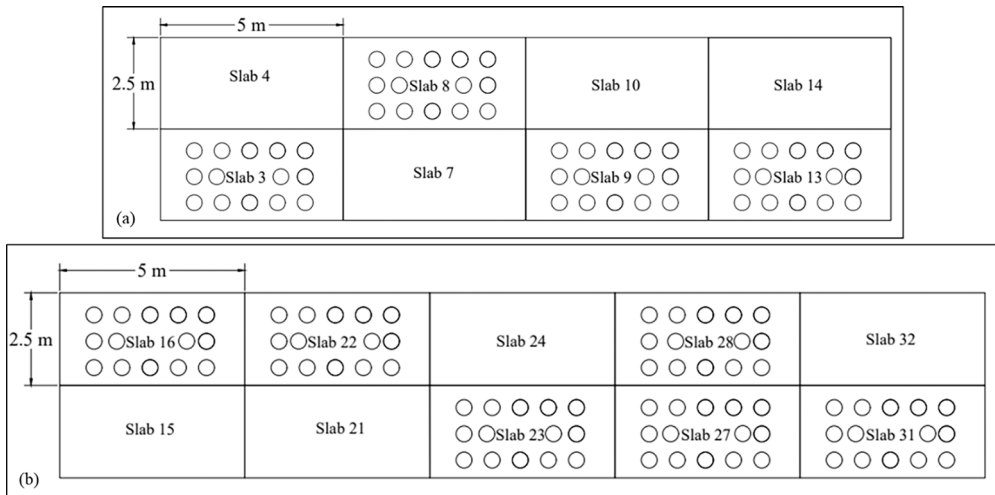
Figure 6. Schematic of the ravelled pervious concrete pavement slabs.

- i. *Ravelling*: The schematic of slabs subjected to ravelling are presented in Figure 6. Ravelling was attributed to: (a) improper compaction at the time of construction resulting in low-density mixtures, (b) heavy loading at premature age and (c) sudden stopping of vehicles.
