Effect of self healing and continuous hydration on the mechanical properties of cyclically loaded early age concrete

A case study of early age cyclic loading on a concrete bridge deck

Masters Graduation Thesis

for the partial fulfilment of the
Master of Science in Civil Engineering and Geo-Sciences
at Delft University of Technology

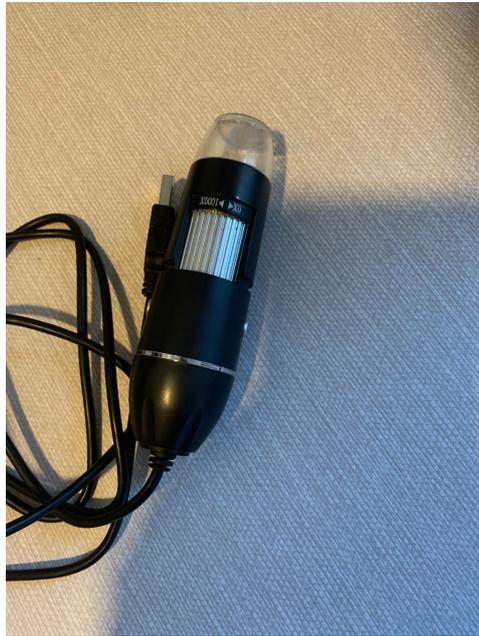
Figure 4.5: Portable microscope for the analysing of micro cracks

due to the cyclic loading. The microscope would be used to analyse the crackwidths caused due to cyclic loading and visualisation of any self healing products formed due to continuous hydration in concrete. For the visual inspection and measurement of the crackwidths, a crack width measuring card with the range of 0.05 mm till 3mm has been used for the study.

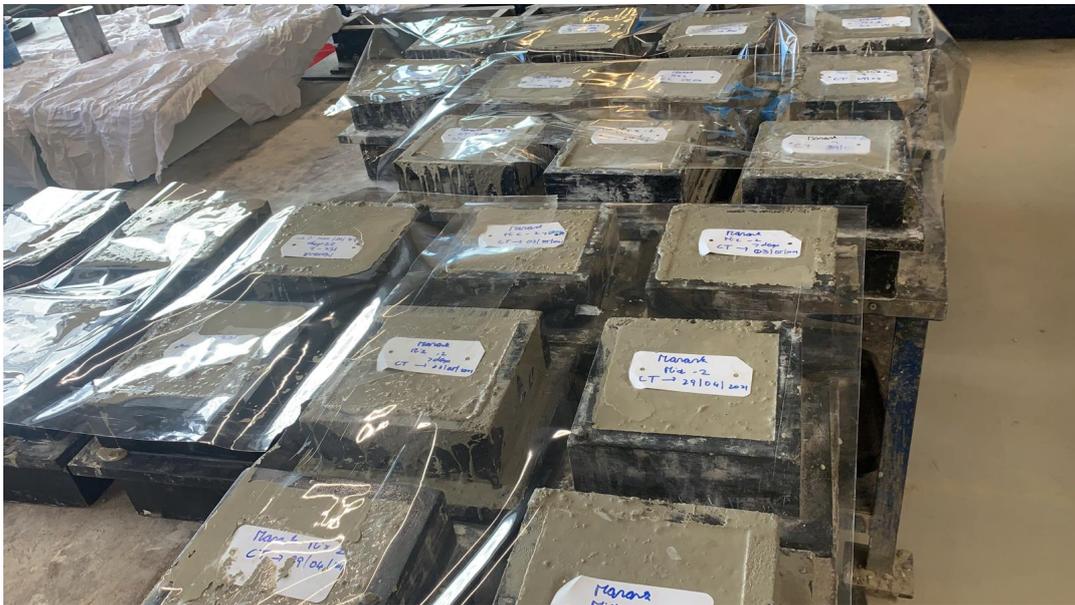
Figure 5.2: Finished casted concrete cubes

Compressive strength of 3 cubes were analysed at the age of 3rd day. Compressive strength of the cubes was respectively: 32.43MPa, 31.25MPa, 31.77 MPa with the average strength of 31.81 MPa at the age of 3 days. The slump of the concrete achieved was 72 mm. After the casting of concrete cubes, the cubes were covered with the plastic sheets to avoid any cracking due to shrinkage. After 24 hours, the finished cubes shall be transferred to the fog curing room. This phenomenon can be seen in the figure 5.2.

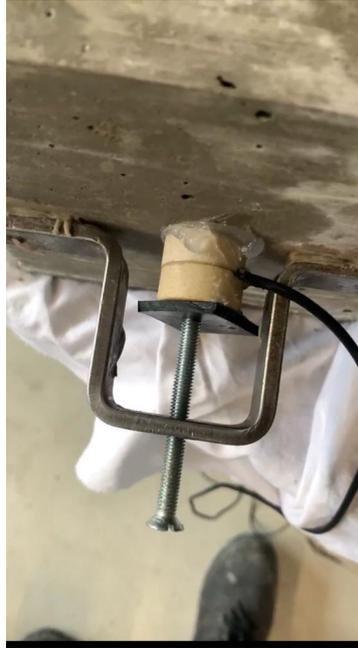
Figure 5.28: Attached sensors through the holders to the concrete cube

In order to predict the moment or load cycle which causes change in the structural medium in terms of occurrence of micro cracking inside the concrete cubes, CODA wave interferometry analysis is used. The sensors are attached through the holders to the concrete surface and the waves are recorded. This can be visualised from the figure 5.28. As mentioned before, 2 readings have been recorded, one at the start of the cycle and one at the end of the cycle. After each load cycle, the real time CC value has been computed by stretching and comparing the signal from previous load cycle.

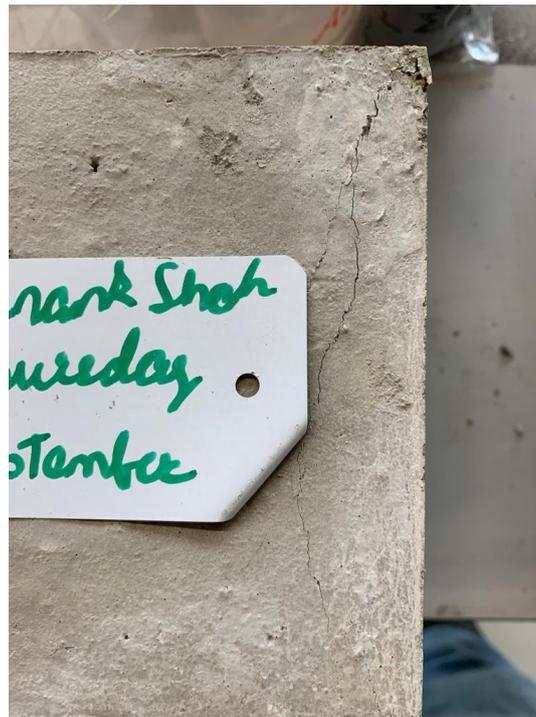
Figure 5.56: Cracking caused due to 70% loading

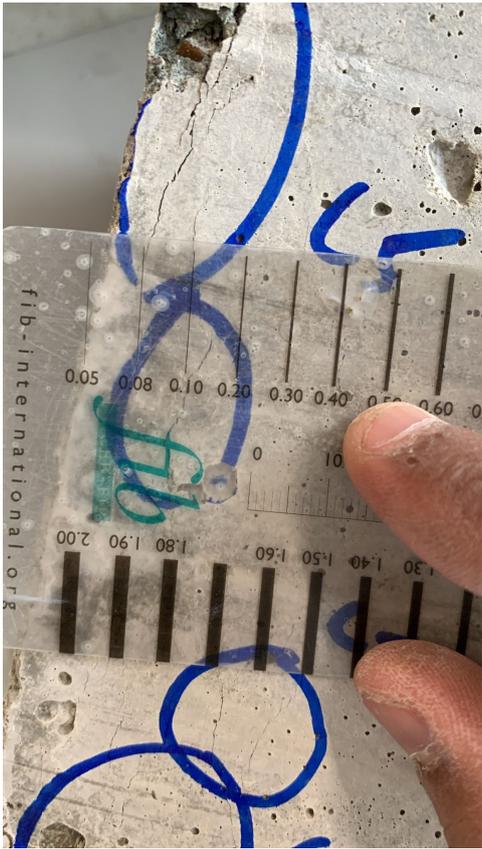
Figure 5.61: Crack-width analysis (before hydration) Zone 5

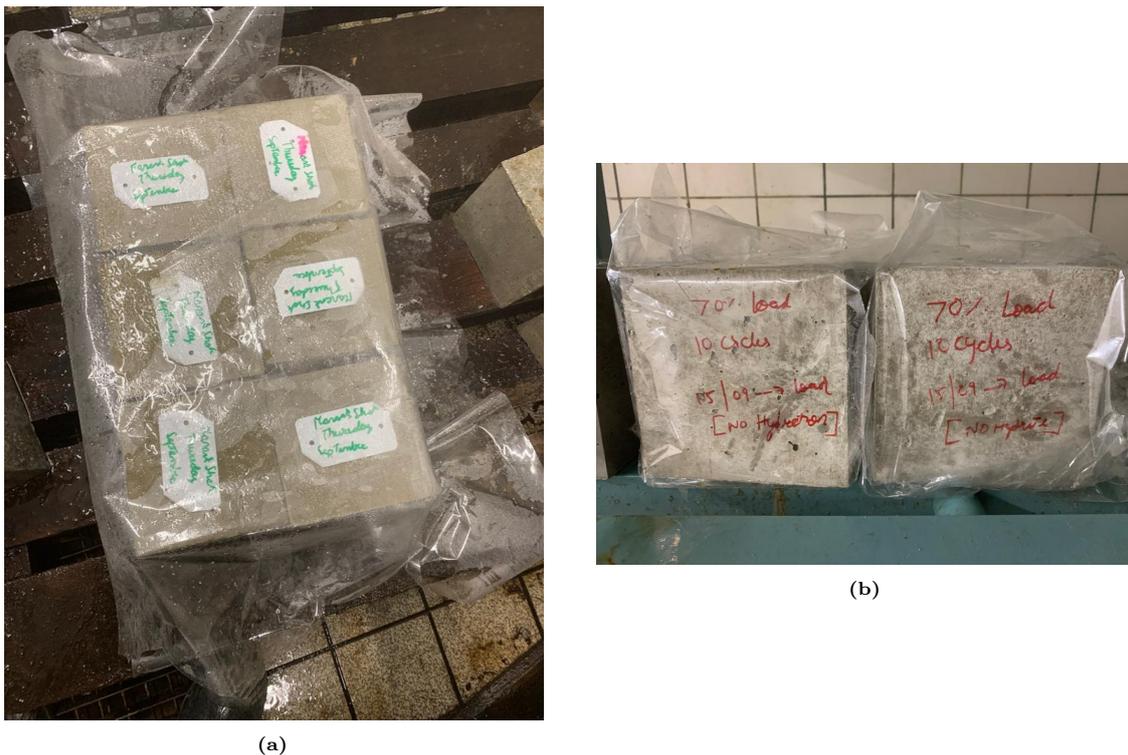
Figure 5.68: Effect of hydration on strength development of concrete (a) Unloaded samples (b) Loaded samples
