**Femoral prosthesis neck fracture following total hip arthroplasty  
a systematic review**

# Femoral prosthesis neck fracture following total hip arthroplasty — a systematic review

**Keywords:** Total hip arthroplasty, Fatigue fracture, Trunnionosis, Corrosion

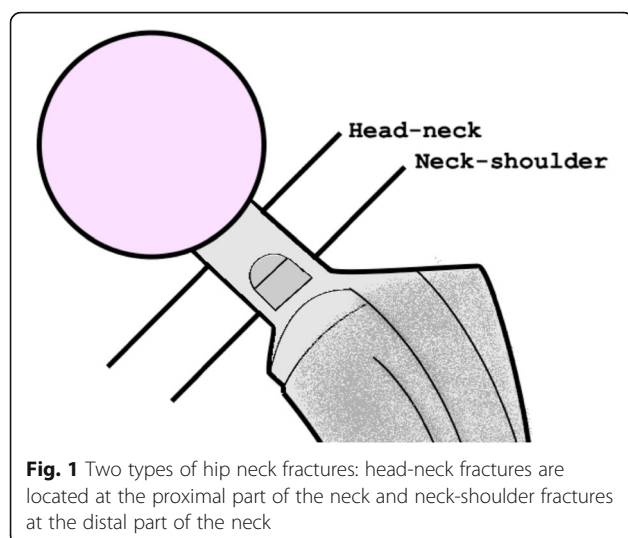
Hip neck fatigue fractures can be divided into head-neck fractures and neck-shoulder fractures (Fig. 1). Head-neck fractures are located at the proximal part of the neck while neck-shoulder fractures at the distal part of the neck. A head-neck fracture is an example of gross trunnion failure and is possibly caused by a cascade starting with fretting at the head-neck coupling leading to damage of the metal by corrosion [6]. The loss of material could lead to a fatigue fracture of the neck. In contrast, a neck-shoulder fracture is not related to the modular connection.
