DAMAGE STATES OF STRUCTURAL SILICONE GLAZED FACADES

S. Bianchi¹, V. Hayez², G. Lori³, M. Overend¹, G. Manara³

Abstract: *Unitized curtain walls play an integral role in contemporary architectural designs, offering advantages such as lightweight construction, high quality control and ease of installation. However, recent post-earthquake surveys have revealed their vulnerability to damage, raising concerns about potential hazards in post-earthquake scenarios. Even slight-to-moderate damage can lead to loss of functionality and economic losses, arising from breaches in the air/water tightness of the building envelope and costly repairs/replacement. Furthermore, as the damage progresses from moderate to severe, it poses a life-threatening risk to occupants and pedestrians due to falling glass or debris from the damaged façade. Among the different types of unitized curtain walls, structural silicone glazing emerges as a resilient assembly system with the potential to enhance the seismic performance of the façade. Nevertheless, despite initial studies on the seismic behaviour of the silicone bonding sealant, research in this field remains limited. Typically, experimental investigations

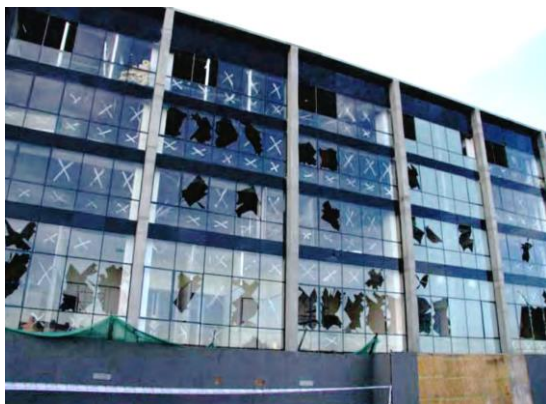
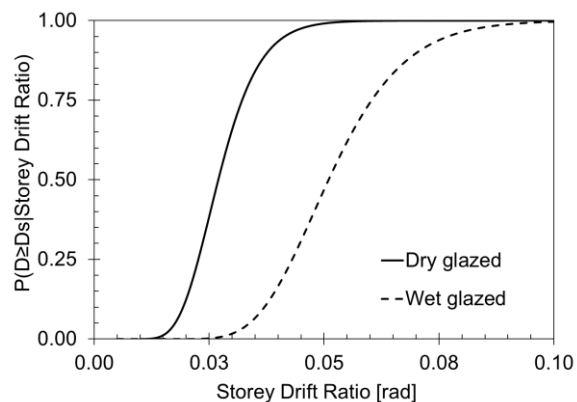
Figure 1. (a) Glazing damage observed after Chile 2010 earthquake (Miranda *et al.* 2010); (b) Fragility curves for glass cracking of a dry vs. wet glazed system (data elaborated from Memari *et al.* 2011).

In this context Structural Sealant Glazing (SSG) systems are typically considered to outperform other glazing systems acknowledged. This is supported by fragility data collected and analysed from experimental testing. For example, Figure 1b illustrates a comparison in terms of the probability of glass fracture between dry-glazed (with rubber gaskets and mechanical restraints) and wet-glazed systems (employing structural silicone). This data demonstrates the SSG solution is able to withstand higher seismic demand before achieving the same damage condition. Current building codes therefore provide guidelines for properly sizing structural silicone joints, being the design crucial for enhancing structural performance. If the glass curtain wall lacks specially designed connections to isolate it from the building frame and accommodate relative motion, the seismic racking motion of the building frame will place substantial demands on the integrity of the sealant that secures the glass to the curtain wall framing (Zarghamee *et al.* 1996).

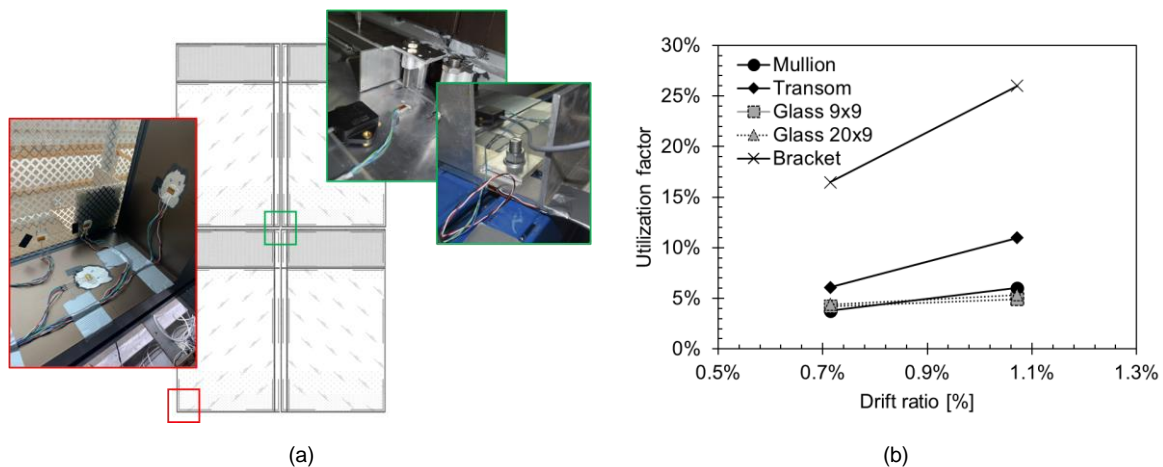
Figure 5. (a) Location of strain gauges in the specimen. (b) Utilization factor of the different façade components at the two intensity levels.

In addition to recording facade movements in terms of displacements and rotations, acceleration values were also measured at the center of the glass panels for both the 20x9 and 27x9 units, as well as at the bracket connections. Focusing on the earthquake records, it was observed a maximum amplification factor in the range of 1.2-1.3 for both units due the components' inherent resilience and flexibility of the frame system. The amplification factor was calculated by comparing the recorded glass acceleration with the acceleration at the bracket connected to the seismic beam. Furthermore, strain values were recorded in the different façade components to quantify utilization factors, representing the ratio of actual stress applied to the maximum stress the component can safely withstand. This test configuration included strain gauges in the following locations (Figure 5a): (i) bottom glass panels (U3 20x9, U4 9x9), positioned near the setting blocks where higher stresses are expected due to the panel's rotational behavior; (ii) frame system, in a corner on both the bottom transom and the vertical mullion; (iii) one of the brackets connected to the seismic beam. A filter was applied to the recorded strain data to eliminate noise outside the response range. Utilization factors were calculated assuming maximum strength values of 40MPa, 160MPa, and 355MPa for the glass, aluminum frame and steel brackets, respectively. The results indicated that both the glass and frame had utilization factors of less than 10% when investigating Levels 1 and 2 for this configuration, with the transom experiencing higher stress levels. In contrast, the bracket achieved a maximum utilization factor of 26% (Figure 5b), further affirming that its design is sensitive to the peak seismic force/acceleration values.
