## The 2021 flood event in the Dutch Meuse and tributaries from a hydraulic and morphological perspective

Strijker, Bart; Asselman, Nathalie; de Jong, Jurjen; Barneveld, Hermjan

Journal of Coastal and Riverine Flood Risk

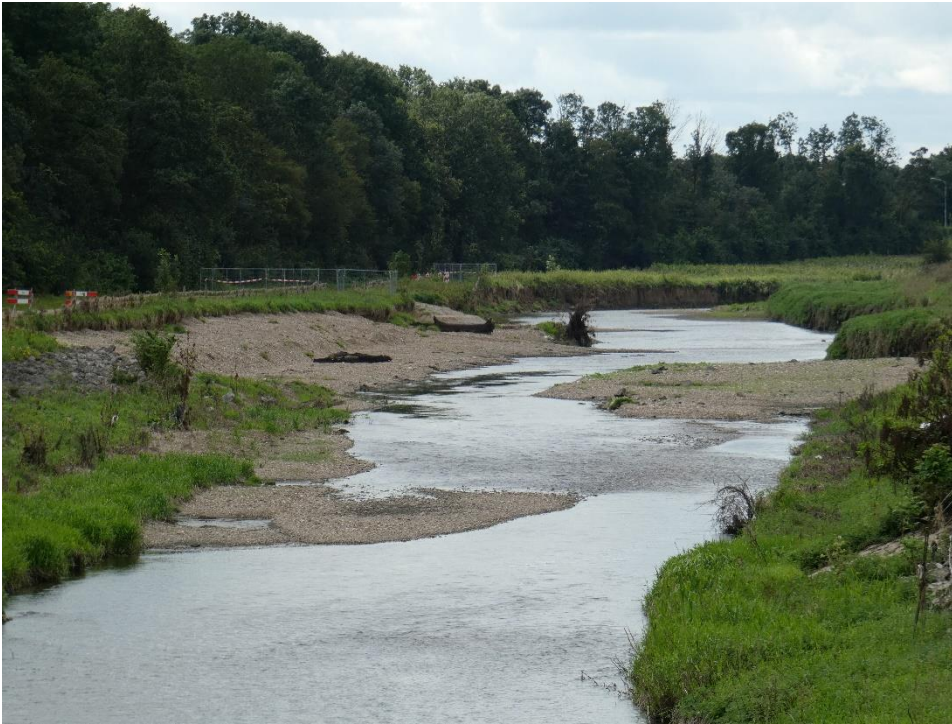
Figure 16: Morphological changes in the Old Meuse showing bank erosion and bar development. Photo looking in upstream direction.

Some major morphological changes were noted in the Old Meuse just downstream from the culvert under the Juliana Canal which conveys the water of the Geleenbeek towards the Old Meuse, see Figure 16.
