## The Restorations of the Rietveld Schröder House a reflection

# THE RESTORATIONS OF THE RIETVELD SCHRÖDERHUIS

A REFLECTION

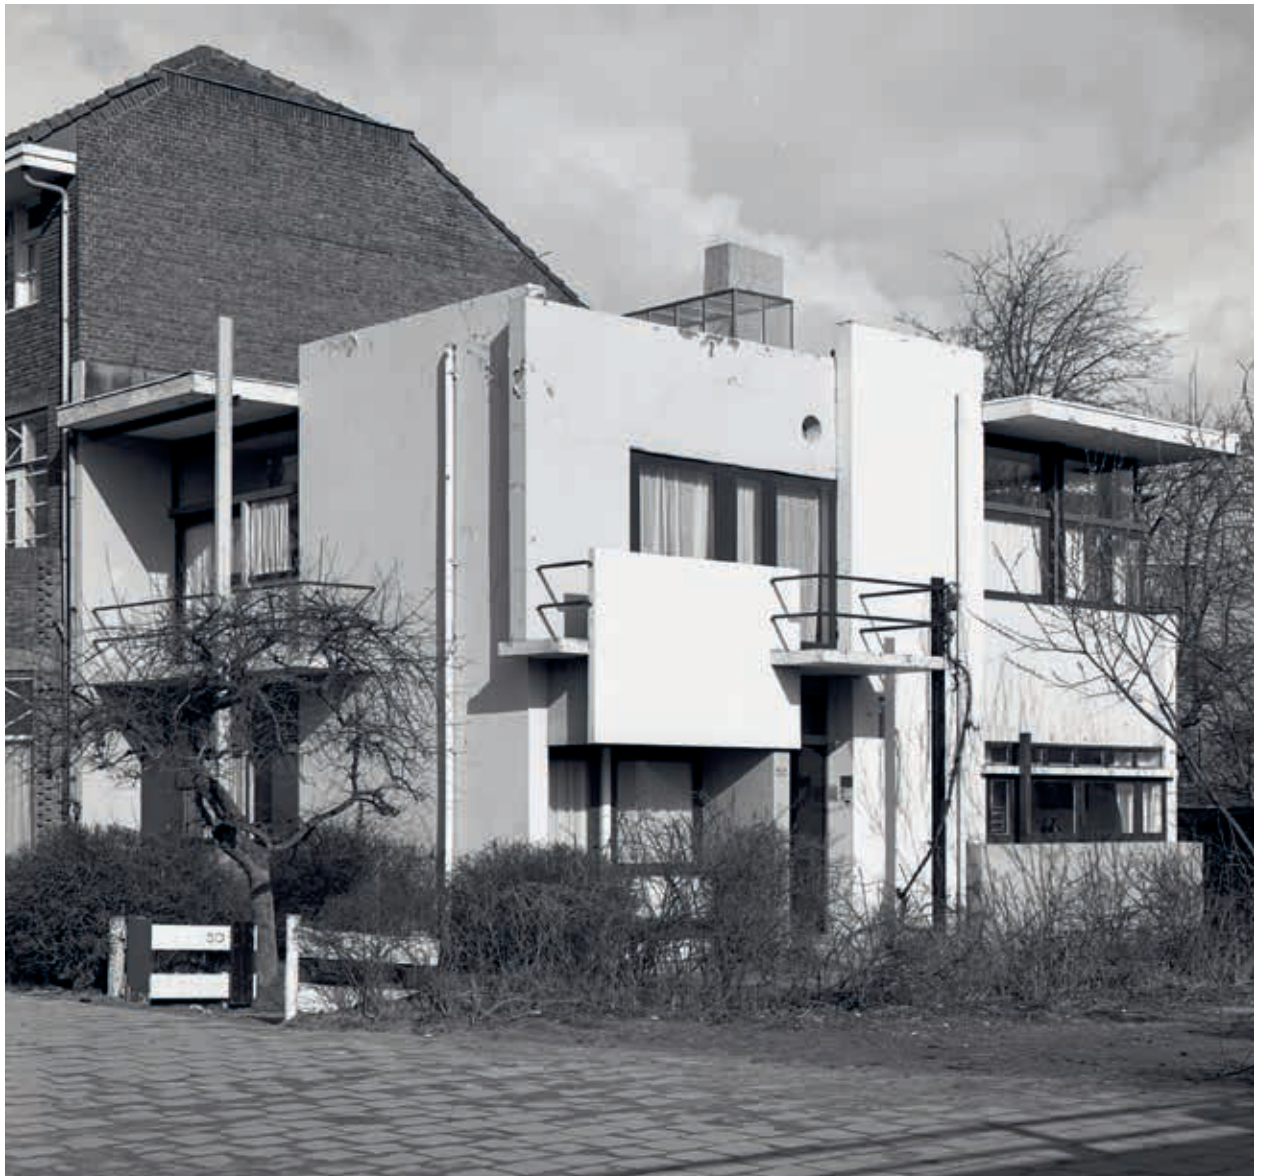
2. At the beginning of the 1970s the poor state of repair of the Rietveld Schröder House was clearly visible (Het Utrechts Archive)

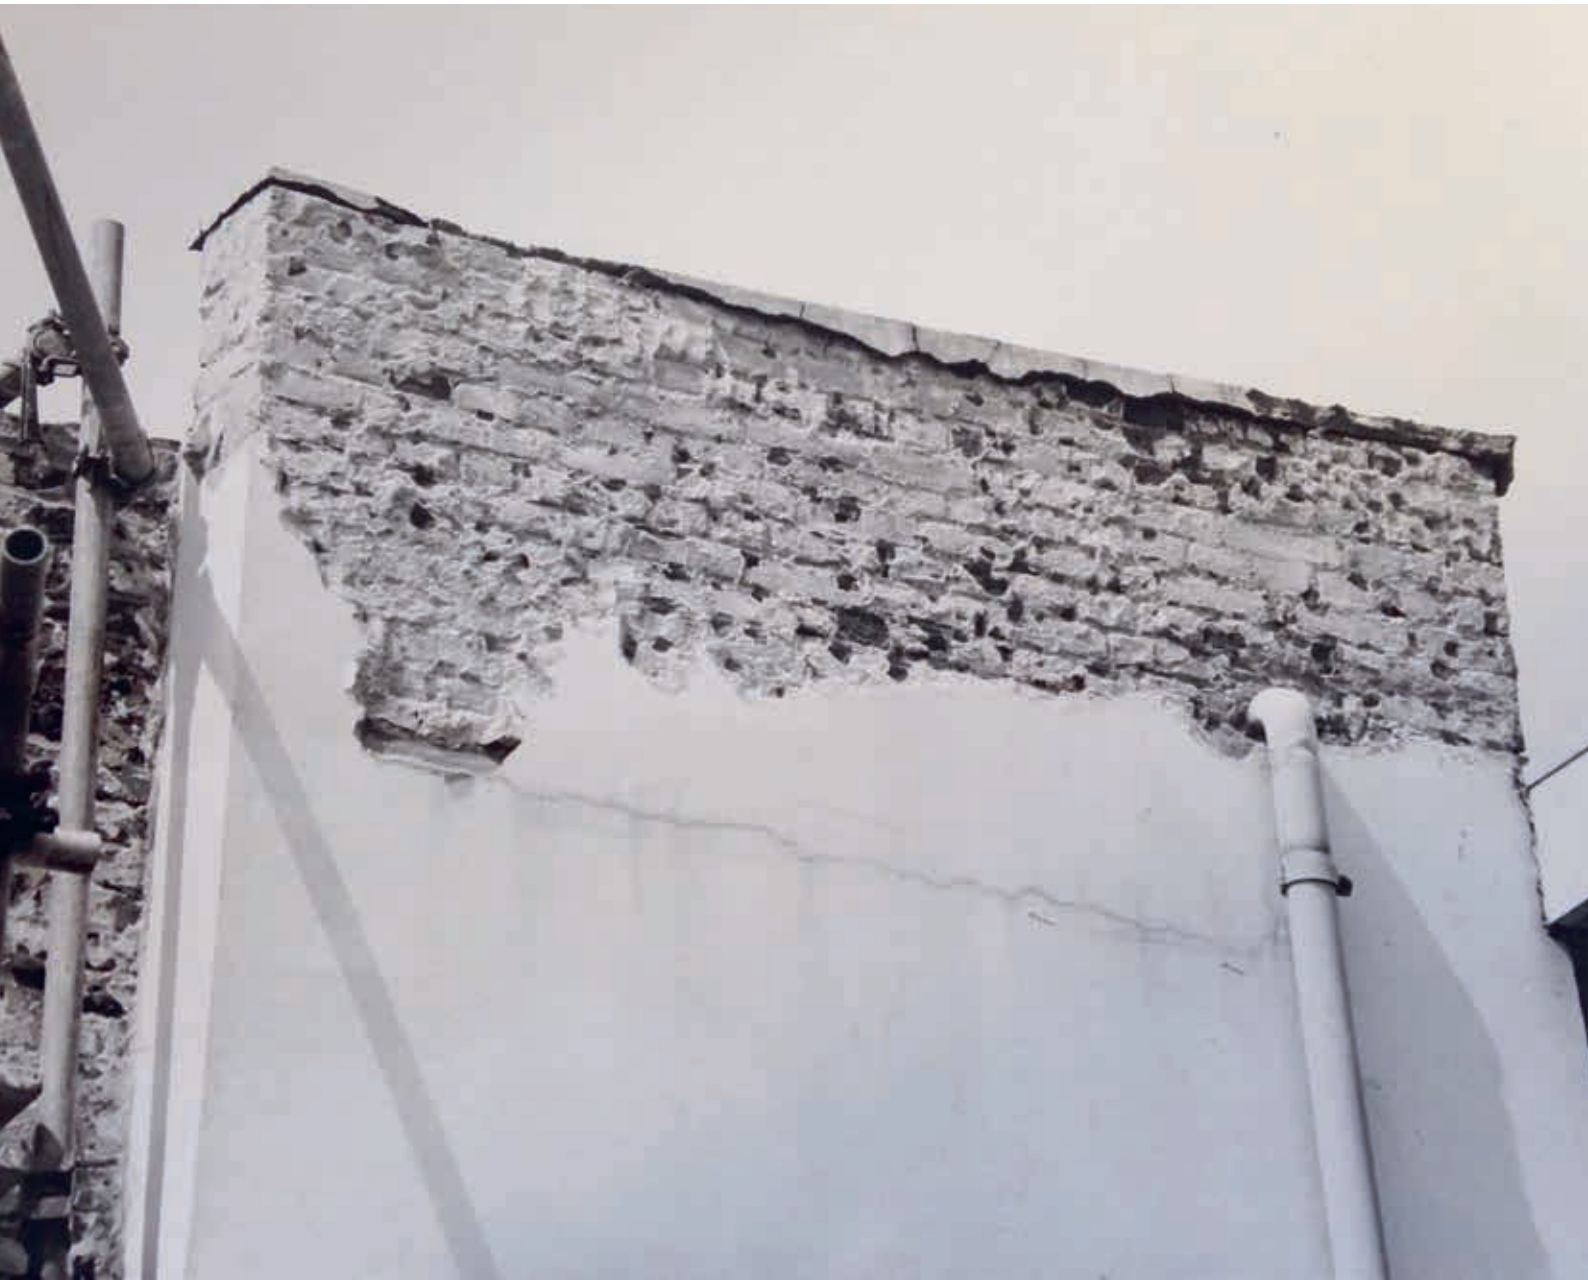
7. Only the render on the upper part of the white wall beside the front door of the Rietveld Schröder House was chipped away in 1979 (Bertus Mulder archive)

Recent research has shown that the problems with the plasterwork soon returned. The paintwork was again exhibiting cracks, the new coat of render had failed to adhere, and there were dark patches in the coat of paint. In October 1975, therefore, the new plasterwork was partially removed and redone. But the hairline cracks returned once more. Eventually, in late 1978, Mulder and the client decided to strip the problematical wall back to the brickwork. That substrate proved to be homogeneous and of reasonably good quality. The earlier repairs with synthetic mortar had held up well. Mulder's report on this (1980) contained a notable sentence: 'The other plasterwork that had remained in place during the restoration had to be removed as well in order to obtain a single homogeneous layer of render and to avoid bonding problems between old and new work.'<sup>21</sup> This statement would appear to imply that Mulder stripped all the walls and then had them replastered and repainted, which is what the photographs also appear to show (figs. 5 and 6). But if we examine the photographs more closely, we can also see areas with the render still intact, such as the wall below the ground-floor window overlooking Prins Hendriklaan. Mulder recently recalled that plaster remained in place on the wall beneath the kitchen window and on parts of the white surfaces of the front entrance wall and the rear wall (fig. 7)<sup>22</sup>

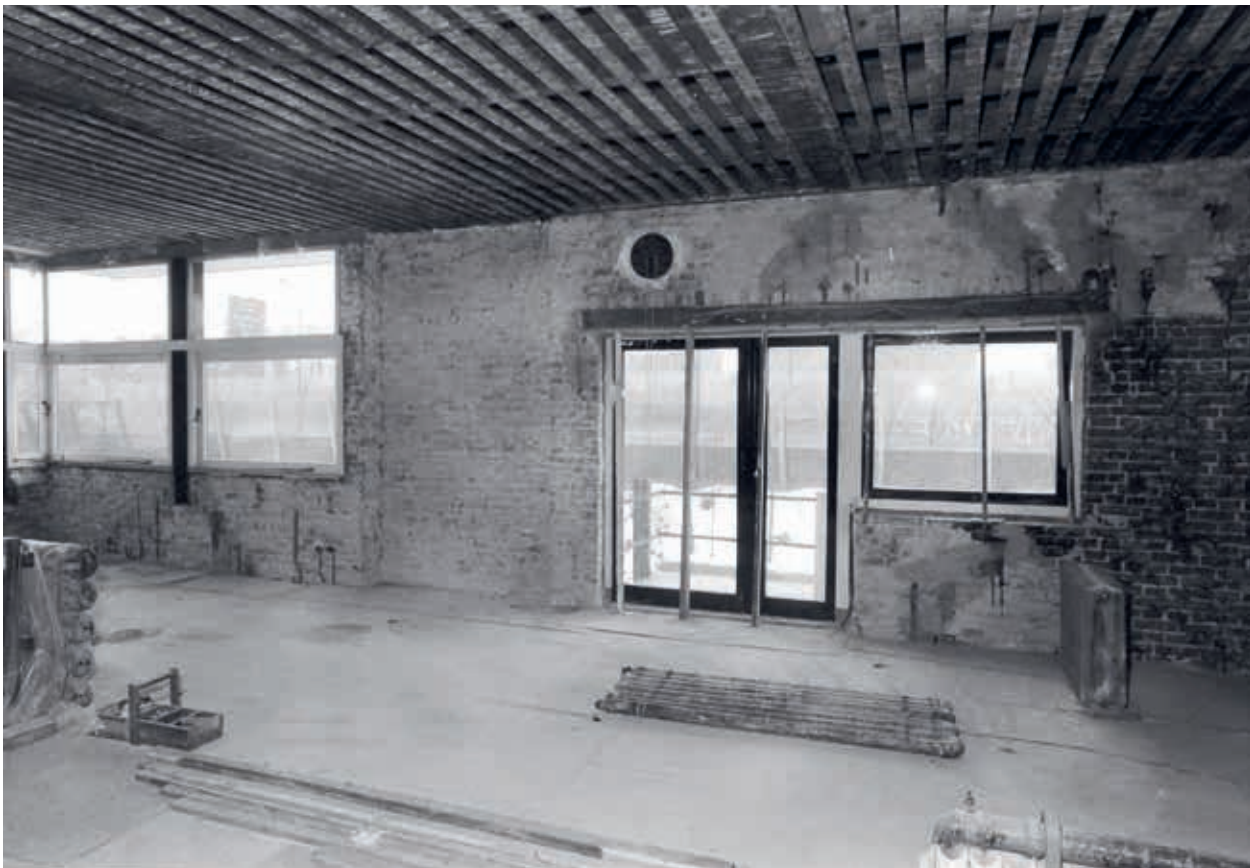
14. During the restoration of the upper floor of the Rietveld Schröder House in 1985-1986, Bertus Mulder completely stripped the walls and ceiling (Bertus Mulder archive)

Bertus Mulder had become so familiar with the house over the years that he knew exactly where to look for original traces and other clues of importance for the reconstruction. He set to work rigorously: the walls were chipped back to the bare bricks and the ceiling was demolished, after which the brickwork and plasterwork were repaired and renewed as with the exterior (fig. 14). Before allowing the old plaster to be carted away and destroyed, Mulder examined it with respect to colour and composition. The plasterer, H. van de Kant, prepared the new plaster using the correct composition and sanded the base coat 'with jute on a wooden board' in a circular motion in order to achieve the same grainy effect as under Rietveld.<sup>37</sup> Because the
