Project Ladysmith

Multidisciplinary Project

Delft University of Technology

Project duration: September 5th, 2016 – October 28th, 2016

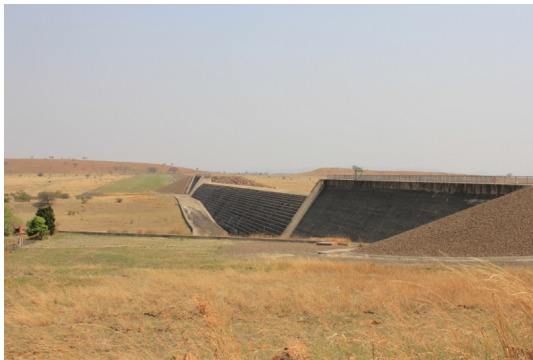
(a) The dam as seen from downstream

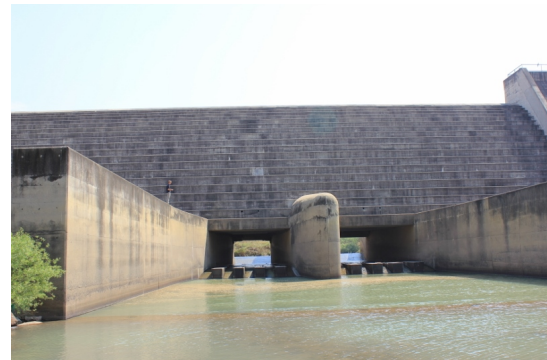
(b) Two uncontrolled bottom outlets

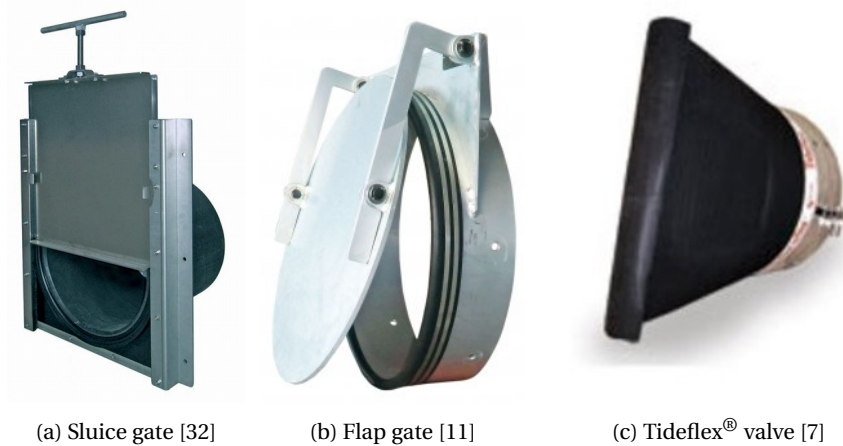
Tideflex[®] valves from the Red Valve Company, shown in Figure 4.7c, are basically a rubber construction with a curved bill that is normally closed. It is stated that they are sensitive enough to open with as little as 2.54 cm of pressure difference. They are supposed to be self-draining, need little to no maintenance, seal around small debris and have a lifespan of 35 years [38][36]. SSI proposed three different options to replace the storm water valves with Tideflex[®] valves [36]. From the 2011 report made by SSI on an assessment of the storm valves, done in October 2010, it is found that at that time not all the outfalls had been equipped with Tideflex[®] valves. This indicates that the municipality chose to execute one of the low-cost options proposed by SSI in 1997, see Table B.1. A comparable report made by Royal HaskoningDHV in 2014 shows that by then all drainage outlets were equipped with Tideflex[®] valves. However, that same report of 2014, shows that some of the Tideflex[®] valves have gapping valve bills "that could allow enough backflow at high river levels to adversely impact upstream roads and developments" [28]. This is often the result of incorrect installment or the accumulation of sand and debris in or around the valves, decreasing the functionality of the system (see Figure B.2). From field observations the same conclusion is drawn, see Figure D.9a for an example.

Figure 4.7: Pictures of valve types

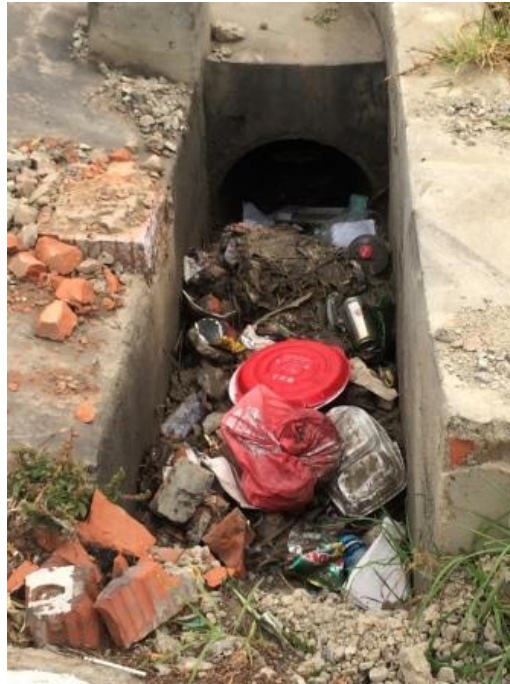
Another factor that might influence the drainage system is the sewerage system of Ladysmith. At some points the sewerage system is blocked and in a bad state due to a lack of maintenance [41] [44] [55] [49]. Sewage is then able to leak into open channels or the storm water drainage system, which discharges untreated to the Klip River.

Figure 4.8: Blocked drainage inlet CBD Ladysmith

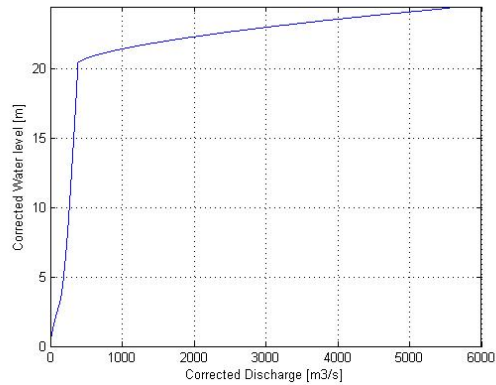
Figure A.3: Q-h relation large discharge

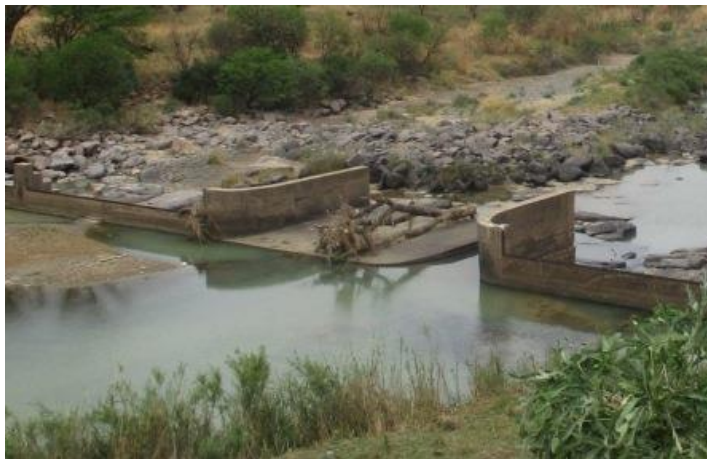
A second flow measurement station (V1H038) is located approximately 2.5 kilometers downstream of the Qedusizi Dam. The measurement station consists of a concrete weir structure covering the entire width of the Klip River. In the middle of the structure a spillway is placed through which water is able to flow. Furthermore, water can be stored behind the structure to a height of maximum 1 meter. As well as V1R005, station V1H038 contains a pressure gauge from which the monthly spill volume (m^3), the daily average flow (m^3/s) and instantaneous flow (m^3/s) are calculated. Figure A.4 shows an impression of station V1H038.

Figure A.4: Station V1H038

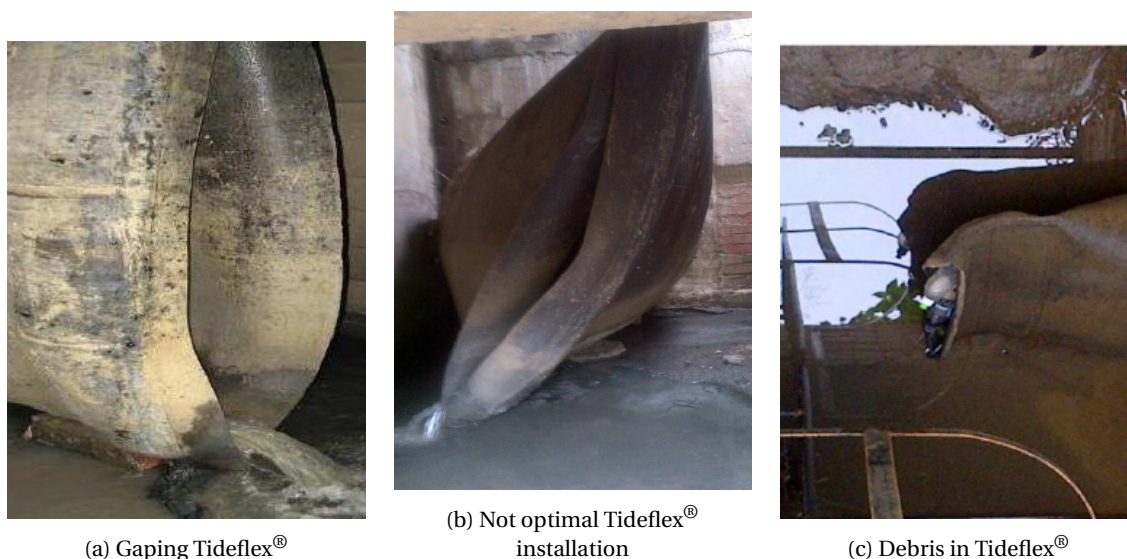
- Of the 22 chambers inspected, all of them were fitted with Tideflex® valves (see Table Table B.1).
- In the recommendation more regular maintenance with removal of debris and silt is advised, see Figure B.2c
- An additional conclusion is that some Tideflex® valves are gaping open, of which some deliberately kept open. installed incorrectly and some should be replaced, see Figure B.2a and Figure B.2b.

Figure B.2: State of some Tideflex® valves, from 2014 report by Royal HaskoningDHV

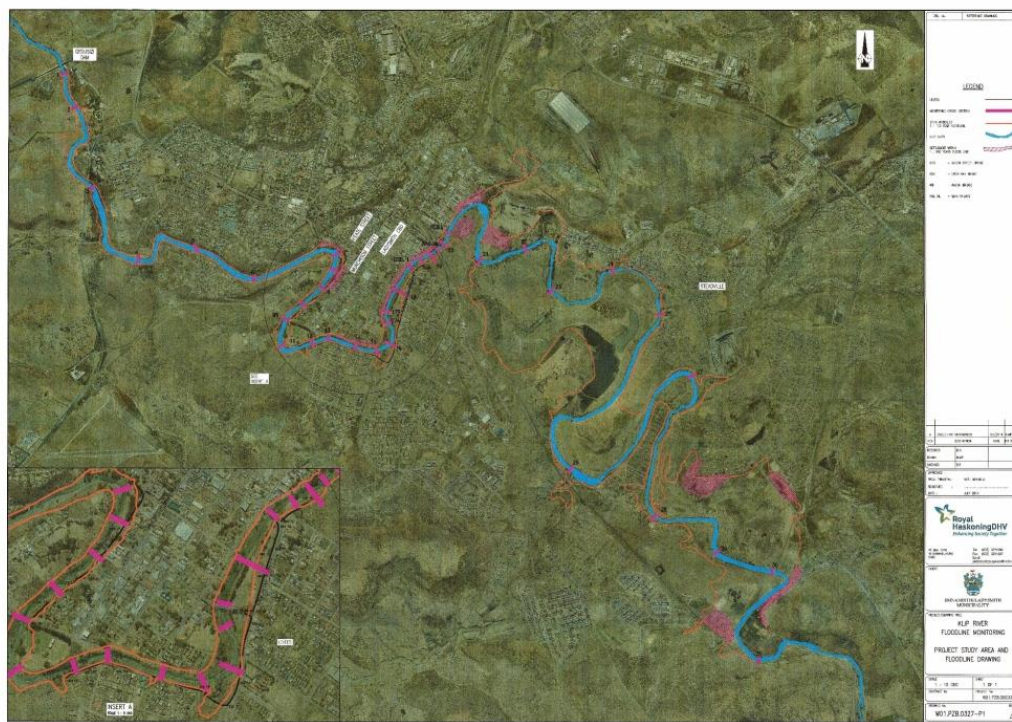
Figure B.3: Cross-sections of the floodline monitoring and backwater analysis

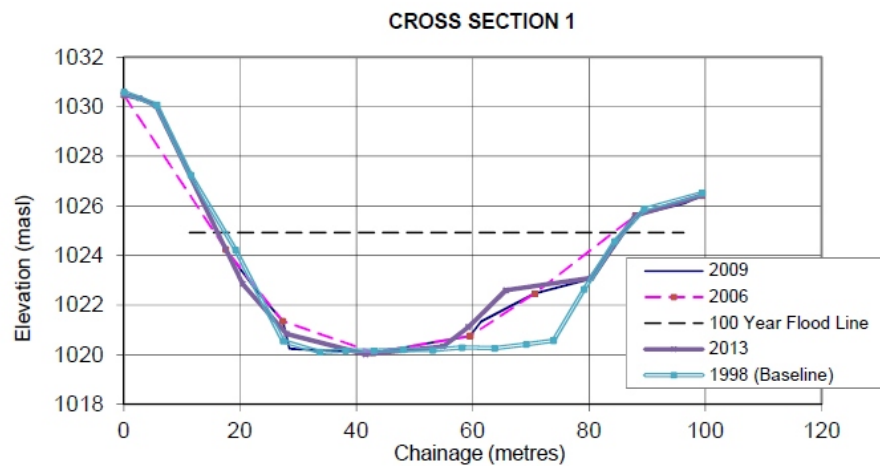
Figure B.5: Example of the cross-section survey

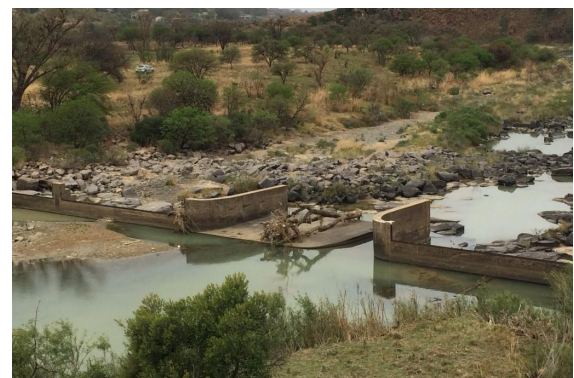
(b) Weir V1H038 including tree

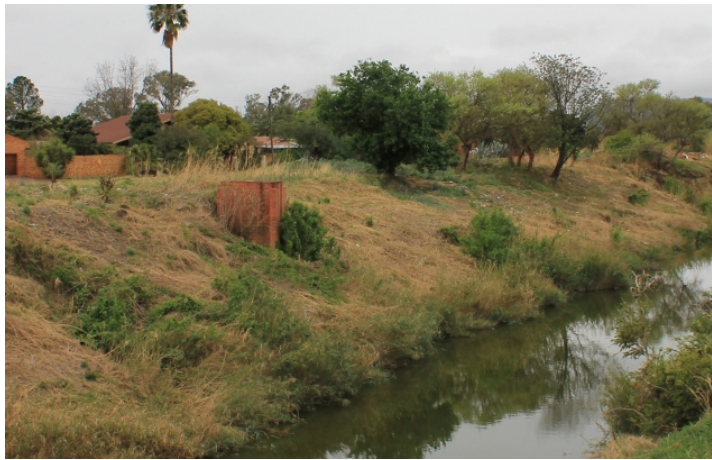
Figure D.7: Drainage outlet in Klip River

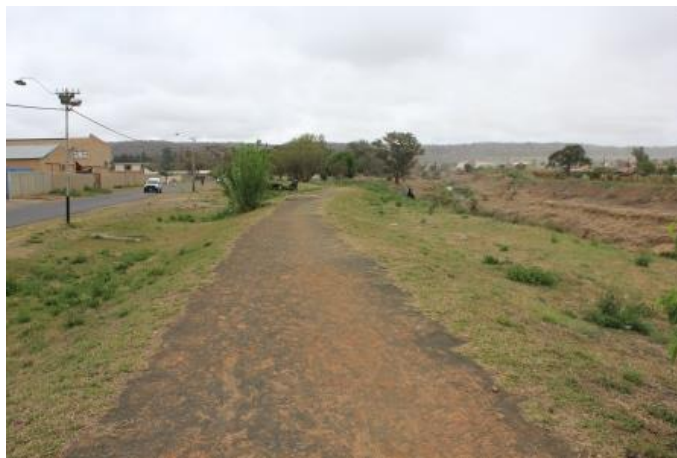
Figure D.8: Levees at one location along the CBD

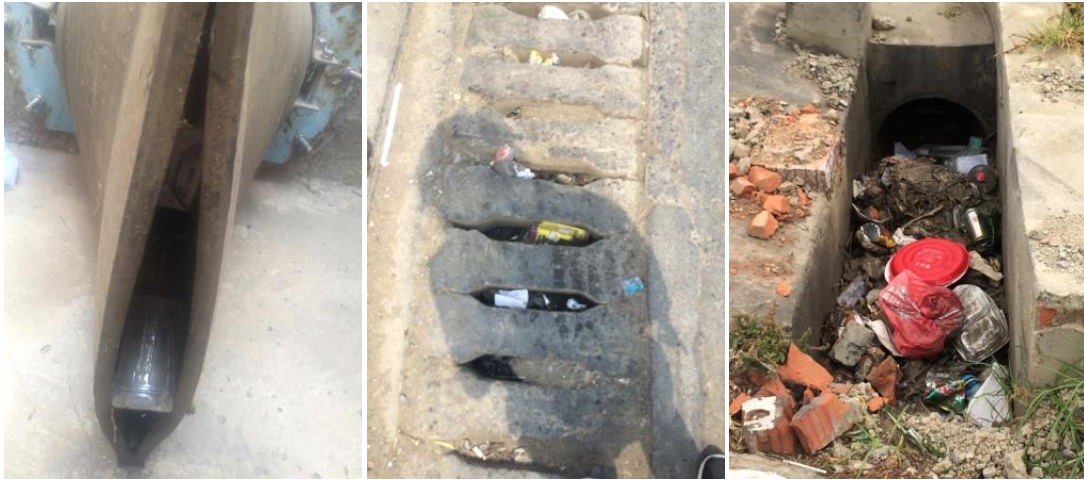
(a) Storm watervalue with debris
