# The Noble Patina of Age

W. J. Quist and A. J. van Bommel

**Abstract** This contribution discusses the aesthetic aspects of ageing and focusses on the use of the terms ‘patina’ and ‘damage’ to decide on the cleaning of historical facades and the application of artificial ageing. Conservation campaigns can be characterised by the wish to preserve an object, building or building complex as a coherent piece of cultural heritage. This contribution discusses the professional debate on balancing between preserving values, i.e. represented by patina and the need to intervene from a technical point of view. Cases of cleaning of limestone and sandstone, together with replacement of natural stone and the application of artificial ageing, are used to illustrate the debate. The perception of professionals is compared with the perception of laymen.

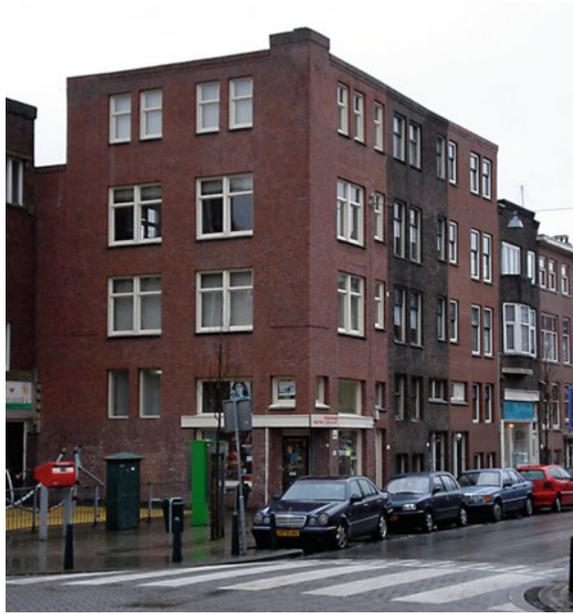
**Fig. 1** Although technically not necessary, visible traces of ageing are often removed, i.e. when cleaning brickwork facades (photo: W.J. Quist)

view—for restoration and reconstruction of the historical architecture. How the (Dutch) layman exactly fits in is not studied, but it is assumed that—looking at many neatly cleaned and restored houses—the majority of the Dutch fit into the second category (see Fig. 1). The boost of facade cleaning in the Netherlands went hand in hand with the renovation of late-nineteenth and early twentieth-century dwellings. Facade cleaning was, first and for all, part of the process in which old dwellings were upgraded to a level that was acceptable by modern standards, and therefore renovated dwellings had to look neat and clean.

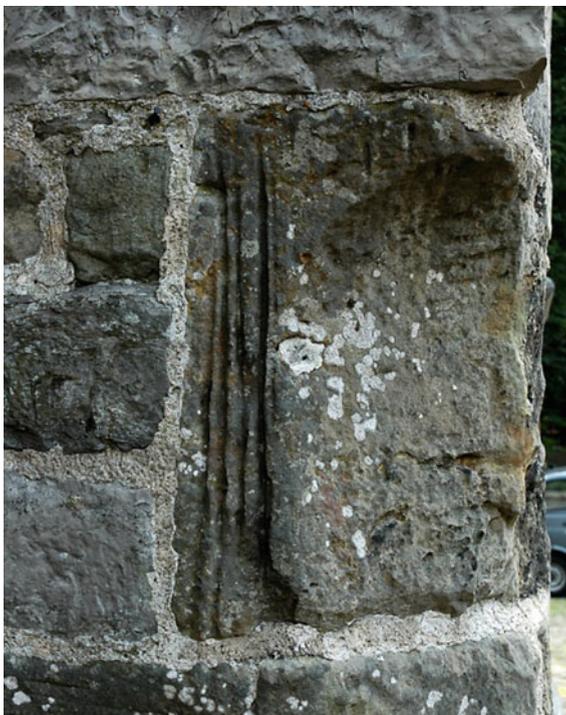
**Fig. 2** Highly valued man-made traces at St. Bavo Church Aardenburg (photo: W.J. Quist)

the individual in charge of the work” [24]. This article is often referred to in many ways to advocate the preservation of the ‘architectural layers’ in a historical building, but can it be used in favour of preserving a ‘patina’? Figures 2 and 3 show two different ‘traces of time’. Figure 2 shows carvings, used to sharpen a knife or to gather stone powder with addressed healing capacities, can be called ‘mechanical damage’, but, due to their historical meaning, the stone will never be repaired or replaced. Figure 3 shows a black crust on sandy limestone. Is this ‘damage’ as safe as the first one? Although it is a comparable trace of time, the latter will often be cleaned away, based on a hazy mix of technical and aesthetic reasons.

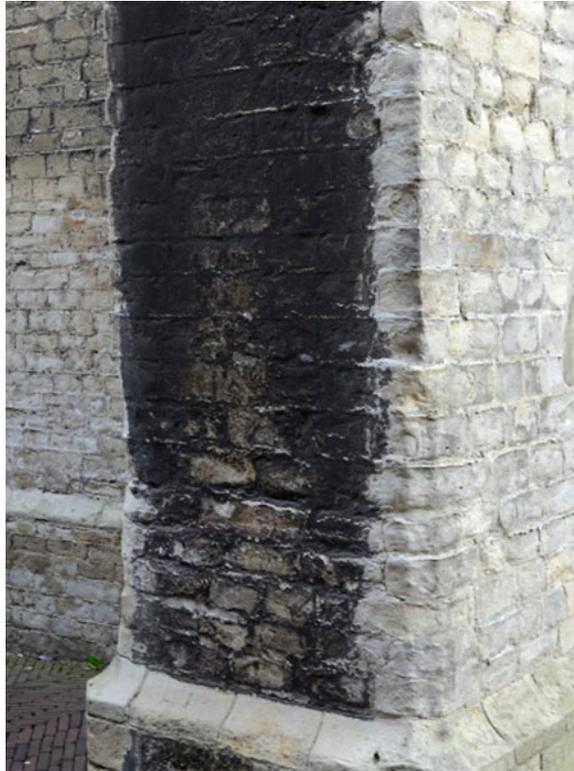
**Fig. 3** Black crust due to weathering at Old Church Delft (photo: W.J. Quist)

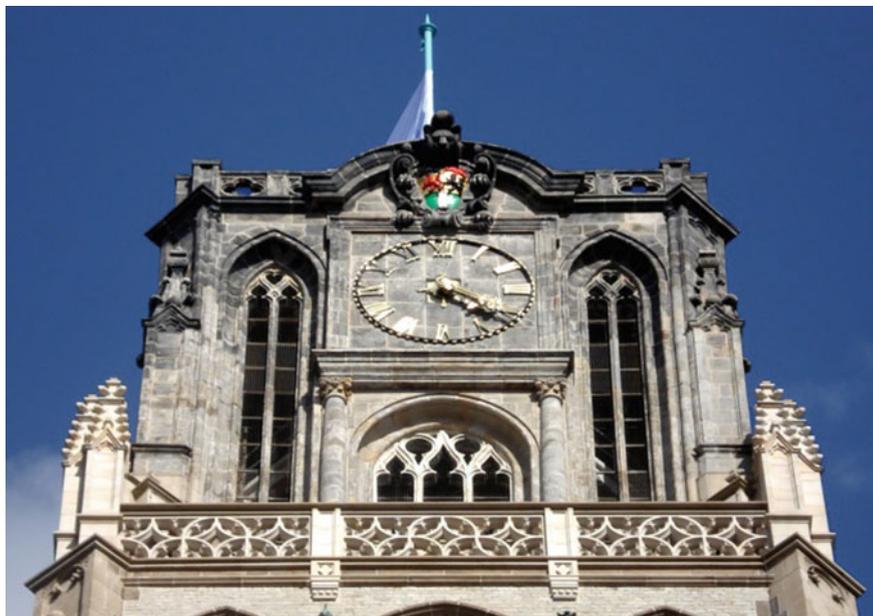
**Fig. 4** Application of an artificial patina on new sandstone to visually match old sandstone at St. Lawrence Church Rotterdam (photo: W.J. Quist)

the use of artificial products to colour came in use. Together with careful partial cleaning of old blocks of sandstone, the application of an artificial patina on the brightly yellowish-looking new blocks of Bentheim sandstone helped to unify the architecture of the façade of the Royal Palace in Amsterdam [30–34]. Figures 4 and 5 show the tower of the St. Lawrence Church in Rotterdam, which has recently been restored in sandstone. Partially, the new blocks have been aged artificially to aesthetically match the greyish old stones. The new sandstone for the balustrade and the pinnacles on the corners of the towers were seen as an architectural entity on its own and therefore not aged artificially.

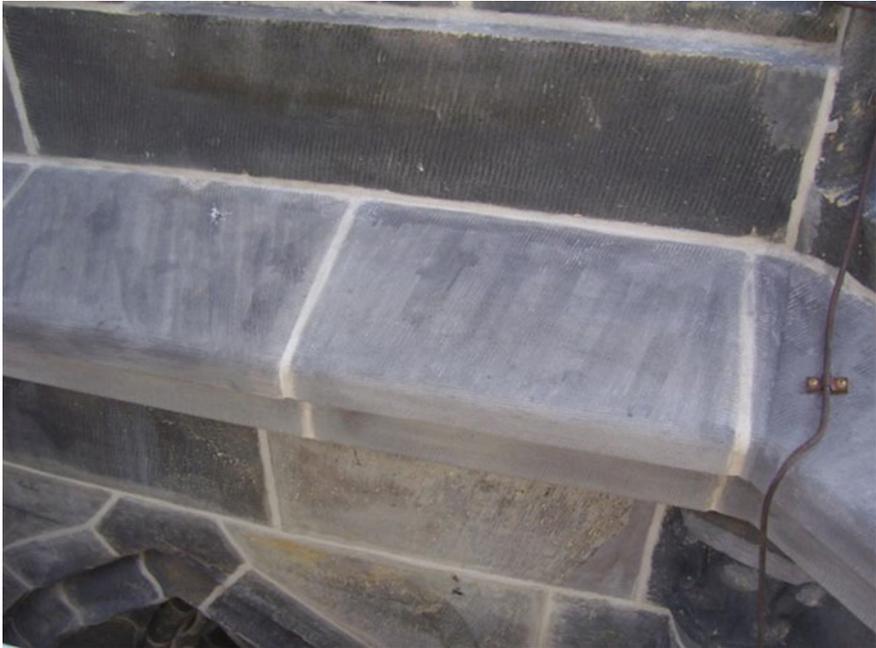
**Fig. 5** Detail of the artificial patina on new sandstone at St. Lawrence Church Rotterdam (photo: T.G. Nijland)

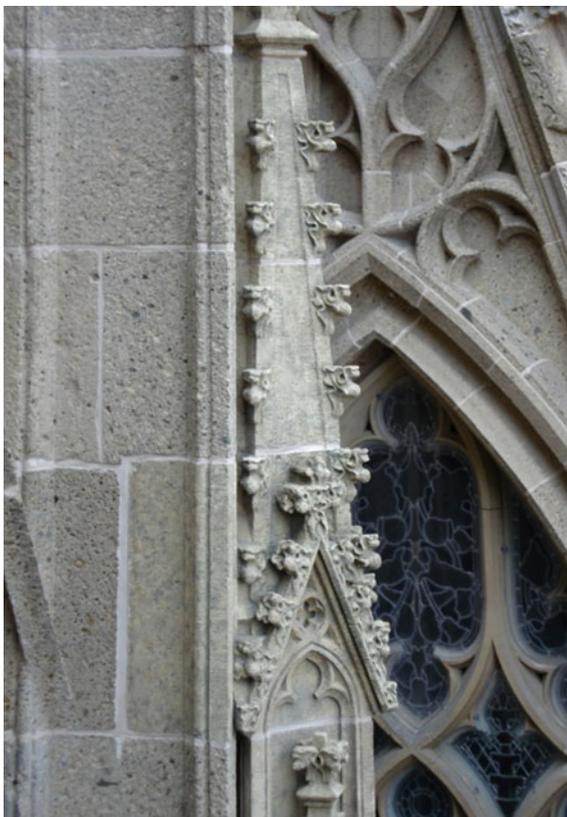
**Fig. 6** Colour on Peperino Duro to visually match Weiberner tuff stone at St. Johns' Cathedral, 's-Hertogenbosch (photo: W. J. Quist)

The technical possibilities of applying artificial ageing (i.e. with pigments fixated by ethyl silicate) imposes an ethical question. Can it also be used to colour a different type of stone to match its surroundings? Figures 6 and 7 show two examples of types of stone that were coloured to match their surroundings, not by anticipating its change of colour when ageing, but by altering its natural colour. Figure 6 shows a pinnacle in Peperino Duro coloured as it were Weibern tuff stone. A highly durable type of stone has been used and afterwards coloured to match. Is it fake, or is it an example of ‘making use of all possibilities there are’?

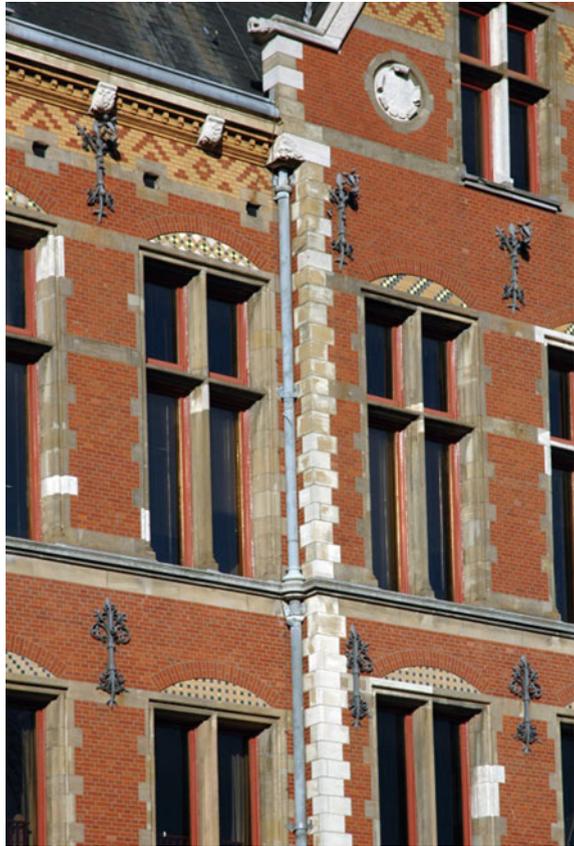
**Fig. 7** The applied artificial patina on limestone at the Central Station of Amsterdam has been washed away by rain (photo: W.J. Quist)

Figure 7 shows the effect of ageing of artificial ageing. Due to an almost complete ban on the use of sandstone from 1954 onwards, it was in many cases necessary to choose another type of stone for replacement of degraded sandstone [28, 29]. In the case of the Central Station of Amsterdam, white limestone with an

artificial colouring was chosen to replace brownish sandstone. After 25 years the colour on the limestone has been washed away, and both types of stone can easily be distinguished. This example clearly shows that aesthetics were once a reason to apply colour, but is this treatment repeatable, both technically and financially?
